# Failure Analysis and Field Failures: a Real Shortcut to Reliability Improvement

G. Mura, G. Cassanelli

Nice, Côte d'Azur, France, 27-29 September 2006

### **ABSTRACT**

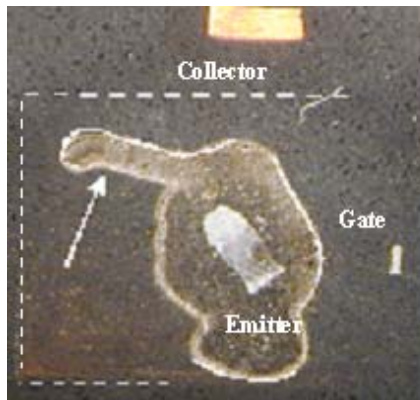
Fig. 1 Optical micrograph of the top surface after mechanical grinding. The dashed line defines the edges of the underlying chip. The view identifies the three sectioned metal connections (Emitter, Collector and Gate). The curvilinear lines delineate the carbonised plastic area, whose arrowed part belongs to the neighbourhoods of the original wire path.

The first set of hypotheses pointed towards sudden stresses, like EOS or ESD due to some transient event at the switching-on. An accurate Failure Analysis was then started to find the evidence of the real mechanism. The first attempt to remove the plastic package by mixed grinding and chemical etching revealed (fig.1) an extended thermal damage of the plastic itself all around the thick Emitter wire. Carbonisation of the plastic mould prevented from uniform removal of the package, but a first strong indication for a catastrophic overheating was obtained.

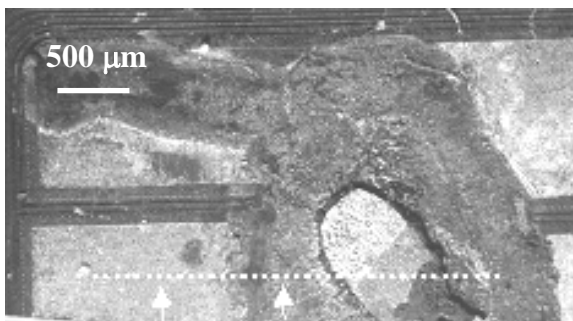
Fig. 2 DUT surface after the plastic removal. Pointed line indicates the direction of sectioning

The complete removal of the plastic package was then carried out (fig.2), together with a cross-section of the damaged area (fig. 3). As a result, all the fingerprints

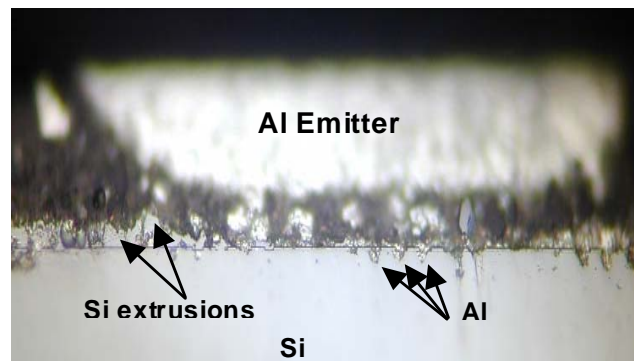
Fig. 3a General view of the sectioned area under the Emitter wire. Silicon extrusion into the Al metallization, and also Al intrusion into the Silicon crystal are displayed.

of Al-Si interdiffusion were present and manifest (fig.3 a,b,c):

- 1) the reverse Al pyramids, hanging from those parts of the top Silicon surface, laterally limited by the SiO<sub>2</sub> encapsulated polysilicon gates, where direct Al-Si contact makes the Emitter connection and
- 2) the Silicon precipitates inside the original upper Al thin film.

The key point is that the interdiffusion mechanism is not compatible with a sudden, transient phenomenon that would have resulted in fusion and chaotic re-crystallisation of the vertical structure. It should be argued that during the limited life of the device, an overcurrent was allowed to flow, undetected, able to expose the die to excessive temperature.

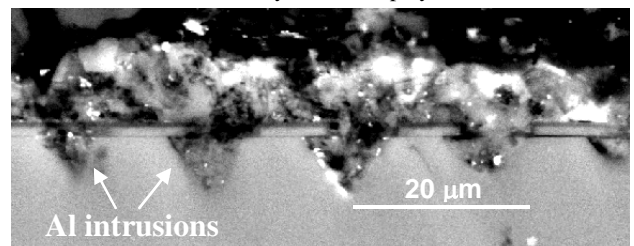
Fig. 3b SEM Detail of the Al intrusions. The polyhedric shape of the Al-filled cavities is a fingerprint of solid-state interdiffusion of Si into the overlying metallic thin film.

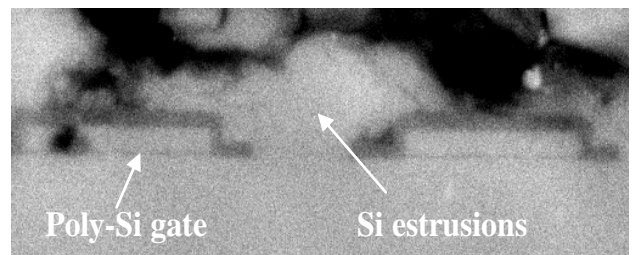
Fig. 3c SEM Details of the Si extrusions. The polysilicon gates (encapsulated in  $\text{SiO}_2$ ) look intact.

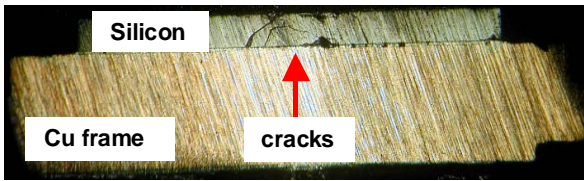
Fig. 4 section of the chip/thermal sinks structure. The cracks roughly crowd along the expected current/heat flux lines from the upper Emitter wire contact to the lower Collector surface.

The origin of the overcurrent may be inferred by the statistics for IGBT devices, that indicate the latch-up mechanism as one the most frequent problems. The uncommon situation here is the relatively long survival of the device, up to its ultimate and irreversible short circuit, witnessed by the shown interaction at the wire contact and by the cracking of the die (fig.4).

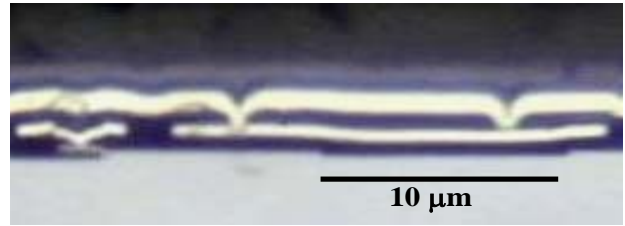
Fig. 5 Optical view of a cross sectioned device

A preliminary characterization of a device of the same lot revealed the structure of the multiple metal layer, where a very large upper metal layer (fig.5) run over the most part of the peripheral circuitry.

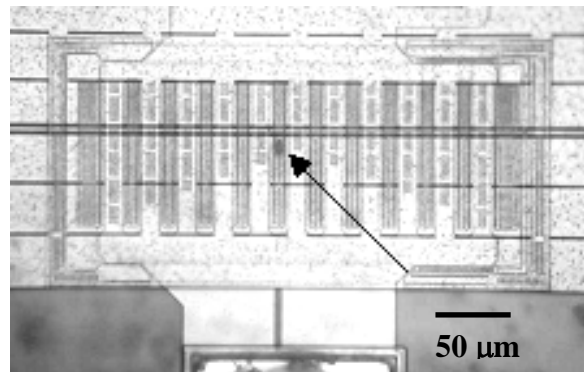
Fig. 6a General view of the surface of the failed input pin of the first chip, upon removal of the plastic package. The arrow points to a small “burnt” area.

At a first glance, the optical inspection of the surface of one of the failed chips only showed minor damages (fig.6a), ill proportioned to the severity of the measured short-circuit: only a very small area showed some “burning” at the top metal layer in the region of the most

strongly failed input pin. No other evidences were found across the whole chip.

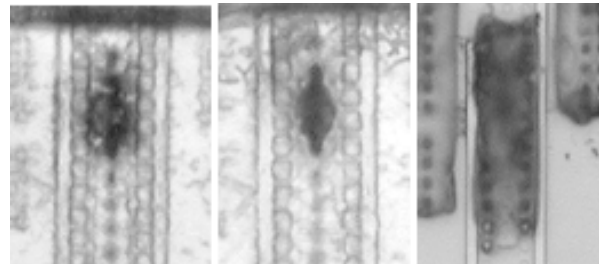
Fig. 6b Optical micrograph of the damaged area after sequential removal of polyamide (left) and nitride passivation (middle), and finally after HF (right)

Some new information came during the chemical delayering of the device (fig.6b): at the “burning” place, the nitride etch opened a hole into the upper metal layer, and the HF etch was not able to remove some islands of the lower metal layer. In general, this would be not strange at all, because some mix between silicon and aluminium, oxygen, possibly nitrogen and other elements is a normal effect of a thermal excess (fusion). The anomalous thing is that nothing looks melt: the upper metal layer displays a hole with indented boundaries, and the surviving “islands”, rich of Silicon as expected, simply preserve, like a cast, the shape of the original aluminium, with its edges and reliefs.

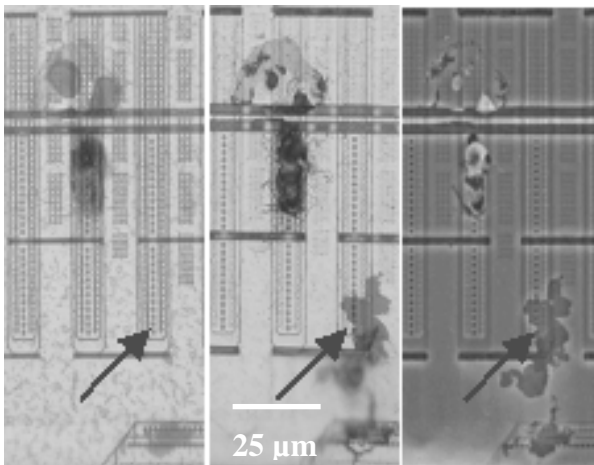
Fig. 7 Optical view of the damaged area after selective polyamide (a) and nitride (b) removal. The SEM image corresponding to b is displayed in (c). The arrows point the interdiffusion region on the top metal layer.

The situation was even more evident on a second chip, where some more extended damage was observed at the surface of the failed pin. It is pointed out by the arrows in fig.7. The etch of the nitride passivation opened a hole (fig.7b) where the upper metal layer seemed intact (fig.7a). The edges of the hole strictly recall a polycrystalline structure, as expected for the aluminium layer. In fig 7b, and even more clearly in the SEM figure

7c, the hole shows an intact lower level metallization or, at least, a layer that preserves the original forms of that layer.

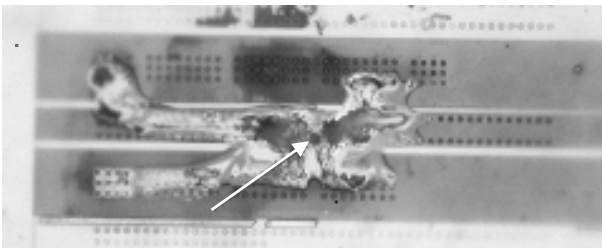
Fig. 8 (a) Optical view of the damaged area after complete HF etching.

Upon HF cleaning of the surface (fig.8), the evidence arose for a central, small spot (arrowed) into Silicon from which a “Si-fountain” sprung from the substrate into the metal layers, branching into four different directions. This ultimately allows, with the aid of fig.7 that compares the same region at different etching levels, to individuate the connection of the different structures of the damage: Silicon (amorphous) was present at the top metal level, which caused its removal under the etch of the passivation, while Aluminium penetrated the Silicon bulk, and was removed during the HF etch.

The relevant point is the casual occurrence of the discharge at some internal point of the circuits, but always under the wide upper metal layer. This suggested the possibility that not an I/O instability could cause the damage, but some capacitive coupling of the large parasitic capacitor, made of the upper metal layer and the substrate, and some huge electromagnetic disturbance near the device. The presence of a power switch very close to the board mounting the failed devices moved to introduce some specific protection (electrical shield and increased spacing between the critical elements), and the result was the complete disappearance of the problem.

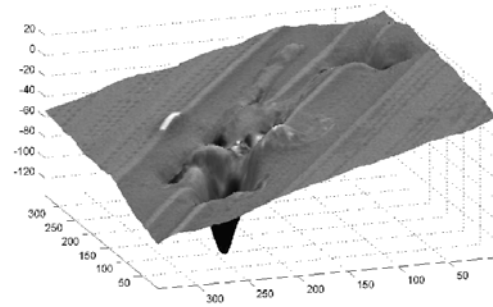
Fig 8(b) SEM 3D reconstruction [2] of the same detail, showing the central source of the Si material.

A 3D reconstruction [2] of the SEM images of the exposed Silicon surface (fig.8b) clearly shows the deep penetration of the damage (the interdiffusion “fountain”),

This is the other side of that same Al-Si interdiffusion phenomenon that appeared for the IGBT analysis. In this case, indeed, not the Al penetration into Silicon, but the progressive substitution of Al by Si atoms, coming from some deep contact point, to be found, is displayed. It is the same phenomenon whose seeds have been indicated for the previous IGBT case as “Si extrusions”. The phenomenon is quite known, but it is always amazing to see the capability of Si to completely substitute Al, even preserving the shape of the metal layer.

It should be noticed as, once again, the evidence for Al-Si interdiffusion does NOT state that it is the root failure mechanism: the small spot clearly addresses towards ESD. Anyway, it is a secondary consequence, whose occurrence witnesses that the device operated a relevant time after the first failure firing before reaching the short-circuit state that flagged the failure.
