Simultaneous monitoring of a collapsing landslide with video cameras

K. Fujisawa and J. Ohara

Public Works Research Institute, Japan

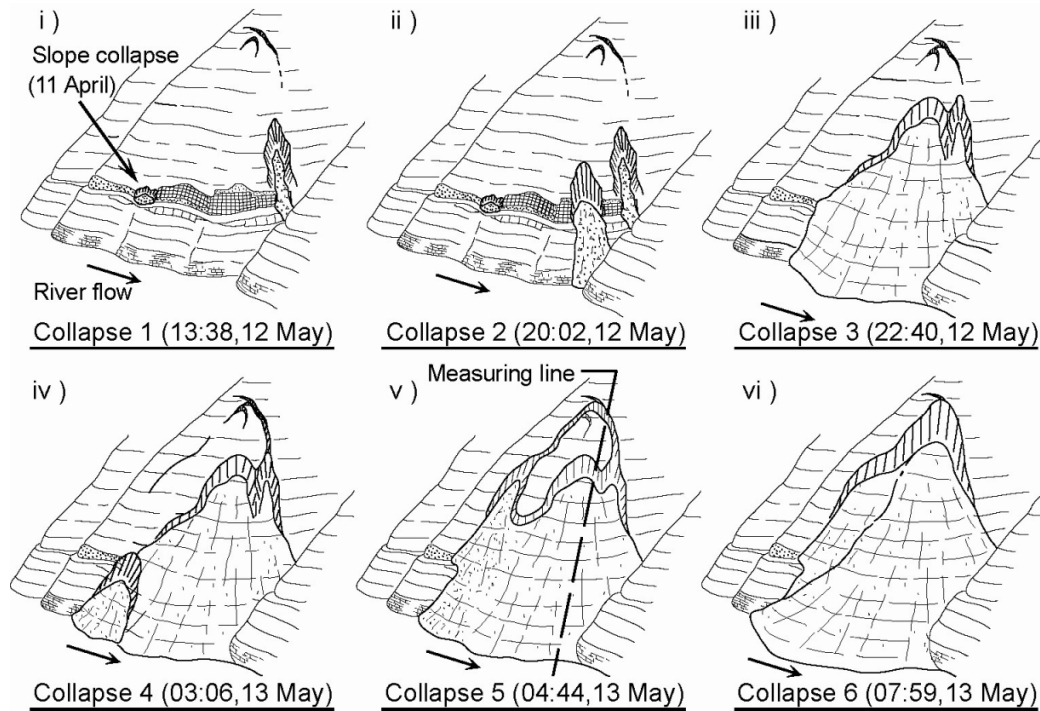
The analysis of images before and after the landslide showed that the slope collapse involved debris in excess of 1000 m³, and that six separate landslide events occurred. Figure 2 shows sketches of each landslide event, numbered 1 through 6. Based on analysis of the images, the sequence of events leading to the landslide is thought to be as follows:

1. Slope collapse is confirmed on the slope next to the road on the mountain on 11 April. A major crack is identified at the top of the slope on 21 April. A slope collapse of approx. 2000 m³ (Fig. 2i) occurs near the downstream extension of the crack at 13:38 on 12 May.

2. Several minor falling rock events occur in the region of Collapse 1 followed by a further slope collapse on 11 April. A second slope collapse of around 1000 m³ (Fig. 2ii) occurs at 20:02 on 12 May a short distance upstream of Collapse 1.

3. A steady succession of falling rock and slope collapse events begins at 22:23 on 12 May, in the vicinity of Collapses 1 and 2, leading to a major slope collapse of approximately 10 000 m³ at 22:40 (Fig. 2iii).

4. After a brief hiatus following Collapse 3, the next major slope collapse (Fig. 2iv, estimated at 1000 m³) occurs at 03:06 on 13 May near the foot of the slope on the upstream side. Due to the camera angle and poor visibility at night, the images provide only limited detail, although evidence of localized tree shaking suggests that the crack at the head of the landslide was beginning to extend upstream of the slope.

5. A further slope collapse (Fig. 2v, 1000 m³) occurs at 04:44 on 13 May on the slope further up the slope from Collapse 4.
6. Falling rock and slope collapse events begin at approximately 07:40 on 13 May on the middle and lower part of the slope and become more frequent, culminating in a major slope collapse (Fig. 2vi, 40 000 m³) at 07:59. This is followed by more falling rocks and minor collapses, but without any further significant topographical

Fig. 2. History of collapses.

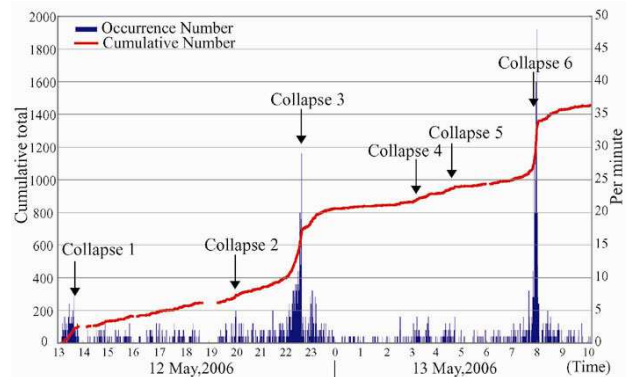
Figure 3 shows the count of falling rock events, slope collapses and fallen trees. Prior to the six major collapses, the frequency of these events steadily increased. The rate of increase was particularly pronounced prior to the two largest collapses (numbers 3 and 6).

Fig. 3. Other events – falling rocks, slope collapses and fallen trees.

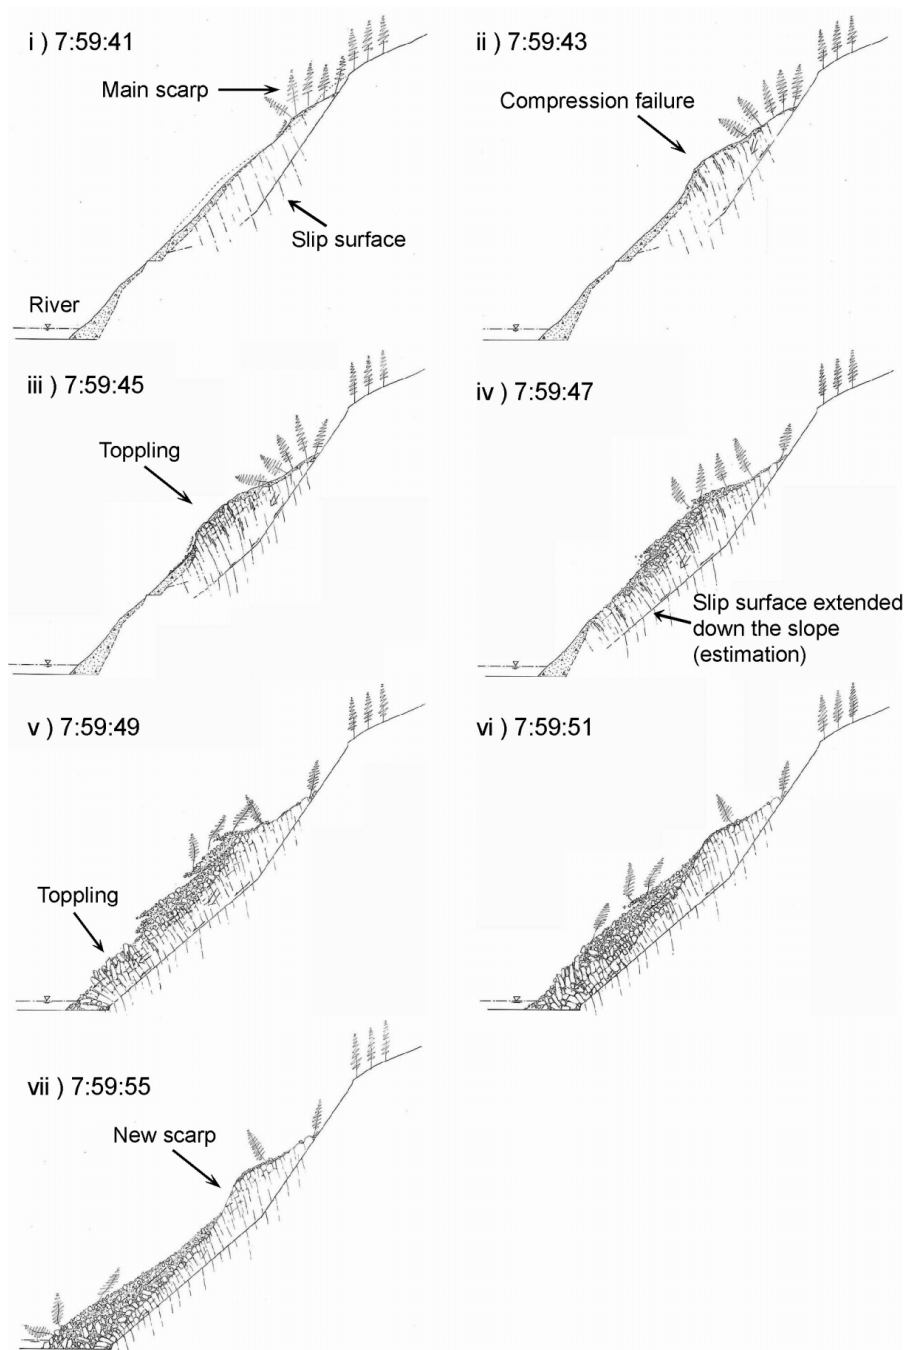
Figure 4 shows the results of sketches made for about 20 s during the movement of Collapse 6 shown in Fig. 2 (occurring at 7:59 a.m. on 13 May), the largest slide that occurred while the landslide moved.

As shown in Fig. 4, the section diagrams were estimated based on several images taken from some different angles representing the 20 s from 07:59:35 to 07:59:55 on 13 May. These section diagrams were prepared along the measuring line shown in Fig. 2v. These were used to study the state of change of the moving soil mass accompanying the movement of the landslide.

The results showed that cracks formed in the landslide body located below the main scarp at the time of Collapse 5, and the collapse expanded from that location. When the landslide started to move, many collapses began to occur along the edges of the landslide (head – side/toe) (Fig. 4i). The movement of the landslide is thus assumed to be accompanied by a toppling movement (Fig. 4ii–iii). Afterwards, the head to the middle of the landslide body was crushed, resulting in the formation of debris deposit. (Fig. 4iv) As this debris deposit covered the entire lower part of the slope, the toppling was confirmed at the toe of the landslide (Fig. 4v–vi). It is presumed that the toppling occurred at the toe of the

Fig. 4. History of collapses during sliding of Collapse 6 (occurring at 7:59 a.m. on 13 May).

landslide because the stress produced by the movement of the landslide reached the lower part of the slope. The landslide body remained near the top of the slope; however, because the collapse flowed downward with the toppling, a new scarp was formed near the center of the slope (Fig. 4vii).

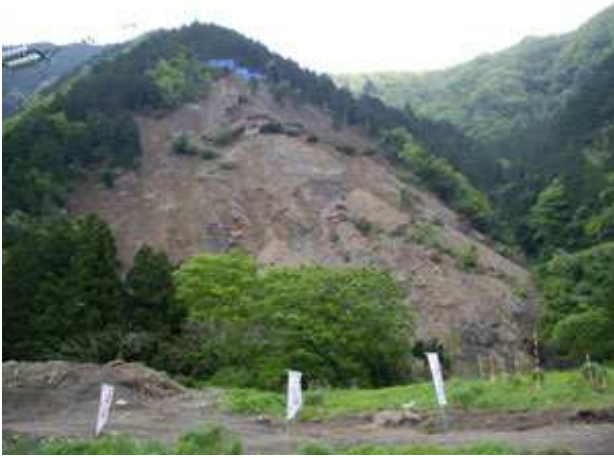
approximately 150 m in width by 135 m in height, with a volume of approximately 250 000 m³ (Fig. 5).

Fig. 5. General view of the landslide site (14 May 2006).

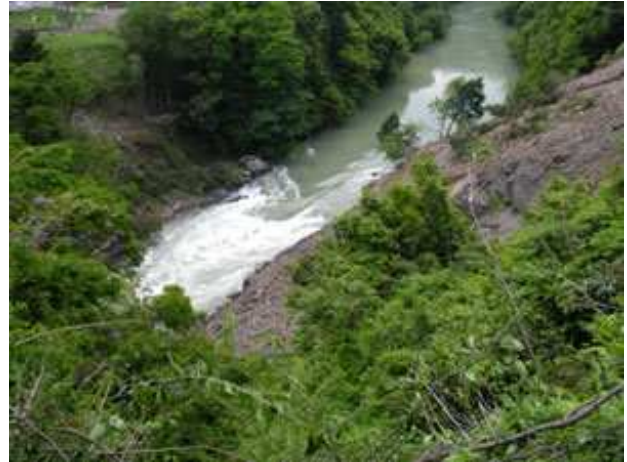
Image analysis, together with field measurements using a ground-based laser scanner after the collapse, indicated that the landslide produced a total of 50 000 m³ of debris. It flowed into the river during the landslide. As Fig. 6 shows, this blocked some two-thirds of the width of the river, and also caused damage to several local roads, but most of the landslide body remained on the affected slope.

Fig. 6. Debris deposits in the river course (14 May 2006).
