Seismic vulnerability of dwellings at Sete Cidades Volcano (S. Miguel Island, Azores)

A. Gomes, J. L. Gaspar, G. Queiroz

A. Gomes, J. L. Gaspar, G. Queiroz. Seismic vulnerability of dwellings at Sete Cidades Volcano (S. Miguel Island, Azores). *Natural Hazards and Earth System Sciences*, 2006, 6 (1), pp.41-48. hal-00299244

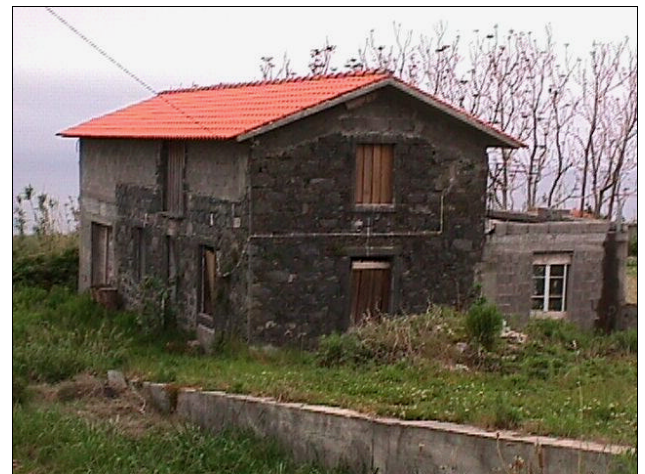
however the majority of the recent houses are built with blocks of concrete mixed with fine volcanic materials, such as basaltic lava and scoria fragments. Another point that came up during the field survey was related to the observation that several old dwellings had suffered recent interventions, in most of the cases to increase the number of rooms or even floors. For example, it was detected that some dwellings have sections where the external walls are made from loose or weakly cemented stones, while other sections are built with concrete blocks (Figs. 8 and 9). Houses in these conditions were considered to be of class A, due to the different behaviour of the structure in response to a seismic solicitation.

Fig. 8. Dwelling with external walls in stone and in concrete blocks.

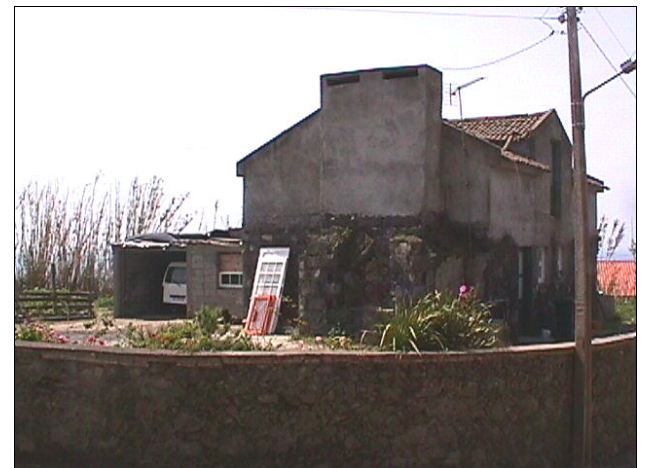
Fig. 9. Dwelling with external walls both in stone and in concrete blocks.
