Tsunami vulnerability of buildings and people in South Java – field observations after the July 2006 Java tsunami

S. Reese¹, W. J. Cousins², W. L. Power², N. G. Palmer², I. G. Tejakusuma³, and S. Nugrahadi³

¹National Institute of Water and Atmospheric Research (NIWA), Wellington, New Zealand

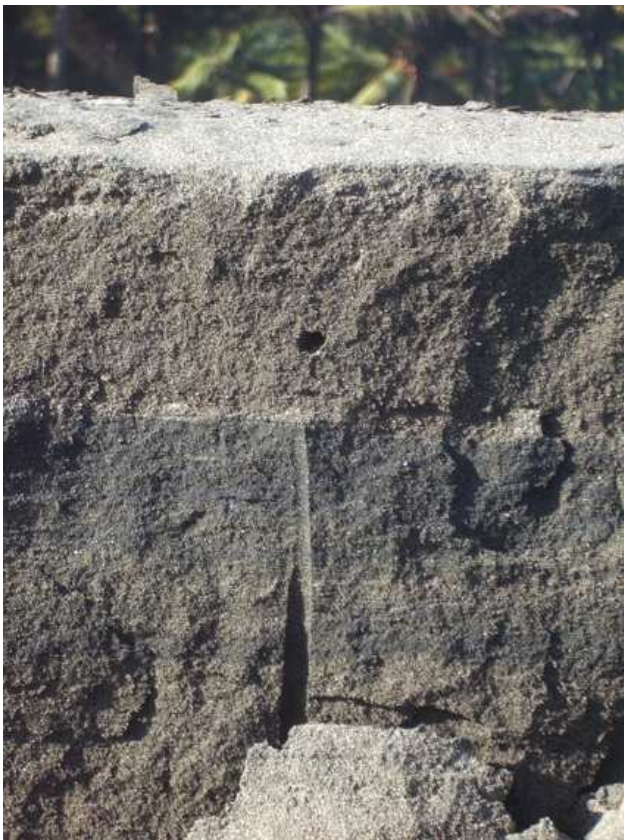
Fig. 3. Sand deposit left by the tsunami.

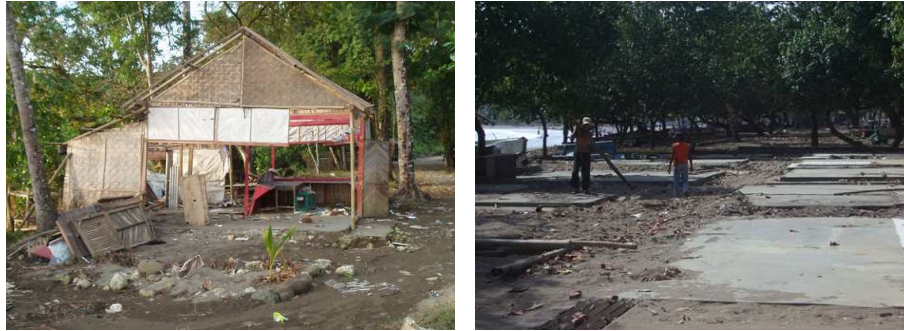
Performance of these structures was on average poor with a few exceptions, for instance where buildings were on strong piles. In nearly all cases a flood depth of less than a metre (above floor) caused light to moderate damage, 1.5 to 2 m resulted in roughly 70% destroyed and 30% lightly to heavily damaged but repairable, and a depth exceeding 2 m essentially caused total destruction (Fig. 11).

Fig. 11. Typical damage to semi-permanent wooden shops, after inundation to nearly 1 m depth (a) and to 3 m (b). Only the concrete floors remain in the right image, where prior to the tsunami there had been a row of more than 30 shops.

In Pangandaran the band of severe damage was not more than about 50 m wide, typically comprising a row of timber shops along the beach plus one or two rows of buildings separated from the shops by the beach street (Fig. 11, right image).

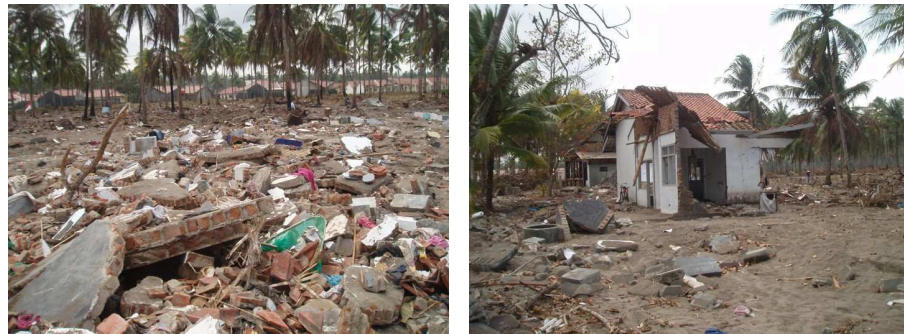
Many of the single story residential structures and shops were made of unreinforced brick walls on concrete foundations. The construction was weak, with single-skin brick walls, often plastered on both sides. The vast majority of roofs were covered with clay tiles, a few with corrugated steel sheets. The observed damage levels were not much different from the timber/bamboo ones (Fig. 12).

The main difference was that slightly more houses remained upright where the flood depth was greater than 2 m. But most of them seemed not repairable apart from the concrete floor which often remained intact.

Fig. 12. The remains of traditional brick houses after inundation to a depth of ca. 3 m (a). There were a few partially intact (b).

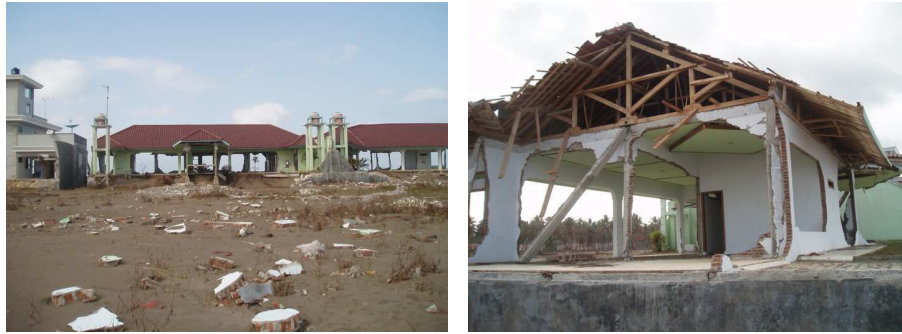
The non-engineered masonry structures had rudimentary reinforced concrete columns, and single-skin infill brick walls that were often plastered on both sides. Buildings typically had concrete floors and were one and two-storey houses and shops. Columns ranged from 100 mm × 100 mm with 4 wires of 3 mm diameter, to 200 mm × 200 mm with 4 smooth bars of 8 to 12 mm diameter at the four corners. The walls suffered punching shear failure, often with holes punched through multiple walls. Even though the reinforcement was rudimentary, it improved the performance significantly. The observed damage levels were

- <1 m of water – minor damage only,
- 1.5 to 2 m of water – light to moderate damage (repairable), and
- 3 to 4 m of water – serious damage, but buildings upright and probably repairable (Fig. 13).

Fig. 13. Two relatively well-made apartment complexes (a) with rudimentary reinforced concrete columns (b), after inundation to a depth of 3.8 m.

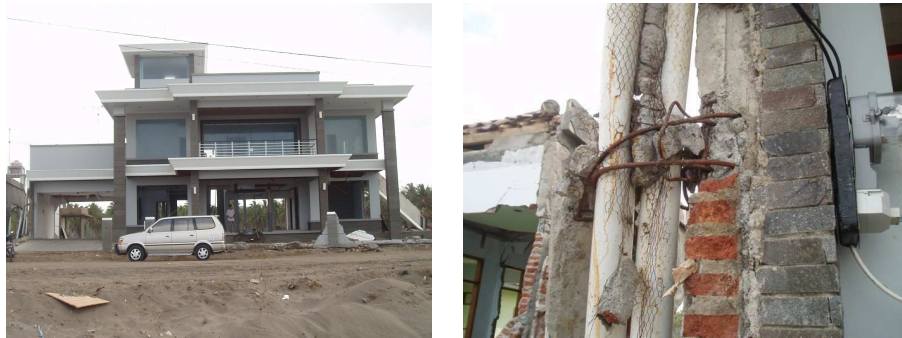
These robust constructions were the predominant structure type for hotels, but also some shops and houses. Often with two or more storeys, they had brick infill walls with plastering on both sides, reinforced concrete columns of at least 200 mm × 200 mm, at least 6 bars of 12 mm reinforcement, and concrete floors. These well-constructed and reinforced buildings survived the tsunami with minor damage only. Damage was often limited to broken windows and

doors or failed first floor walls which could be due to the effect of debris. Observed damage levels were:

- <1 m of water – zero to light damage to ground floor,
- 1.5 to 2 m of water – light to moderate damage to ground floor (repairable), and
- 3 to 4 m of water – moderate damage to ground floor (holes punched through 1 or more walls), but building upright and repairable (Fig. 14).

Upper storeys were untouched and provided refuge to people. Overall damage levels were low (<5 to 20%).

Fig. 14. Well engineered beachfront villa after inundation to a depth of 3.8 m (a). Reinforcement detail is shown at right (b).
