# Investigation and hazard assessment of the 2003 and 2007 Staircase Falls rock falls, Yosemite National Park, California, USA

G. F. Wiecezorek<sup>1</sup>, G. M. Stock<sup>2</sup>, P. Reichenbach<sup>3</sup>, J. B. Snyder<sup>4</sup>, J. W. Borchers<sup>5</sup>, and J. W. Godt<sup>6</sup>

Received: 31 January 2008 – Revised: 23 April 2008 – Accepted: 23 April 2008 – Published: 6 May 2008

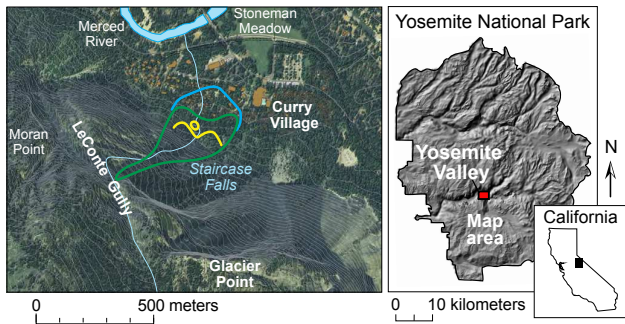
**Fig. 1.** Map of Glacier Point area in Yosemite Valley, California showing 26 December 2003 Staircase Falls rock fall into Curry Village. Green lines show initial detachment area, travel path, and limit of rock debris; yellow lines delimit areas where trees were knocked down; blue lines show limit of flyrock. Contour interval is 20 m. Inset shows location of Yosemite Valley in Yosemite National Park, California.

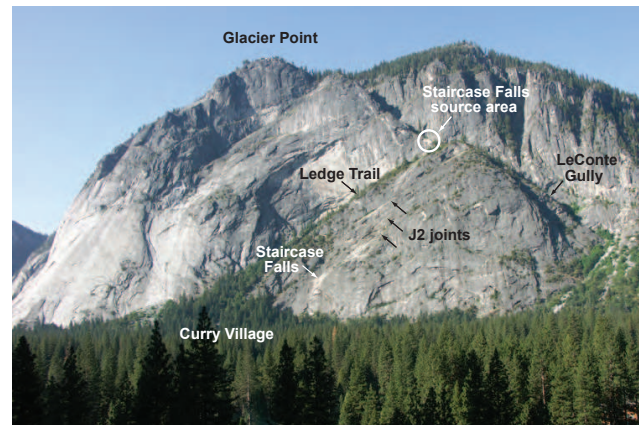
**Fig. 2.** Western portion of Glacier Point showing Staircase Falls rock-fall detachment area (circled) and path of Staircase Falls and abandoned Ledge Trail along eastward dipping J2 joint sets (see Table 1 for joint orientation data). Cliff faces exhibit influence of vertical regional joints weathered back along J1 exfoliation joints, which are present on nearly all visible rock surfaces.

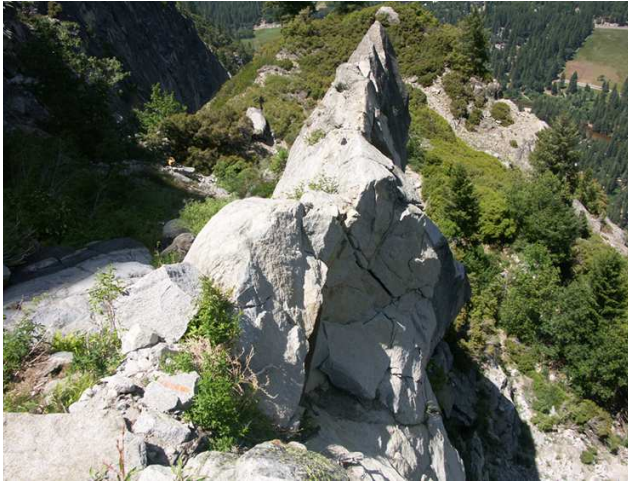
**Fig. 3.** Staircase Falls rock-fall detachment area, showing narrow projecting bedrock fin. 2003 and 2007 rock falls occurred from center-right side of fin. Floor of Yosemite Valley 555 m below is in upper right of photograph. Staircase Creek flows down left (south-west) side of fin before turning sharply right (northeast) around the base of fin to top of Staircase Falls.

Subsequent observation of the detachment area in April 2004 revealed additional potentially unstable rock in the form of a fractured, jointed, and moderately weathered bedrock fin (Fig. 3). We estimated the volume of potentially unstable rock remaining at the detachment area, in the form of the narrow bedrock fin (Fig. 3), to be  $\sim 350\text{ m}^3$ . Only a few meters of rock separate the Staircase Creek channel in LeConte Gully from the active detachment surface of the Staircase Falls source area (Fig. 3).

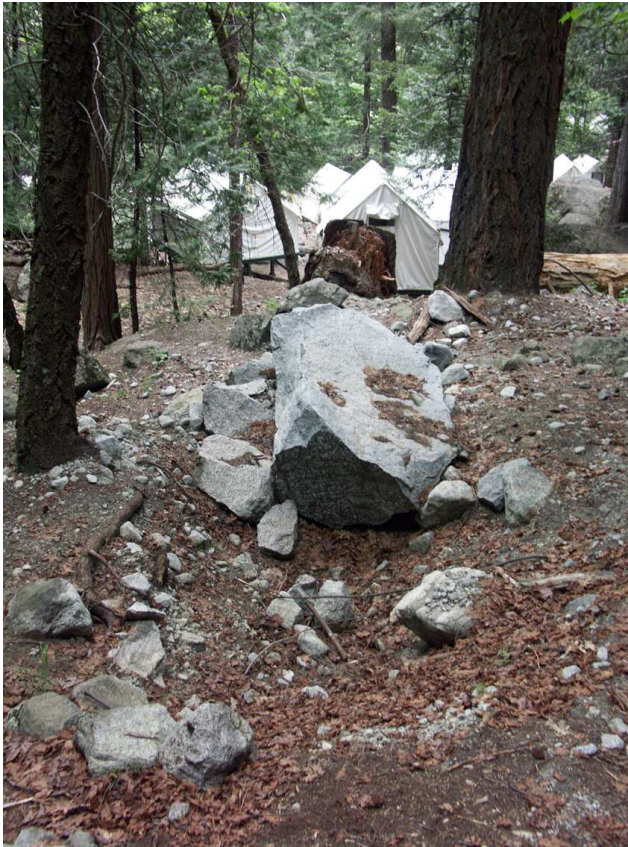
**Fig. 5.** Part of rock-fall deposit from 26 December 2003 Staircase Falls rock fall.  $4\text{ m}^3$  (11 metric tons) block landed  $\sim 120\text{ m}$  beyond base of cliff, leaving prominent impact crater.

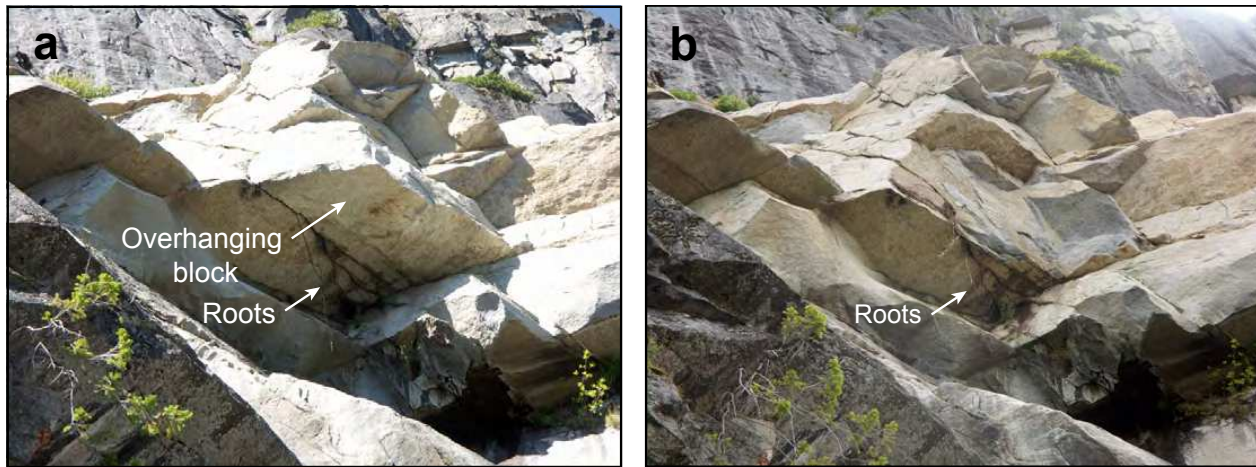
At 02:53 PST on 9 June 2007, another rock fall occurred from the Staircase Falls detachment area. The 9 June 2007 rock fall consisted of an  $18\text{ m}^3$  (49 metric tons) block that fell from the middle portion of the 26 December 2003 rock fall detachment area (Figs. 3, 6). This was a small sized rock fall according to the criteria of Wiczorek and Snyder (2004). This block fell to the large ledge immediately below the detachment area, sweeping additional debris off the edge. Debris fell onto a large area of the talus slope near the base of Staircase Falls, sending flyrock into the first row of visitor cabins along the southwestern edge of Curry Village. Fly-rock fragments struck one cabin, but there were no injuries. Assessment of the detachment area later that day revealed that the rock fall consisted of a prominent rectangular overhanging block (Fig. 6), identified previously as a potential hazard. Prior to failure, this block was bounded on all sides by open fractures, with tree roots projecting from fractures at the base of the block (Fig. 6).

**Fig. 6.** Staircase Falls rock-fall detachment area (a) before and (b) after 9 June 2007 rock fall, which consisted of failure of overhanging rectangular block, bounded by open fractures containing roots, in center of photo (a). Dark stain in lower right of both photographs results from seepage of Staircase Creek through bedrock fin.

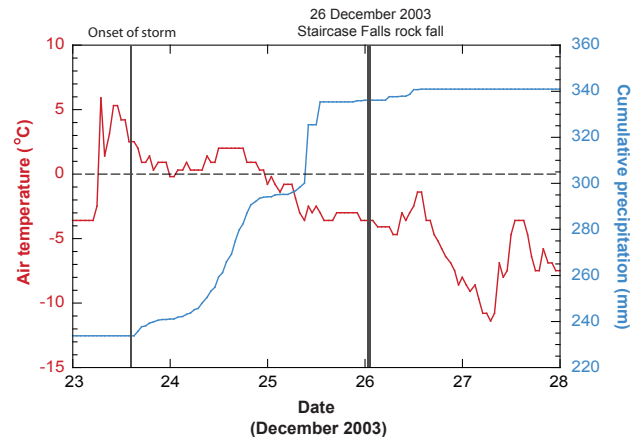
**Fig. 7.** Air temperature (red line) and cumulative annual precipitation (blue line) for 23–28 December 2003. Dashed horizontal line marks 0°C. Thin black bar marks onset of storm. Thick black bar marks 26 December 2003 Staircase Falls rock fall, which occurred after 102 mm of precipitation fell over previous 48 h, and after 24 h of sub-freezing temperatures. Data from Yosemite Valley weather station (Station YYV, California Department of Water Resources, California Data Exchange Center, <http://cdec.water.ca.gov/>), with air temperatures scaled to detachment area elevation assuming an adiabatic lapse rate of  $-0.65^{\circ}\text{C}/100\text{ m}$  (Lunquist and Cayan, 2007).

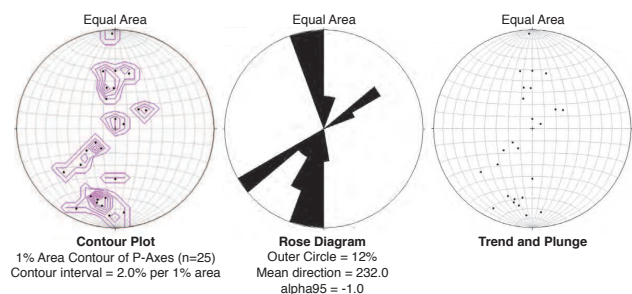
**Fig. 8.** Contour plots, rose diagrams, and trend and plunge data for joint surfaces at Staircase Falls rock fall detachment area ( $n=25$ ) (see Table 1 for data). More joints exist than were measured.

Measurements of 25 joints at and near the Staircase Falls detachment area (Fig. 8) reveal at least 19 joints of three major joint sets (J6, J9, J13). Assuming a static friction strength of  $\geq 35^\circ$  for granitic rock (Barton and Choubey, 1977), we evaluated the initial slope of the detachment area, which dips approximately  $60^\circ$  northeast, with each of the three major joint planes and possible joint plane intersections. The results suggest that the 26 December 2003 failure occurred primarily along a J9 joint surface, with an average dip of  $53^\circ$  north. The subsequent travel paths of rock debris were strongly influenced by the east-trending J2 joint sets that form the Ledge Trail ledge and the treads of Staircase Falls (Figs. 1, 2).

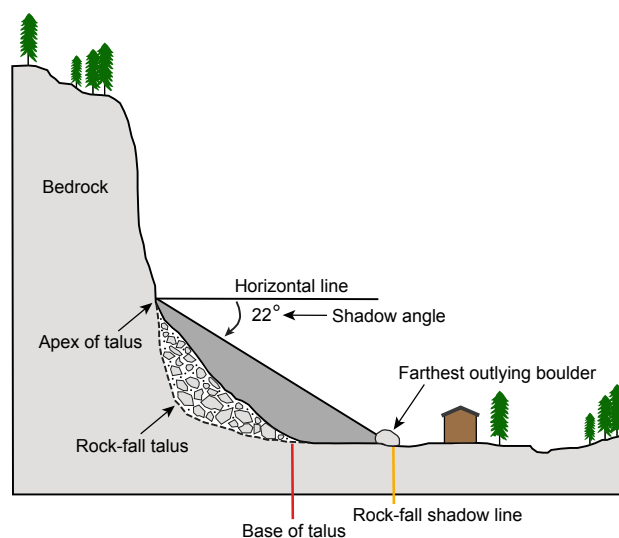
**Fig. 9.** Schematic of rock-fall talus slope, base of talus (red line), and farthest outlying boulder, illustrating determination of rock fall shadow angle and shadow line (orange line); after Wiecezorek et al. (1998, 1999), modified from Evans and Hungr (1993).

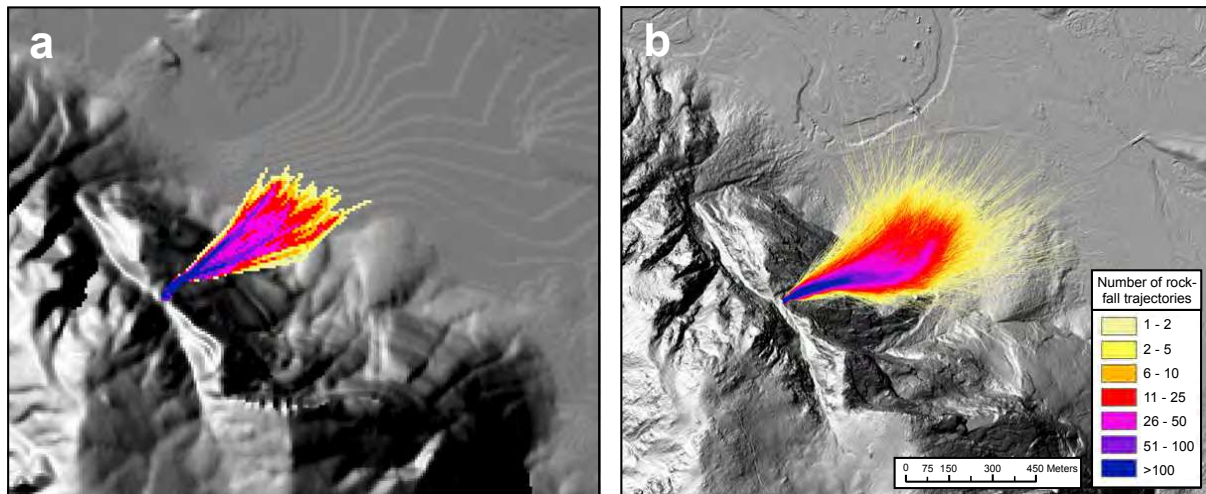
**Fig. 10.** Comparison of STONE rock-fall simulations on Digital Elevation Models (DEMs) of varying resolution. Colors show number of rock-fall trajectories. (a) simulation performed on 10 m DEM showing 100 blocks launched from each DEM cell of detachment area (6 cells) for total of 600 rock fall trajectories. (b) Simulation performed on filtered (bare earth) 1 m DEM derived from airborne LiDAR data, showing 100 blocks launched from each DEM cell of detachment area (112 cells) for total of 11 200 rock fall trajectories.

First, to assess the affect of varying DEM resolution on model output we simulated an unspecified rock-fall from the Staircase Falls detachment area performed on a 10 m resolution DEM, and compared this with a simulation of the same rock fall performed on a higher resolution 1 m DEM (Fig. 10). The 1 m DEM was produced from filtered (i.e., bare earth) airborne Light Detection and Ranging (LiDAR) data, and reveals subtle topographic features not resolved in the 10 m DEM. As such, the increased resolution of the 1 m DEM significantly improved the resolution of the STONE model results (Fig. 10). It is difficult to directly compare results from the 1 m and 10 m DEMs because they necessarily have a different number of source cells and, hence, produce a different number of rock-fall trajectories. Nevertheless, there are some visible differences between the two simulations. For example, the path of highest cumulative count of rock-fall trajectories shifted to the east in the 1 m DEM simulation, presumably due to subtle topographic features below the detachment area that are not resolved in the 10 m DEM (Fig. 10). The greater resolution of the 1 m DEM increases the dispersion of rock fall trajectories, a result consistent with those described in previous rock fall model comparisons (Lan and Martin, 2007; Agliardi and Crosta, 2003). Rock-fall trajectories generally extended farther from the base of cliffs in the 1 m DEM than in the 10 m DEM (Fig. 10), a

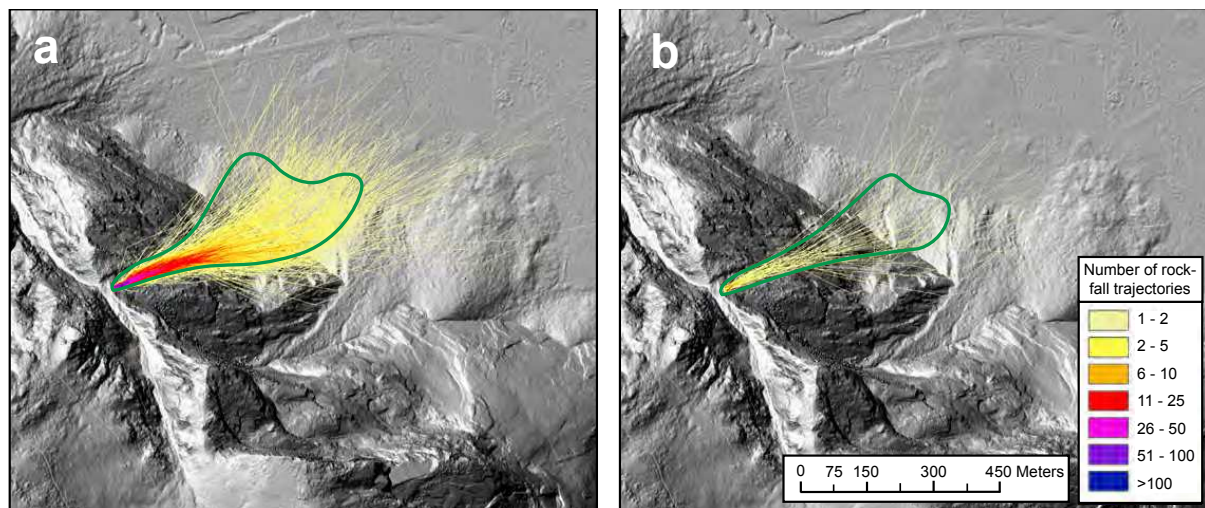
**Fig. 11.** Comparison of STONE model simulations and mapped extent of rock debris for 2003 and 2007 Staircase Falls rock falls. Colors show number of rock-fall trajectories. **(a)** Simulation of 26 December 2003 rock fall, with 10 blocks launched from each DEM cell of detachment area (112 cells) for total of 1120 rock fall trajectories. Mapped limit of actual rock debris (excluding flyrock) shown by green line. **(b)** Simulation of 9 June 2007 rock fall, with 1 block launched from each DEM cell of detachment area (112 cells) for total of 112 rock fall trajectories. Mapped limit of actual rock debris (excluding flyrock) shown by green line.

Using the 1 m DEM, we then simulated the 26 December 2003 and 9 June 2007 rock falls and compared the results with the actual distribution of rock debris mapped in the field (Fig. 11a, b). Overall, the simulated rock-fall trajectories match well the actual mapped distribution of rock debris, with the majority of simulated trajectories falling within the zone of actual rock debris deposition. Furthermore, many observed dynamics of the Staircase Falls rock falls are displayed in the simulations, including the strong influence on trajectories of the east-trending J2 joint surfaces below the detachment area and the morphology of the talus slope (Fig. 11a, b). For both the 2003 and 2007 event simulations, a small number of trajectories extended farther from the base of the cliff than the mapped distribution of rock debris (Fig. 11a, b). This apparent “overshoot” of the simulated trajectories may be due to several factors. First, some values we assume for input data may not accurately represent the range of rock-dynamics (e.g., Lan and Martin, 2007); although we have assumed reasonable values for these input parameters (Lan and Martin, 2007; Chau et al., 2002), specifically calibrated to Yosemite Valley rock falls (Guzzetti et al., 2003), we cannot empirically verify them, resulting in some uncertainty. Second, STONE does not account for certain factors such as block shape, air drag, block fracturing, and/or energy dissipation by vegetation in the impact zone. Although the filtered (bare earth) 1 m DEM is a substantial improvement over the previously available 10 m DEM, even

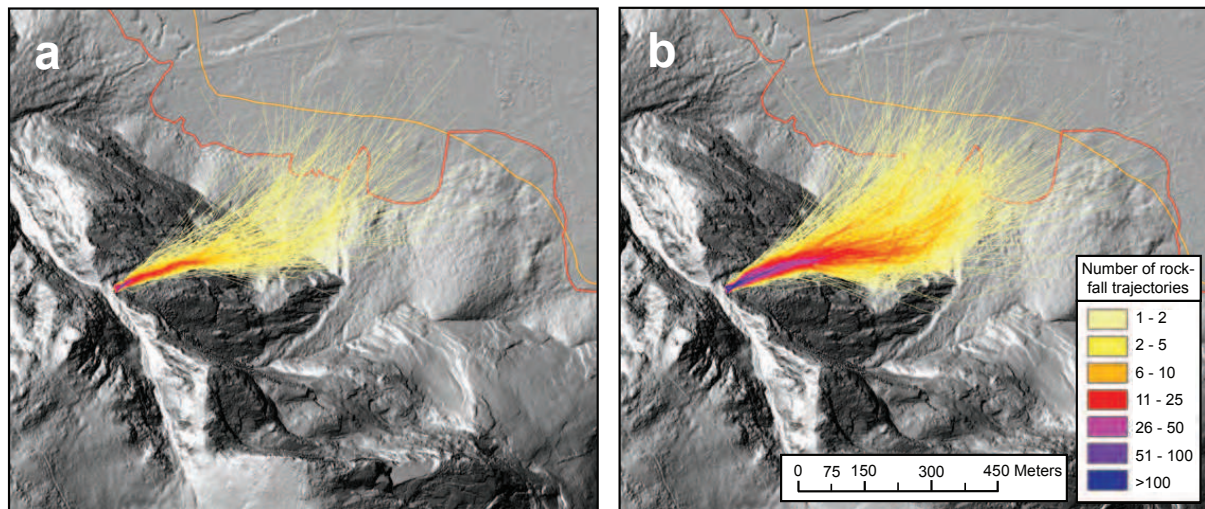
**Fig. 12.** Assessment of future rock-fall hazard from Staircase Falls detachment area with example STONE simulations of (a) 6 blocks (672 trajectories) and (b) 20 blocks (2240 trajectories) launched from each DEM cell of detachment area (112 cells), representing partial and total failure of remaining rock mass, respectively. Colors show number of rock-fall trajectories. Red line delineates base of talus (including debris flow deposits), orange line is rock-fall shadow line (Wiczorek et al., 1998, 1999).

Finally, considering that  $\sim 320 \text{ m}^3$  of potentially unstable rock remains at the detachment area, we used STONE to assess rock-fall hazards associated with potential future Staircase Falls rock falls (Fig. 12a,b). Because STONE treats each block as a dimensionless point-mass, we cannot explicitly simulate an increase in rock-fall volume (Guzzetti et al., 2002). However, by calibrating simulations of the 26 December 2003 and 9 June 2007 rock falls with the actual events, we were able to scale the number of blocks launched from the source area to approximate the volume of potentially unstable rock remaining at the detachment area; in this way, the number of launched blocks serves as a proxy for rock-fall volume. We simulated a range of scenarios, from partial failure of the estimated remaining rock mass (e.g., Fig. 12a) to

total failure (Fig. 12b). The size of the simulated rock-fall runout zones is directly related to the number of launched blocks, i.e., larger rock “volumes” extend farther beyond the base of the cliff (Fig. 12a,b). Depending on the size of future failures from the detachment area, rock debris from future events has the potential to travel farther beyond the base of the cliff than debris resulting from the 26 December 2003 rock fall; this debris may even travel beyond the rock-fall shadow line (Fig. 12b).
