Using geophysics on a terminal moraine damming a glacial lake: the Flatbre debris flow case, Western Norway

Abstract. A debris flow occurred on 8 May 2004, in Fjærland, Western Norway, due to a Glacial Lake Outburst Flood and a natural terminal moraine failure. The site was investigated in 2004 and 2005, using pre- and post-flow aerial photos, airborne laser scanning, and extensive field work investigations, resulting in a good understanding of the mechanics of the debris flow, with quantification of the entrainment and determination of the final volume involved. However, though the moraine had a clear weak point, with lower elevation and erosion due to overflowing in the melting season, the sudden rupture of the moraine still needs to be explained. As moraines often contain an ice core, a possible cause could be the melting of the ice, inducing a progressive weakening of the structure. Geophysical investigations were therefore carried out in September 2006, including seismic refraction, GPR and resistivity. All methods worked well, but none revealed the presence of ice, though the depth to bedrock was determined. On the contrary, the moraine appeared to be highly saturated in wat

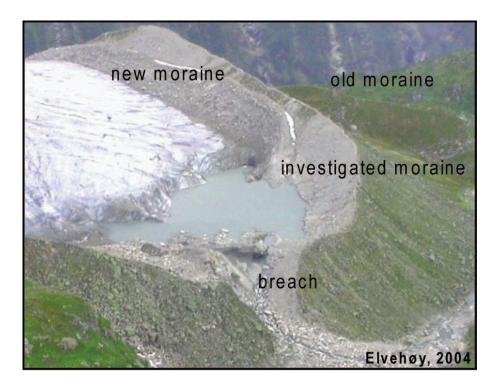
Fig. 2. Aerial photography of the moraine site after the 2004 GLOF.

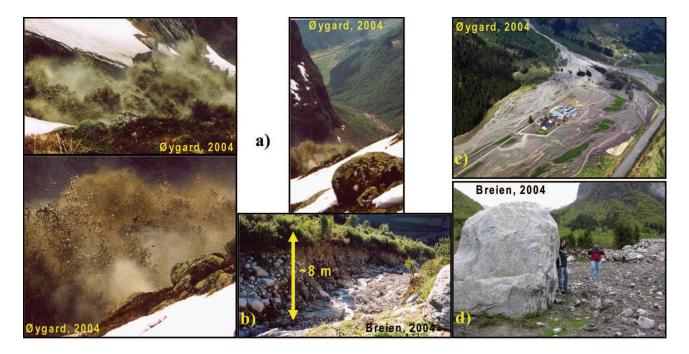
Thorough studies of the 2004 Flatbre debris flow and its possible causes can be found in Breien (2005) and Breien et al. (2008), especially regarding the dynamic of the debris flow. Key glaciologic information was also provided by the Norwegian Water Resources and Energy Directorate (NVE, M. Jackson, personal communication). The site is at about 1000 m a.s.l., i.e., below the normal permafrost elevation in Norway (about 1400-1600 m a.s.l.; Etzelmüller et al., 2003). But local conditions may lower this limit; the site is at the edge of the largest glacier on the European continent; i.e., the Jostedalsbreen glacier. The small lake behind the moraine is regularly emptied each year (seasonal activity), but mostly subglacially, draining out to the regenerated outlet glacier Supphellebreen (steep down-going part of the glacier in Fig. 1b). No damage is reported for such events and the site was therefore not considered as potentially dangerous (Vaksdal and Melvold, 2003). However, events similar to the one in 2004 may have occurred in 1924 and 1947, although not on such a large scale as in 2004 (Breien, 2005). In 2004, E. Øygard, owner of both the nearby farm in the valley and the cabin close to the moraine, was a witness of the GLOF and subsequent debris flow, and took photographs (Fig. 3a). The violence of the event is clearly demonstrated by the depth of the erosion along the flow path (Fig. 3b), the size of the flooded area in the valley (Fig. 3c) with a total run-out of about 3 km, and the size of the transported boulders (Fig. 3d).

Fig. 3. (a) Photographs taken by E. Øygard during the 8 May 2004, GLOF. (b) Erosion along the path of the flow. (c) Boulder fan and part of the mud flooded area. (d) Example of transported boulders down in the valley.

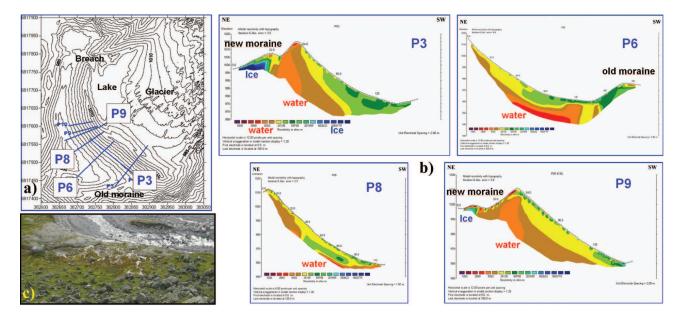
Fig. 4. Electrical resistivity data. (a) Location of the profiles. (b) Examples of electric tomography profiles, with P3 and P9 showing both very low resistivity down in the main moraine (high water saturation) and very high resistivity (ice in the new moraine). The old moraine shows intermediate values.

Figure 4b shows four of the profiles. On both profiles P3 and P9, the acquisition line went through the new moraine, which explains the very high observed resistivity values (above 200 000 Ohm m, blue colors), characteristic of ice. As one of the questions to be answered by using geophysics was the presence of ice in the moraine, the resistivity profiles gave us a quick answer, i.e., no ice core observed in the penetrated area, observation later confirmed by both GPR and seismic refraction. On the contrary, the inner part of the main moraine is characterized by rather low resistivity values (the opposite side of the scale, red-brownish colors) indicating a progressive water saturation of the moraine material with depth. Profiles P6 to P8 show the lowest resistivity value, and this corresponds to a zone of the moraine where water seepage is observed at its foot (Fig. 4c). Note that this zone is away from the breach and may indicate a preferential path of water flow through the moraine.

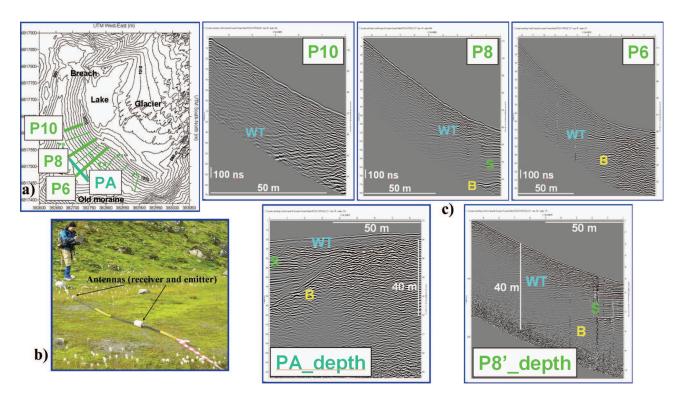
Fig. 5. GPR. (a) Location of the profiles. (b) 50 MHz equisition system with both emitting and receiving antennas on the same rod and pulled by an operator (c) Examples of processed profiles, the upper ones being in time, and the lower ones obtained after depth conversion. Water-table like reflectors (WT), bedrock (B) and lake-deposit sediments (S) are identified.

The data were processed using ReflexW. Though the structure inside the moraine is quite heterogeneous, with different grain sizes from rather fine sand to large boulders, the GPR results showed several interesting features with clear reflectors down to 30–40 m in depth (Fig. 5c). Some are associated with water-table like features (strong and near horizontal reflectors, see P6). Others are typical layered structures (in PA and P8) believed to be lake deposits in an older lake trapped by the older moraine. In addition, bedrock is clearly reached in several profiles. Strong diffractions at dipping bedrock can be seen along Profile PA at the foot of the moraine, thus giving the possibility to estimate velocities at several depths in order to properly convert from time to depth (bottom profiles in Fig. 5c). A velocity in the main moraine and a different one in the lake deposits were then used.

Despite a chaotic image inside the top part of the moraine due to interfering diffractions on boulders, the water-table like reflectors seem to correspond to the zones of higher water content detected by resistivity. The rather fine layered structure below the moraine may also channelize water from the glacier and under the moraine, which may in turn increase its internal erosion.

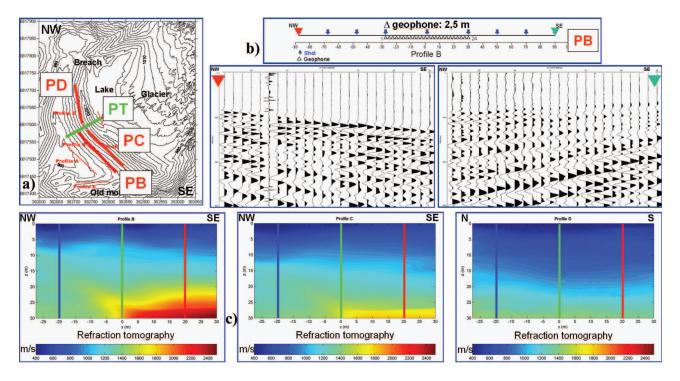
Fig. 6. Seismic refraction data. (a) Location of the profiles. (b) Example of 2 shots for one of the profile (PB). (c) Refraction tomography results for 3 profiles.

The seismic refraction data were of very good quality and hammer blows were sufficient for offsets up to 80 m from the receiving line extremities (Fig. 6b). The data were systematically of better quality above the wetter zone identified by both resistivity and GPR, while showing weaker firstarrivals away from that zone, either towards the breach or on the South-East side. We used the wavefront-based tomography approach of ReflexW to produce tomograms, as in Fig. 6c and Fig. 7b. No ice-velocity is found within the moraine, in agreement with resistivity. Within the moraine, the velocity increases with a rather linear gradient (compaction and/or capillarity-induced water content) up to waterlike velocities, followed by a transition zone believed to correspond to the highly water-saturated sediment package, before reaching the bedrock (Fig. 7c). The good quality of the data, also shown in Fig. 7d, was unexpected and a denser acquisition in lines, receivers and shots, would have permitted a 3-D tomography.

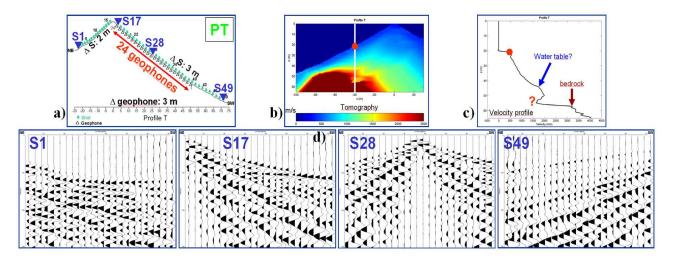
Fig. 7. Seismic refraction data (2). (a) Geometry of the transverse profile (see location in Fig. 6a) with 24 fixed geophones and 49 hammerblow positions. (b) Final tomography result. (c) Vertical velocity profile at the lateral position given in (b). (d) Examples of shot recordings.
