Seismically reactivated Hattian slide in Kashmir, Northern Pakistan

Jean F. Schneider

Jean F. Schneider. Seismically reactivated Hattian slide in Kashmir, Northern Pakistan. *Journal of Seismology*, 2008, 13 (3), pp.387-398. <10.1007/s10950-008-9103-5>. <hal-00478432>

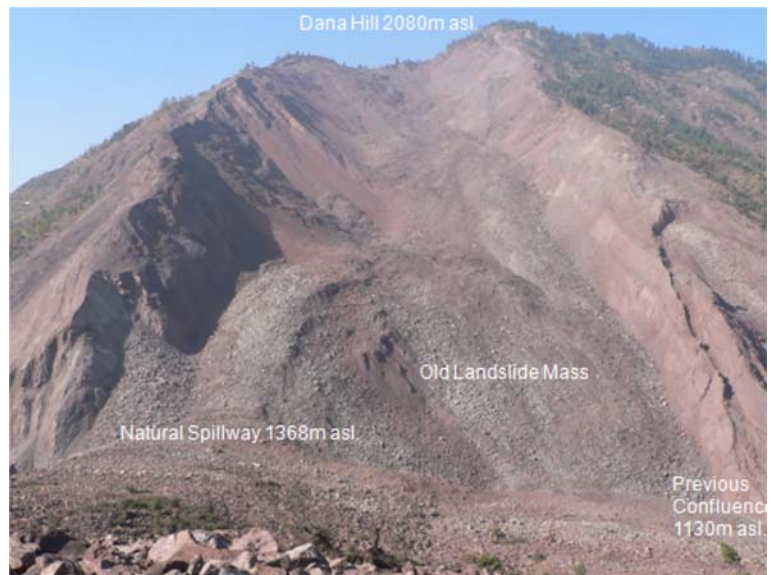
Fig. 3 View from top of the natural dam (1446 m a.s.l.) westwards towards slide scar on Dana Hill. The asymmetric, ESE dipping syncline can be recognized as well as the large central debris mass that remained in the lower half of the slide. The author postulates an older consolidated slide mass, only partly affected by the actual slide, and partly buried below this actual debris. Secondary slumps appear at the front of this mass and a secondary steeply inclined slide is clearly visible at the right (northern) edge of the photograph of early December 2005

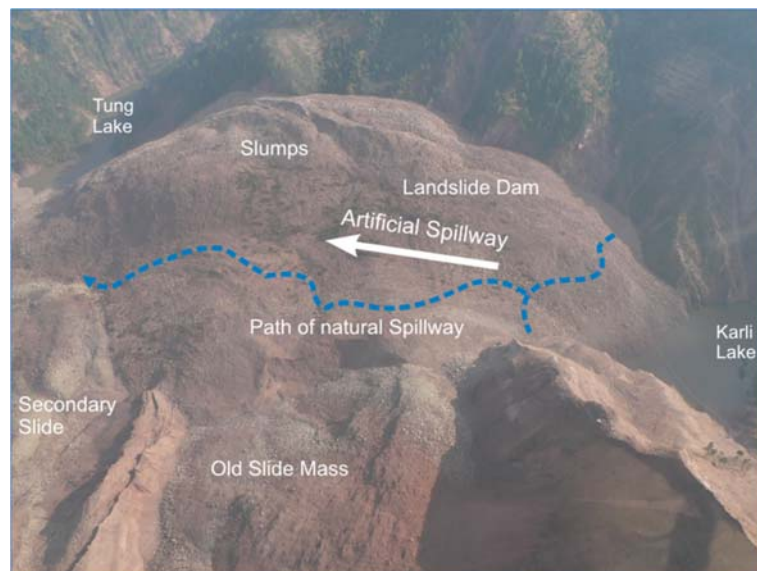
Fig. 4 Helicopter view from above slide eastwards towards the natural dam formed by the landslide debris. At least three ridges can be distinguished, confirming the locally reported three surges. The above mentioned secondary slumps and slides can be seen in the foreground. Slumps have also slid northwards from the crest of the new debris dam. Vegetation on the contact between debris mass and opposite slope is intact and a distal trough was left open. This oblique photograph of early

December 2005 also shows the growing Karli and Tung lakes and the possible natural path of overflowing lake water (blue line). The white arrow indicates the planned 450-m-long artificial spillway, which was constructed in the first half of 2006. The smaller Tung Lake has also an artificially controlled overflow; Karli Lake level has reached the constructed spillway in April 2007

- As a first measure, helipads as well as a 4 km access road from Hattian to the dam sites needed to be built for transport of heavy equipment.
- Excavation of a spillway, 130 m long, to lower the water table at Tung Lake, a comparatively easy task, which was begun as soon as the road reached this dam.

- Overflow by Karli Lake of the natural saddle (1369 m a.s.l.) at the foot of the affected slope needed to be avoided, not least because backward erosion of the dam by an overflow was thought to be very likely. So a second spillway, 425 m long, was constructed in the period up to June 2006 to keep the water table low at impounding Karli Lake and to reduce back erosion in case of an overflow. Since an excavation (undercutting) at the foot of the slide could have interfered with the stability of the slope, a deeper channel with reinforcement by gabions and riprap was planned in the central part of the dam rather than in the lower-lying saddle (Fig. 4). Possible seepage or piping was monitored closely, as the hazard of inner erosion (suffusion) is given especially during the first phase of consolidation. Drill holes with piezometers were planned to observe the rising and progressing pore water front.

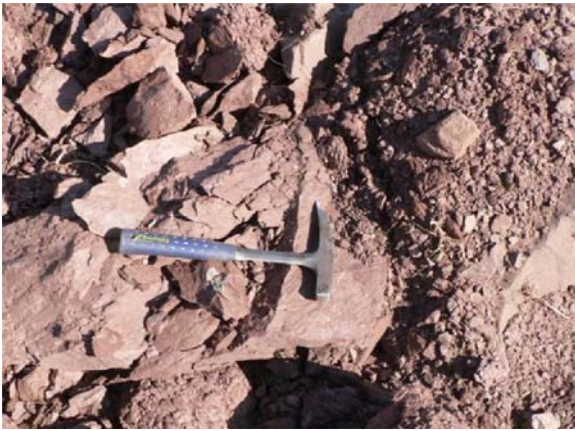
Fig. 5 Shale of the Murree Formation on dam proximal to the landslide (hammer for scale). The clayey to silty material is crumbling apart, wetted by the morning dew. The resulting soil is quite impermeable and can thus act as an aquiclude. Monsoon rainfall will enhance this effect, adding to the consolidation of the slide debris

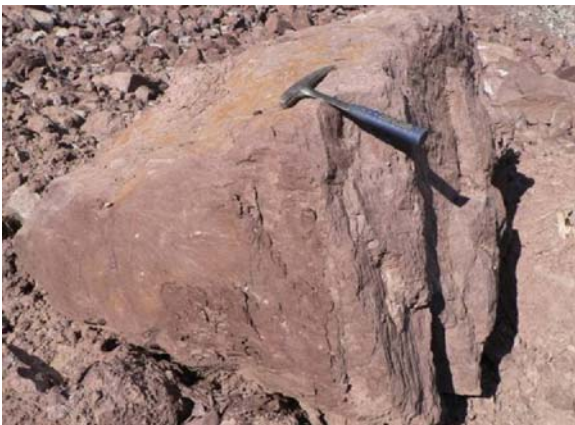
Fig. 6 Sandstone block of Murree Formation in the distal highest part of slide mass (elevation 1446 m, hammer for scale). The size and number of large blocks increases with increasing distance from slide (segregation). While excavating the artificial spillway in the proximal area, only a few large blocks have been found

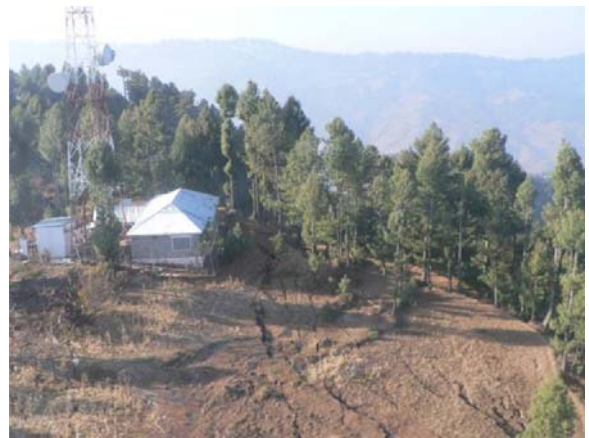
Fig. 7 Lateral spreading at Dana hilltop in the vicinity of the SCO-Tower. Most cracks are oriented N – S. Such cracks can be seen all along the Dana hillcrest from the Tanda fault in the south to Dana hilltop (Heli view to south)

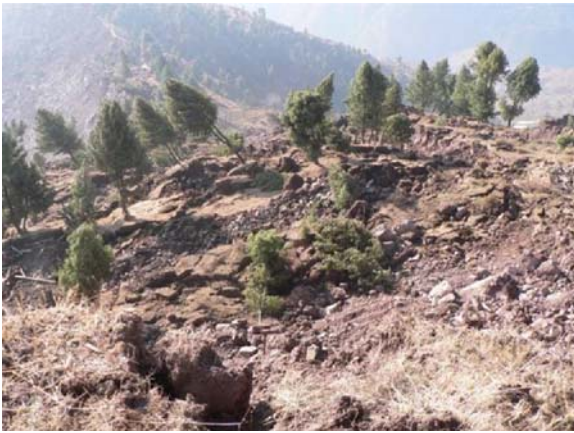
The escarpments as well as the V- to U-shaped elongated sliding trough again have a tectonic origin, dominated by a NNE-plunging syncline with, in parts, tightly folded anticlines and other structural complications. Furthermore, both the top and the eastern side of Dana Hill are completely shattered, laterally spread and crisscrossed by cracks, slumps and slides, with the cracks striking mostly perpendicular to the synclines and anticlines, i.e. NNW–SSE (Fig. 7). At the south-facing escarpment of the slide, on the western crest of Dana Hill, there is still a large amount of destabilized rock material lying or hanging in critical condition, possibly allowing further rock-slides (Fig. 8).

Fig. 8 Massive disruption of the Murree formation at the hillcrest between the communication tower and the top of actual landslide (view to south). This scene looks quite different from a normal landslide escarpment. Large amounts of shattered rock remain on the slope in unstable condition, which could potentially create further mass movements

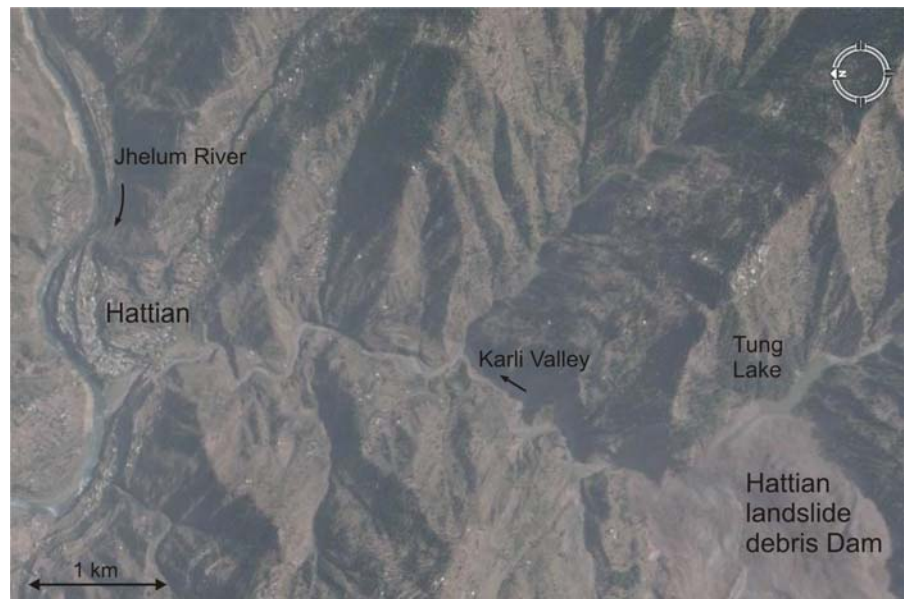
Fig. 9 Google Earth (©2007 Google, ©2008 Digital Globe, ©2008 Europa Technologies, high resolution composite dated 10-03-2006, eye altitude 5.6 km). Possible flood pathway from dam site at right (south) over 4 km downstream through narrow gorge to Hattian and Jhelum Valley at left. The smaller Tung lake, with its artificial spillway, is visible at middle right of scenery. The construction of the lower part of the 450 m long Karli Lake spillway on the slide mass is not visible to this date in the lower right corner of the composite

critical hazards with respect to a potential outburst flood. This could have led to a flood wave or debris flow rushing down Karli valley towards Hattian and the Jhelum valley.

- Hazard maps as well as preliminary evacuation plans of vulnerable areas, dwellings and infrastructure in the upstream and downstream areas prone to flooding had to be compiled. Appropriate measures needed to be taken, and the most hazardous areas were evacuated.

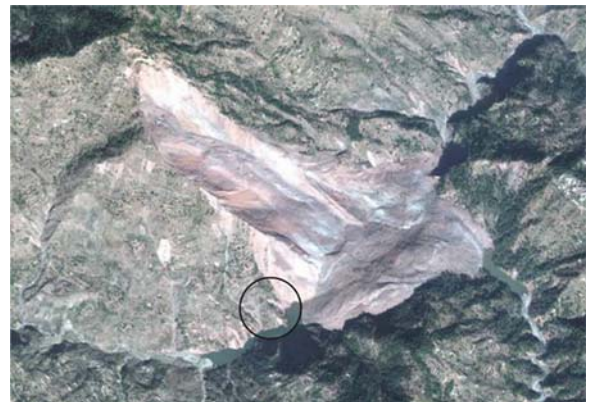
Fig. 10 Oblique true colour scenery of Hattian slide and lake formation area (©2005 DigitalGlobe, QuickBird II, 27-10-2005). Note the complex geometry of the slide with its central bulge, lower part of it interpreted by the author as an older mass. The debris dam shows ridges and scars. The Karli and Tung lakes are observed to have started to fill up. Clearly visible is the narrow gorge downstream of the landslide dam. The SE facing slope of Dana Hill (left side of the image) shows recent landslide scars. The Tanda Fault is just outside the image on the left side; the hazardous slide developing on the left side of the lake shore is encircled and shown in detail in Fig. 11

In Figs. 10 and 11, an active slide or slump is visible, developing on the left shore of the growing lake. This mass movement could trigger a flood wave, if a sudden failure would occur. A rapid lowering of the lake level caused by a partial dam failure was faired during the early stages of natural overflow of the dam. This would have caused an overpressure of the interstitial water in the slope triggering the slump. This hazard was minimized by human interaction and by time.

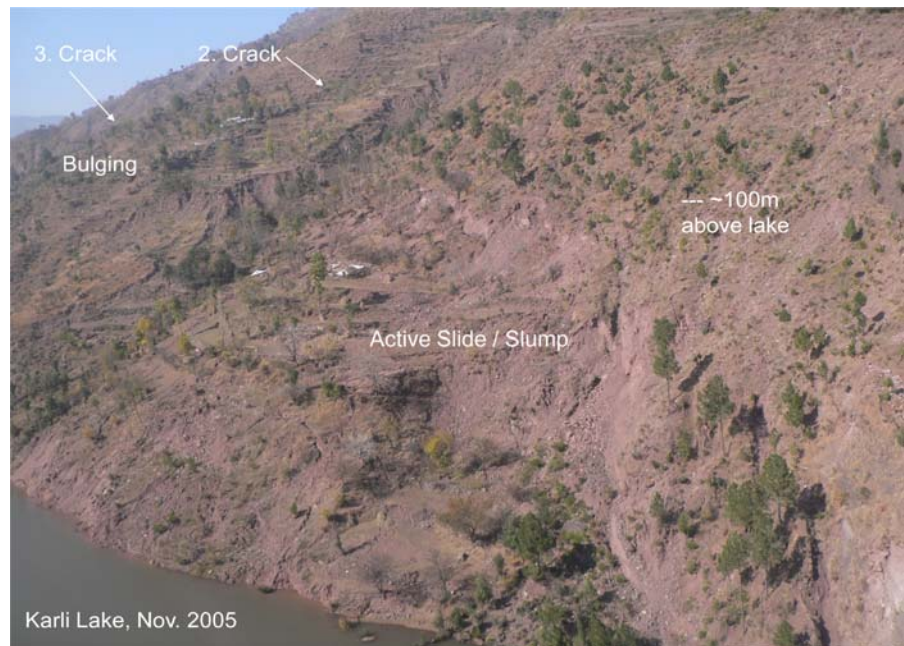
Fig. 11 Helicopter view (Nov. 2005) of the active slide or slump on the lower flank of Dana Hill, west or orographic left side of Karli Lake. In the mean time, the lake level rose up to the destroyed houses on the sliding mass. Note the bulging and cracking of the slope south of the active slide. The unstable foot of this slope is submerged. Possible consequences of these mass movements are discussed in the text above

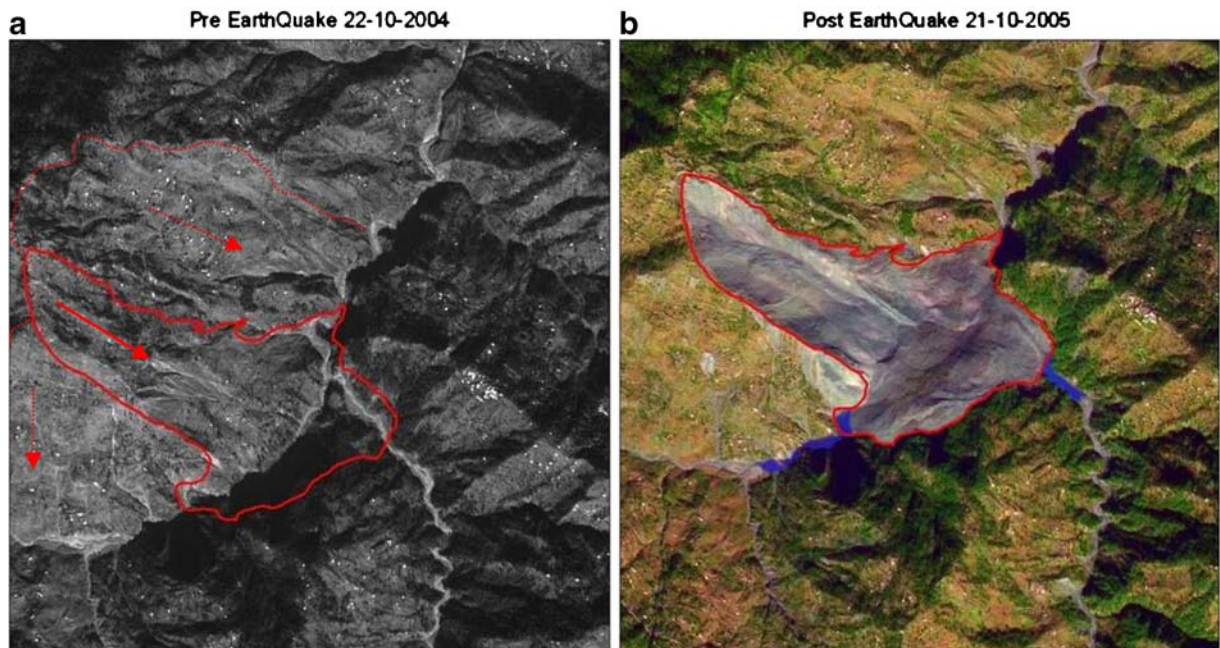
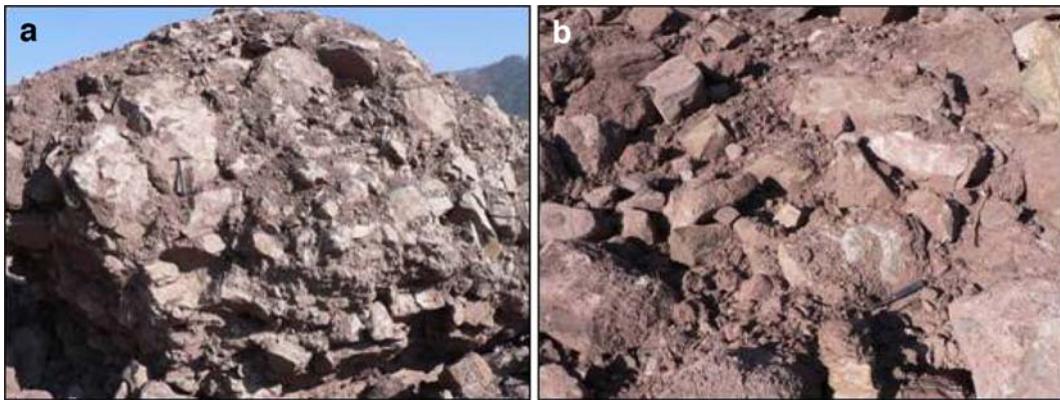
Fig. 12 a, b: Satellite images of Hattian slide area (SPOT 4, XI and panchromatic M-modus, sceneries by SUPARCO, Pakistan, 2005, modified by the author) before the slide (22-10-2004, left), as well as after the earthquake triggered slide (21-10-2005, right), also showing the early stage of the formation of Karli and Tung Lakes. Karli Stream flows north (towards the

top of the image). Note on the left image the escarpment and sliding mass of the earlier (historical?) landslide at approximately the same location as the actual one (solid arrow). Two even older, possibly Holocene landslide scars (dashed lines and arrows) were detected during field reconnaissance and are recognizable just north and south of the actual event

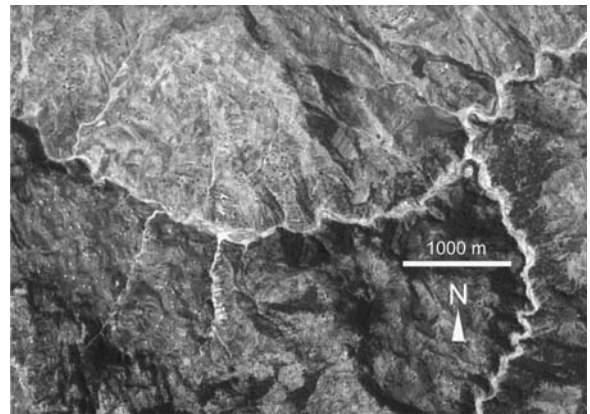
Fig. 14 Analogue CORONA photo (15-09-1971, courtesy of T. Nakata). Confluence of the Tung and the Karli streams (approx. 1,130 m a.s.l.) with the south facing former landslide (in the upper left of the photo), and the lower part of the “historic” landslide, showing the deeply incised streams and the eroded base of the slide (in the upper right of the photo, see Figs. 2 and 12a for orientation). Karli Stream is flowing from left to right. This view shows, when compared to Fig. 12, more details of the rugged surface and the deeply incised stream bed, with which the actual landslide interfered. Here, in 1971 (and also 2004, Fig. 12), no major village is visible, suggesting an exaggeration of the death toll (up to 1000 casualties) in Dandbeh hamlet caused by the slide
