Seismically reactivated Hattian slide in Kashmir, Northern Pakistan

Jean F. Schneider

Received: 20 March 2008 / Accepted: 3 April 2008 / Published online: 14 May 2008
© Springer Science + Business Media B.V. 2008

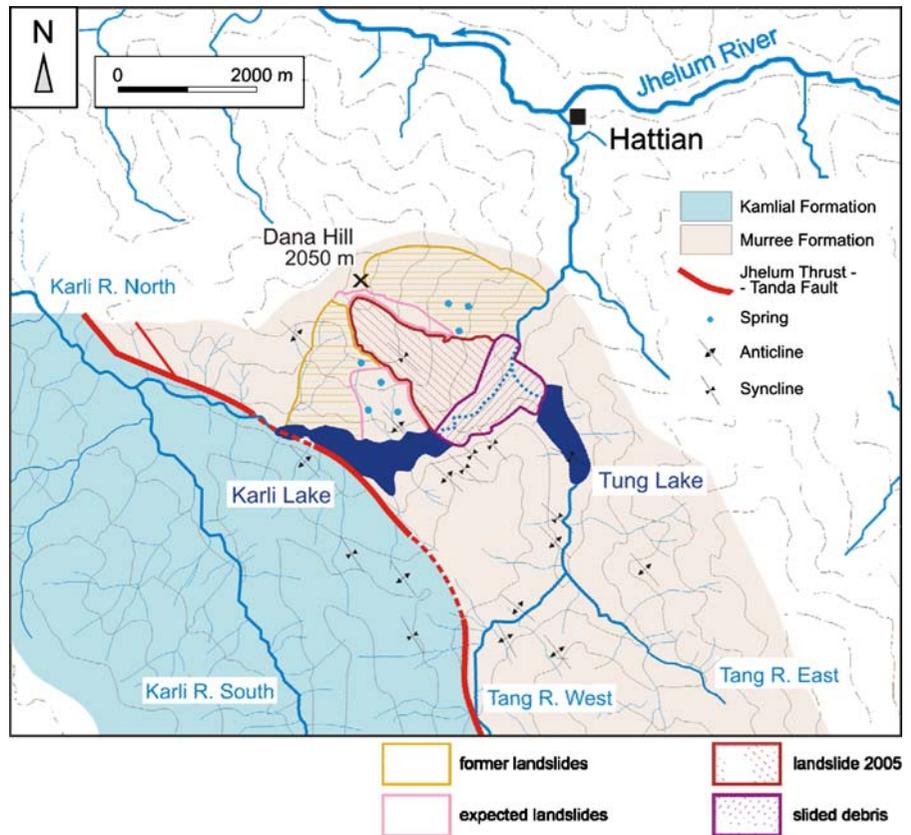
Fig. 2 Hattian Landslide sketch map. The information shown is interpreted from Kausar et al. (2006) and our own investigations. The perimeter of the “historic” landslide discussed below coincides roughly with landslide 2005

mountain, a clear one facing east, another one facing south (see Fig. 2). The other postulated former slide was a younger, probably historic landslide at the same location as the actual landslide.

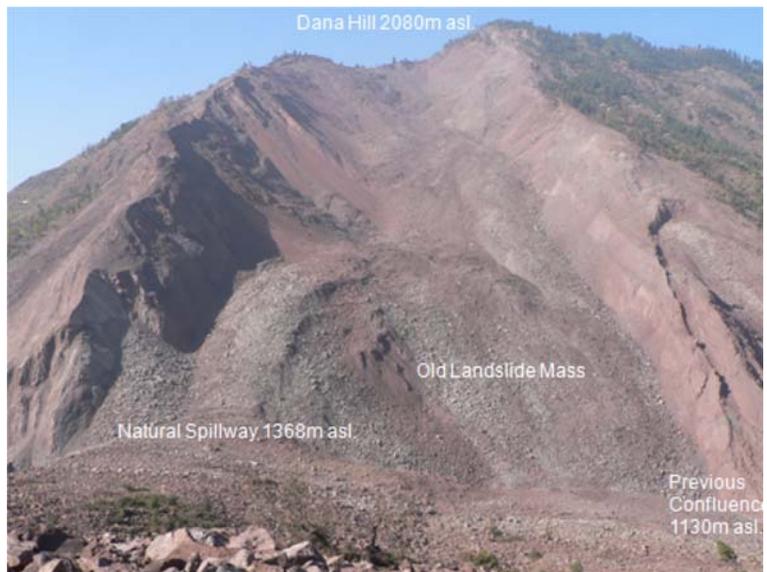
Fig. 3 View from top of the natural dam (1446 m a.s.l.) westwards towards slide scar on Dana Hill. The asymmetric, ESE dipping syncline can be recognized as well as the large central debris mass that remained in the lower half of the slide. The author postulates an older consolidated slide mass, only partly affected by the actual slide, and partly buried below this actual debris. Secondary slumps appear at the front of this mass and a secondary steeply inclined slide is clearly visible at the right (northern) edge of the photograph of early December 2005

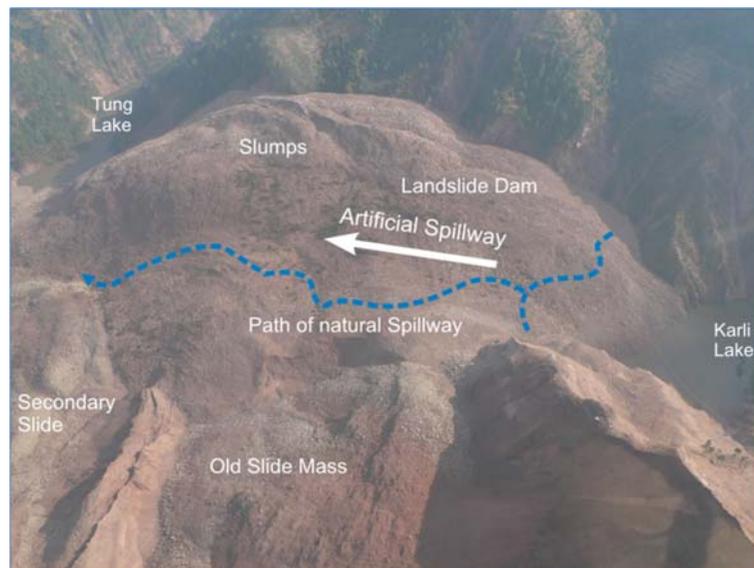
Fig. 4 Helicopter view from above slide eastwards towards the natural dam formed by the landslide debris. At least three ridges can be distinguished, confirming the locally reported three surges. The above mentioned secondary slumps and slides can be seen in the foreground. Slumps have also slid northwards from the crest of the new debris dam. Vegetation on the contact between debris mass and opposite slope is intact and a distal trough was left open. This oblique photograph of early

December 2005 also shows the growing Karli and Tung lakes and the possible natural path of overflowing lake water (blue line). The white arrow indicates the planned 450-m-long artificial spillway, which was constructed in the first half of 2006. The smaller Tung Lake has also an artificially controlled overflow; Karli Lake level has reached the constructed spillway in April 2007

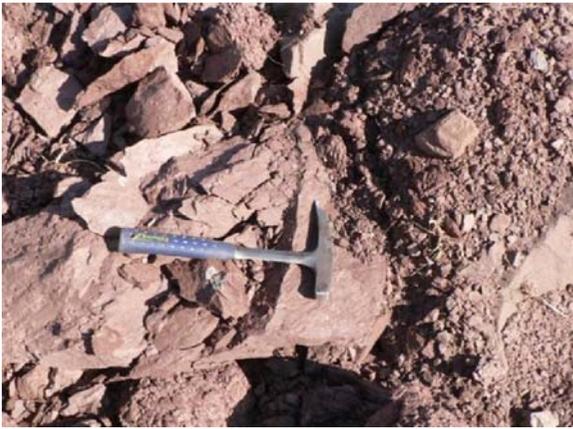
Fig. 5 Shale of the Murree Formation on dam proximal to the landslide (hammer for scale). The clayey to silty material is crumbling apart, wetted by the morning dew. The resulting soil is quite impermeable and can thus act as an aquiclude. Monsoon rainfall will enhance this effect, adding to the consolidation of the slide debris

and it was in this formation that the present landslide occurred on Dana Hill (Figs. 5 and 6).

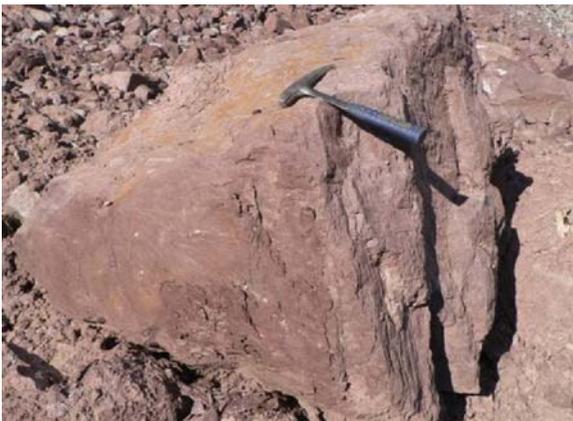
Fig. 6 Sandstone block of Murree Formation in the distal highest part of slide mass (elevation 1446 m, hammer for scale). The size and number of large blocks increases with increasing distance from slide (segregation). While excavating the artificial spillway in the proximal area, only a few large blocks have been found

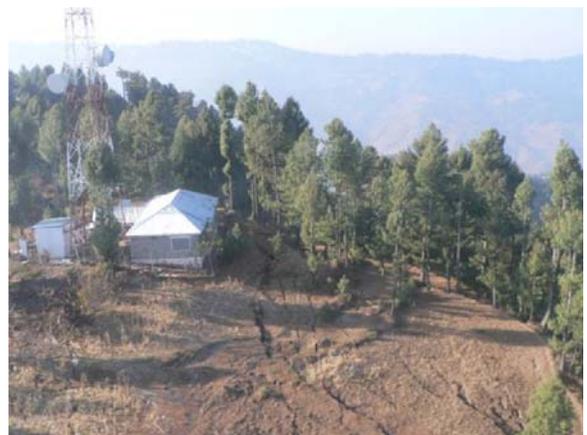
Fig. 7 Lateral spreading at Dana hilltop in the vicinity of the SCO-Tower. Most cracks are oriented N – S. Such cracks can be seen all along the Dana hillcrest from the Tanda fault in the south to Dana hilltop (Heli view to south)

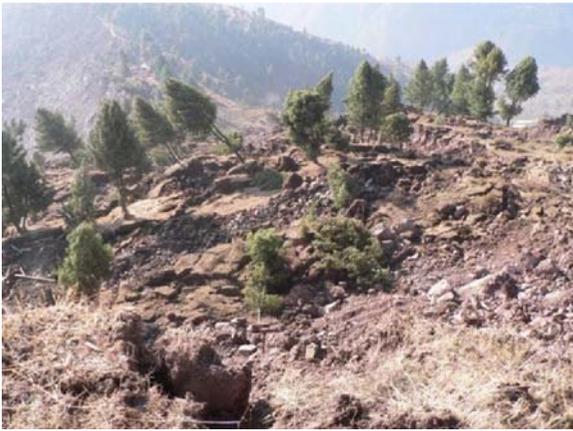
The escarpments as well as the V- to U-shaped elongated sliding trough again have a tectonic origin, dominated by a NNE-plunging syncline with, in parts, tightly folded anticlines and other structural complications. Furthermore, both the top and the eastern side of Dana Hill are completely shattered, laterally spread and crisscrossed by cracks, slumps and slides, with the cracks striking mostly perpendicular to the synclines and anticlines, i.e. NNW–SSE (Fig. 7). At the south-facing escarpment of the slide, on the western crest of Dana Hill, there is still a large amount of destabilized rock material lying or hanging in critical condition, possibly allowing further rock-slides (Fig. 8).

Fig. 8 Massive disruption of the Murree formation at the hillcrest between the communication tower and the top of actual landslide (view to south). This scene looks quite different from a normal landslide escarpment. Large amounts of shattered rock remain on the slope in unstable condition, which could potentially create further mass movements

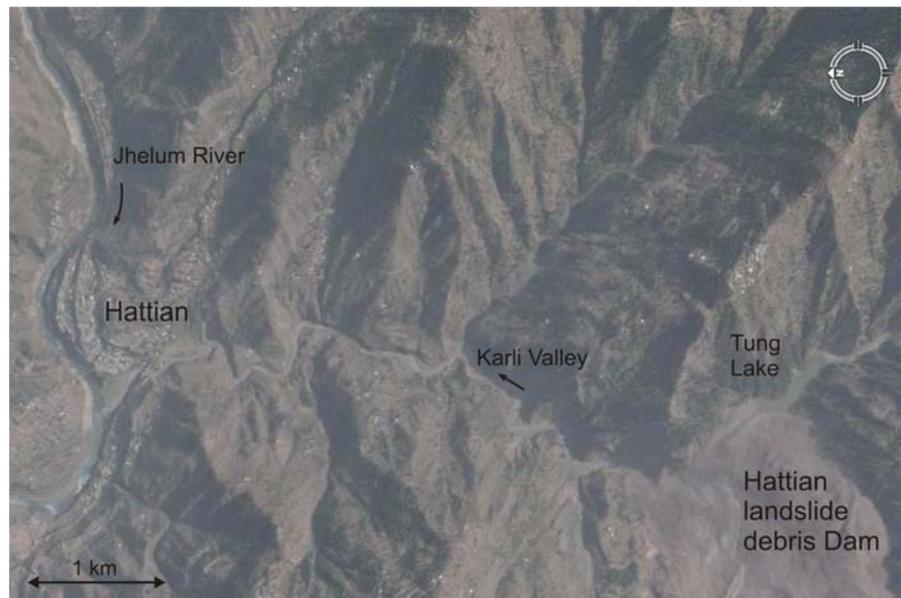
Fig. 9 Google Earth (©2007 Google, ©2008 Digital Globe, ©2008 Europa Technologies, high resolution composite dated 10-03-2006, eye altitude 5.6 km). Possible flood pathway from dam site at right (south) over 4 km downstream through narrow gorge to Hattian and Jhelum Valley at left. The smaller Tung lake, with its artificial spillway, is visible at middle right of scenery. The construction of the lower part of the 450 m long Karli Lake spillway on the slide mass is not visible to this date in the lower right corner of the composite

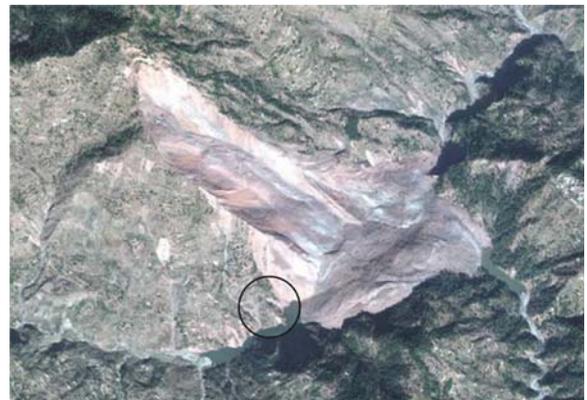
Fig. 10 Oblique true colour scenery of Hattian slide and lake formation area (©2005 DigitalGlobe, QuickBird II, 27-10-2005). Note the complex geometry of the slide with its central bulge, lower part of it interpreted by the author as an older mass. The debris dam shows ridges and scars. The Karli and Tung lakes are observed to have started to fill up. Clearly visible is the narrow gorge downstream of the landslide dam. The SE facing slope of Dana Hill (left side of the image) shows recent landslide scars. The Tanda Fault is just outside the image on the left side; the hazardous slide developing on the left side of the lake shore is encircled and shown in detail in Fig. 11

In Figs. 10 and 11, an active slide or slump is visible, developing on the left shore of the growing lake. This mass movement could trigger a flood wave, if a sudden failure would occur. A rapid lowering of the lake level caused by a partial dam failure was faired during the early stages of natural overflow of the dam. This would have caused an overpressure of the interstitial water in the slope triggering the slump. This hazard was minimized by human interaction and by time.

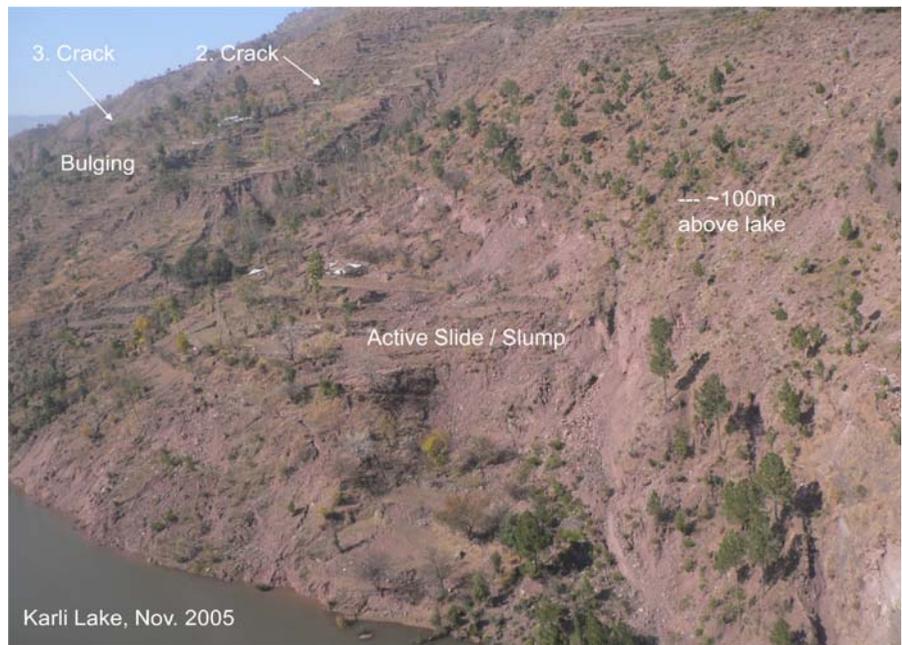
Fig. 11 Helicopter view (Nov. 2005) of the active slide or slump on the lower flank of Dana Hill, west or orographic left side of Karli Lake. In the mean time, the lake level rose up to the destroyed houses on the sliding mass. Note the bulging and cracking of the slope south of the active slide. The unstable foot of this slope is submerged. Possible consequences of these mass movements are discussed in the text above

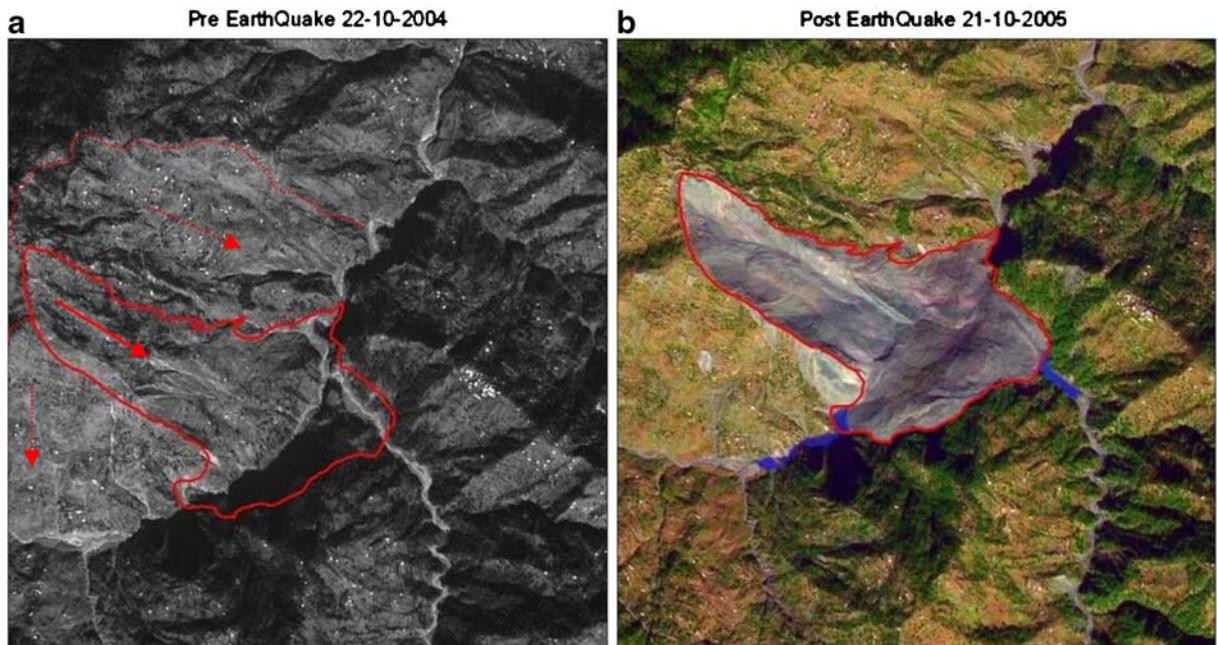
Fig. 12 a, b: Satellite images of Hattian slide area (SPOT 4, XI and panchromatic M-modus, sceneries by SUPARCO, Pakistan, 2005, modified by the author) before the slide (22-10-2004, left), as well as after the earthquake triggered slide (21-10-2005, right), also showing the early stage of the formation of Karli and Tung Lakes. Karli Stream flows north (towards the

top of the image). Note on the left image the escarpment and sliding mass of the earlier (historical?) landslide at approximately the same location as the actual one (solid arrow). Two even older, possibly Holocene landslide scars (dashed lines and arrows) were detected during field reconnaissance and are recognizable just north and south of the actual event

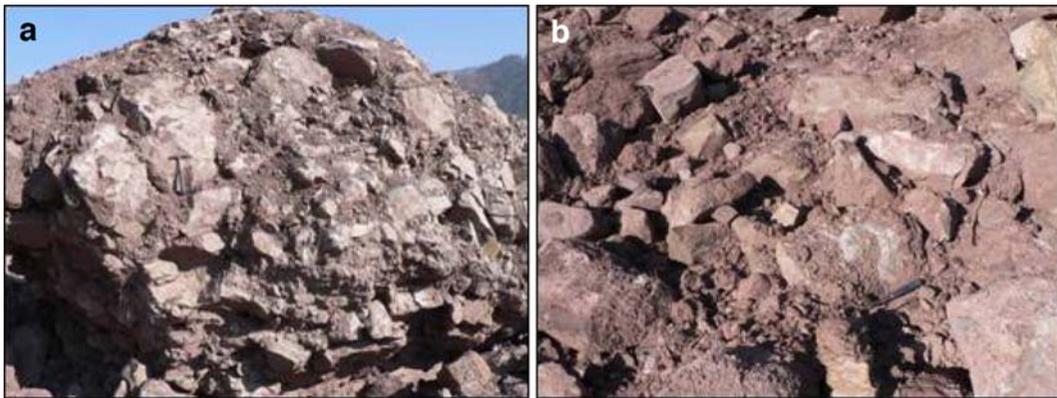
Fig. 13 a, b: Cemented breccia of slide debris from former landslide found in central distal area of landslide dam on the left photo. The cement consists of carbonates (tested with hydrochloric acid, see hammer for scale). The right photo

shows in comparison a similar breccia with sandstone components, clay and silt as matrix, but not cemented, lying in the central part of the actual landslide dam (see hammer for scale)

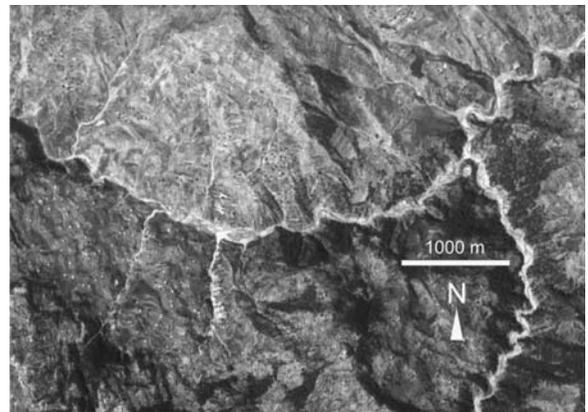
Fig. 14 Analogue CORONA photo (15-09-1971, courtesy of T. Nakata). Confluence of the Tung and the Karli streams (approx. 1,130 m a.s.l.) with the south facing former landslide (in the upper left of the photo), and the lower part of the “historic” landslide, showing the deeply incised streams and the eroded base of the slide (in the upper right of the photo, see Figs. 2 and 12a for orientation). Karli Stream is flowing from left to right. This view shows, when compared to Fig. 12, more details of the rugged surface and the deeply incised stream bed, with which the actual landslide interfered. Here, in 1971 (and also 2004, Fig. 12), no major village is visible, suggesting an exaggeration of the death toll (up to 1000 casualties) in Dandbeh hamlet caused by the slide
