Stripping phenomenon in thick pavement top layers

N. Vulcano Greullet, Jean Pierre Kerzreho, Armelle Chabot, V. Mauduit

N. Vulcano Greullet, Jean Pierre Kerzreho, Armelle Chabot, V. Mauduit. Stripping phenomenon in thick pavement top layers. 11th International Conference on Asphalt Pavements, Aug 2010, Nagoya Aichi, Japan. pp.552-561. hal-00559938

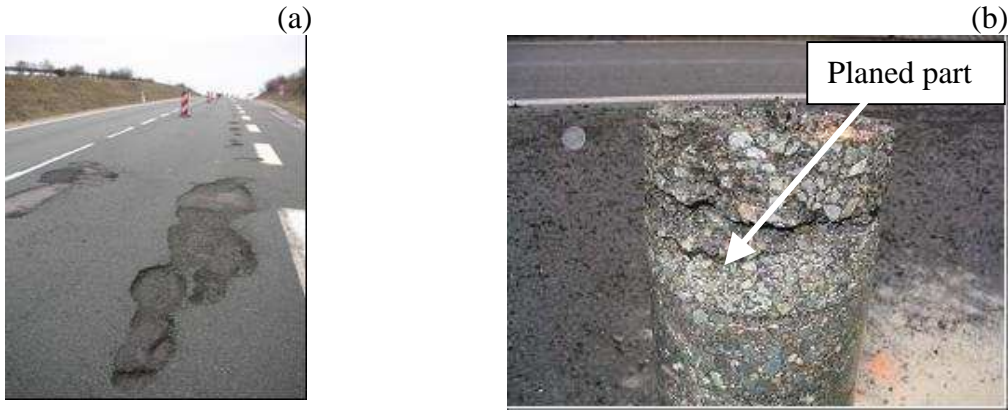
The degradation survey carried out in 2005 reveals clean transverse and longitudinal cracks at wheel track level on the traffic lanes throughout the 2.5 km of the section considered. The first 500 meters of the section also present extensive repair works and significant branched longitudinal cracking. Previous deflection measurements, however, had not shown any particularly structural failure sign. During winter 2005/2006, many potholes, which made emergency repair sometimes several times a day necessary, appeared in a few days (Figure 1). These 5 to 12-cm deep and several square decimetre large potholes were numerous, close to each other and located on the climbing lane, preferentially on the lane wheel tracks.

The samples extracted from the pavement after degradations had appeared show that the hydraulic bound base course is in very good condition whereas the cracked and crazed wearing course rests on two degraded layers.

Figure 1: Pavement whose wearing course is laid on a planed surface. (a) Potholes in chains (b) Damaged binder course under the wearing course.

The first case demonstrates that, in certain conditions, milling the upper part of the pavement before laying a new wearing course can weaken the first interface. The mechanical action of the planer, whose speed is sometimes too high, can be the cause of microcrack formation within the remaining underlying layer evolving under the action of traffic (Figure 1b). Planing also implies that the lowest part of the former wearing course can sometimes remain on the pavement when milling depth is not deep enough. This remaining 1- or 2-cm thick layer certainly constitutes a weak point for the structure. It can, indeed, suffer from a deficiency in compaction. Moreover, at the bottom of the new course, there are not one but two interfaces, between which a thin, bitumen layer where infiltration water can accumulate, is found. In rainy, wintry conditions, this zone close to the pavement surface is *a priori* particularly sensitive to freeze-thaw cycles.

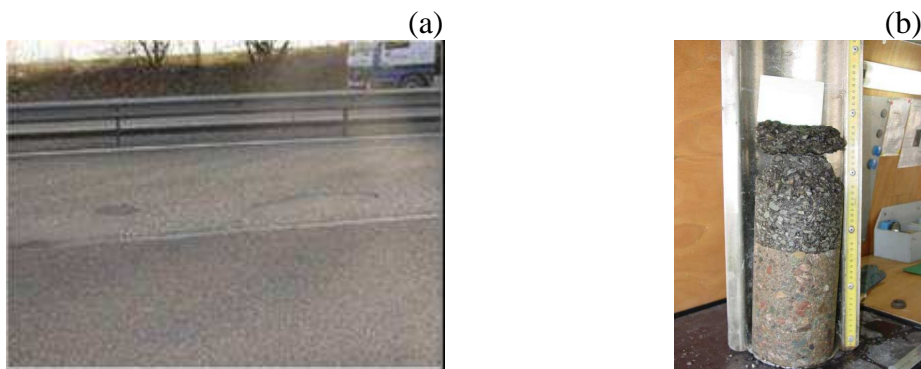
During winter 2007/2008, potholes developed within a very short lapse of time requiring frequent and urgent repairs (Figure 2).

Figure 2: Pavement whose the drainage system is unsatisfactory. (a) Pothole repair (b) Core sample showing base and sub-base in good condition.

Pothole dimensions could exceed one square decimetre, be 6 to 8 cm deep and were found on both the slow and the fast lanes over a linear section of nearly 3 km. They were principally located at the lowest point of the longitudinal section where there is no water outlet.

The problems observed in the second case are obviously arising from the absence of a satisfactory pavement drainage system, for which long-term adverse effects are well known (Apul et al. 2002). A poor or non-existent drainage system, not carefully designed geometry, a locally unfavourable road configuration (low points, superelevation transition zone, for instance) are as many parameters connected to pavement construction or operating, which can cause the stagnation of runoff water within the pavements. Whole portions of road are then exposed to stripping and its ensuing damages: segregation of the binder/aggregate pair, delamination, spontaneous water-in-bitumen emulsion phenomenon, etc. (Kiggundu et al. 1988, Hicks, 1991, Castenada et al., 2004). Material coming off can increase under the action of traffic.

- pavement condition survey to detect saturated zones within foundations (visual survey after rain events, use of radar, etc.),
- treatment of the spotted zones with suiting materials and measures,
- improvement of already available laboratory tests in order to ameliorate the water resistance qualification of pavement materials and interfaces.

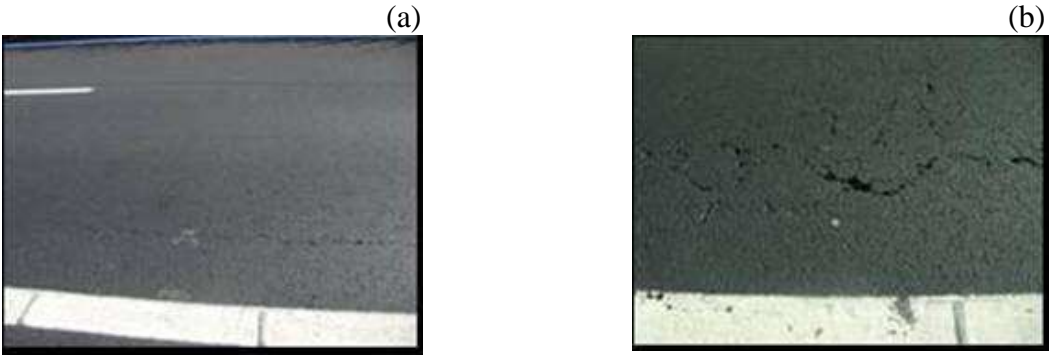
Figure3: Longitudinal crack at wheel track level on the slow lane. (a) Initial crack (b) Crazing evolution.

Crazed zones evolve into a surfacing consisting of small separate blocks, which, in rainy wintry conditions combined with heavy traffic, can come off the road and require many selective repairs.

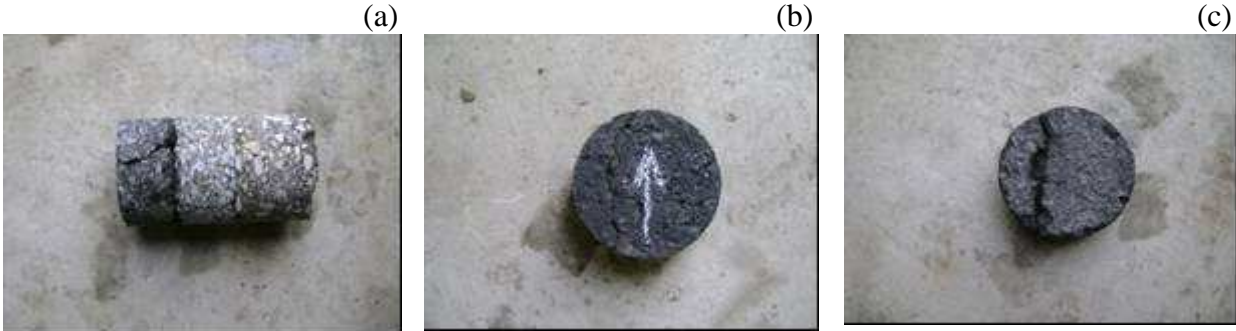
Figure4: Core sample taken at longitudinal crack level. (a) The first interface is detached whereas the first layer is cracked straight down. (b) View from above the wearing course. (c) View from below the wearing course.

The core samples taken on the newly formed longitudinal cracks show that cracks do not go deeper than the first interface (Figure 4a). The photographic view of the wearing course from above shows an open crack with a few spalls (Figure 4b). The view from below the course, on the other hand, reveals that the crack is wider opened than at the surface (Figure 4c). Cracking probably started from the bottom of the wearing course long before appearing at the surface and then spread upward across the whole thickness of the layer.

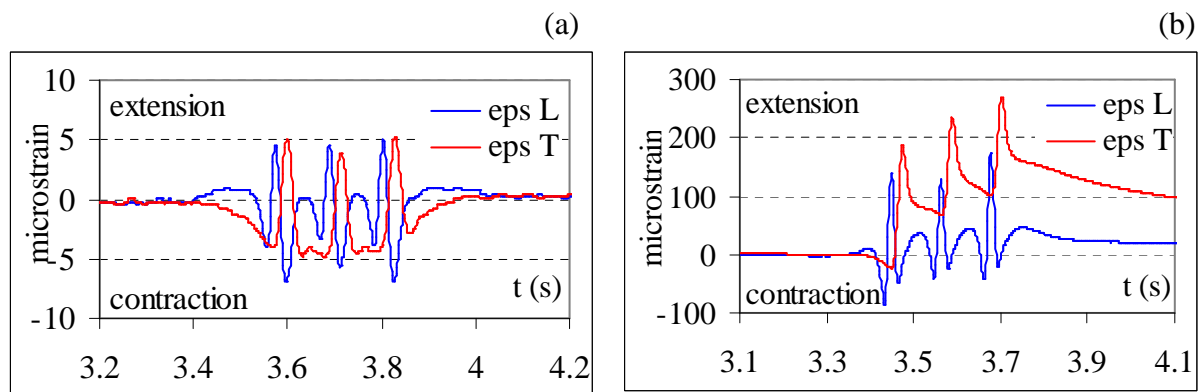
The charts of the recording instruments plot the deformations measured at the bottom of the wearing course (Figure 6) and at the top of BiC1 (Figure 7) for both profiles. The curves display some significant microstrains with opposite signs on both sides of the interface at high temperatures. They reveal some displacements of the layers despite the tack coat good adhesive capacity as proved by the core samples extracted from the pavement at the end of the test.

Figure6: Microstrain signal at the bottom of the BC course. (a) Microstrains for profile 1. (b) Microstrains for profile 2.

Figure 6b presents transverse deformation values 1.6 times higher than longitudinal ones, which could account for longitudinal cracking. However, it is also possible, in these conditions, that a fatigue event with delamination specific of the interface is being observed. Elastic structural computations using the Alizé software (Autret et al., 1982) (www.lcpc.fr) or viscoelastic ones using ViscoRoute software (Chabot et al., 2009) (Chupin et al., 2009) performed with data sets corresponding to the temperature and interface conditions described, confirm the argumentation. They also can be used to clarify the demonstration through a comprehensive study of strain and stress fields.

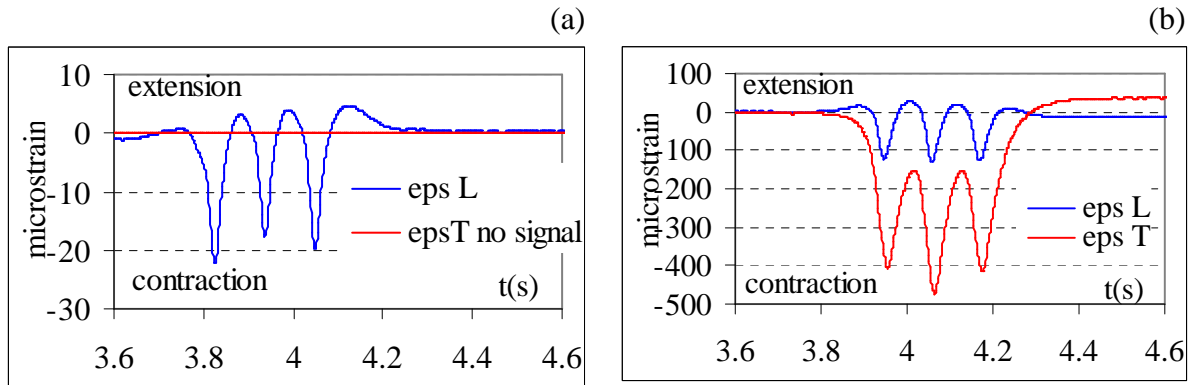
On the other hand, in cold or temperate conditions, the deformations are much smaller and correspond to contraction or very small traction effects at the bottom of the wearing course, and to contractions in the upper part of the binder course.

Figure 7: Microstrain signal at the top of the first binder course. (a) Microstrains for profile 1
(b) Microstrains for profile 2.
