**GIS Evaluation of the Impacts on the Built and the ‘Natural’ Environment of the 11 March 2011 Tsunami in Rikuzentakata, Iwate Prefecture, Japan**

C. Gomez<sup>1,2\*</sup>, P. Wassmer<sup>3,4</sup>, C. L. Kain<sup>1</sup>, M. De Villiers<sup>1</sup>, K. Campbell<sup>1</sup>, S. Ward<sup>1</sup>, A. Moghaddam<sup>1</sup>

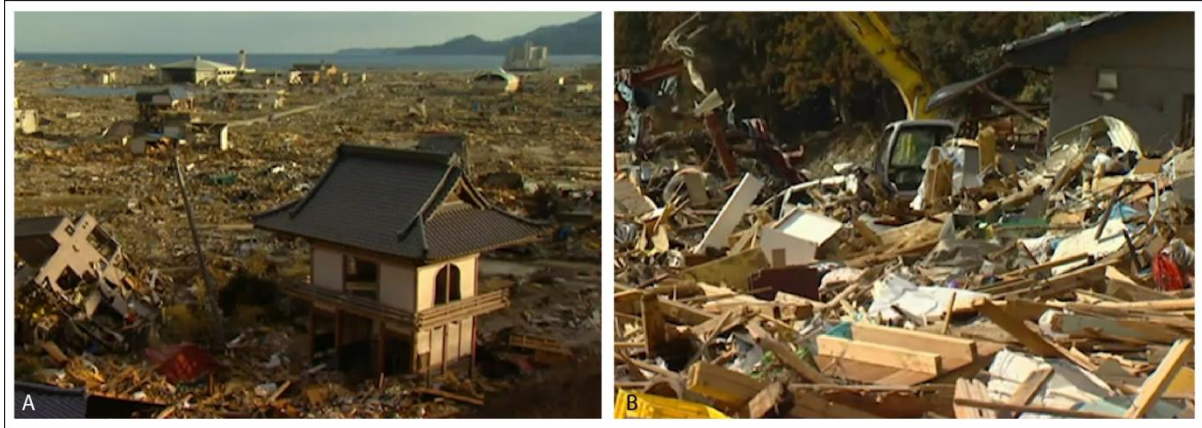
Fig. 2 View of the bay in front of Rikuzentakata (A) and zoom of the rubble in the destroyed municipality (source: images extracted and adapted from Al Jazeera, 2011)

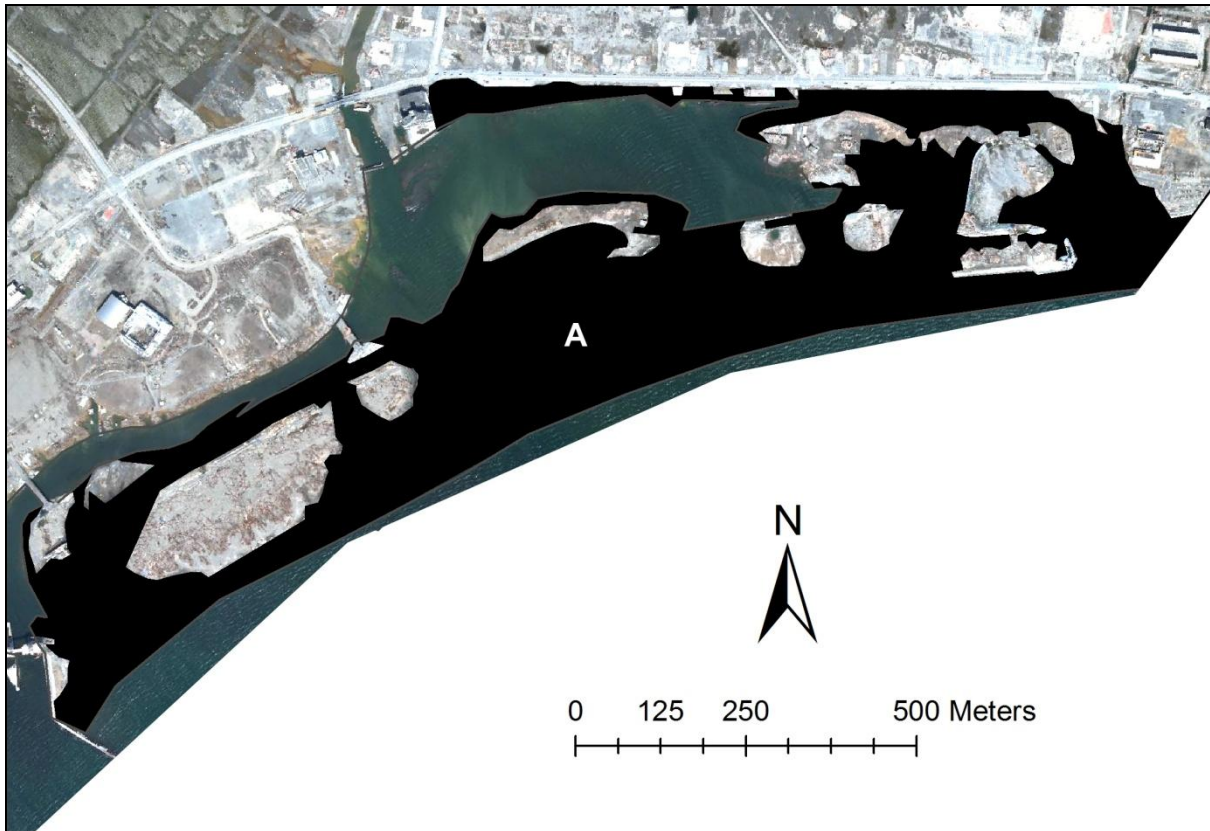
The length shoreline studied here is approximately 1,800 m for a measure done with a control vertex every 100 m. We have observed an average retreat of the seashore of 345 m in this area, with a high standard deviation of 110 m, meaning that some areas hold well against the tsunami, whereas were highly eroded. Areas where the shoreline did not retreat correspond to the areas where concrete wave-breaker protected the shore. On the contrary, areas such as the lagoon barrier and the lagoon recorded a draw-back of up to 501 m. For these highly eroded areas, the retreat of the shoreline was stopped due to the presence of roads parallel to the coast, which played the role of a 'stop-bank'. This shoreline retreat doesn't however mean that a corresponding amount of land has been lost (Fig. 4), because of the presence of the lagoon. This retreat has also created a series of 9 main islands that are disconnected from the mainland. The total surface of land lost to the tsunami is 0.37 km<sup>2</sup> (Fig. 4).

Fig. 4 Area lost to the tsunami in March 2011 (A). The exact causes of this loss cannot be solely determined from aerial photographs as it could be a mix of subsidence and erosion.

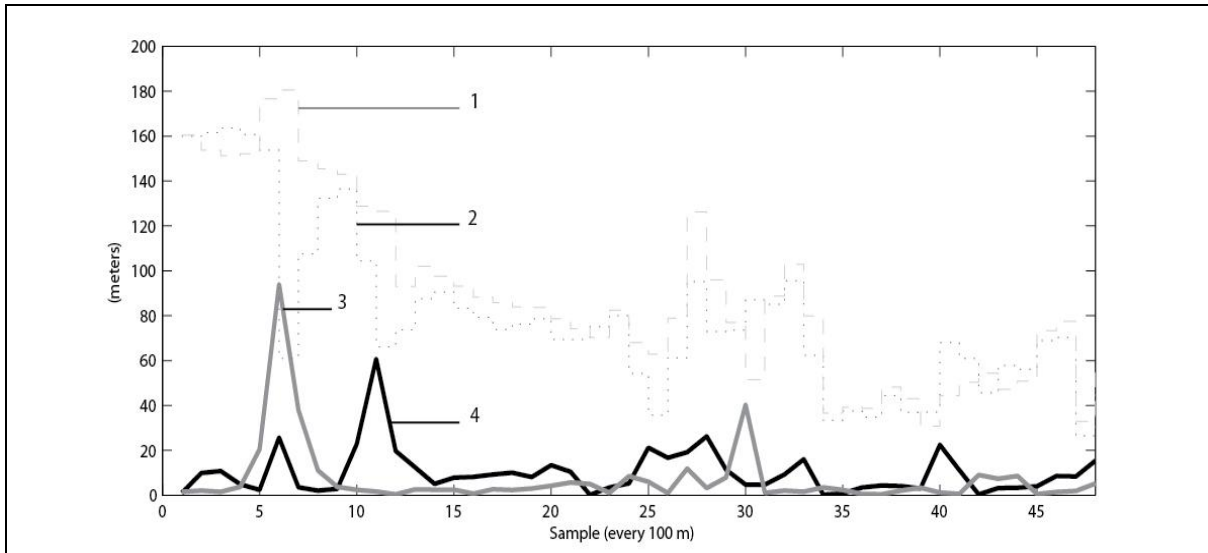
The 4.8 km length of the Kesen River studied here has been impacted by the tsunami. The average width of the active channel has increased from 79 m to 88 m on average (Fig. 5), with a maximum width of 163 m in 2010 that became 180 m after the tsunami. Minimum values have also increased from 26 m to 30 m. The maximum peak of erosion is 94 m for the right bank against 60 m on the left. This exceptionally high value on the right bank is due to the total disappearance of a pointbar located between 50 and 60 m from the river mouth. The maximum erosion for the left bank is also due to a pointbar that developed against the stop-bank in the active channel. It is interesting to note that there is no clear gradient – away from the sea - in the lateral erosion along the 4.8 km, which one would have expected with the progressive energy dissipation. However, the influence of the mingling between build and natural environment makes quantification difficult, and the erosion that took place along the river was all contained between the concrete stop-banks.

Fig. 5 Planform changes of the Kesen River along 4.8 km. (1) Width of the active channel in July 2010; (2) Width of the active channel on March 13, 2011; (3) Lateral erosion of the right bank; (4) Lateral erosion of the left bank.

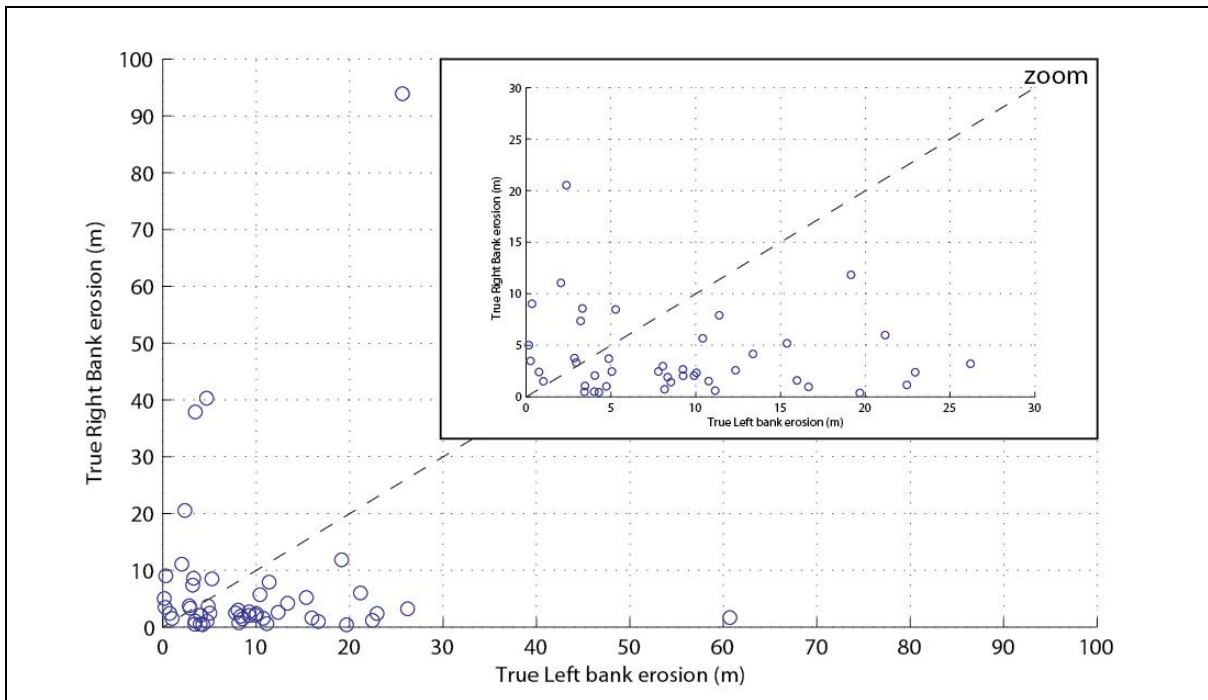
The position of the active channel within the limits of the stop-banks is at the origin of an erosive dissymmetry between the left and right banks (Fig. 6). The left bank (to the East on the figures) has lost 10 m on average, whereas the right bank lost 7 m on average. We can find a similar ratio for the minimum erosion data: 0.16 m and 0.4 m (right and left banks respectively).

Fig. 6 Correspondence of the lateral erosion between the right bank and left bank. The scatter plot shows that there is no strict relation between the lateral erosion of the right and left bank for each sampled transect.

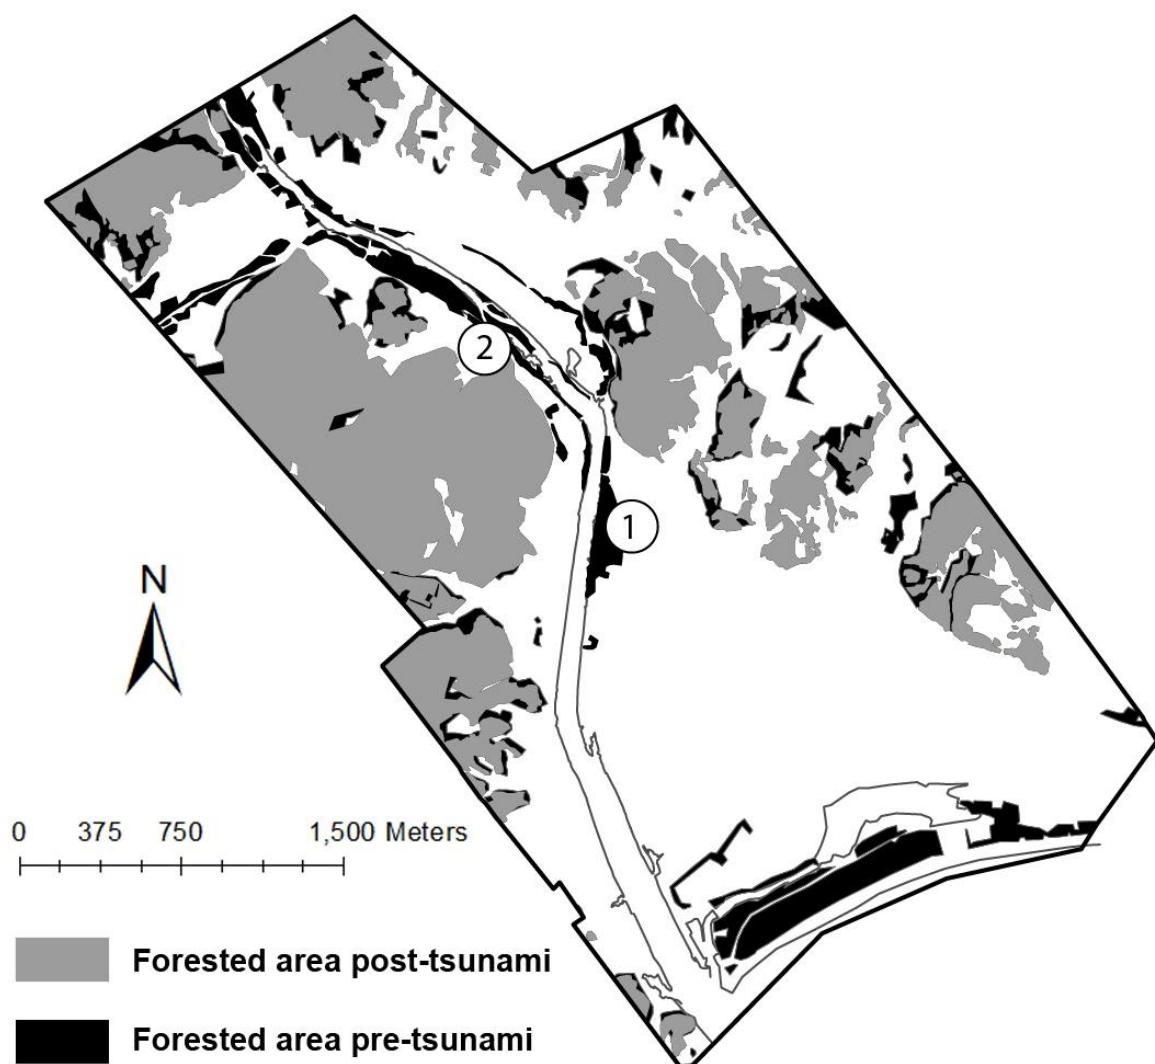
195 m from the closest bank and 250 m to the active channel central line. The largest area of flattened trees (1 on Fig. 7) measures 42,000 m<sup>2</sup>. It is located on a left pointbar, along the Kesen River, only 2.5 km from the river mouth. The second area, where trees have been flattened is located on a right bar (2 on Fig. 7). It is 5,500 m<sup>2</sup> and it is located 3.6 km from the river mouth.

Because of the physical destruction of the lagoon's barrier, forested land in the area subsequently disappeared as well. This forested area was composed of two curtains of vegetation located on one or both sides of the lagoon with one interruption (Fig. 7). The total loss of forested area is 0.26 km<sup>2</sup>, which is a 100% lost, except for one of the pine-tree. Only 66,000 m<sup>2</sup> of the land that hosted this forested area hasn't been colonized by sea-water, and 38,000 m<sup>2</sup> of this land is located at the back of the lagoon in an area that was protected by a stopbank and around the high-school ground.

Fig. 7 Impacts of the tsunami on forested areas in the municipality of Rikuzentakata; (1) and (2) are areas where the trees has been flattened down.

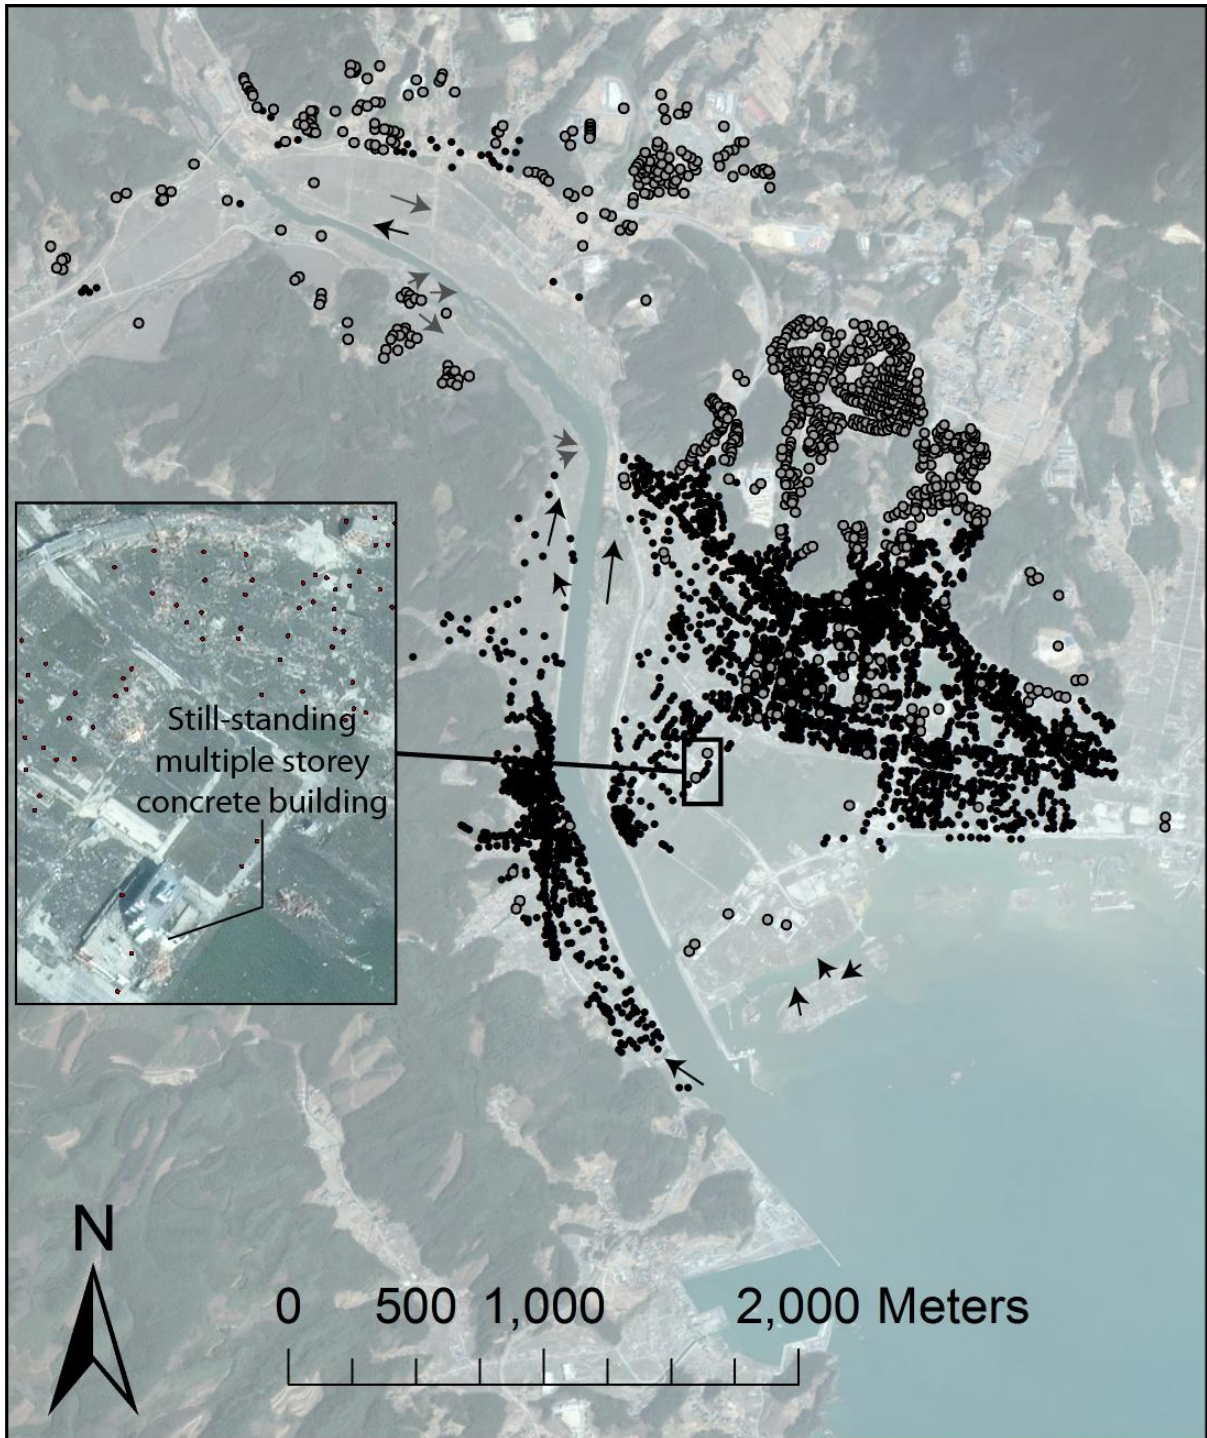
In Rikuzentakata, the ‘light’ constructions have responded poorly to the vertical load and the upward forces produced by the tsunami waves. Based on the image analysis, we have identified different types of destruction: (1) destruction due to sliding over the foundations and/or overturning of the structure, in such a way that we can still observe the concrete slab on the ground; (2) scouring of the surrounding land and of the place where a building was standing. Such destruction has mostly affected timber and steel frame buildings. High-rise buildings (4 storeys and more), with a RC or SRC structure resisted the tsunami (Fig. 10-B)

The area of maximum destruction of buildings is encountered in the lowland plain up to 3 km inland. Buildings have been destroyed (Fig. 10) regardless of the density of the built environment, the orientation of the houses and for most of them their structure (wood or metallic structures). Buildings of the city council, sport-centres and part of school buildings have structurally survived the tsunami. This has moved the barycentre of the Rikuzentakata buildings from 1400 m to 2400 m from the shoreline, modifying the spatial distribution of building density (Fig. 11).

Fig. 10 Location of destroyed buildings (black points) and still standing buildings (grey points); Black arrows are orientation associated with the uprush; Grey arrows are orientations associated with the backwash. The complexity of orientations marker is interesting; however they are very difficult to understand at this stage.

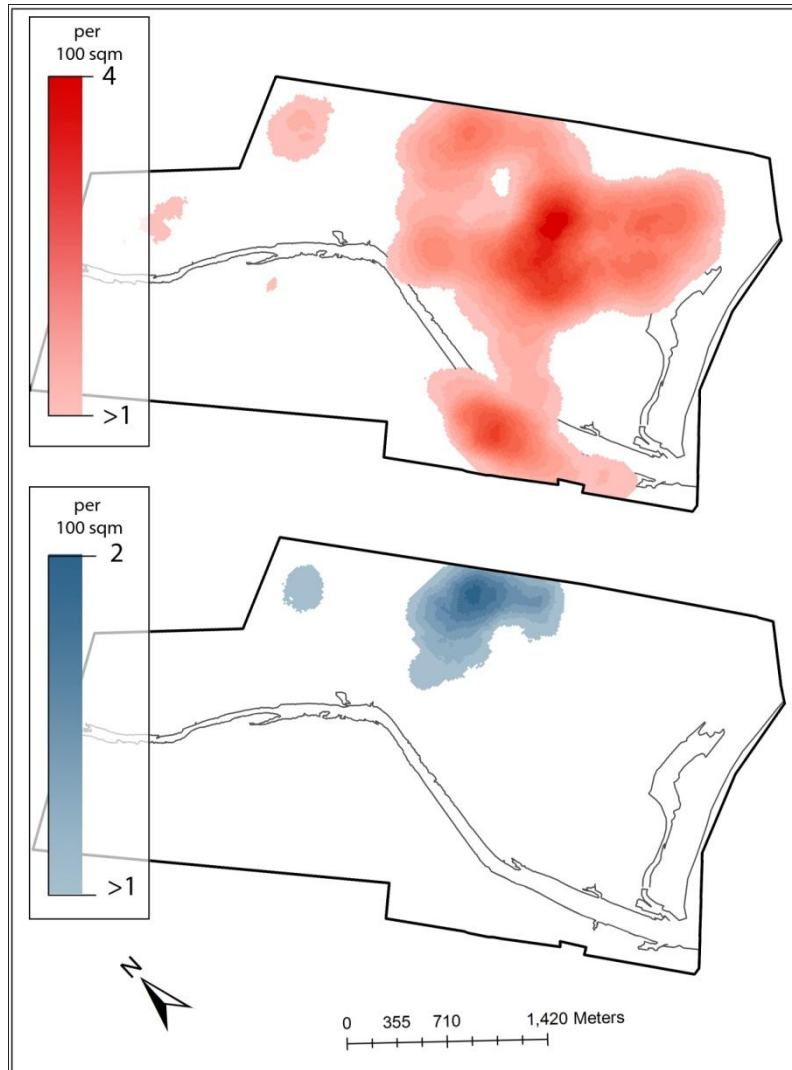
Fig. 11 Change in building density (number of building in a radius of 150 m, data provided in 100 m<sup>2</sup>).
