GIS Evaluation of the Impacts on the Built and the 'Natural' Environment of the 11 March 2011 Tsunami in Rikuzentakata, Iwate Prefecture, Japan

GIS Evaluation of the Impacts on the Built and the ‘Natural’ Environment of the 11 March 2011 Tsunami in Rikuzentakata, Iwate Prefecture, Japan

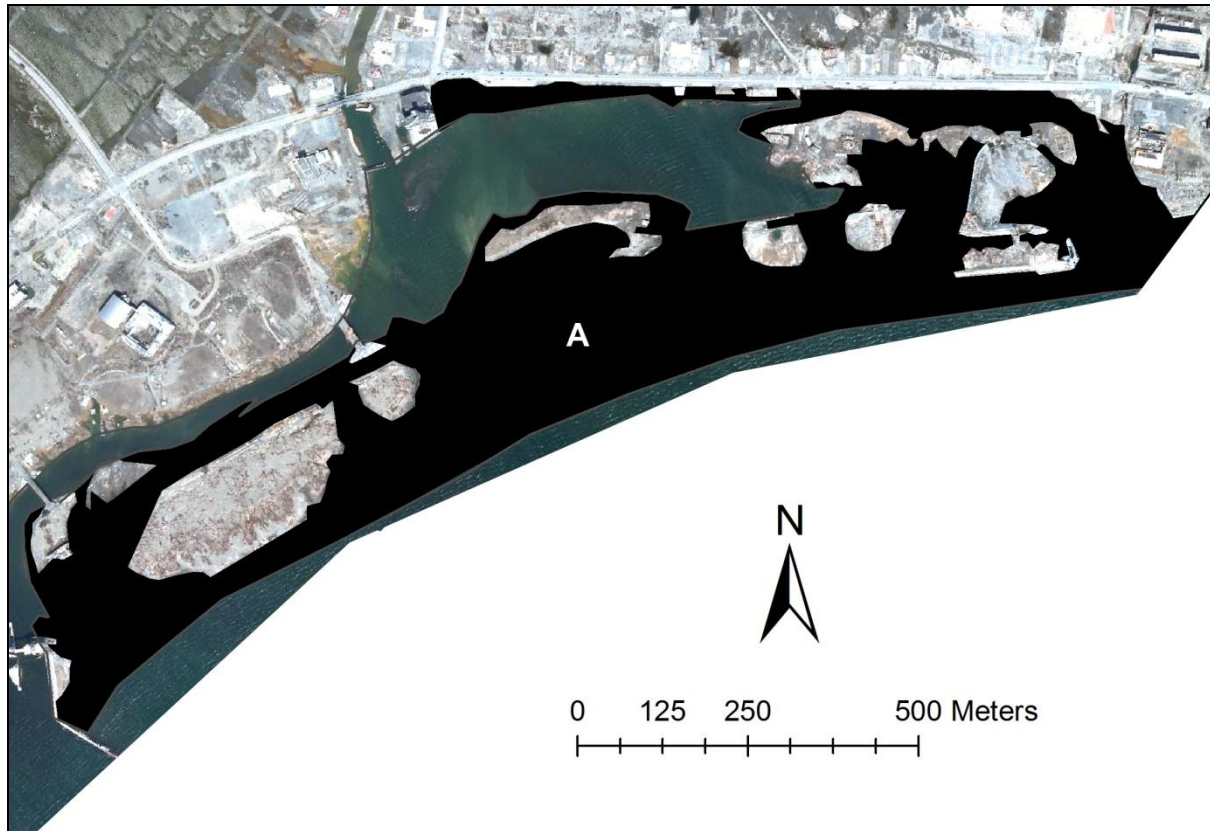
The length shoreline studied here is approximately 1,800 m for a measure done with a control vertex every 100 m. We have observed an average retreat of the seashore of 345 m in this area, with a high standard deviation of 110 m, meaning that some areas hold well against the tsunami, whereas were highly eroded. Areas where the shoreline did not retreat correspond to the areas where concrete wave-breaker protected the shore. On the contrary, areas such as the lagoon barrier and the lagoon recorded a draw-back of up to 501 m. For these highly eroded areas, the retreat of the shoreline was stopped due to the presence of roads parallel to the coast, which played the role of a 'stop-bank'. This shoreline retreat doesn't however mean that a corresponding amount of land has been lost (Fig. 4), because of the presence of the lagoon. This retreat has also created a series of 9 main islands that are disconnected from the mainland. The total surface of land lost to the tsunami is 0.37 km² (Fig. 4).

Fig. 4 Area lost to the tsunami in March 2011 (A). The exact causes of this loss cannot be solely determined from aerial photographs as it could be a mix of subsidence and erosion.

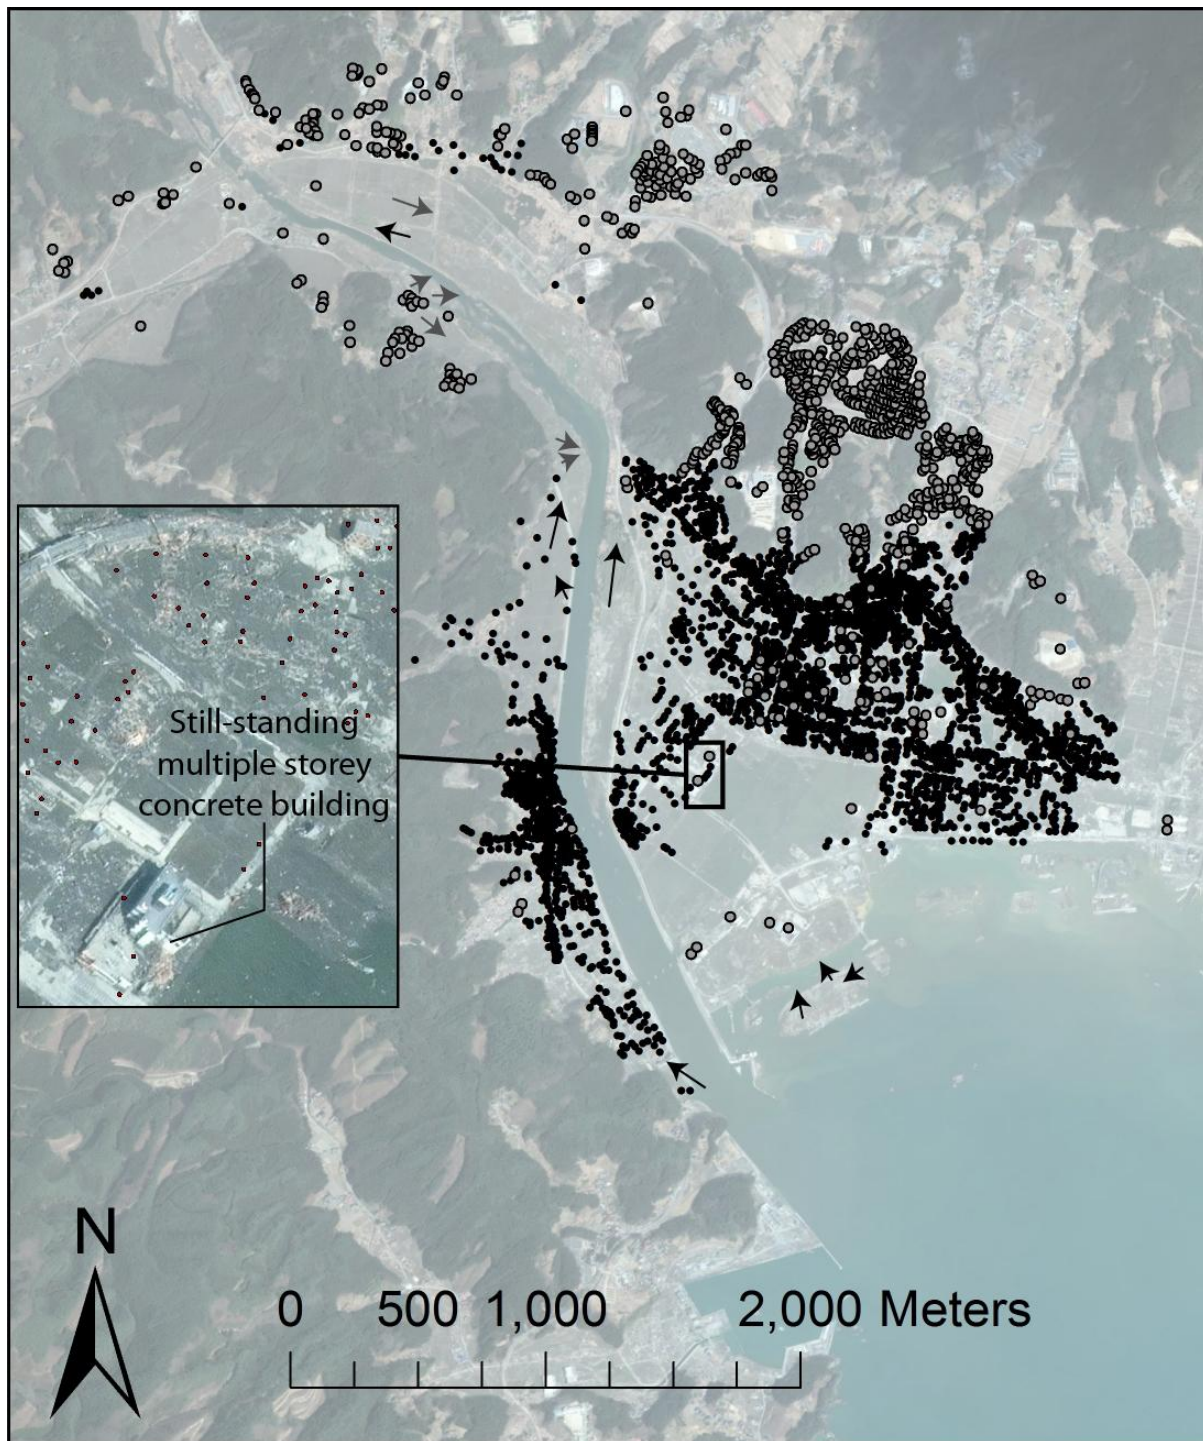
In Rikuzentakata, the ‘light’ constructions have responded poorly to the vertical load and the upward forces produced by the tsunami waves. Based on the image analysis, we have identified different types of destruction: (1) destruction due to sliding over the foundations and/or overturning of the structure, in such a way that we can still observe the concrete slab on the ground; (2) scouring of the surrounding land and of the place where a building was standing. Such destruction has mostly affected timber and steel frame buildings. High-rise buildings (4 storeys and more), with a RC or SRC structure resisted the tsunami (Fig. 10-B)

The area of maximum destruction of buildings is encountered in the lowland plain up to 3 km inland. Buildings have been destroyed (Fig. 10) regardless of the density of the built environment, the orientation of the houses and for most of them their structure (wood or metallic structures). Buildings of the city council, sport-centres and part of school buildings have structurally survived the tsunami. This has moved the barycentre of the Rikuzentakata buildings from 1400 m to 2400 m from the shoreline, modifying the spatial distribution of building density (Fig. 11).

Fig. 10 Location of destroyed buildings (black points) and still standing buildings (grey points); Black arrows are orientation associated with the uprush; Grey arrows are orientations associated with the backwash. The complexity of orientations marker is interesting; however they are very difficult to understand at this stage.

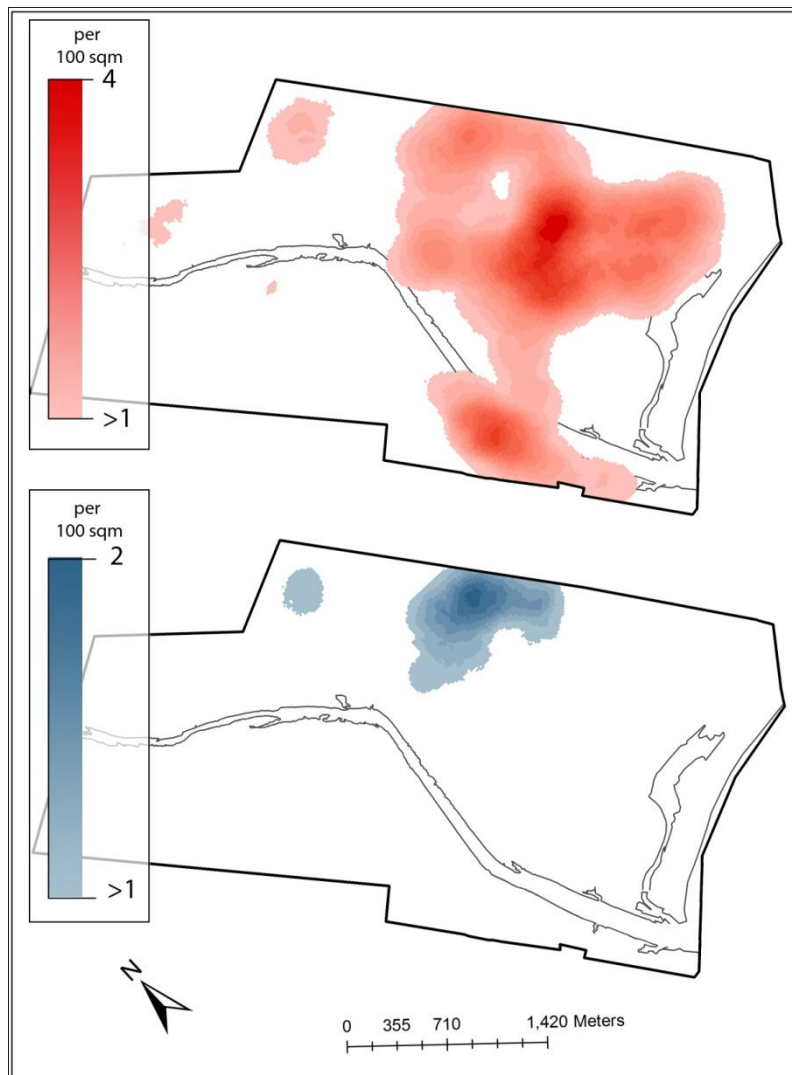
Fig. 11 Change in building density (number of building in a radius of 150 m, data provided in 100 m²).
