The Friant-Kern canal : a forgotten example of lime-treated structure in hydraulic conditions

Gontran HERRIER¹, Eric BERGER², Stéphane BONELLI³

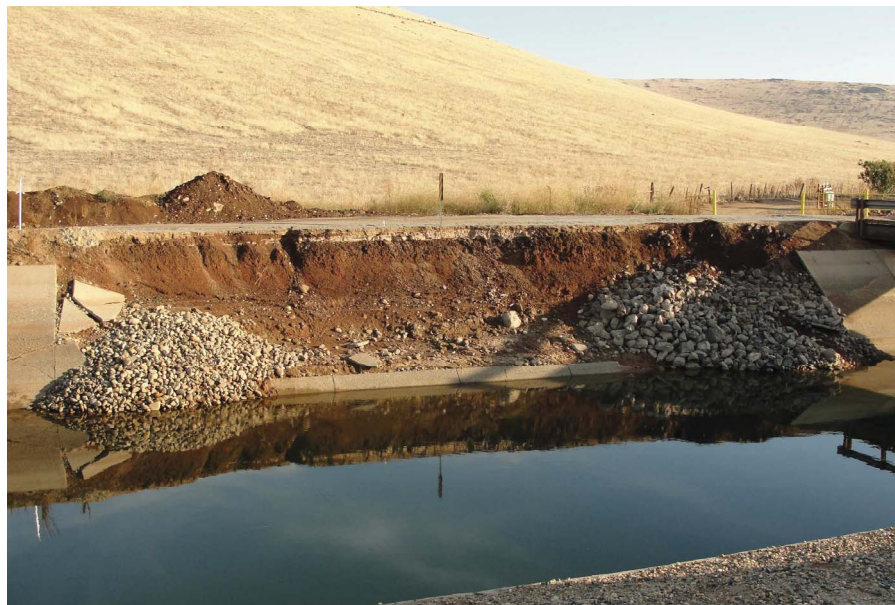
Of the 87 km of canal built with Porterville clays, 37 are earth-lined and 50 concrete-lined. Failures have occurred in both sections, and began only 3 years after construction. Cracks, sliding and sloughing of slopes have been a continuing, expensive maintenance problem. In the concrete-lined sections, the swelling of the clay foundation caused many of the concrete panels to crack with “pop-outs” of blocks or even slides of entire concrete panels (Figure 1, picture taken in November 2010).

Figure 1: Concrete lining failure on the Friant-Kern canal (Nov. 2010).

The concrete pop-outs and slide of the panel is due to the swelling of expansive clay, material used for the embankment. A temporary protective gravel layer was placed at the junction with remaining concrete panels.

The normal repair technique for the concrete-lined areas has been, after a dewatering step, to remove the broken concrete pieces and the loose embankment, compact imported suitable earth in place and place new concrete lining. The problem with that technique was the availability of suitable soils, and/or the transport costs for bringing the materials to the jobsite. In the earth-lined sections, the sloughed earth was typically replaced by gravel or rock, this procedure being accomplished with the canal still full of water. This technique is described as not entirely successful for several reasons: it is not permanent, it is unsightly, it degrades the hydraulic properties of the canal (water flow), and finally may result in a thinner section of impervious embankment. [Garver, 1987]

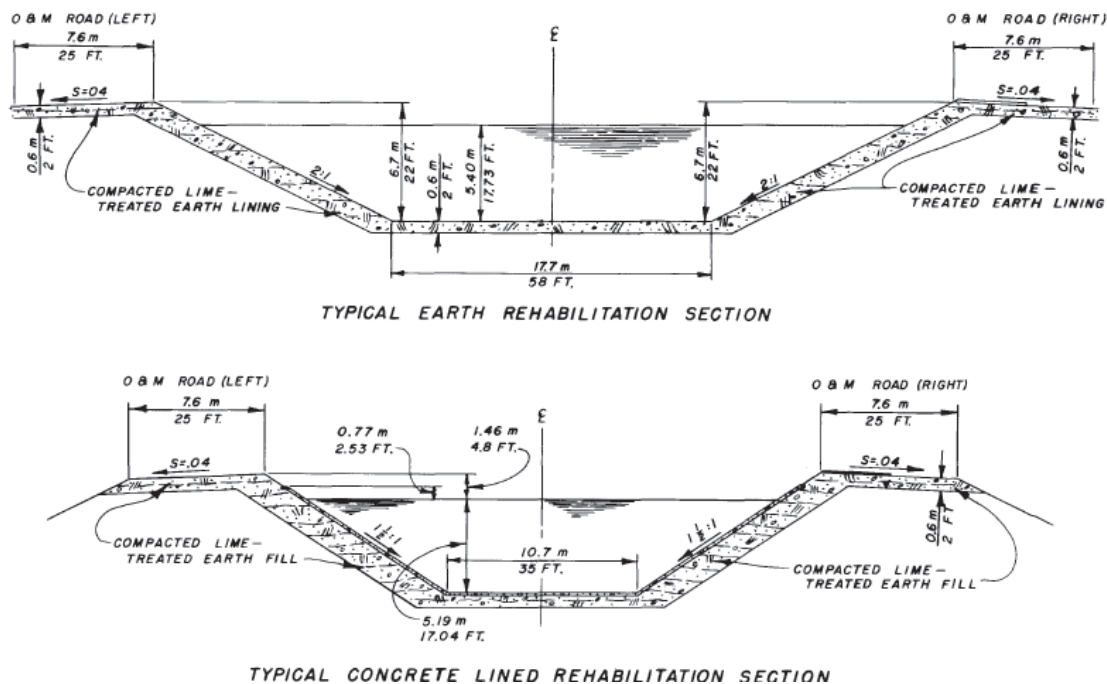
Figure 2: Cross-sections of rehabilitated canal sections (From Howard, 1976).

Figure 2 shows the cross-section of the rehabilitated earth-lined and concrete-lined sections. Thicknesses of lime-treated soil layers were approximately 1.2 m on the banks, 60 cm in the bottom and on the parallel service roads. The earth-lined section had 2:1 side slopes, instead of a 3:2 slope in the case of concrete-lined areas.

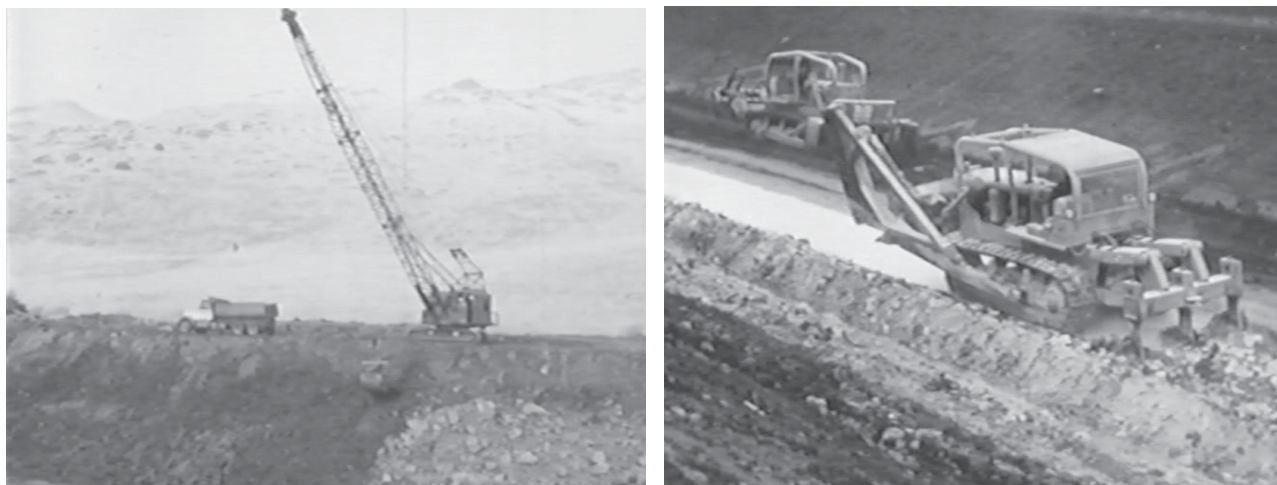
Figure 3: Devices used for removing the failed material from the banks (left) and for soil-lime mixing (back ripper, right). (Source : National Lime Association)

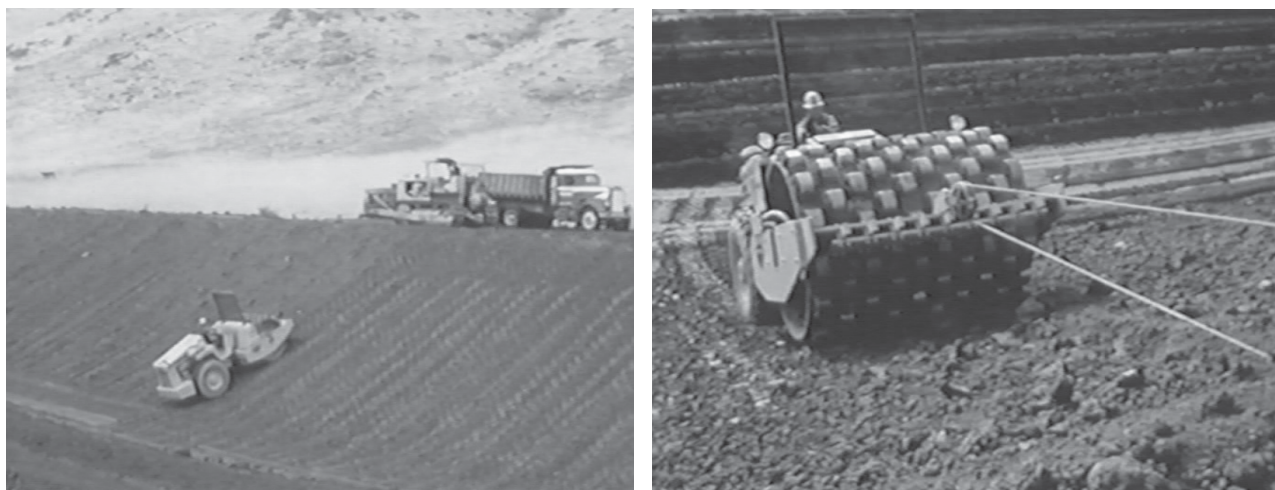
Figure 4: Compaction procedure on the canal banks (First project). (Source: National Lime Association)

A “yo-yo” fashion was adopted; the compaction was performed by a sheepfoot roller (kneading compaction).

After final mixing, the material was allowed to mellow overnight before placement. The soil was placed on the banks in 30 to 40 cm lifts and compacted with a vibrating sheepfoot roller (kneading compaction procedure) that was winched up and down the slope with a crawler tractor (yo-yo fashion, Figure 4).

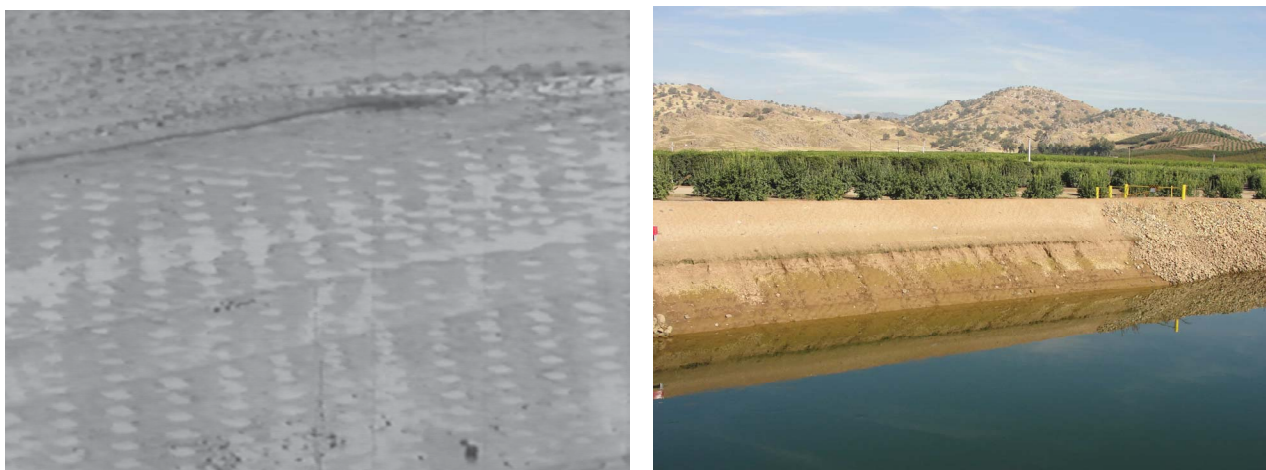
Pictures of the canal bottom were taken 1 year after the first project completion, and 1 year irrigation service (Figure 5, left). The sheepfoot roller imprints left after compaction were evident. Even 35 years after repair works, the same imprints are still visible on the blankets (Figure 5, right). Those elements indicate that the lime-treated soil was not subjected to erosion on either the bottom or the banks. According to written and oral testimonials, the lime stabilized lining has performed very well and no new slips or slides have occurred. In terms of mechanical resistance, cores taken from undisturbed block samples showed a compressive strength of 2.2 MPa (1 month after works completion) and 3.4 MPa (1 year), demonstrating additional strength evolution of the material even in constant contact with water.

Only a minor amount of erosion is visible along the water line (see Figure 5, right). This is probably due to the removal of “clay balls”, fragments of original soil that remained untreated, due to the poor efficiency of mixing operations. These minor faults don’t affect the stability or functions of the canal. It is interesting to point out that a gravel belt was originally specified at the wave line for erosion control, but lack of time permitted only a short section of gravel belt to be placed. After the first irrigation season, the USBR concluded that the erosion was not significant on the unprotected lining, and that the gravel belt was unnecessary. That decision saved \$60.000 in construction costs. In the case of the steeper (3:2) concrete-lined section, time ran out again for placing all the concrete linings on the lime-treated banks, leaving this material exposed to water flow. Even in this more confined cross-section where the flow reaches high values (above 100 m³/s, with a velocity of 1.4 m/s), no damage was identified. [Gutschick, 1978] According Mr. Tom Fusek, head of maintenance operations for a large portion of the Friant-Kern Canal, no damage has occurred on the treated sections since the restoration works; the lime stabilized lining is the material that needs the least maintenance, small amounts of loam are deposited by the water flow and are easily removed by a simple raking of the slope surface.

Left : sheepfoot roller imprints filled with water, at the canal bottom after 1 year irrigation (source : National Lime Association).

Right : picture taken end of 2010, during a maintenance phase. Junction of a lime-treated and an untreated zone, covered with gravels. Note the minor erosion along the wave line, and the still visible compactor imprints, after 35 years of service.
