Compressive Failure of UD-CFRP Containing Void Defects: *In situ* SEM Microanalysis

Julia Hapke^{*,a}, F. Gehrig^b, N. Huber^a, K. Schulte^b, and E.T. Lilleodden^a

Abstract

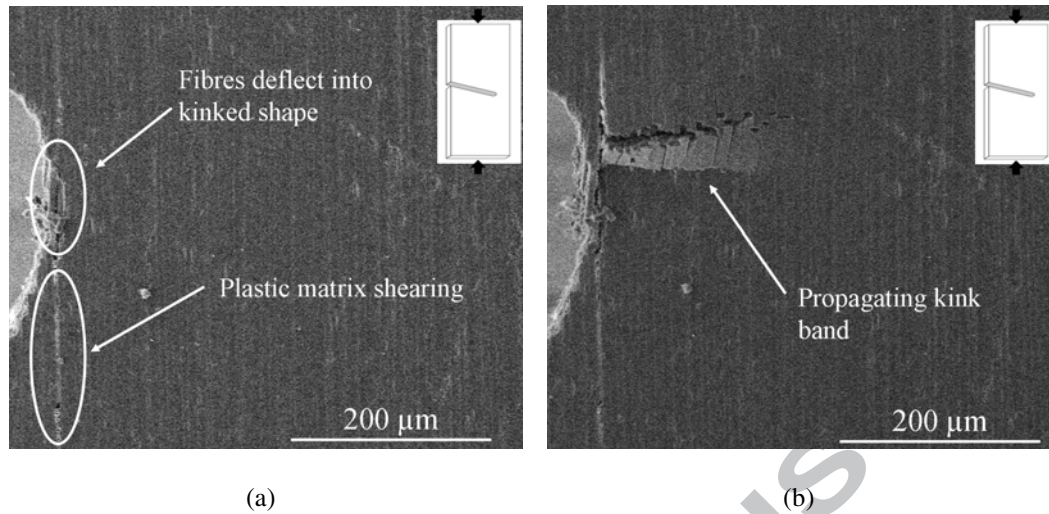
The first feature visible upon loading is large plastic shearing in the matrix, as evidenced by the formation of shear cups (Fig. 3(a)). Another *in situ* SEM study by Sivashanker et al. [18] on centre-notched specimens revealed fibre kinking as well as longitudinal splitting induced by interfacial debonding. However, such interfacial debonding was not observed in our experiments. Furthermore, the clearly visible matrix degradation shown in Fig. 3(a) supports the assumption of a largely stable fibre-matrix bonding at this

Figure 3: Two subsequent frames from the movie captured during initial loading. Frame (a) is the last frame before kink band propagation starts. Already visible is large plastic matrix shearing and fibre deflection into a kinked shape. Taken 0.2 sec later, frame (b) shows a kink band already having propagated over more than a 100 μm , illustrating the sudden and catastrophic nature of failure.

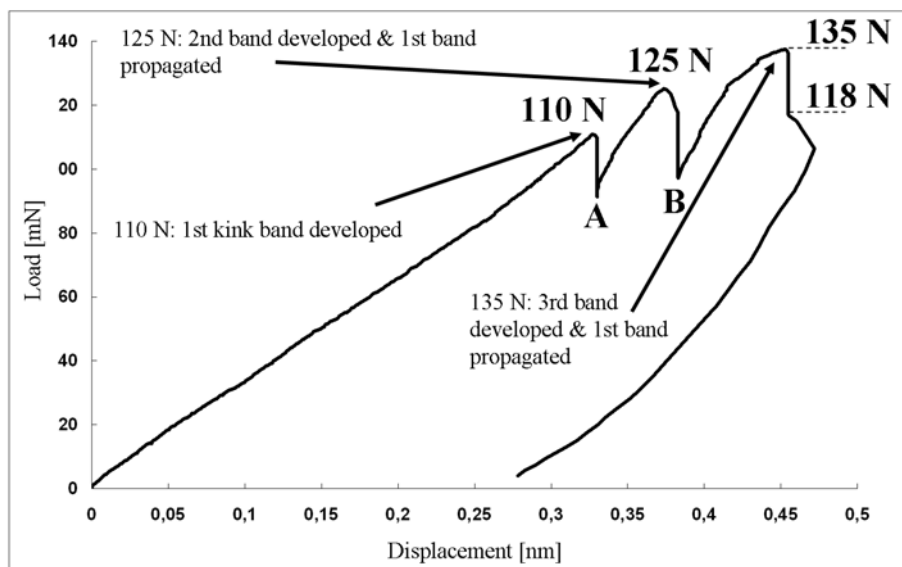
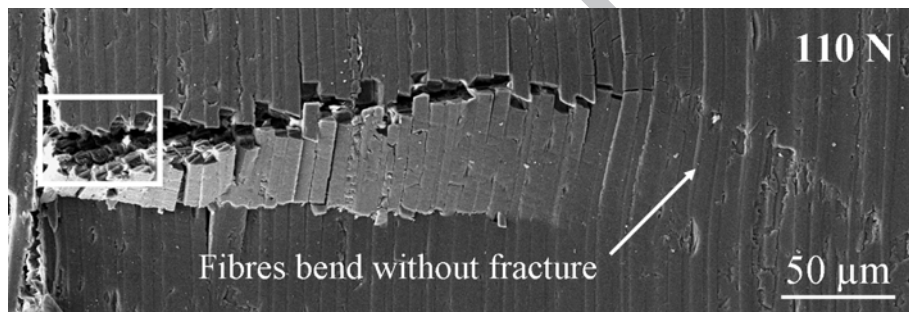
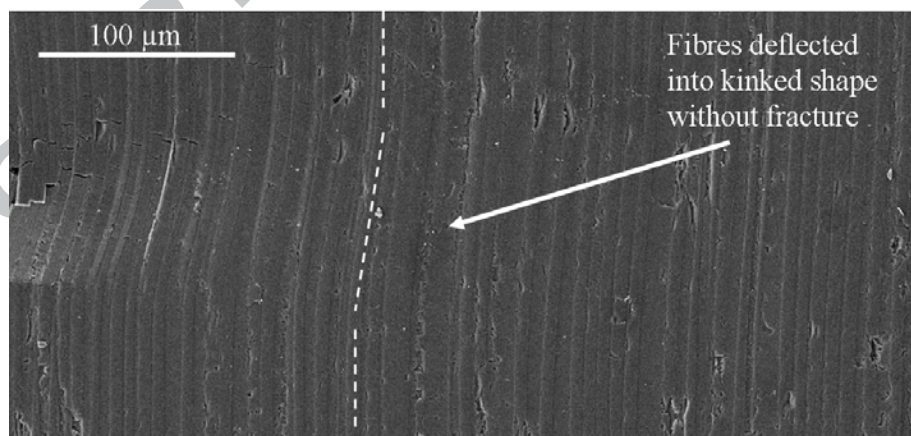
As evidenced in Fig. 4(a), every hold segment is accompanied by significant load relaxation. While held at constant displacement before final unloading, further fibre fracture occurred at the band tip, as shown in Fig. 6(a) and 6(b) taken at an interval of 15 minutes during the constant displacement period. During reloading, an additional kink band is initiated at the same site, propagates along the same path and shares one boundary with the original band. The formation of such additional kink bands can be observed on all tested specimens during loading after a holding period. However, only the initial band is ever observed to propagate across the whole width of the sample; subsequent kink bands arrest as soon as the shared boundary with the initial bands terminates.

Figure 4: (a) A generic load-displacement curve including several hold periods for imaging followed by further loading; at the point labelled with 110 N the kink band has been arrested directly after it has started to propagate. The associated images are presented in (b), revealing fibres already bent but not yet fractured ahead of the band tip. Also a large out-of-plane deformation is visible, especially close to the notch ground. In (c), fibre deflection into a kinked shape of yet unfractured fibres is visible in front of the fracture zone.

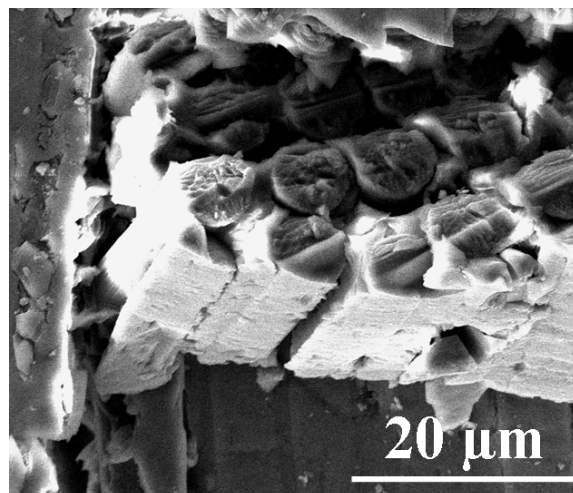
Closer examination of the fibres' fracture surfaces in Fig. 5 reveals smooth lines along the fibre transverse axis on fibres in several plies, suggesting that fracture is mainly driven by the deformation in the thickness direction. As the fibres on the surface plies have been partly removed by sample polishing, this out-of-plane deformation is not necessarily a result of specimen misalignment, but rather a consequence of the surface fibres' reduced load-bearing capacity due to their smaller cross section and damaged internal structure. The issue of possible influences from surface effects will be addressed in greater detail in the section on the analysis of the defect morphology in the plies below the surface. Due to the large out-of-plane deformation, the final fibre inclination and the kink band angle cannot be determined from the SEM images directly. However, bandwidth measurements have been made, showing values in the range of 50 to 60 μm for all bands.

Figure 5: A higher resolution image of the area highlighted in Fig. 4(b), showing lines along the fibre transverse axis on the fibre fracture surfaces, suggesting fracture to be mainly driven by out-of-plane forces.

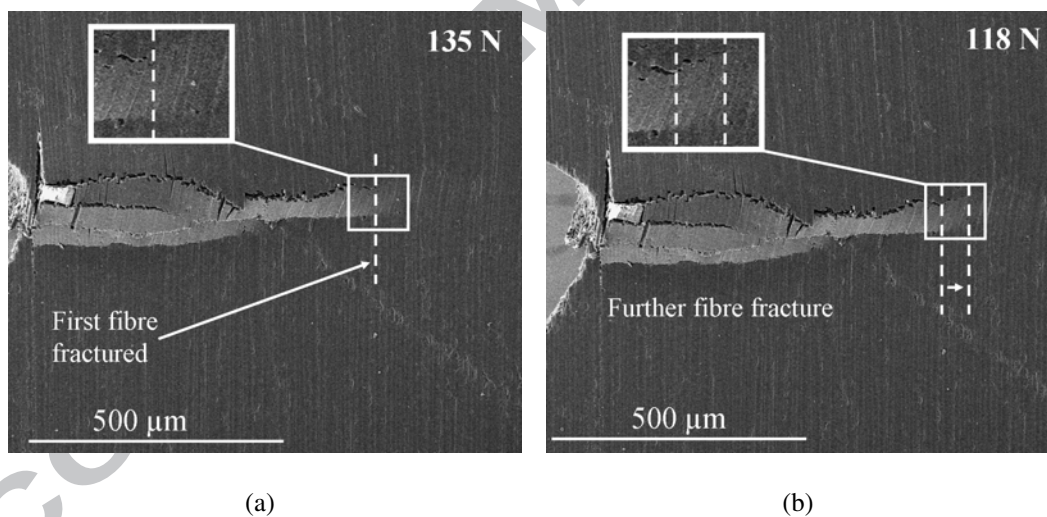
Figure 6: Images taken at the beginning (a) and 15 min. later at the end (b) of a hold period, marked with 135 N and 118 N in Fig. 4(a). Highlighted areas show further fibre fracture at the band tip, illustrating the large impact of time-dependent processes on damage morphology.

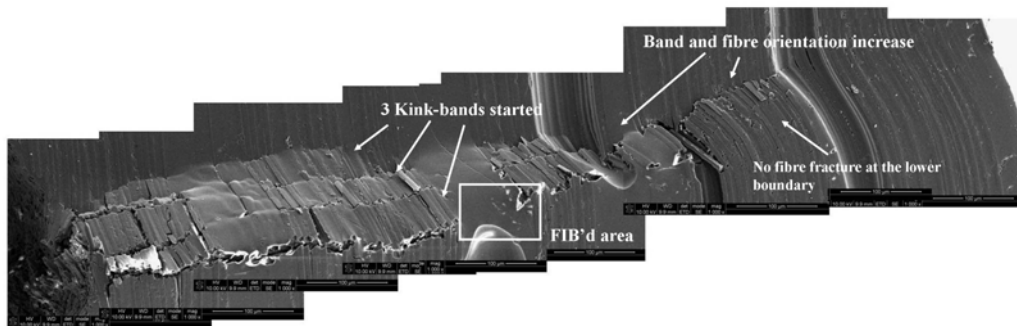
Figure 7: Final kink band morphology in a void-containing specimen. Loading has been interrupted three times, after each hold period a new kink band has started from the stress riser; only one band has propagated over the entire specimen width. Band and fibre inclination increase cumulatively with each void passed; in the final band segment fibre fracture is reduced to only one boundary. In the area highlighted, surface plies have subsequently been removed by the FIB technique to analyse damage morphology in the plies below.

In the case where a defect is located with its centre in front of the defect (Fig. 7), no failure propagation through the void can be observed. Fibres bend and deflect into the void, but the absence of the load-transferring resin seems to effectively hinder band propagation. Resin-rich areas, usually found to circumvent voids in composite materials, were not observed to have any influence on band evolution.

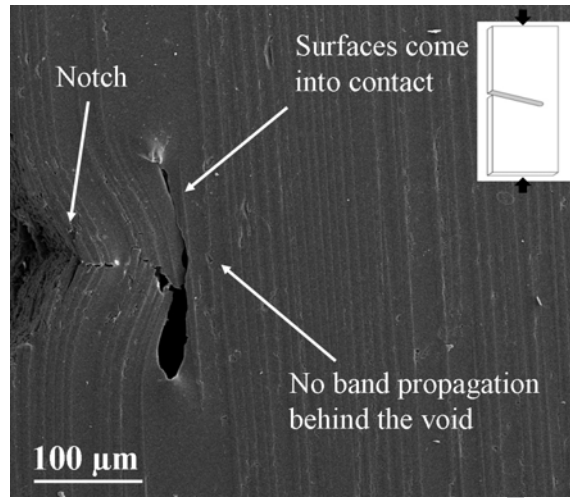
Figure 8: Final kink band morphology in a void-containing specimen; in contrast to the specimen presented in Fig. 7 here the kink band had to propagate directly into the void's centre. Fibres and matrix undergo large deformations bringing the void's inner surfaces into contact, no band propagation behind the void can be observed.

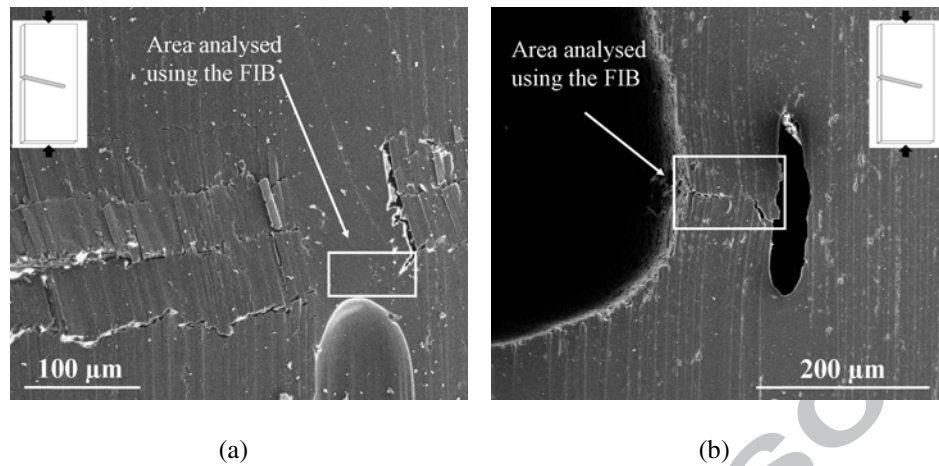
Two specimens were analysed weeks after testing to examine the effects of time-dependent relaxation. One sample was re-examined two weeks after testing (Fig. 9(a)) and a second one four weeks after testing (Fig. 9(b)). In both cases significant changes in the failure pattern are evident. Fibres and voids have almost completely returned to their original configuration and the fibres' kinked shape has vanished. A *post mortem* investiga-

Figure 9: : In (a), the specimen presented in Fig. 7 is shown two weeks after testing, significant relaxation of the former pronounced kinked fibres is visible. A micrograph of the specimen presented in Fig. 8 four weeks after testing is given in (b); fibres have almost returned into their initial shape. In the areas highlighted in (a) and (b), material has been removed from the surface using the focused ion beam technique.

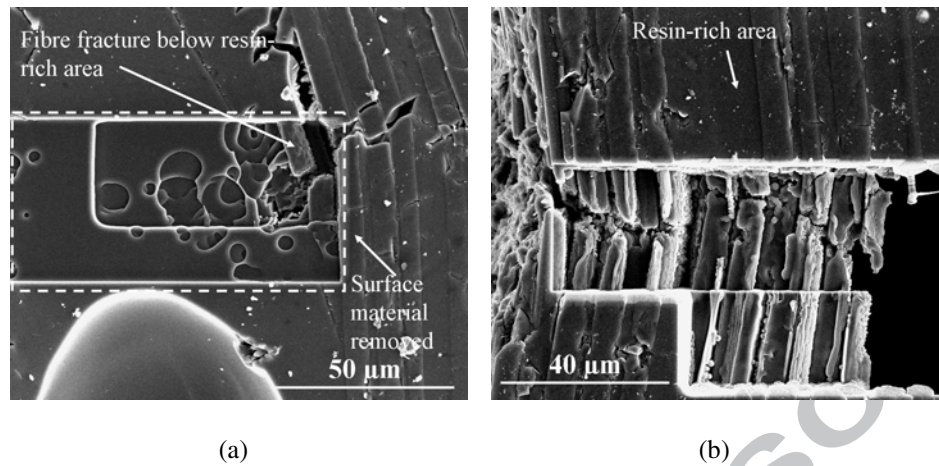
Figure 10: Fractured fibres below the resin-rich area denoted in Fig. 9(a) can be observed in (a), damage in the sub-surface plies resembling the pattern visible in Fig. 9(b) is presented in (b).
