Experimental Simulation of the Paks-2 Cleaning Tank Incident Through Separate Effect and Integral Tests

Z. Hózer^{*}, M. Horváth, M. Kunstár, L. Matus, I. Nagy, T. Novotny, E. Perez-Feró, A.
Pintér-Csordás, N. Vér, A. Vimi, P. Windberg

ABSTRACT

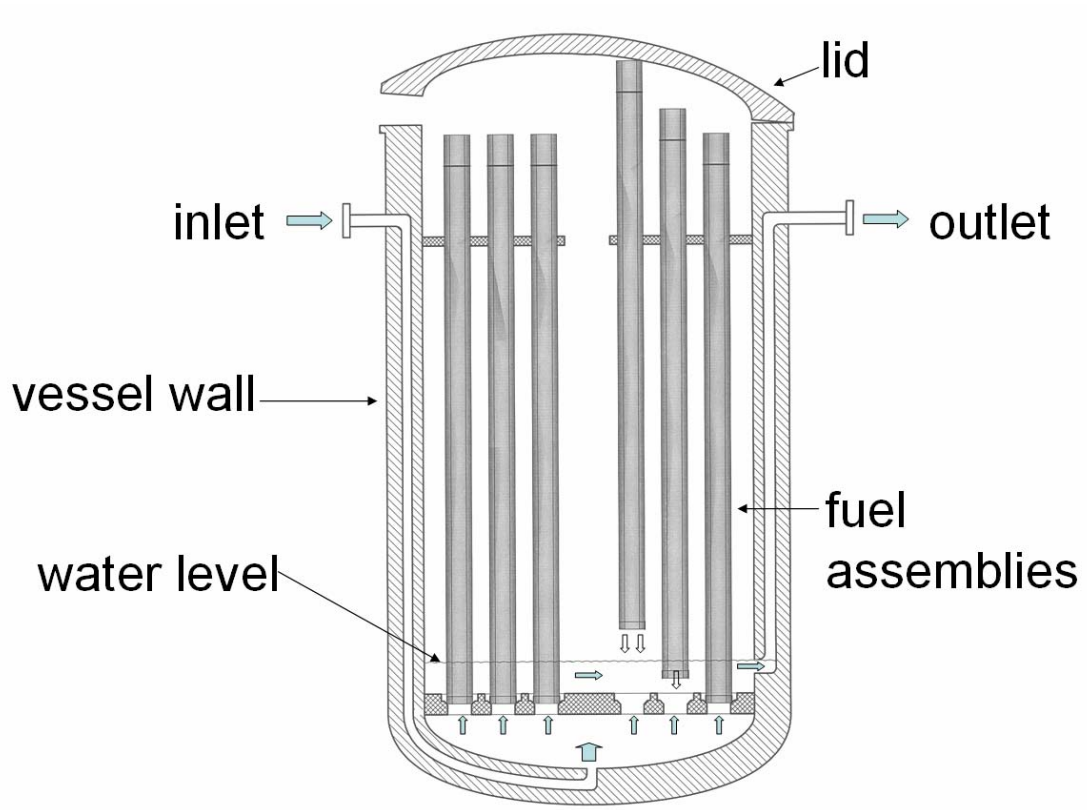
Hózer, Fig. 1.

During the visual examination of the Paks-2 cleaning tank lid, several scratches were observed on the internal surface. These were obviously the signs of interaction between the fuel assembly headers and the internal surface of the lid. The cleaning tank had a lower plate and an upper spacer plate to prevent horizontal shift of the assemblies, but the assemblies were not fixed at the top. The normal operation of pumps with high flow rate (170t/h) during chemical cleaning did not change the position of the assemblies, since several batches of fuel assemblies were treated in the cleaning tank before the incident and in those cases interactions between the assemblies and the lid were not observed. It is very probable that the operation of a low flow rate (21 t/h) pump could not move the 215 kg assemblies even during the seven hours dry phase and so the mechanical contact with the lid took place at the opening of the cleaning tank (Fig. 1).

Fig. 1. Cleaning tank with fuel assemblies touching the lid during the opening of the tank

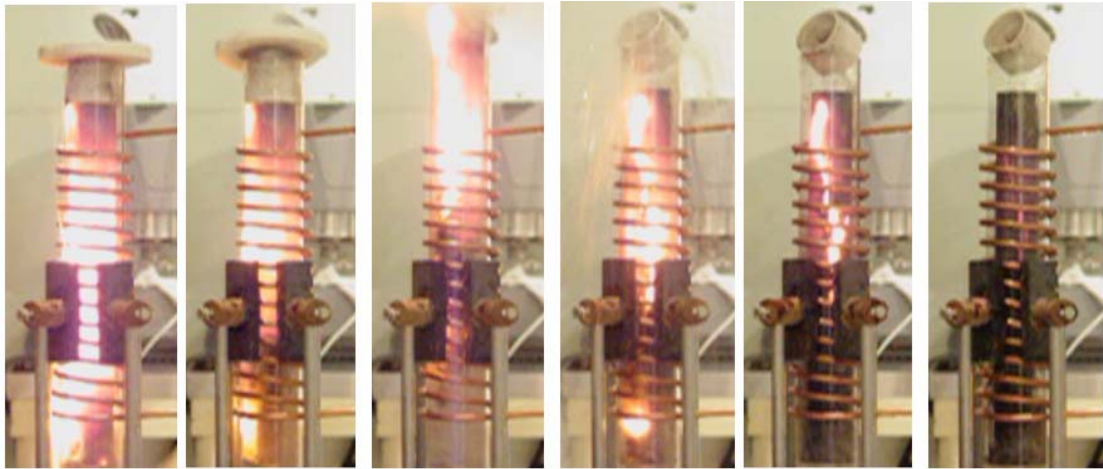
Hózer, Fig. 2.

The experimental results confirmed that the upward shift of the fuel assemblies took place presumably during the quenching phase of the incident. The main reason for the change of the vertical position was the penetration of cold water into the fuel assemblies from the bottom and its fast evaporation. The internal blockage caused by ballooning enhanced the effect of pressure increase on the vertical acceleration of assemblies. The produced steam could not leave the assembly in horizontal direction, for the VVER-440 assemblies are covered by shrouds. The cross section in the upper direction was partially closed by clad ballooning, so the produced steam had to flow out at the bottom and the assembly moved up as a consequence of this rocket force type effect.

Fig. 2. Snapshots illustrating the change of bundle position during injection of cold water from the bottom

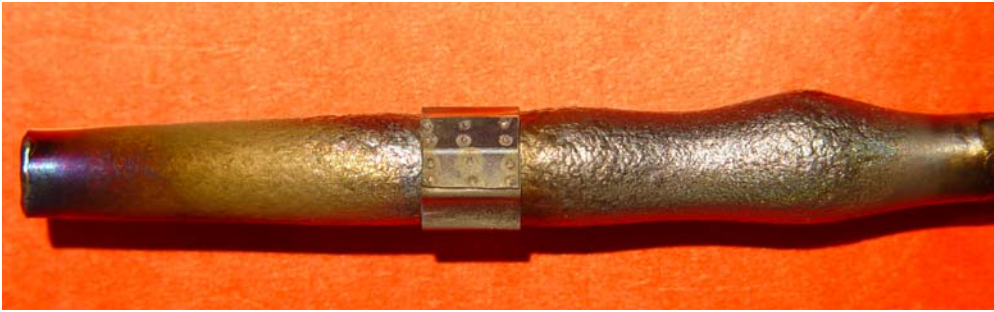
Hózer, Fig. 4.

- If the ballooning took place at the spacer grid, then the burst of cladding would happen later i.e. at higher pressure compared to burst at the cylindrical part of the cladding tube.
- In some cases the spacer grid could prevent the burst of the cladding and thus initiated a secondary ballooning in another position along the fuel rod (see Fig. 4).

Fig. 4. View of sample with secondary ballooning away from the position of the spacer grid

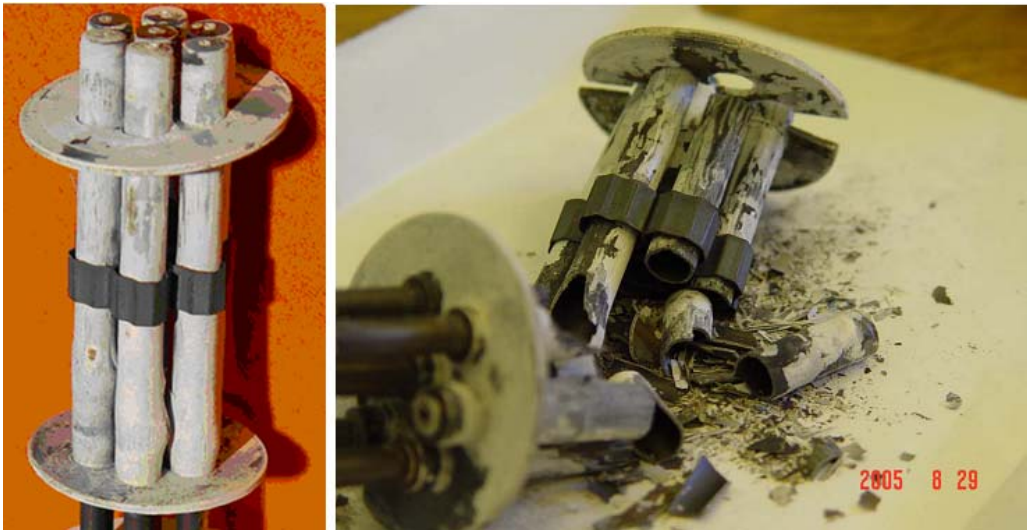
Hózer, Fig. 5.

Mechanical testing of a seven rod bundle was carried out after oxidation in steam. Radial mechanical load was applied at the elevation of the spacer grid on the bundle. The total energy of the knock was ≈ 260 mJ. After 6000 s of oxidation at 1000 °C the bundle was so brittle that even this small load was enough to break the full bundle (Fig. 5) into small pieces. This test indicated that the failure of the fuel rods at the spacer grid took place as a result of radial mechanical load transfer through the spacer. During the opening of the cleaning tank in the Paks-2 incident about 4 tonnes of cold water penetrated into the vessel. Since the lid was opened only on one side, the injection of water took place in a complex 3D manner, it created asymmetrical radial loads on the fuel assemblies. The fuel rods are connected to each other through the spacer grids, so the mechanical load from one fuel rod to the other could be transferred only through the spacers. Such load transfer could take place during the quenching phase of the Paks-2 incident and this effect caused the failure and break of many fuel rods.

Fig. 5. View of seven rod bundle after oxidation and ballooning in steam (left) and followed by radial mechanical testing (right)

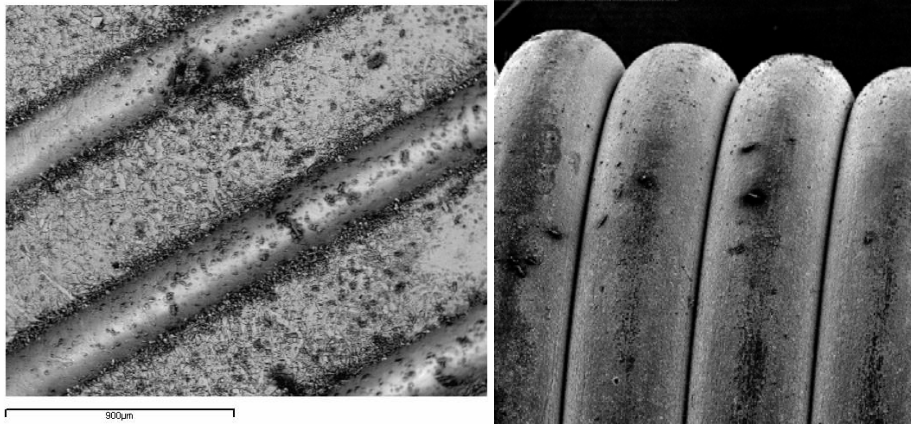
Hózer, Fig. 7.

The contact between the steel spring and the zirconium cladding was examined in details by scanning electron microscopy (Fig. 7). The BEI (Backscattered Electron

Fig. 7. Signs of interaction on the internal surface of cladding (left) and on the surface of the spring (right) after test without oxidation

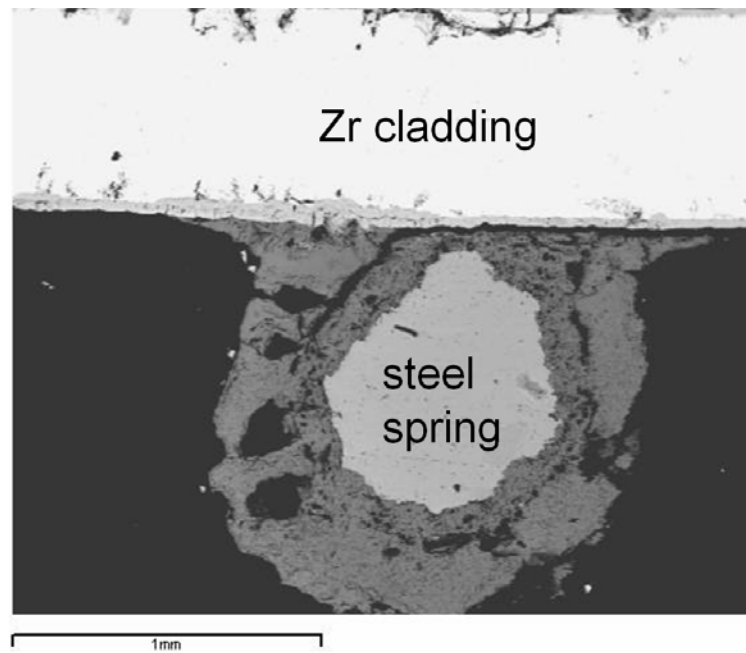
Hózer, Fig. 8.

Image) view of an oxidised sample showed significant oxidation of the spring and formation of cracks in the 400-500 μm thick iron oxide scale (Fig. 8). The thickness of the zirconium oxide layer was between 30-100 μm on the surface of the cladding. Considering the seven hour dry phase of the incident and the possible temperature range, the above oxide layer thicknesses could be similar to the real values in the cleaning tank. The crack formation was probably the result of thermal stresses during the cool-down of the samples.

Fig. 8. BEI view of the interface between steel spring and zirconium cladding after oxidation

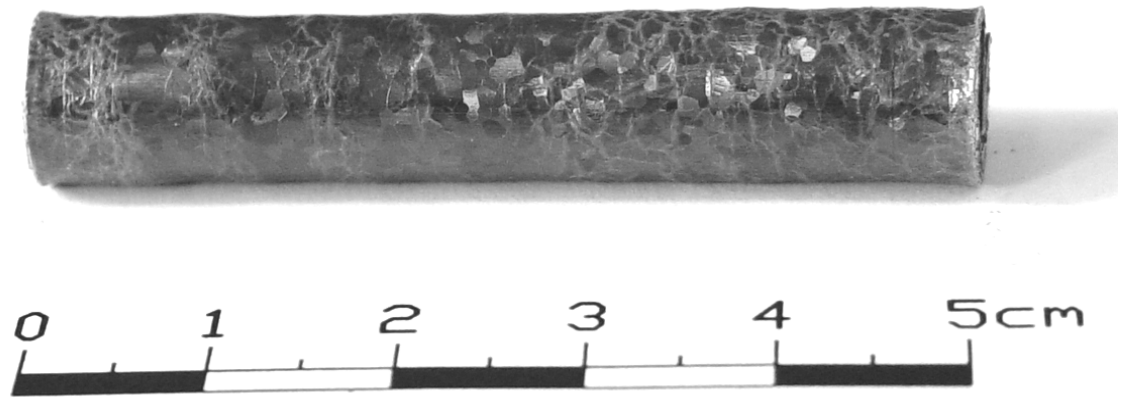
Hózer, Fig. 9.

The phenomena (Fig. 9) observed at the Paks NPP could be reproduced only if the following conditions were met:

- There was tight contact between the spring and the fuel rod cladding in cold state before the test.
- Eutectic formation took place during the high temperature phase of the test.
- The sample was oxidized for long time in steam atmosphere.

It was an unexpected observation that the bulge of the external spiral was located not at the location of the spring wires, but between the wires. The bulge formation was obviously the result of the oxidation process which is normally accompanied with diameter increase, but in the present tests this size increase was limited by the eutectic contact with spring wires. The experimental results underlined that the steel spring played only negligible role in the behaviour and the failure of the fuel rods during the Paks-2 incident.

Fig. 9. Cladding sample showing the external spiral shaped deformation

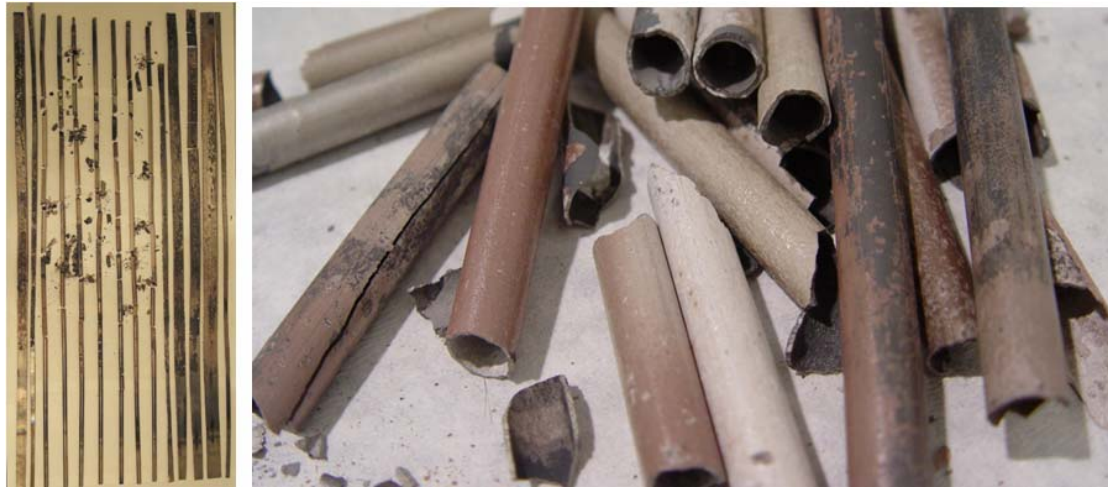
Hózer, Fig. 12.

The original purpose of the preliminary test was the testing of different components and data acquisition system of the facility. In order to have information on the kinetics of the zirconium oxidation and on the dynamical behaviour of the system with hydrogen production, pieces of fuel rod cladding and plates of zirconium shroud were placed in the test section. The total amount of zirconium alloy was equal to the mass of the zirconium in the 7-rod bundle that was used in the later tests. The cladding tubes were heavily fragmented during the test: the fuel rods were broken into several pieces and during the handling of the tubes further fragmentation took place (Fig. 12).

The shroud plates were mainly intact, but so brittle that the 2 mm thick plates could be broken by hands.

Fig. 12. View of Zr cladding and shroud after seven hours of high temperature oxidation and final quenching by cold water in the preliminary test (left picture: reconstructed vertical state of plates and tubes, right picture: close view of the tubes)

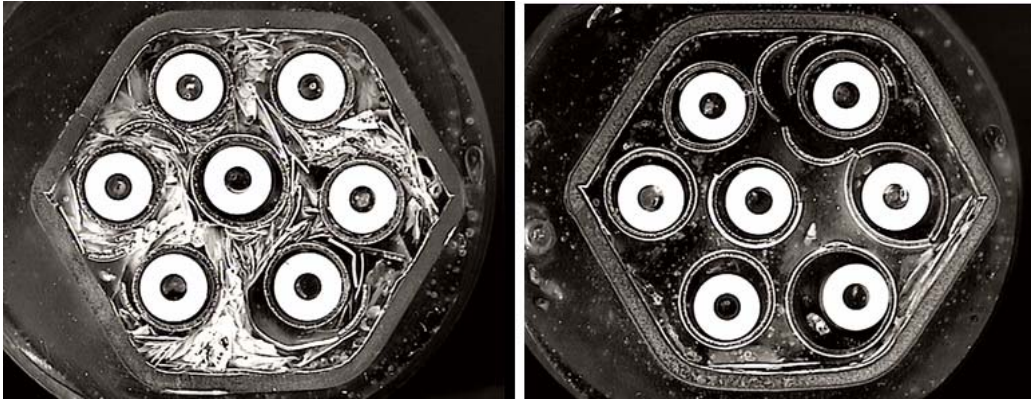
Hózer, Fig. 13.

In the CODEX-CT-1 test the fuel rods were pressurized in the beginning of the test to different values. The rods with high pressure lost their integrity due to burst at 800-900 °C. Long ballooned sections were observed in the post-test examinations. The hottest part of the rods was in the central-upper section at about 700 mm elevation. The bottom part of the rods (about 50 mm) was cooled by water and the temperatures remained low in that section. The fuel rods and bundles suffered severe damage during the tests. The final state was characterized by fragmentation, formation of cracks and brittle failure of the Zr components. The bottom part of the fuel bundle that was cooled by water remained intact. The experience of handling of fuel rods after the test showed that the material was very brittle: even a small mechanical load lead to further fragmentation of the cladding and the shroud. Cross section of the CODEX-CT-1 bundle is shown in Fig. 13. Large ballooning of the tubes can be noticed in both cross sections. In the lower cross section the accumulation of fuel rod fragments can be seen which were fallen down from higher elevations. In the preliminary test and CODEX-CT-1 test the produced hydrogen was released from the test section meanwhile the internal pressure of the cleaning tank model was kept constant. During those two tests 200-300 dm³ of H₂ was released, the atmosphere contained 60-80 vol.% hydrogen and the average degree of oxidation was above 20% ECR. The maximum temperature during the oxidation phase reached 1250 °C in the upper part of the bundle (Fig. 14).

Fig. 13. Cross sections of the CODEX-CT-1 bundle at 360 mm (left) and mm 560 mm (right) elevations
