Experimental Simulation of the Paks-2 Cleaning Tank Incident Through Separate Effect and Integral Tests

Z. Hózer, M. Horváth, M. Kunstár, L. Matus, I. Nagy, T. Novotny, E. Perez-Feró, A. Pintér-Csordás, N. Vér, A. Vimi, et al.

*Hungarian Academy of Sciences KFKI Atomic Energy Research Institute, H-1525
Budapest, P.O. Box 49, Hungary*

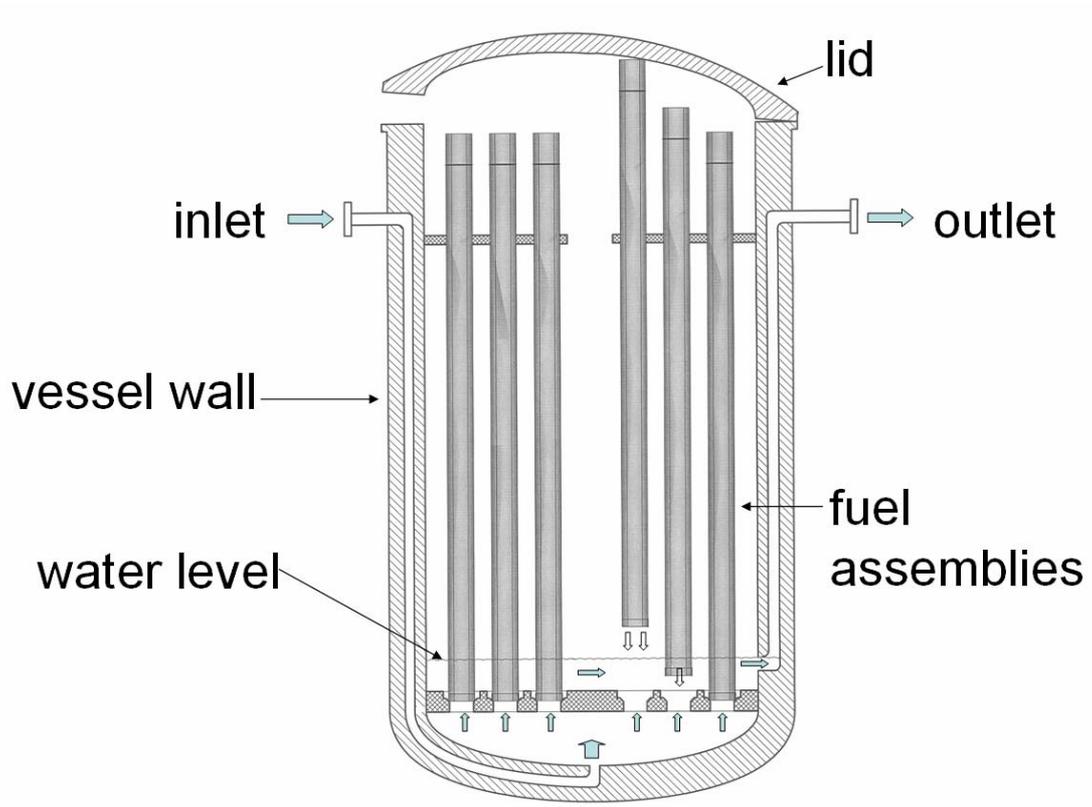
Hózer, Fig. 1.

During the visual examination of the Paks-2 cleaning tank lid, several scratches were observed on the internal surface. These were obviously the signs of interaction between the fuel assembly headers and the internal surface of the lid. The cleaning tank had a lower plate and an upper spacer plate to prevent horizontal shift of the assemblies, but the assemblies were not fixed at the top. The normal operation of pumps with high flow rate (170t/h) during chemical cleaning did not change the position of the assemblies, since several batches of fuel assemblies were treated in the cleaning tank before the incident and in those cases interactions between the assemblies and the lid were not observed. It is very probable that the operation of a low flow rate (21 t/h) pump could not move the 215 kg assemblies even during the seven hours dry phase and so the mechanical contact with the lid took place at the opening of the cleaning tank (Fig. 1).

Fig. 1. Cleaning tank with fuel assemblies touching the lid during the opening of the tank

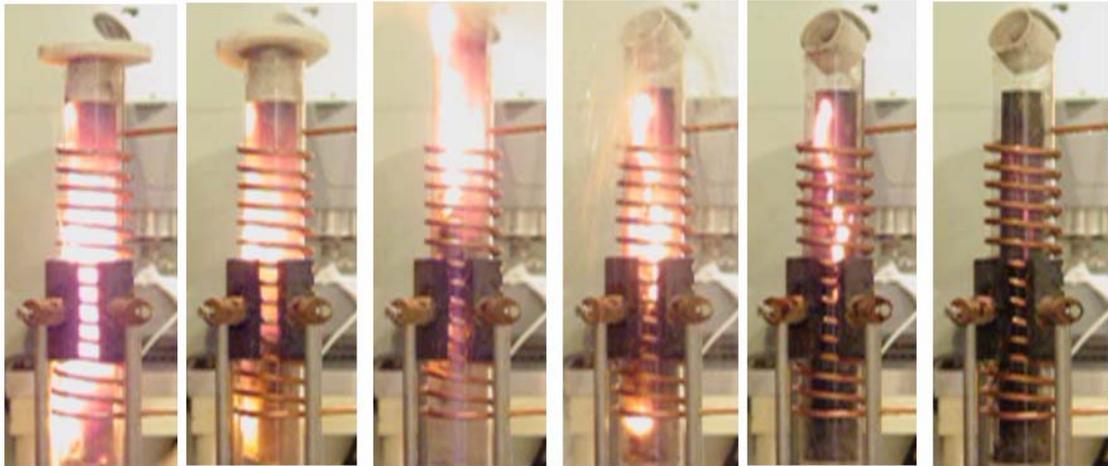
Hózer, Fig. 2.

The experimental results confirmed that the upward shift of the fuel assemblies took place presumably during the quenching phase of the incident. The main reason for the change of the vertical position was the penetration of cold water into the fuel assemblies from the bottom and its fast evaporation. The internal blockage caused by ballooning enhanced the effect of pressure increase on the vertical acceleration of assemblies. The produced steam could not leave the assembly in horizontal direction, for the VVER-440 assemblies are covered by shrouds. The cross section in the upper direction was partially closed by clad ballooning, so the produced steam had to flow out at the bottom and the assembly moved up as a consequence of this rocket force type effect.

Fig. 2. Snapshots illustrating the change of bundle position during injection of cold water from the bottom

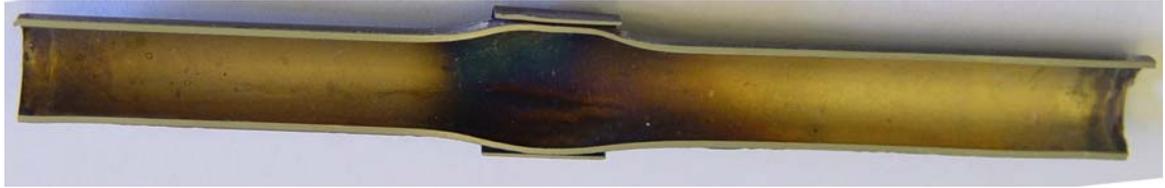
Hózer, Fig. 3.

Fig. 3. Cross section of ballooned tube

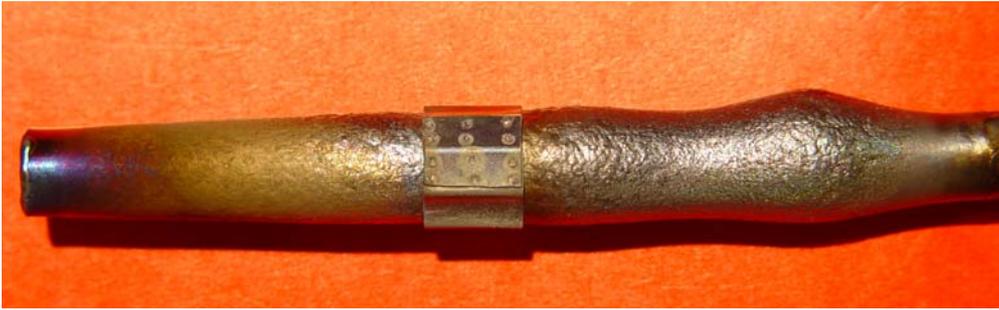
Hózer, Fig. 4.

- If the ballooning took place at the spacer grid, then the burst of cladding would happen later i.e. at higher pressure compared to burst at the cylindrical part of the cladding tube.
- In some cases the spacer grid could prevent the burst of the cladding and thus initiated a secondary ballooning in another position along the fuel rod (see Fig. 4).

Fig. 4. View of sample with secondary ballooning away from the position of the spacer grid

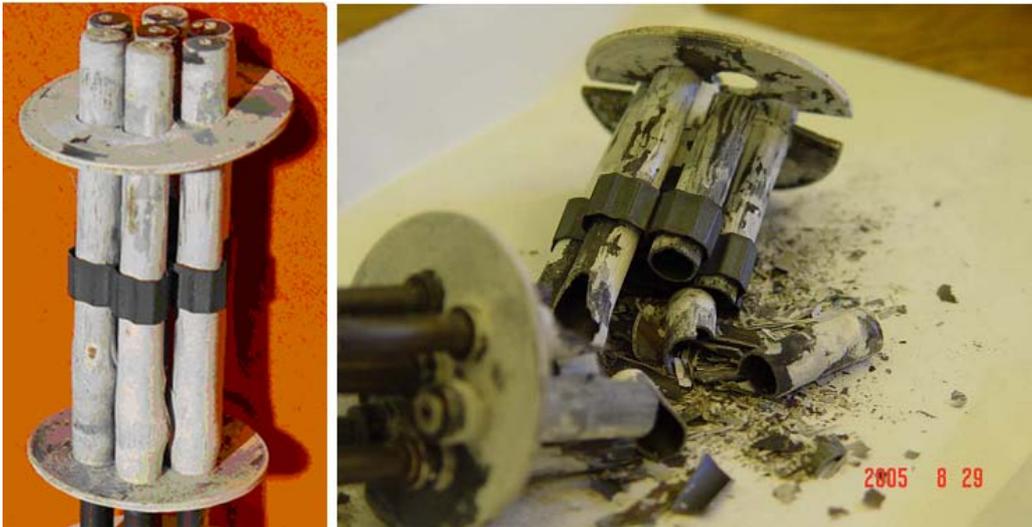
Hózer, Fig. 5.

Mechanical testing of a seven rod bundle was carried out after oxidation in steam. Radial mechanical load was applied at the elevation of the spacer grid on the bundle. The total energy of the knock was ≈ 260 mJ. After 6000 s of oxidation at 1000 °C the bundle was so brittle that even this small load was enough to break the full bundle (Fig. 5) into small pieces. This test indicated that the failure of the fuel rods at the spacer grid took place as a result of radial mechanical load transfer through the spacer. During the opening of the cleaning tank in the Paks-2 incident about 4 tonnes of cold water penetrated into the vessel. Since the lid was opened only on one side, the injection of water took place in a complex 3D manner, it created asymmetrical radial loads on the fuel assemblies. The fuel rods are connected to each other through the spacer grids, so the mechanical load from one fuel rod to the other could be transferred only through the spacers. Such load transfer could take place during the quenching phase of the Paks-2 incident and this effect caused the failure and break of many fuel rods.

Fig. 5. View of seven rod bundle after oxidation and ballooning in steam (left) and followed by radial mechanical testing (right)

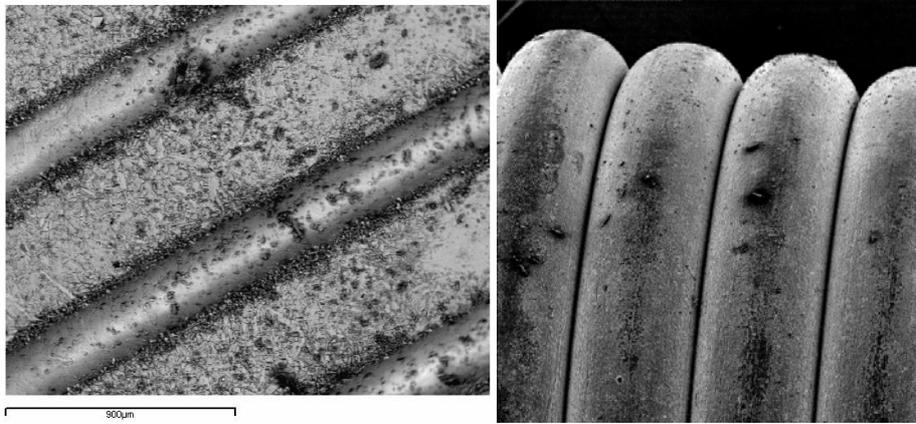
Hózer, Fig. 7.

The contact between the steel spring and the zirconium cladding was examined in details by scanning electron microscopy (Fig. 7). The BEI (Backscattered Electron

Fig. 7. Signs of interaction on the internal surface of cladding (left) and on the surface of the spring (right) after test without oxidation

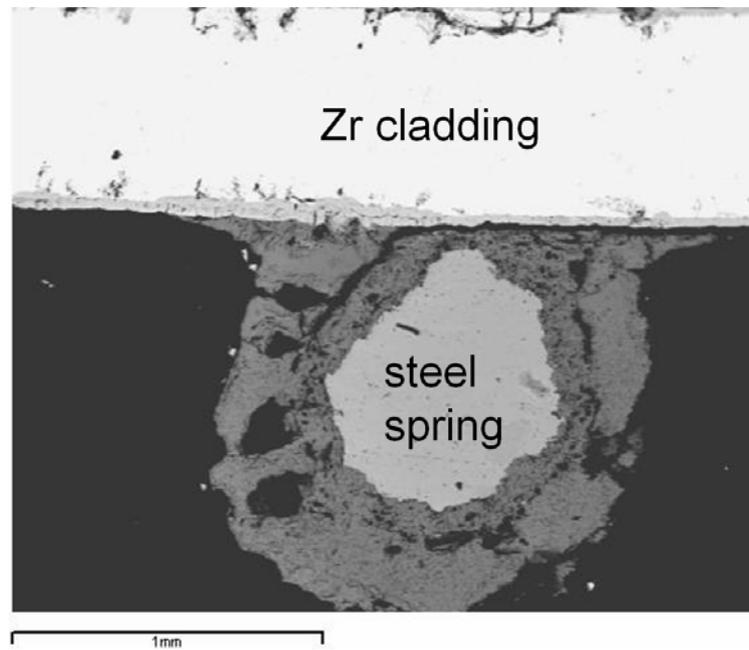
Hózer, Fig. 8.

Image) view of an oxidised sample showed significant oxidation of the spring and formation of cracks in the 400-500 μm thick iron oxide scale (Fig. 8). The thickness of the zirconium oxide layer was between 30-100 μm on the surface of the cladding. Considering the seven hour dry phase of the incident and the possible temperature range, the above oxide layer thicknesses could be similar to the real values in the cleaning tank. The crack formation was probably the result of thermal stresses during the cool-down of the samples.

Fig. 8. BEI view of the interface between steel spring and zirconium cladding after oxidation

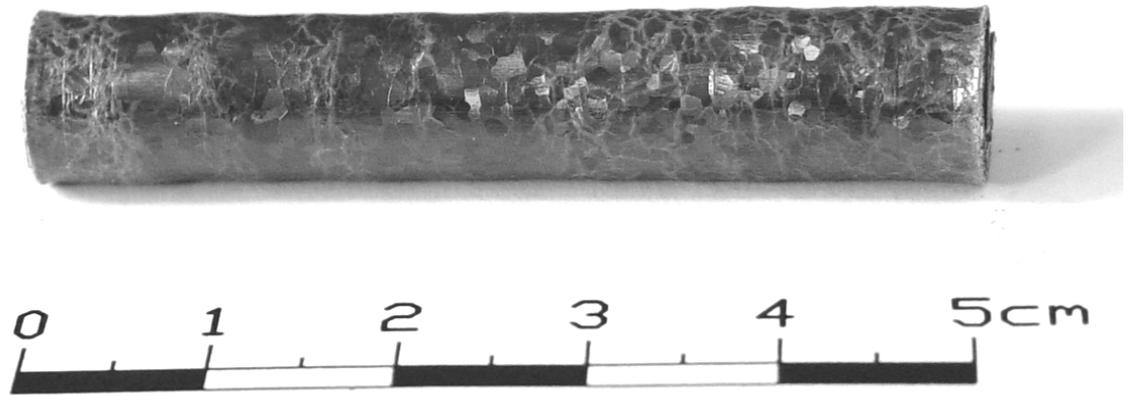
Hózer, Fig. 9.

The phenomena (Fig. 9) observed at the Paks NPP could be reproduced only if the following conditions were met:

It was an unexpected observation that the bulge of the external spiral was located not at the location of the spring wires, but between the wires. The bulge formation was obviously the result of the oxidation process which is normally accompanied with diameter increase, but in the present tests this size increase was limited by the eutectic contact with spring wires. The experimental results underlined that the steel spring played only negligible role in the behaviour and the failure of the fuel rods during the Paks-2 incident.

Fig. 9. Cladding sample showing the external spiral shaped deformation

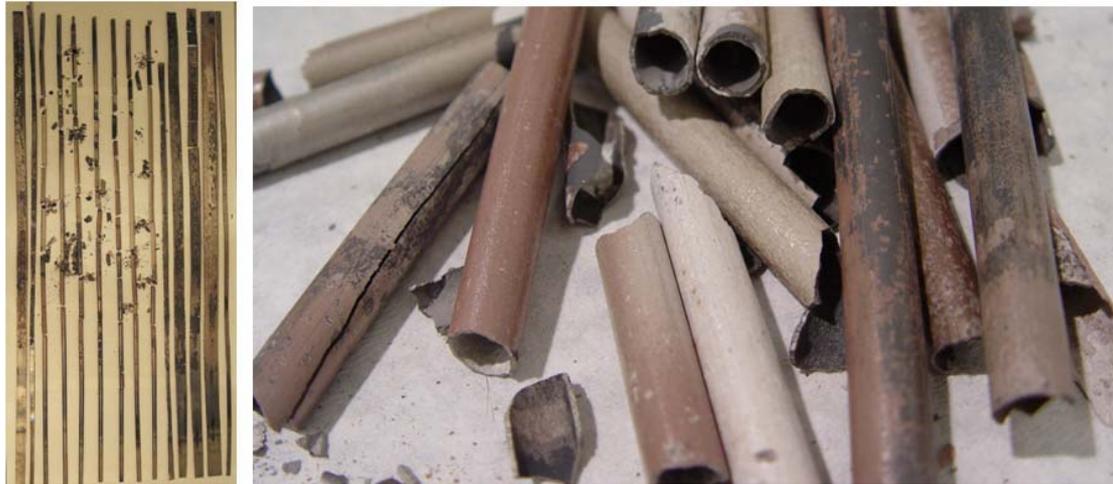
Hózer, Fig. 12.

The original purpose of the preliminary test was the testing of different components and data acquisition system of the facility. In order to have information on the kinetics of the zirconium oxidation and on the dynamical behaviour of the system with hydrogen production, pieces of fuel rod cladding and plates of zirconium shroud were placed in the test section. The total amount of zirconium alloy was equal to the mass of the zirconium in the 7-rod bundle that was used in the later tests. The cladding tubes were heavily fragmented during the test: the fuel rods were broken into several pieces and during the handling of the tubes further fragmentation took place (Fig. 12).

The shroud plates were mainly intact, but so brittle that the 2 mm thick plates could be broken by hands.

Fig. 12. View of Zr cladding and shroud after seven hours of high temperature oxidation and final quenching by cold water in the preliminary test (left picture: reconstructed vertical state of plates and tubes, right picture: close view of the tubes)

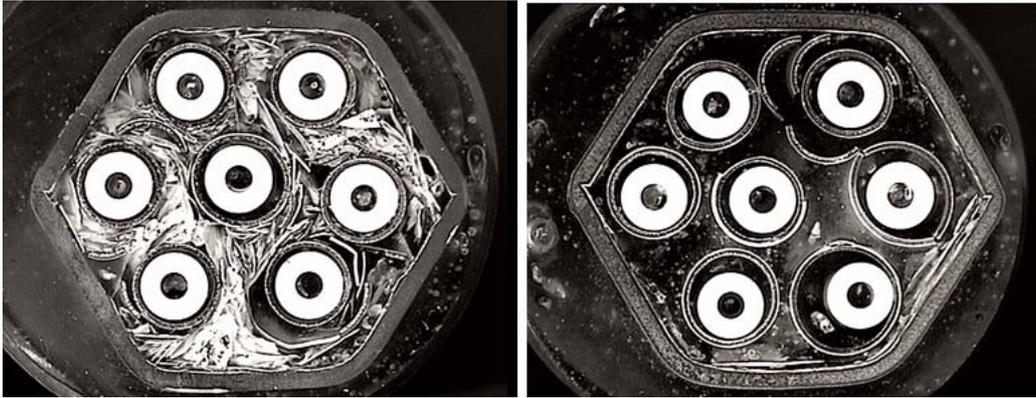
Hózer, Fig. 13.

In the CODEX-CT-1 test the fuel rods were pressurized in the beginning of the test to different values. The rods with high pressure lost their integrity due to burst at 800-900 °C. Long ballooned sections were observed in the post-test examinations. The hottest part of the rods was in the central-upper section at about 700 mm elevation. The bottom part of the rods (about 50 mm) was cooled by water and the temperatures remained low in that section. The fuel rods and bundles suffered severe damage during the tests. The final state was characterized by fragmentation, formation of cracks and brittle failure of the Zr components. The bottom part of the fuel bundle that was cooled by water remained intact. The experience of handling of fuel rods after the test showed that the material was very brittle: even a small mechanical load lead to further fragmentation of the cladding and the shroud. Cross section of the CODEX-CT-1 bundle is shown in Fig. 13. Large ballooning of the tubes can be noticed in both cross sections. In the lower cross section the accumulation of fuel rod fragments can be seen which were fallen down from higher elevations. In the preliminary test and CODEX-CT-1 test the produced hydrogen was released from the test section meanwhile the internal pressure of the cleaning tank model was kept constant. During those two tests 200-300 dm³ of H₂ was released, the atmosphere contained 60-80 vol.% hydrogen and the average degree of oxidation was above 20% ECR. The maximum temperature during the oxidation phase reached 1250 °C in the upper part of the bundle (Fig. 14).

Fig. 13. Cross sections of the CODEX-CT-1 bundle at 360 mm (left) and mm 560 mm (right) elevations
