The detection of aeronautical defects in situ on composite structures using Non Destructive Testing

Christian Garnier ^{a,*}, Marie-Laetitia Pastor ^b, Florent Eyma ^b, Bernard Lorrain ^a

A study of three Non Destructive Testing methods (Ultrasonic Testing, InfraRed Thermography and Speckle Shearing Interferometry, known as Shearography) was carried out on different specific types of composite specimens having a variety of defects. The aim of this study is to evaluate the efficiency of these NDT methods in the detection of in site defects resulting from Barely Visible Impact Damages (BVID) or in-service damages to complex surfaces such as wings or rods. The size and position of all the defects were determined by GVI (General Visual Inspection): GVI being the reference. The evaluation of the three NDT techniques enabled conclusions to be drawn regarding defect detection and size. The first part of the study deals with determining and measuring defects. It appears that only the ultrasonic method enables the depth of a defect to be determined. In the second part of the study, the results obtained by the three NDT methods are compared. Finally, the feasibility and the time taken to s

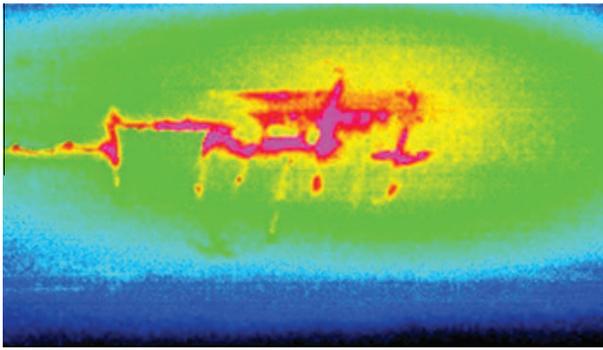
Fig. 4.2. InfraRed Thermography map of Specimen A.

The InfraRed Thermography tests made it possible to identify the presence of defects on Specimen A in a very short time, around 30 s (cf. Fig. 4.2). The size of the pixel is calculated from the images. Therefore, the dimensions of the defects can be determined accurately. Indeed, the defect is 97 mm \times 20 mm. It is obvious that the results obtained with InfraRed Thermography are similar to GVI measurements (maximum deviation around 10%).

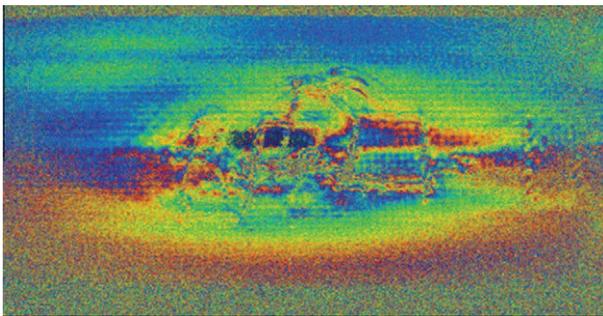
Fig. 4.3. Shearography map of Specimen A.

The defects on Specimen A were identified quickly by Shearography tests, around 1 min (cf. Fig. 4.3). It is important to note that the images obtained by Shearography are not easily analysed. There were many defects on this specimen and Shearography detected them all. This means that a considerable amount of the information was shown on the image, making it illegible. Nevertheless, it was possible to determine the size of the defects. The range of the defect area is 107 mm \times 22.5 mm. The difference between the GVI and the Shearography results represents 9% as regards length and 25% as regards width. This measurement variation is due to the difficult in analysis of the shearographic image.

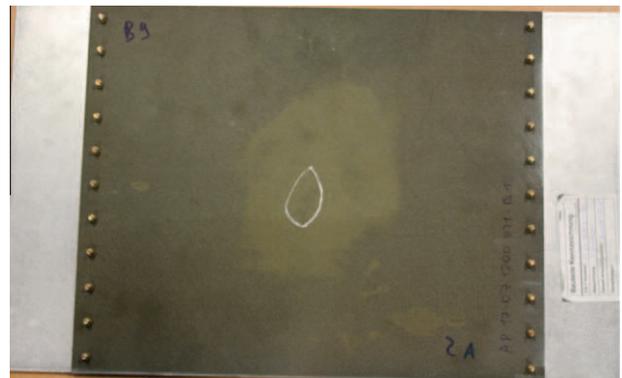
Fig. 4.4. Specimen B: carbone/epoxy plate.

Specimen B damage is the result of a lightning impact which occurred in service. The defect measures 41 mm and 75 mm.

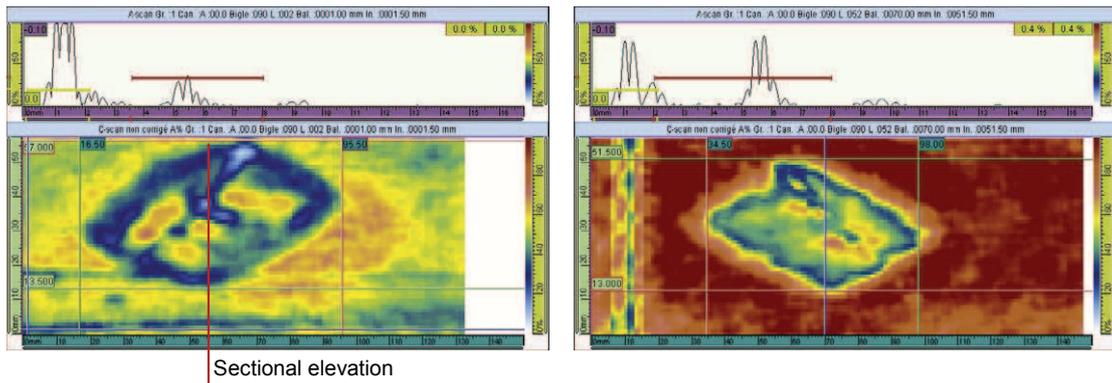
Fig. 4.5. Ultrasonic Testing map of the both faces of Specimen B.

Two C-Scan inspections were carried out : one on the front of the specimen and the other one on the back. For the front surface inspection (i.e. the surface on which the lightning impact is located), the defect measured 43.5 mm \times 79 mm (cf. Fig. 4.5). On the back, the defect measurements were 38.5 mm \times 63.5 mm (cf. Fig. 4.5).

Three reasons may explain the relatively smaller size of the defect on the back:

- firstly, signal loss through the thickness of the specimen,
- secondly, surface coating on the back,
- thirdly, position of the probe focus because the defect is on the surface.

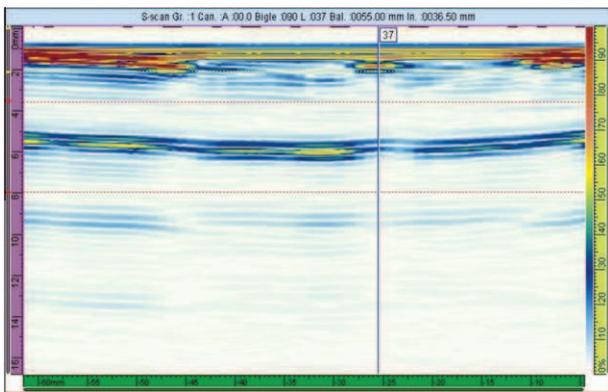
Fig. 4.6. Sectional elevation of the 2D map (S-scan).

The in-depth position is the same from both front and back. The shape of the defect is similar to that of the GVI defect. The actual size of the defect on the specimen and its UT size are virtually the same (around 5%). From the 2D map, a sectional elevation can be traced showing that the defect is on the surface of the specimen (Fig. 4.6).

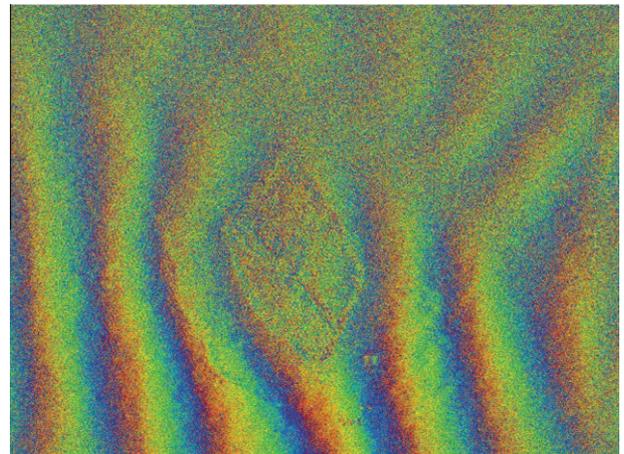
Fig. 4.8. Shearography map of Specimen B.

The defects on Specimen B can be identified by Shearography tests in a relatively short time: approximately 1 min (cf. Fig. 4.8). The size of the defect is 37.5 mm × 59.5 mm. The differences between the GVI and the Shearography measurements are 8% as regards length and 21% as regards width. This difference is due to the fact that the shearographic image is a little fuzzy preventing the size of the defect to be measured properly.

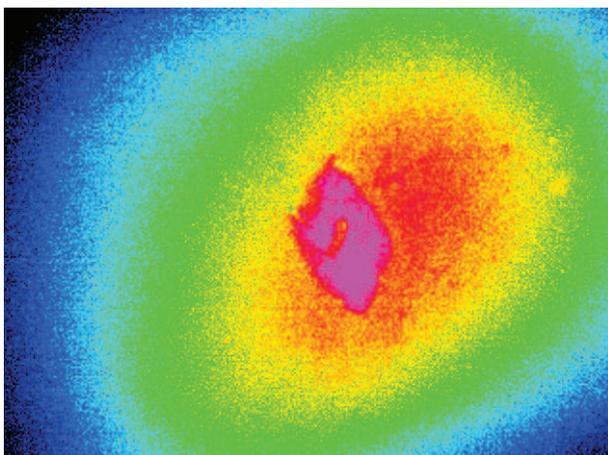
Fig. 4.7. Infrared map of the defect of Specimen B.

2D mapping of the specimen and identification of the defects can be obtained using IR thermography tests (cf. Fig. 4.7).

The size of the revealed defect is 36 mm length and 60 mm width. Its shape is almost the same as the GVI defect on the damaged surface. The variations between the GVI and the IR thermography measurements are 12% in length and 20% in width.

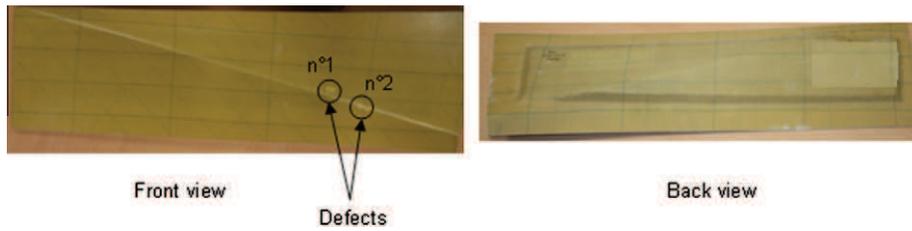
Fig. 4.9. Defects of Specimen C.

The Specimen C defects are two cases of delamination due to the impact of a falling tool or of hailstones. These were created in the laboratory using a drop weight tester. The defect located above geometrical discontinuity is called no. 1 and the defect located on the geometrical discontinuity is called no. 2 (as defined in Fig. 4.9). Defect no. 1 is 13 mm and 9 mm. Defect no. 2 is 18 mm and 8 mm.

For Specimen C, two GVI defects had to be detected. Defect no. 1 was located above geometrical discontinuity and defect no. 2 was located on the angle of this geometrical discontinuity (cf. Fig. 4.9).

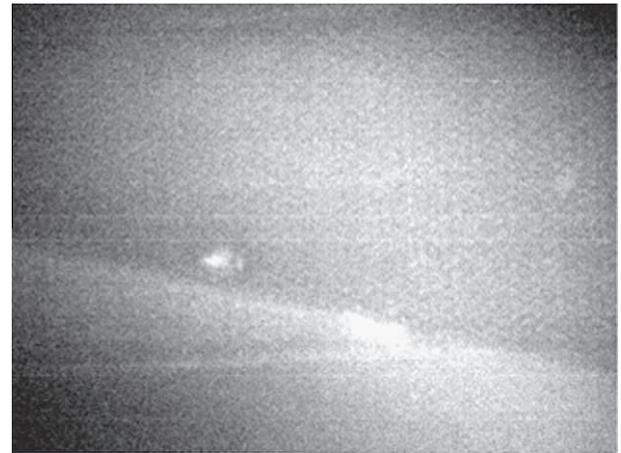
Fig. 4.11. InfraRed Thermography map of Specimen C.

Both defects were determined by InfraRed Thermography within a few seconds (cf. Fig. 4.11). Defect no. 1 is 15 mm × 10 mm. The difference between the GVI and the IR thermography measurements is 15% in length and 11% in width.

The dimensions of the defect no. 2 are 22 mm length and 8.5 mm width. The differences between the GVI measurements and the IR thermography measurements are equal to 22% as regards length and 6% as regards width. The considerable deviation in length can almost certainly be attributed to the focusing problem due to the geometrical discontinuity.

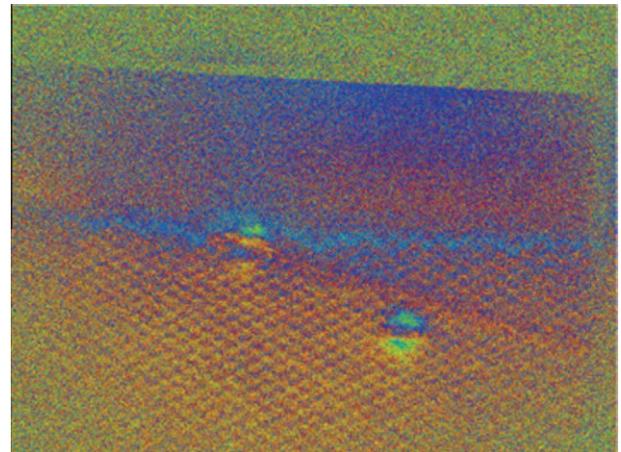
Fig. 4.12. Shearography map of Specimen C.

The defects on Specimen C were identified by Shearography tests within a relatively short time of around 1 min (cf. Fig. 4.12). The image is very clear and the defects are perfectly visible. Shearography therefore seems well suited to the detection of defects in this type of specimen.

Defect no. 1 is 15 mm × 15 mm. The variation between the GVI and the Shearography measurements is 17% in length and 87.5% in width. However, on the shearographic image, the defect appears circular which is not surprising for an impact defect; and so in this case, the GVI measurement may be incorrect.

Defect no. 2 is 15 mm × 8 mm. The variation between the GVI and the Shearography measurements is 16% in length and 11% in width.

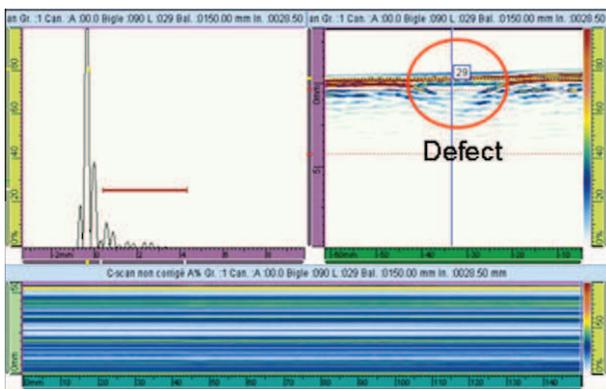
Fig. 4.10. Ultrasonic map on Specimen C.

Defect no. 1 was detected by ultrasonic tests (cf. Fig. 4.10). The geometry of the specimen (defect slightly on the angle) made UT measurement difficult. Thus, only the defect length could be determined: 22 mm. The difference between the GVI and the UT measurements of length is 22%. As shown on Fig. 4.10, the defect was located not only on the surface of the specimen but also in depth.

Defect no. 2 was not detected. Checking this impact was impossible because the device (multi-element probe) was not suitable and the folding angle was variable.
