Failure analysis of carbon black filled styrene butadiene rubber under fatigue loading conditions

Jean-Benoit Le Cam, Bertrand Huneau, Erwan Verron

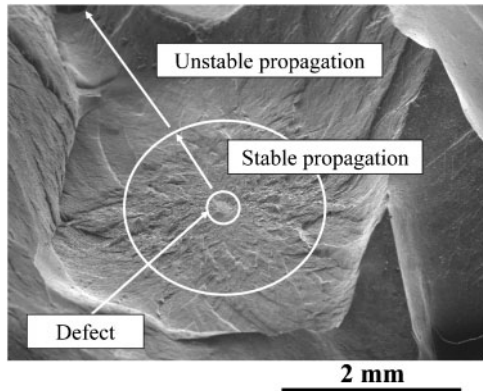
1 Photomicrographs of fracture surface in CB-SBR

The fracture surfaces are observed by SEM; an example of photomicrograph is shown in Fig. 1. To illustrate the discussion, we propose to describe fracture surface with the help of the schematic views presented in Fig. 2.

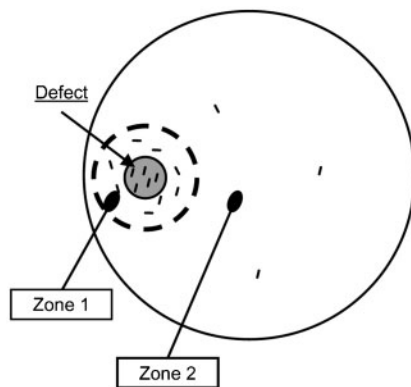
2 Schematic view of fracture surfaces in CB-SBR

Except the nucleation defect area, only two different zones (denoted zones 1 and 2 in Fig. 2a) are observed, independently of the maximum stretch ratio applied.

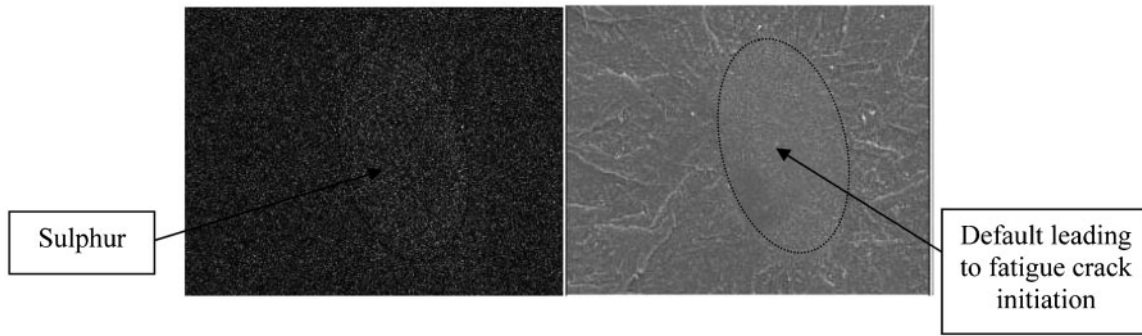
3 EDSX analysis of defects from which crack initiation occurs

Considering several samples, we observe that the nucleation defect is located between sample surface and 6 mm far from the surface and its maximum size is 300 μm in diameter. As shown in Fig. 3, the EDSX analysis demonstrates that these defects contain more sulphur than the rest of the material. Therefore, they correspond to overvulcanised zones in the section. Surface of Zone 1 is rough; it corresponds to a stable propagation of the crack and surrounds the defect. Its size can reach 6 mm in diameter. Zone 2, which surrounds Zone 1, represents the rest of the fracture surface. It corresponds to an unstable propagation of the crack. The surface is relatively smooth and slight bifurcations of the crack can be observed. No fatigue striations are observed for every loading conditions considered in this study.

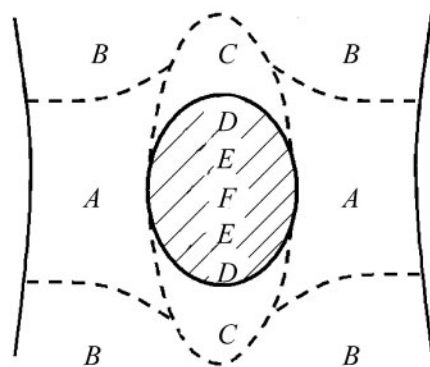
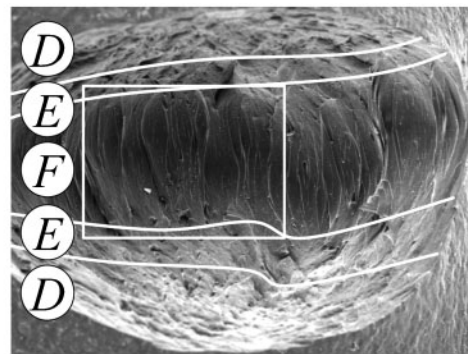
4 a schematic view of crack (D–F) and its surroundings (A–C) and b front view of crack for CB-SBR

Figure 4 presents the fatigue crack and its surroundings: Fig. 4a shows the schematic view, and Fig. 4b presents a photomicrograph of the three zones D, E and F. As for CB-NR, six different areas can be observed as the samples is stretched to the elongation applied during the fatigue test. Before the occurrence of the crack, there are only two zones: the central zone of the sample, denoted A in Fig. 3a, which is the most stretched part of the specimen, and Zone B situated on both sides of Zone A. When the crack occurs, four new zones appear: Zone C which corresponds to the parts of Zone A that are relaxed during crack opening, and Zone D, E and F which constitute the crack itself. Figure 3b shows that Zone F stands for the crack tip, Zone D represents the smooth surfaces generated during crack growth and Zone E denotes the frontier between them. In fact, the major difference between Zones D and F is their stretching level. These three zones also exist for CB-NR, except that Zone D is covered with numerous wrenchings (*see* Fig. 4 in Ref. 5).

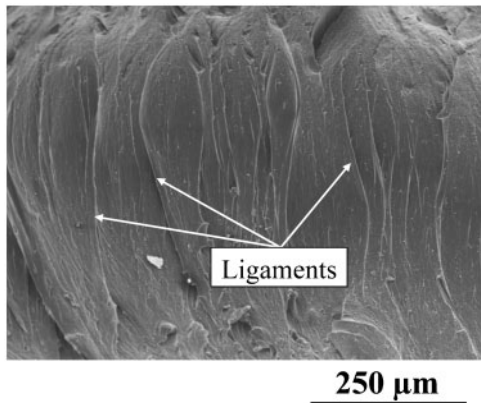
5 Magnification of Zone F in CB-SBR

Figure 5 presents magnification of CB-SBR crack tip. This photomicrograph corresponds to the encircled zone in Zone F in Fig. 4b. Many of long ligaments take place at crack tip and the size of Zone E is revealed very small (*see* the top of Fig. 5). Therefore, it seems to indicate that the broken surface generated by crack growth immediately joins both sides of the crack (Zone F). To describe the zone in which the crack propagates, we should continue to zoom in at crack tip. Figure 6 presents two magnifications of the crack tip. As shown in Fig. 6a, every ligament comes from a line that crosses the crack tip (the white dotted line in the figure). This

result is in agreement with the work of Gent¹⁰ who observed, for static loading conditions, a 'tear line' at crack tip in a precut carbon black-filled polybutadiene (a material that does not crystallise under loading) sample. In the following, the term 'tearing line' will be preferred to 'tear line' as suggested by Gent. Figure 6*b* is a zoom in of the encircled zone in Fig. 6*a*. Zinc oxides are present everywhere on the surface. Some of them are surrounded by elliptical cavities which walls are forming ligaments. The size of these oxides varies between a few hundred nanometers and 5 μm.

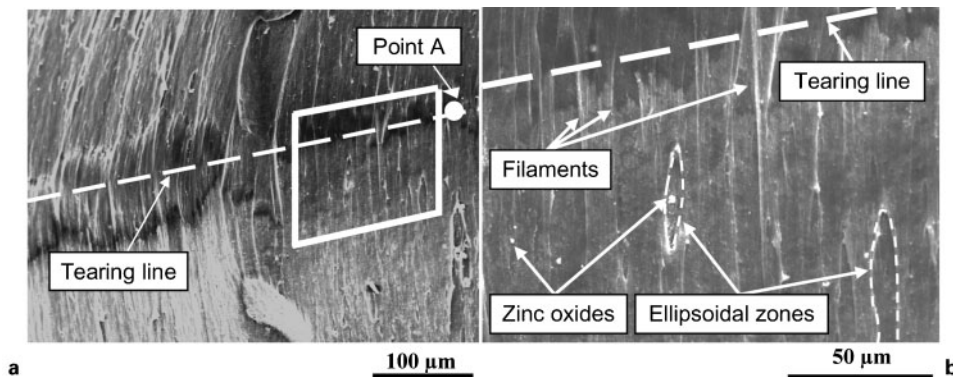
6 Details of crack tip for two magnifications

The zone propitious to microcutting corresponds to the tearing line previously described. It is the zone in which crack grows with the less energy. Thus, crack tip microcutting was performed by concentrating the electron beam at a point of this tearing line (point A, Fig. 6*a*). As material response, a microcut immediately initiates at this point and propagates towards the right side by revealing the zone located behind the crack tip. The artificial microcrack obtained is shown in Fig. 7*a*. It is to note that, for the same adjustment of the electron beam as in Ref. 5 for CB-NR, the time needed to initiate microcrack is inferior to 1 s instead of several seconds for CB-NR. Moreover, ligaments observed all over the crack tip fail without any resistance and for the same energy brought by the electron beam. It seems to indicate that the microstructure of ligaments in CB-SBR is the same whatever the deformation state, i.e. ligaments are not crystallised and the material microstructure is homogeneous at the crack tip. Figure 7*b* is a magnification of the encircled zone in Fig. 7*a*. Here, new ligaments are generated and the microcrack propagates through ZnO particles. Chemical links between ZnO and rubber matrix being highly weak, this zone looks like a cavity opened and stretched. This phenomenon generates two elliptical zones in which ZnO particles are observed. It is to note that elliptical zones observed on both sides of tearing line in Fig. 7*b* proves that this phenomenon takes place also

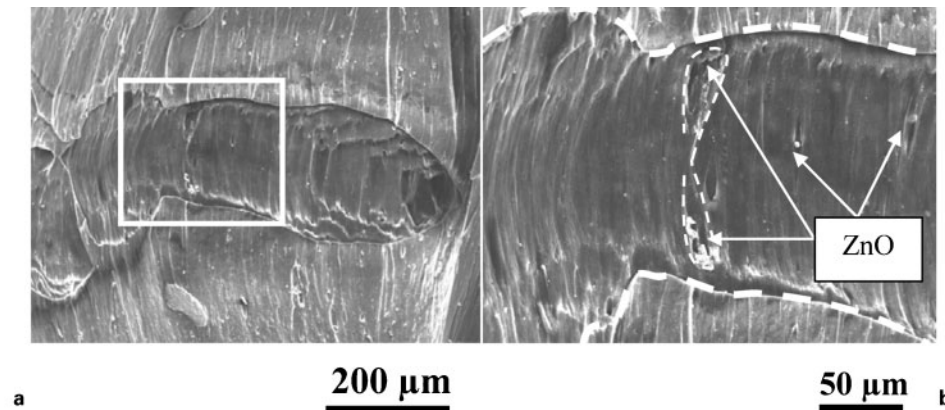
7 Chronology of microcut experiment

a artificial microcrack obtained after concentrating electron beam on point A in Fig. 6*a*; b magnified view of encircled zone of a

naturally (during natural crack propagation). If ZnO particles are not crossed by the crack in their middle, elliptical zones are only observed on one side of the tearing line (Fig. 7b). Finally, the size of revealed cavities being not superior to the one of ZnO particles, our observations do not allow to highlight cavitation from ZnO particles at the fatigue crack tip in CB-SBR. These observations demonstrate that the roughness of fracture surfaces is only due to particles (ZnO, carbon black agglomerates) encountered by the crack during its propagation into a linear zone.
