Common features on damage mechanisms identified on various metal and ceramic on polyethylene articulating surfaces of total hip prostheses

D. Najjar¹, F. Hennebelle², A. Iost¹, H. Migaud³

Abstract. This paper presents a methodology for assessing the in-vivo degradation mechanisms of articular components of total hip replacement (THR) prostheses of Charnley type. The experimental procedure revealed that common features can be observed even if the clinical cases under investigation were quite different with regard to the demographic data. It particularly emphasises the detrimental effects of foreign bodies on the damage of the articulating surfaces. These foreign bodies can migrate into the joint space before embedding definitely into the Ultra High Molecular Weight Polyethylene (UHMWPE) acetabular cup surface where they further participate to a third body wear mechanism accelerated by a progressive increase of the femoral head roughness. Our experimental results underline, from a practical point of view, the need for careful manufacturing and clinical handling of porous surfaces, advocate for a systematic assessment of retrieved components, particularly when changed because of une

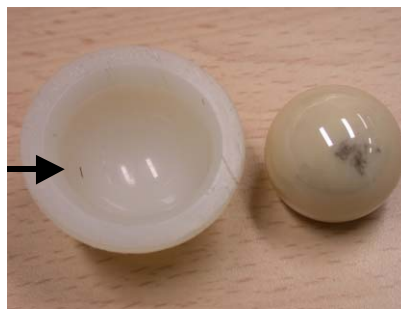
Whatever the diagnosis of revision (wear, osteolysis or broken multicable filament), it must be pointed out that polyethylene debris had been detected by histological analyses on periprosthetic tissues but that no loosening had occurred during lifetime. The four THR prostheses considered in this study were mainly retained because of the visual detection of metallic fibers embedded in the UHMWPE acetabular cups. Fig. 1 presents the retrieved articular components related to clinical case A and shows the presence of such a metallic fiber of millimetre size embedded into the surface of the UHMWPE acetabular cup but detected only after retrieval. Note also the adherent metallic deposit on the ceramic femoral head due to the friction of this counterface with the embedded fiber.

Fig. 1: Retrieved components related to clinical case A. The fibber is marked by a black arrow.

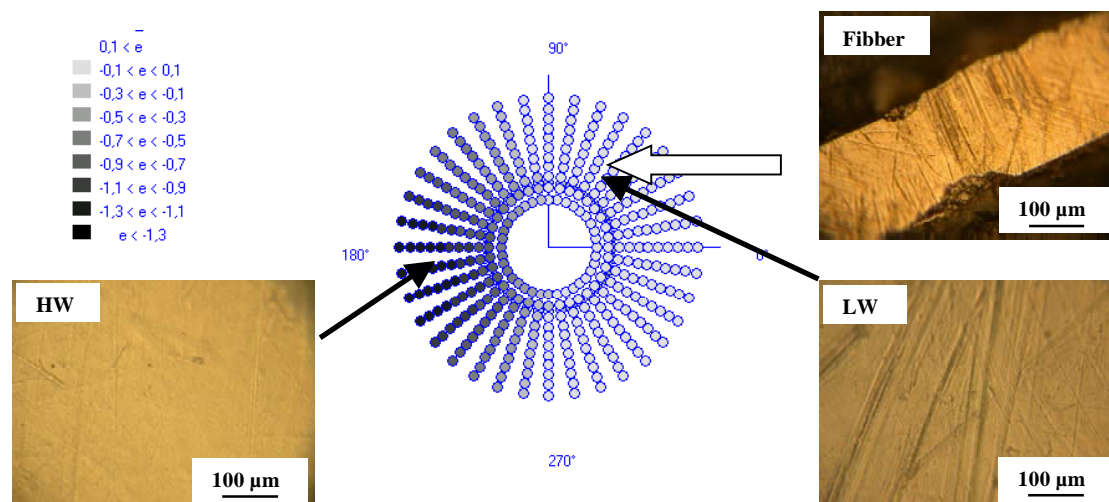
Damage analysis of the UHMWPE acetabular inserts. Whatever the retrieved acetabular cup analysed, the damage of the retrieved consists of dimensional changes at a macroscopic scale associated with degradation of surface topography at a microscopic scale. These retrieved acetabular cups exhibit two distinct areas that are symmetrically located. A first region is characterised by large deviations at a macroscopic scale and has a highly polished smooth appearance at naked-eye. Little scratches are detected by optical microscopic observations in this region denoted HW contrary to the other one denoted LW; region for which the recorded deviations are small (Fig. 2).

Fig. 2: Example of stereographic projection of deviations (e in mm) between points located on the internal surface of the retrieved acetabular cup and those located on a theoretical hemisphere of 14 mm radius (clinical case A). The white arrow indicates the location of the embedded fiber.

In agreement with the conclusions of these authors, it can be concluded that the large deviations recorded in the area HW indicate the effective direction of loading and are the consequence of the femoral head penetration in the UHMWPE acetabular cup by the combination of creep and a fatigue/adhesion wear mechanism. The related values of the maximum linear penetration rates in the UHMWPE are summarised in Table 2 for the four studied clinical cases. Such values are consistent with the clinical penetration rates reported in the literature. While these clinical penetration rates exhibit a great variability, they are generally less than about $0.25 \text{ mm}\cdot\text{year}^{-1}$ and often correspond to an average of $0.1 \text{ mm}\cdot\text{year}^{-1}$ or less [4,6]. Moreover, substantial clinical evidence now accumulating indicates that long term survival of the implant is associated with penetration rates of less than $0.1 \text{ mm}\cdot\text{year}^{-1}$ while case requiring revision often exhibit penetration rates of about $0.2 \text{ mm}\cdot\text{year}^{-1}$ or higher [6].

As far as the region LW is concerned, it is thought that the numerous scratches observed at the surface of the UHMWPE acetabular cups are the consequence of a third-body wear mechanism. Indeed, it is worth noting that some of the detected scratches exactly have the same shape and dimension as the metallic fibbers of millimetre size. Moreover, the surface of these metallic fibbers, always located in this region LW, are also severely scratched (Fig. 2).

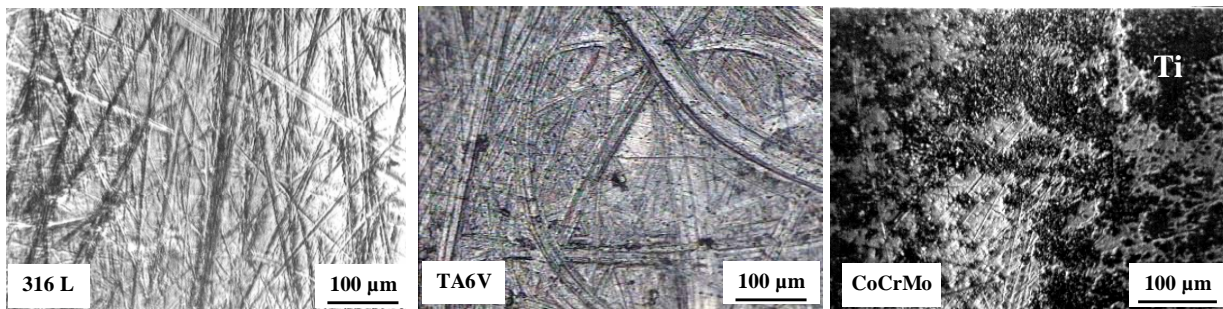
Damage analysis of the femoral heads. Hard foreign bodies undoubtedly increases the rate of removal of polyethylene, but they might be also responsible for the degradation of the retrieved femoral heads [2,4,7]. The deleterious effect of the embedded foreign third bodies of large dimensions is also evident at the surface of all the retrieved femoral heads under investigation in this study. However, the present results show that the wear mechanism at the origin of the degradation of the initial surface finish depends on the nature of femoral head. Indeed, numerous scratches are detected at naked-eye at the surface of the femoral heads made in 316L and TA6V passive alloys. Microscopic observations of such scratches obtained by means of an optical microscope are shown in Fig. 3. These scratches covers approximately 25% of the total surface of the femoral head in the case of the 316L alloy and more than 60% in the case of the TA6V alloy that, among the biomaterials used for manufacturing the femoral heads of THR prostheses, is known to be the less resistant one to abrasive wear. In the case of the CoCrMo alloy, the initial bright finish is only altered on a small area covering less than 10% of the total surface of the femoral head. Observations by means of a Scanning Electron Microscope (SEM) reveal that this area consists of very small scratches combined with an adherent metallic deposit (Fig. 3). As for the zirconia femoral head, this latter can be identified as a titanium deposit by Energy Dispersive Analysis of X rays (EDAX); chemical element which is contained in the original chemical composition of the fibbermesh deposited on the Harris-Galante Mark I metallic shells but not in those of the femoral heads under consideration. In other words, these metallic deposits result from an adhesive wear mechanism due to the friction between the embedded metallic fibbers of large dimensions and the femoral heads.

Fig. 3: Damage of the metallic femoral heads observed by means of an optical microscope for the 316L and TA6V femoral heads and by means of a SEM for the CoCrMo femoral head.

Whatever the wear mechanism, i.e. abrasive wear in the case of the 316L and TA6V alloys and mainly adhesive wear in the case of CoCrMo alloy and zirconia which are more resistant to abrasive wear, the degradation of the topography of the femoral heads leads to an increase of the effective roughness which has been shown to be a major factor in determining the wear of polyethylene and the long term performance of implants [1,3,8,9]. Indeed, whatever the femoral head, the experimental results reported in Table 3 show that the values of the average arithmetic roughness parameter recorded in the damaged areas are always significantly higher than those recorded in undamaged areas having a bright finish. Besides, these latter values are similar as those mentioned in the ISO 7206-2 standard which specifies the guidelines for new acetabular components of THR prostheses [10]. In agreement with others authors [4,6-9], it is also thought that, from a global point of view, the degradation of the initial surface finish by hard foreign bodies is a random phenomenon suspected to be a major factor responsible for the discrepancy existing in the literature between the average clinical and laboratory wear factors as well as the wide spread of results.
