Diagnosis of a large steel bridge close to collapse during a fire

Bruno Godart, Jacques Berthelley, Jean Pierre Lucas

The Mathilde Bridge is one of the six bridges over the Seine River in the city of Rouen and supports heavy traffic. It was built in 1976-79 and is composed of a single metal span 115 m long, consisting of an orthotropic steel deck resting on two girders. On October 29th, 2012, the Mathilde bridge was subjected to a heavy fire and was immediately closed to traffic. After recalling the events, the article describes the decisions that had to be taken in an emergency, then the extended diagnosis which was conducted in order to be able to take a rapid decision on repair or reconstruction.

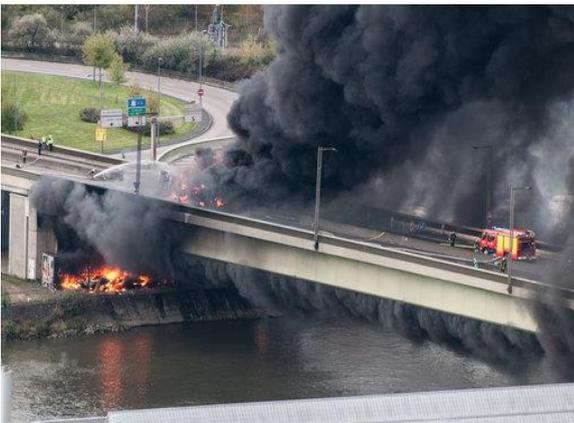
On October 29th, 2012, a tanker truck carrying oil caught fire on the Mathilde bridge, by turning over in an access curve to the bridge. Its load spread over the whole width of the deck of the south steel span, then flowed toward the edges and ends of the bridge and set fire to fairground workers trucks that were parked under one extremity of the bridge. This latter was subjected to a heavy fire whose temperature has been estimated to reach between 650 and 800 °C.

Figure 2: View of the two fires over and under the bridge

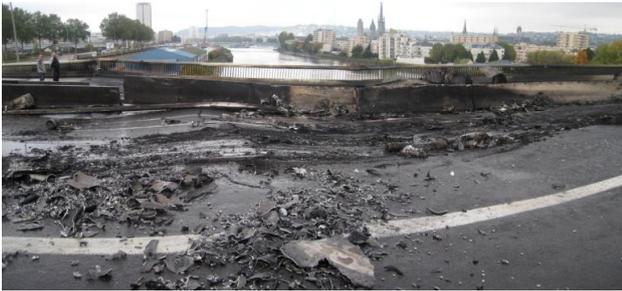
The deck remained distorted like an accordion over a length of about 40 meters from the south abutment (Fig. 3). The transverse beams supporting the deck were alternately raised and lowered due to the combined effect of heat which lowers the modulus of elasticity, and predominantly of the compression that occurred during the fire in the deck due to the restrained expansion of the deck. The web of the downstream girder was distorted dramatically during the fire (Fig. 4): a tensioned diagonal has formed over a length of 8 meters from the abutment with a wave folding the first intermediate vertical stiffener located at 4 meters from the abutment.

Figure 3: Waves of the deck

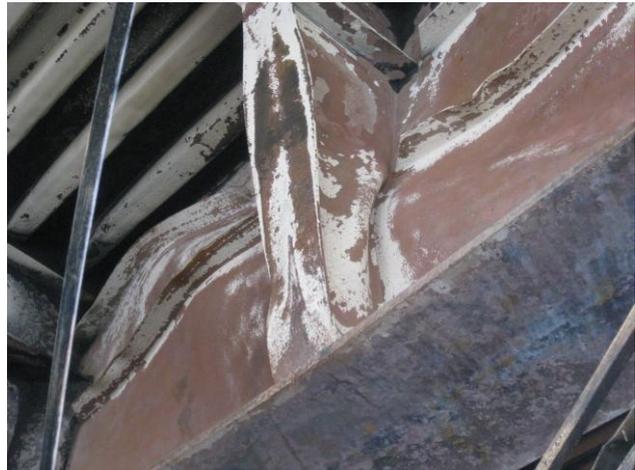
Figure 4: Deformations of the webs of the two first panels of the downstream girder

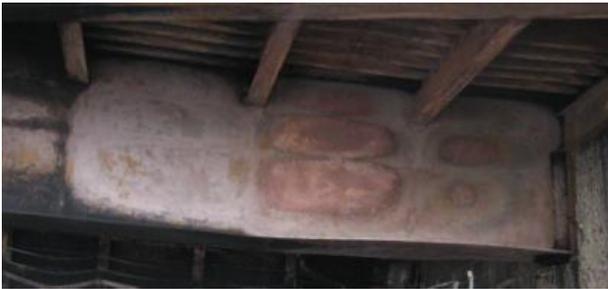
The observation of the residual deformations and colors taken by the corrosion protection containing lead minium indicate that the temperature has reached at least 600 ° C on significant areas (Fig. 5). It could be noticed the white lead oxides of the primer over the entire height of the web and a complete disappearance of the primer in the center of this area.

Figure 5: Colors taken by the corrosion protection Figure 6: Transverse deformation of the web

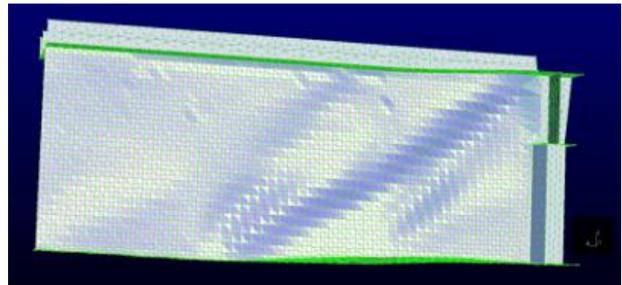
The deformation of the downstream girder was measured using a 3D laser scanner by the company SITES. The laser record allowed to acquire 500 million points including 100 million for the end of the downstream girder. The interpretation of this survey allows the creation of a polygonal mesh with a precision of ± 1 to 2 mm. The main results showed that the girder had a vertical displacement of the order of 210 mm and the transverse deformation of the web of the girder varied between + 18 mm and - 28 mm apart from the mean plane (Fig. 6). It can be assumed that the margins of the ultimate strength of the structure at the peak of the fire were likely very low with respect to the buckling of the downstream girder near its support on abutment. This survey also allowed CEREMA to create a mechanical model of the end of the downstream girder.

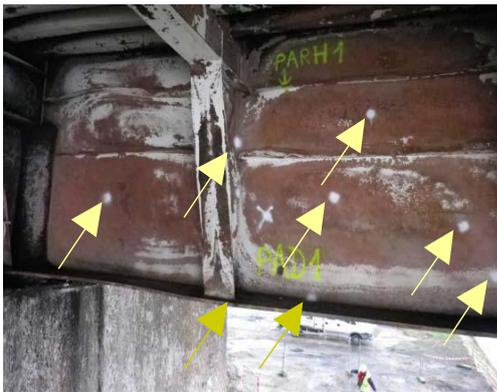
Figure 7: Location of the replicas

It was possible to make ten points of replicas that could be interpreted early December 2012. Nine points were chosen on site according to the curvatures of the steel plate and its surface appearance on the inside of the downstream girder (Fig. 7), because it is between the girders of the bridge that the warm air was trapped and that the temperature rose the most. One of these replicas was made in the area directly sprayed by the firefighters. Some points were localized on welds. A reference point was also taken out of the zone subjected to the fire.

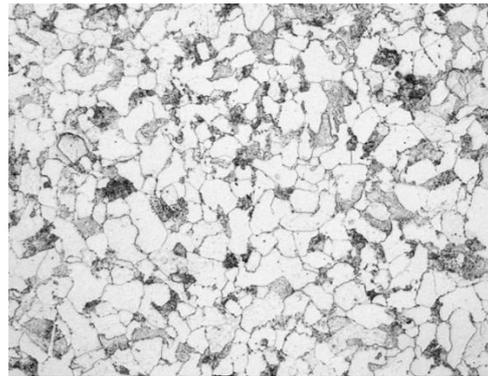
Figure 8: Observed structure of the steel on replicas

The results were very positive because the observed structure of the steel was everywhere purely ferrite-pearlitic without any trace of martensite or other structure degraded by an excessive heat. Moreover, the Welding Institute did not notice any cracking due to creep damage or attack by liquid metals.

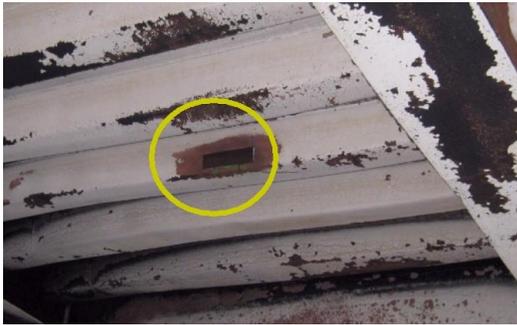
The resilience values Kv (at the temperature of - 20 ° C) taken from the steel deck after the fire were between 75 and 125 J/cm² on the normalized specimen. They were all above the average reference

value KCV fixed at 50 J/cm² and above the individual reference value fixed at 35 J/cm², which eliminates any risk of embrittlement and crack propagation.

Figure 9: Sample taken on a deck trough

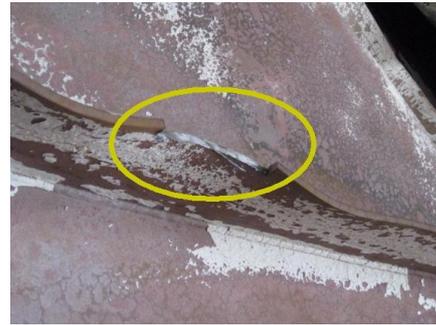
Figure 10: Sample taken on a web stiffener

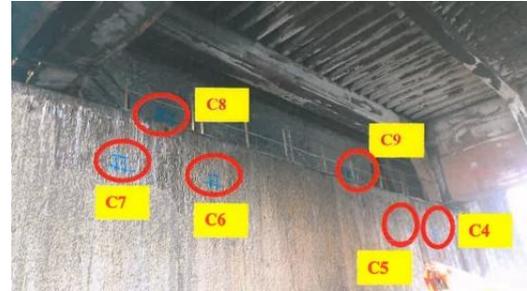
Figure 11 : Location of cores

The succinct hammering of the abutment face showed no degradation of concrete in depth. It seemed that the striated architectural stamping had partially protected the structural concrete that it covered. Some aggregates were observed as turning pink at the surface only. The removal of the deteriorated concrete revealed aggregates having a normal color within 1cm depth beyond the striated architectural stamping. No reinforcement steel appeared because the concrete scales remained of the order of a centimeter and were inferior to the cover depth. It could be concluded that the reinforcement had not been heated to a high temperature

SOCOTEC completed this inspection by a physico-chemical analysis of cores to determine the temperature profile that had been reached (see Fig. 11 for the location of the cores taken).

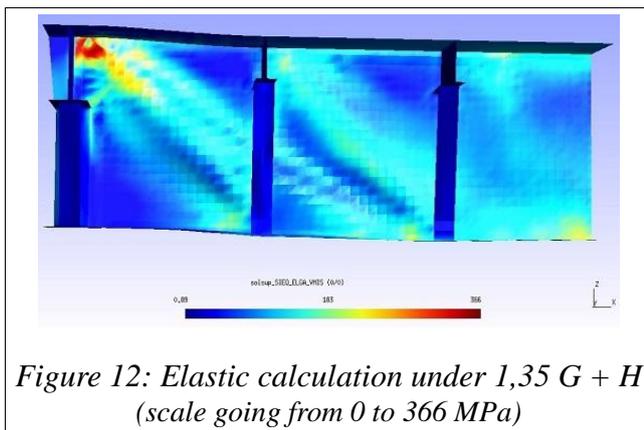
From the laser topographic surveys conducted by SITES, the CEREMA (Setra) developed a mechanical model for the downstream girder end. During December 2012, a first calculation was carried out with an elastic material and large displacements, i.e. taking into account the second order effects such as the membrane effect. This calculation was conducted with Code_Aster STA.10 a general code of finite element analysis of EDF R & D which is available under GNU GPL (<http://www.code-aster.org>) license. It helped to explain the good performance of the bridge under its own weight with Von Mises stresses equal to 366 MPa. The deck then remains in the elastic range under its own weight G (weighted by the coefficient 1.35) and considering the effect of significant residual geometric distortions due to the fire. A horizontal concomitant effort $H = 300$ tons was safely considered to take account of the friction in the bearing. The figures 12 and 13 show the stresses on the extreme fibers of the most stressed shell elements. This first elastic calculation was conducted to understand the behavior of the deformed structure and to re-open the navigation under the bridge.

Figure 12: Elastic calculation under 1,35 G + H (scale going from 0 to 366 MPa)

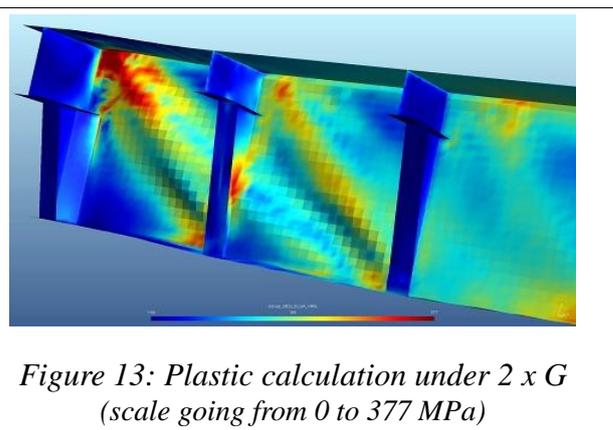
Figure 13: Plastic calculation under 2 x G (scale going from 0 to 377 MPa)

The improved version of Code_Aster 11.3 was then used to show that the structure remained stable until even a load equal to 2 times its own weight (2G). The maximal Von Mises stresses reach 377 Mpa (Fig. 13). At this level of charge, the convergence of the calculation of the structure is obtained by considering both the balance of efforts due to large displacements in the deformed geometry and

the plastic behavior of the material. This safety reserve allows a small engine to access on the bridge for repair work, if the company validates these results.

A replacement of the damaged part of the structure respecting its initial geometry was decided. Indeed, a good overall design of the existing structure has made this option more realistic than a full replacement. It generally makes little change to the orthotropic deck, but a simple overweight to meet some minimum thickness requirements.
