Non-destructive inspection of initial defects of PA6.6-GF50/aluminum self-piercing riveted joints and damage monitoring under mechanical static loading

Amandine Gay^{1,2}, Jean-Michel Roche³,
Patrick Lapeyronnie³, Frédéric Valiorgue² and
Philippe Bertrand²

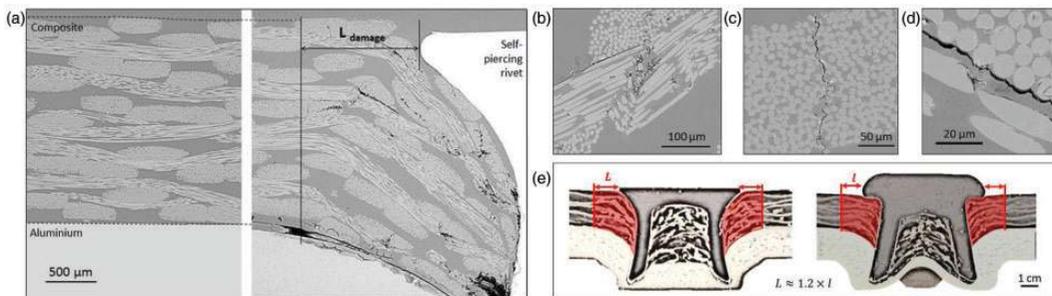
Post-mortem micrographic cross-section observations. In addition to the pulse thermography tests, it was possible to analyze some post-mortem micrographic observations (Figure 3). The composite damage located at the outside rivet interface may have an influence on the joint behavior because the joint failure may occur at this location. Figure 3(a) is a magnification of the composite section at the left side of the self-piercing rivet. Small defects are visible, which should not be detected by non-destructive inspections given their geometric extensions lower than 1 mm. This point will be checked by pulse thermography tests (see “Non-destructive inspection by pulse thermography” section).

Quantitative analysis can be made based on the maximum damage length, defined as the length from the end of the rivet head to the farthest defect. A magnification is useful to identify the type of defects: there are one to three fiber breakages (Figure 3b), around four intra-laminar fiber strand delamination defects (Figure 3c), and three inter-ply delamination defects (Figure 3d) in the sample. The length of the damaged zone measured 1260 μm on average. It is first determined by the tilt of the lower sheet that causes fiber bending. This tilt is due to the lower sheet deformation over the die. The composite upper sheet is no longer supported by the aluminum lower sheet which is deformed (Figure 4a). During the self-piercing rivet flaring, the rivet head pushes the composite sheet against the lower sheet. At the end of the process, the composite sheet is deformed by bending between the rivet and the aluminum as illustrated by Figure 4(b). The damage zone is also affected to a lesser extent by the rivet shape. The damage length is 20% lower for the composite pierced by the button head rivet than for the composite pierced by the countersunk rivet due to the curvature of the rivet shape (Figure 3e).

Figure 3. Composite damage caused by the rivet piercing process: (a) Cross-section of the joint, (b) focus on fiber breakage, (c) focus on intra-laminar fiber strand delamination, (d) focus inter-ply delamination, and (e) difference in terms of composite damage between the two rivet shapes.

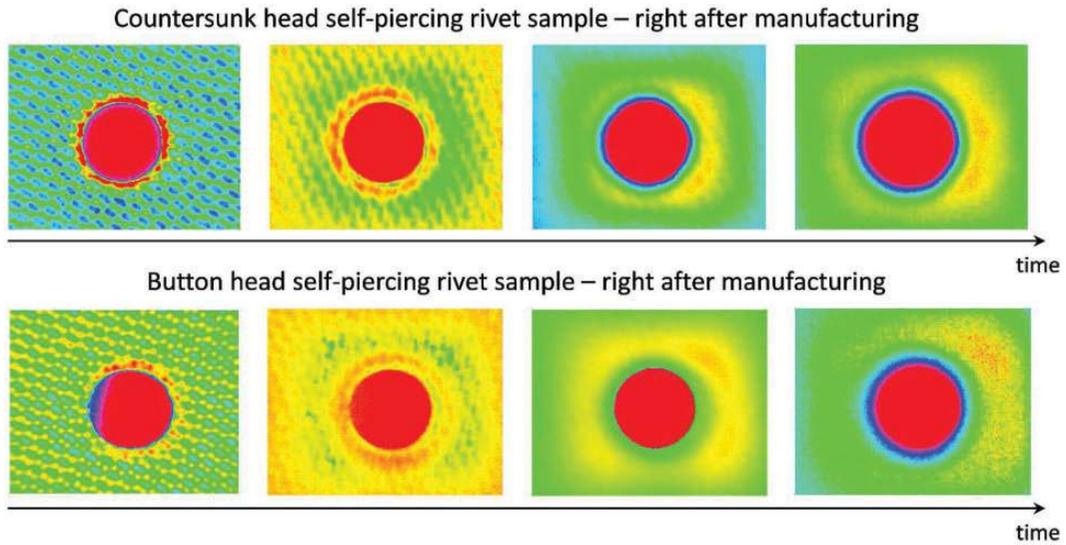
However, a slight dissymmetry of the temperature variation fields between both sides of the rivet is observed (Figure 6).

Figure 6. Second derivative-TSR maps of the rivet area close-up.

observations, it would appear that the composite/aluminum joint is not completely conform on the left side: the surface might be slightly curved, due to the manufacturing process and plastic strain effects. Even though this is definitely not a delamination-like defect, it still might impact the mechanical resistance of the riveted joint, by inducing a premature decohesion of the rivet.

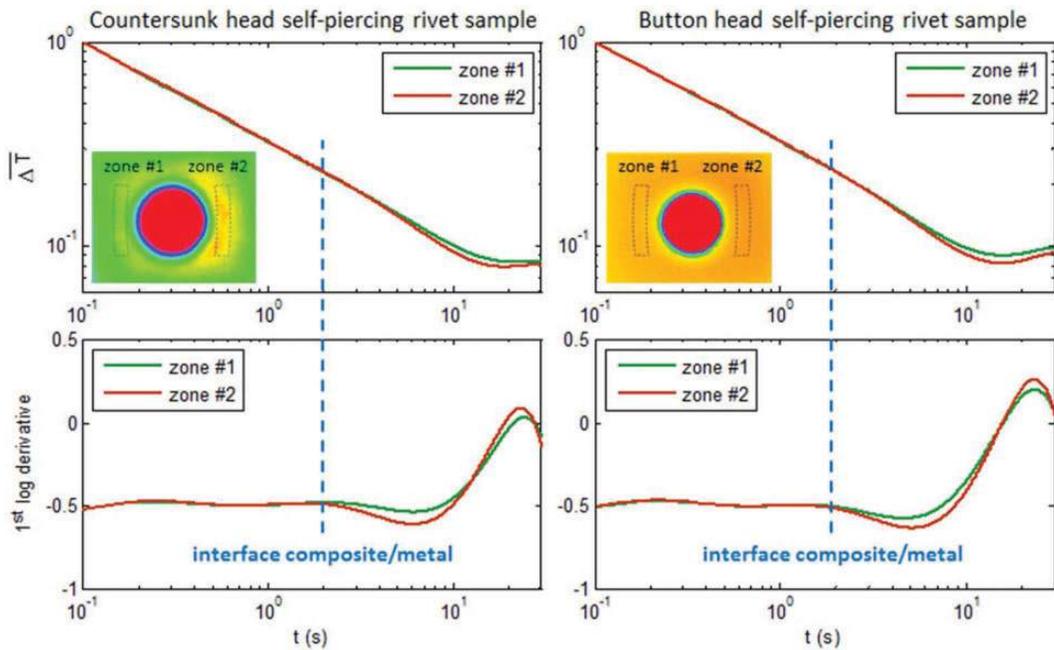
A local analysis of the normalized TSR-fitted thermograms, for each side of the rivet, and of the associated first logarithmic derivatives, shows that the post-flash cooling of the structure is slower on the left of the rivet, that is to say close to the composite edge (Figure 7). The normalized thermogram obtained for the zone located on the left of the rivet, close to the composite edge, is almost similar to the theoretical one of a homogeneous material: linear decrease, with $a - \frac{1}{2}$ slope in a log/log scale, up to the rear-face. The composite / metal interface, which should be detected by a faster temperature decrease, since the thermal diffusivity of aluminum is much higher than the one of the PA6.6, is hardly seen. On the contrary, the thermograms of the region located on the right of the rivet do meet the expectations: a clear slope rupture is observed when the composite / metal interface is reached. Such variations are even more highlighted by the first logarithmic derivatives. Based on those

Figure 7. Time-evolutions of the TSR-fitted normalized thermograms and of the 1st logarithmic derivatives. Studied zones located on thermal 2nd logarithmic derivative images.

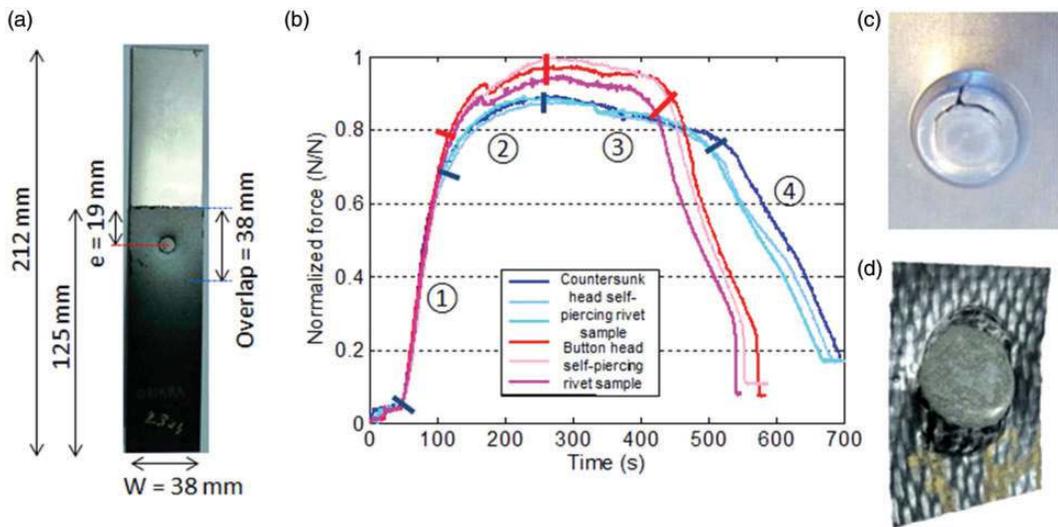
Standard mechanical monitoring. Figure 8 shows the time-evolution of the force and the failure mode of the PA6.6-GF50/aluminum self-piercing riveted joint. All force data are normalized by the maximal force value F_{MAX} reached over all mechanical tests performed on both rivet types. It clearly appears that the button head rivet joint achieves a shear strength higher by 10% than the one of the countersunk rivet joint (Figure 8a).

Once the riveted joint and jaw are set up, the load linearly increases, which is characteristic of an elastic behavior (phase #1). Afterward, the load keeps growing, non-linearly this time, up to the maximum (phase #2). Finally, the rivet is pulled out from the composite, by rotation, generating a load decrease, slow at first (phase #3), then dramatic, until the total detachment of the rivet from the aluminum sheet (phase #4). This failure mode seems to be the combination between bearing and pull-through failures, as observed for composite joints (Aktas, 2005; Kelly and Hallström, 2004; Ueda et al., 2012; US Mil-Hdbk 17 A, 1994). One part of the composite, on the upper side of the rivet (Figure 8b), is crushed (bearing) and is thus lift up, while the other part (the lower side of the rivet) follows the rivet rotation, as if the matter enters in the hole left by the rivet (pull-through). For the highest strengths, the rivet foot even begins to cut off the button on the aluminum side (Figure 8c). In the button head case, the bearing failure is even more obvious as the washer prevents the exit of the rivet.

Figure 8. (a) PA6.6-GF50/aluminum joint, (b) normalized force of the PA6.6-GF50/aluminum joint, (c) failure mode on the aluminum side, and (d) failure mode on the composite side for a button head self-piercing rivet.

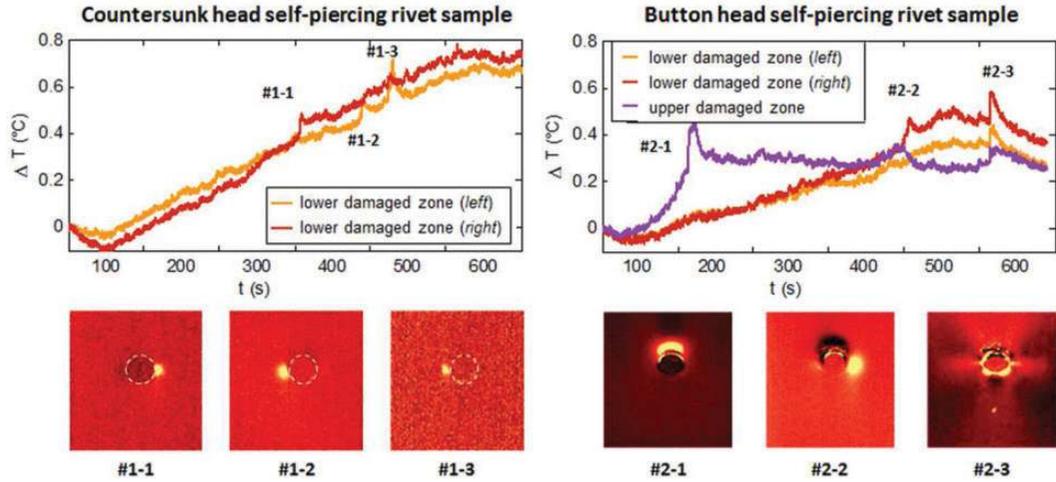
The loss of linearity, both spotted on the force and temperature time-evolutions (dotted line, Figure 10), corresponds to a damage threshold, which is quite similar from one type of rivet to another, found around $0.45 \times F_{MAX}$. The first non-linearities are mainly linked to viscous effects in the composite material and to microscale, diffuse damage. Then, the local temperature rises are associated with intern heat sources that indicate the presence of severe damage, located around the rivet, as illustrated in Figure 11.

The damage scenarios that are observed for both types of riveted joints differ from each other: for the button head rivet samples, the first major damage appears quite early, characterized by a significant rise of temperature, of about half a degree, and is located right above the rivet; for the countersunk rivet samples, the thermal discontinuities are recorded close to the end of the SLJ test,

Figure 11. Heat signatures of the major damage occurring during the SLJ test.

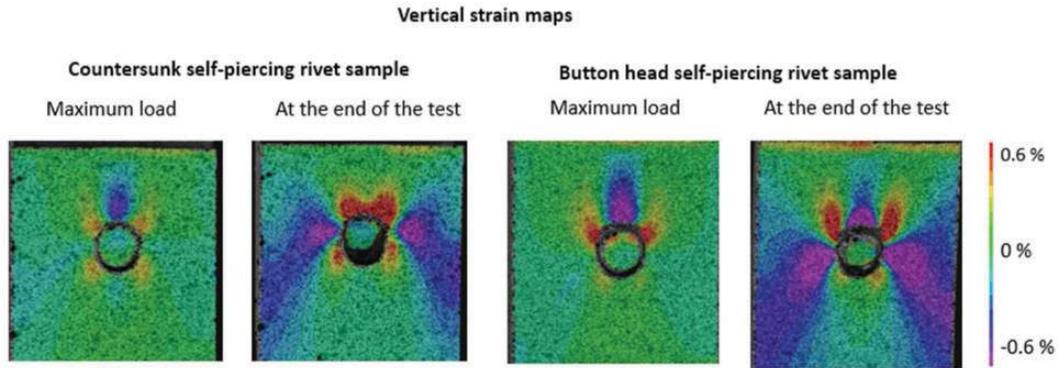
Figure 12. Vertical strain maps at the maximum load and at the end of the SLJ test.

Strain fields enable to link the previously detected local temperature rises to actual mechanical effects (Figure 12): the heat source observed right above the button head rivet (damage #2-1 in Figure 11) is due to a local compression; the other heat sources, for both rivets, are located on a horizontal crease of high deformation gradient. More thorough comparisons are made in “Cross-correlation between experimental data” section (Figures 14 and 15).

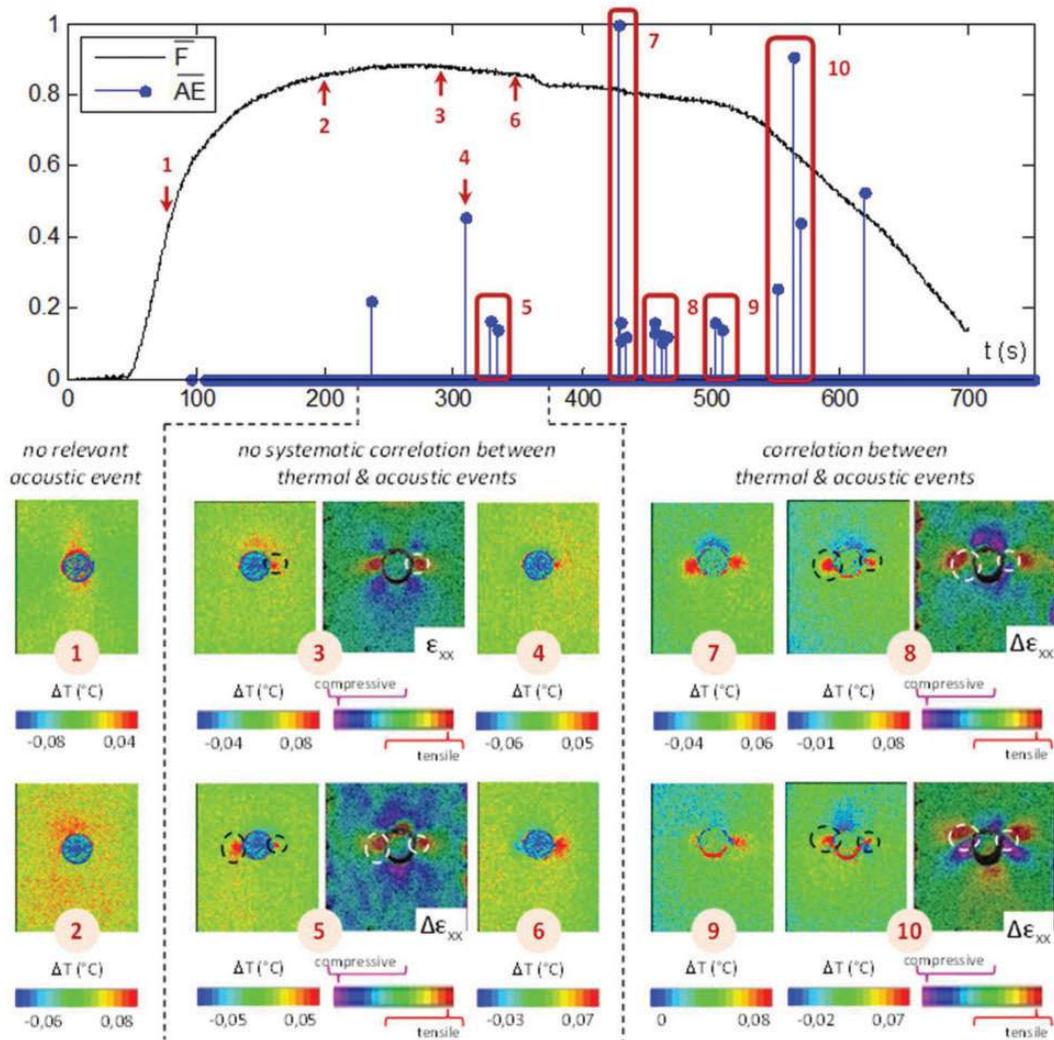
Figure 14. Countersunk head rivet in situ damage behavior under SLJ loading: cross-correlation between acoustic data, thermal and strain fields.

The cross-correlation between thermal and acoustic data confirms the identification of three separate phases for the SLJ tests, identical for both types of rivet: in the first one, light heating is detected but no acoustic event is recorded, or at least no significant one; in the second one, several, clear temperature rises are locally identified while acoustic peaks are not as numerous as what might have been expected and not necessarily correlated with the heating of the composite; in the last one, the acoustic activity is fully engaged and the association of the recorded peaks and temperature jumps appears to be quite consistent.

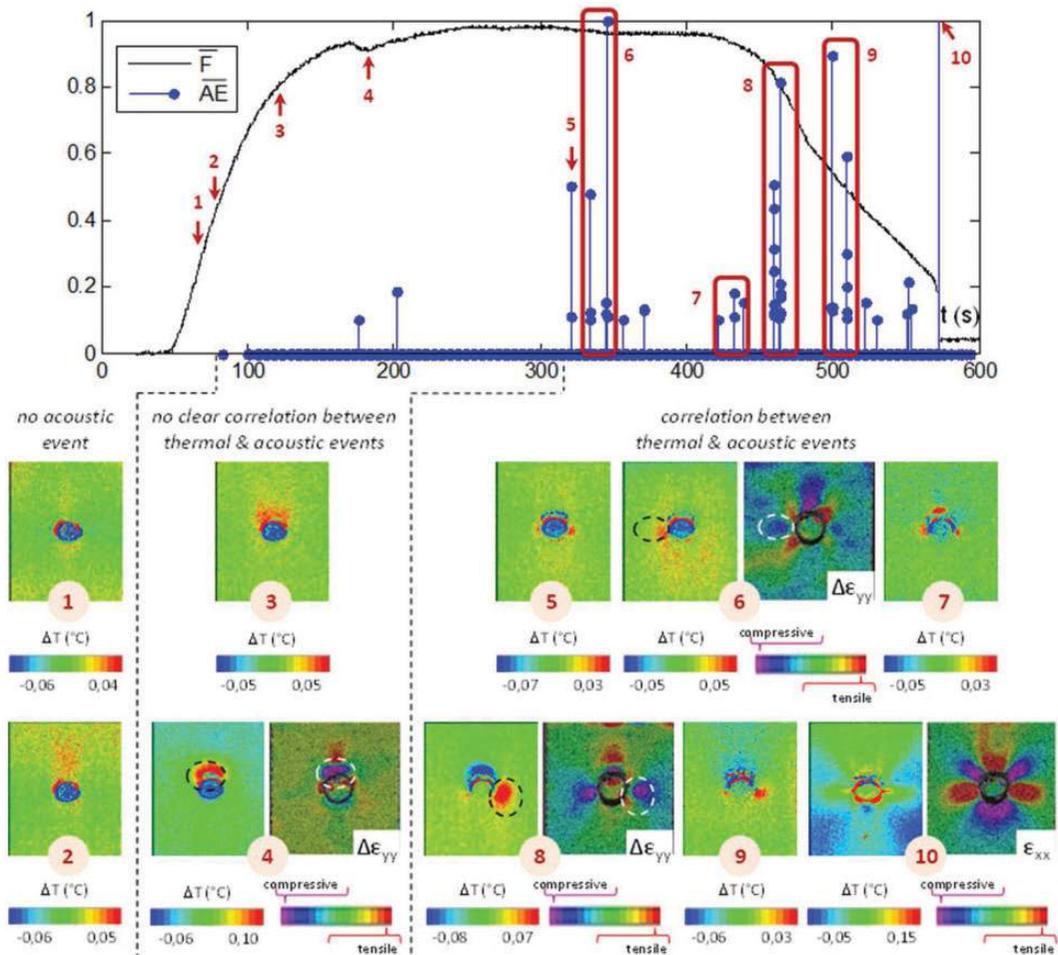
Figure 15. Button head rivet in situ damage behavior under SLJ loading: cross-correlation between acoustic data, thermal, and strain fields.

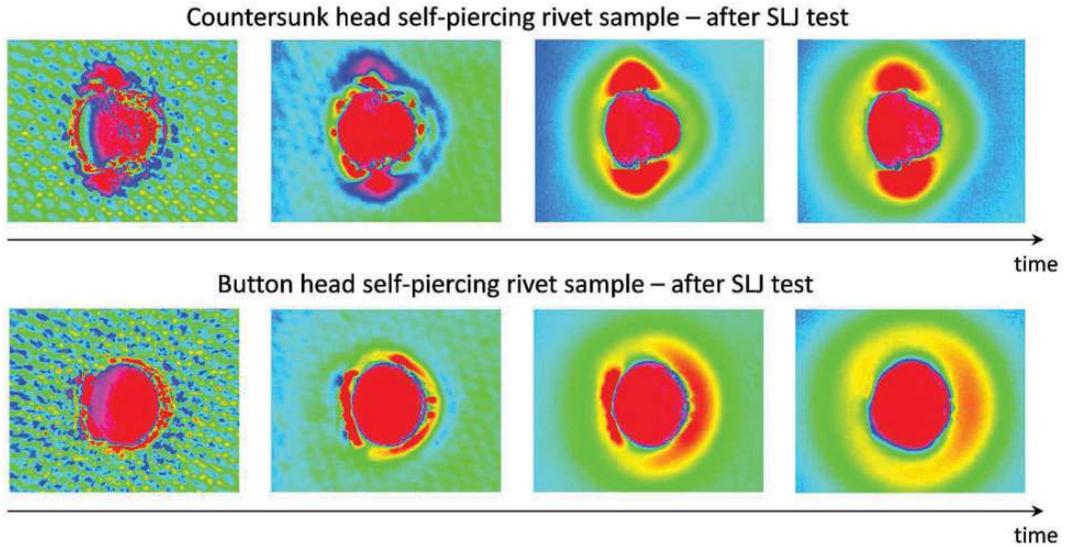
Figure 16. Second derivative-TSR maps of the samples after final mechanical failure.

Severe damage is detected around the rivet, of geometrical extension similar to the rivet diameter. It is visible for early times, which indicates that it is mainly constituted of shallow defects. The countersunk head rivet samples seem to be more damaged on the sides of the rivet than the button head ones (Figure 16), which is in agreement with the previous in situ observations. More globally, the damaged zones detected by post-SLJ test pulse thermography can be linked to the ones detected during the SLJ test (Figure 17).

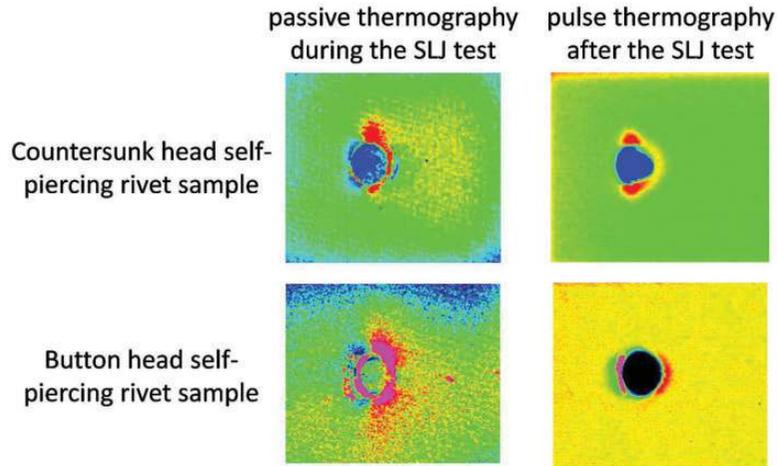
Figure 17. Comparisons between thermal maps acquired during the SLJ test by passive thermography and after the SLJ test by pulse thermography.
