Aluminum metallization and wire bonding aging in power MOSFET modules

EDS 2016

Abstract

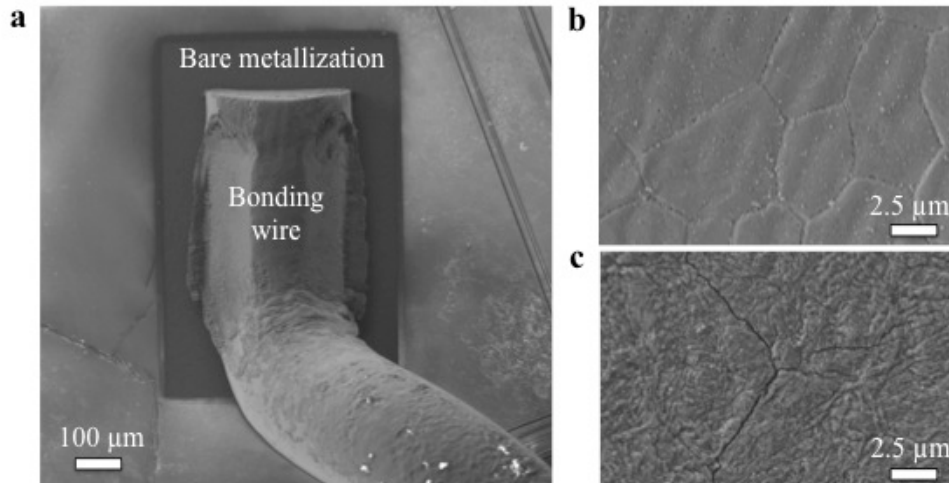
Fig. 2. (a) SEM image of an Al bond wire welded on the Al source metallization. Away from the bonding area the metallization is coated by a SiO_2 passivation layer. At higher magnification, bare metallization (close to the bond wire) of an (b) as-is module and (c) an aged one.

Preliminary surface observations were performed in a Helios 600 FIB/SEM from FEI™. Fig. 2b and 2c show the comparison between the Al metallization (close to the wire bonds, where the passivation layer is absent) before and after aging, confirming a heavy surface reconstruction upon aging.

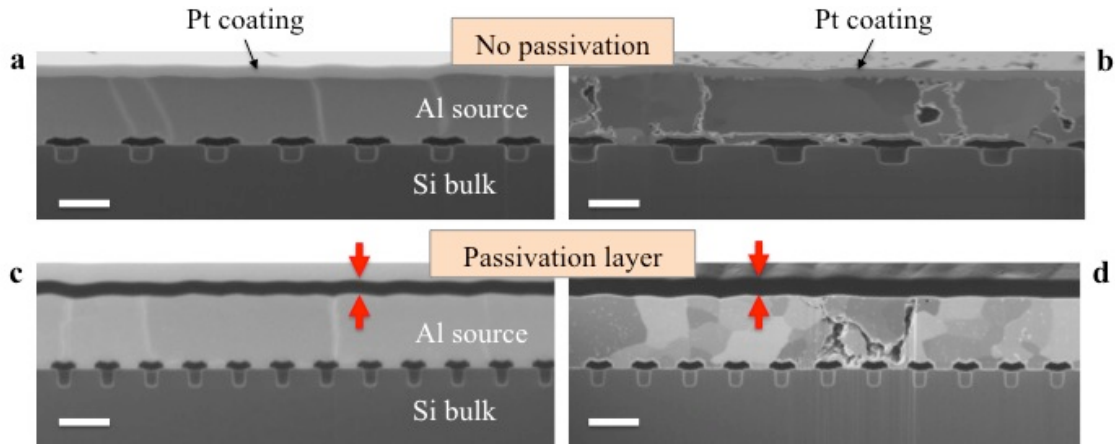
Fig. 3. FIB imaging of the bare metallization of an (a) as-is and (b) aged (70 °C) power module and of a SiO₂ coated metallization in an (c) as-is and (d) aged (70 °C) power module. The red arrows highlight the SiO₂ passivation layer. Scale bar 2.5 μm.

The in-depth structure of the metallization away from the bonding area was observed by making cross-sectional cuts in the FIB/SEM microscope. These cross-sections are observed using ion channeling contrast, which depends on the grain orientation [17]. Fig. 3 shows the comparison between a non-aged module and an aged one and reveals a strong degradation of the aged metallization, both bare and passivated, with many cavities and cracks running from the surface down to the transistor region.

Outside of the bonding area, the initial Al metallization is characterized by a “bamboo” grain structure (Fig. 3a, 3c): the grain size is on the same order of the metallization thickness and most of the grain boundaries run perpendicular to the surface down to the Si substrate.

FIB images of aged modules (Fig. 3b, 3d) show that the repetitive electro-thermal cycles cause the formation of cavities and cracks running from the surface to the transistor region. They follow the grain boundaries, confirming that aging is linked to an enhanced self-diffusion of Al atoms along the boundaries [10,11]. Moreover aging seems to lower the average grain size but, as we also observed in a previous work [9], ACOM mapping (Fig. 8) shows that most of the grain domains revealed by FIB have a small misorientation (less than 10°). This means that they are subgrains formed by the early gathering of pre-existing dislocation inside a single initially large bamboo grain, and the apparent size reduction is only a FIB artifact.

Under the passivation, the Al diffusion process along the grain boundaries is supposed to be cut off or at least slowed down [10,18]. Fig. 3d shows that plastic deformation in the passivated Al metallization is less homogeneous than in the passivation-free metallization: some zones are not aged, whereas in others we observe a weak concentration of cracks and cavities.

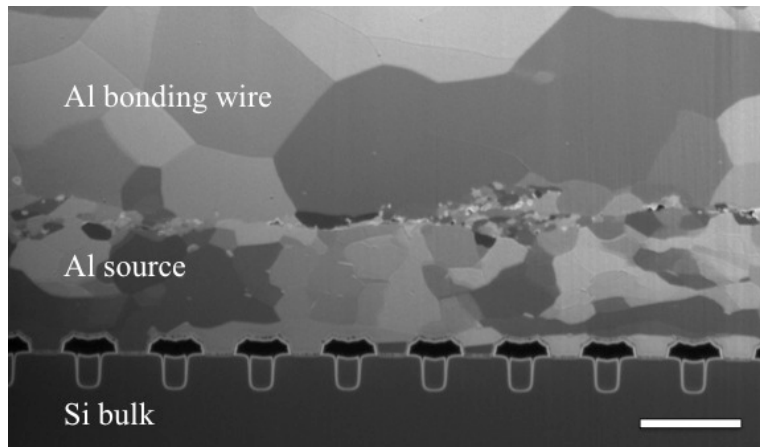
Fig. 5. FIB imaging of the wire-source metallization interface in an as-is power module. Scale bar 2.5 μm .

Under the bonding wire, the Al metallization has endured plastic deformation due to the welding process. Fig. 5 and 7c shows that the initial grain size is systematically smaller in these zones, compared to the bamboo structure (Fig. 3a, 3c) of the naked metallization. One can also notice that grains in the Al wire are much larger. Plastic deformation is highly uneven. Perpendicularly to the wire-metal interface (along the applied stress of the wire bonding), this deformation ranges from 2% to 27% in average in the measured sections. To obtain these values, we have used the measurement method illustrated in Fig. 9. We measure the deformation with respect to a reference (red line) by computing the metallization areas under (zone -) or over (zone +) the reference, which corresponds to the initial position of the metallization surface. Then the deformation is computed as:

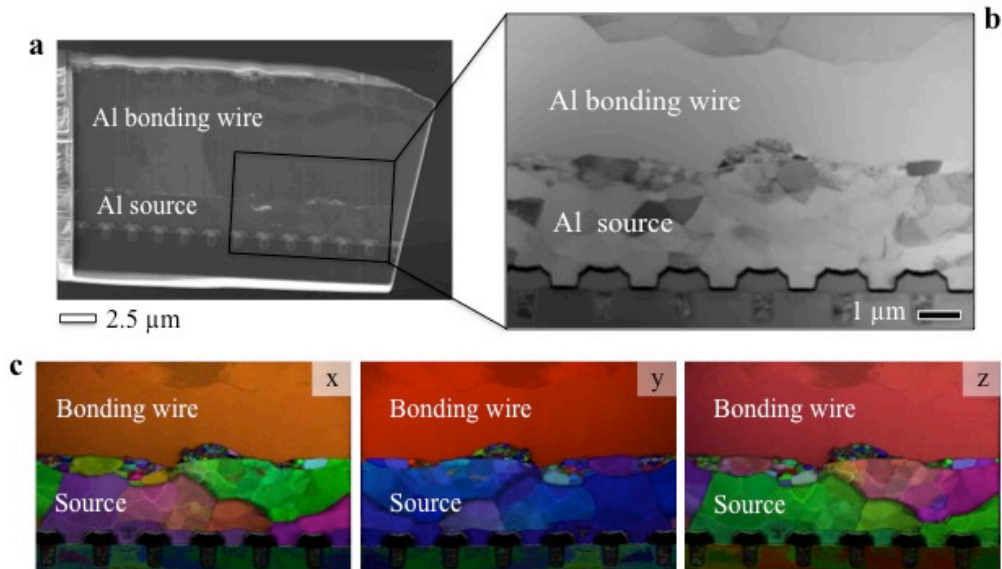
Fig. 7. (a) SEM image of a FIB-prepared lamella from an as-is module and (b) TEM detail of the wire-metal interface, with (c) the relative ACOM orientation maps.

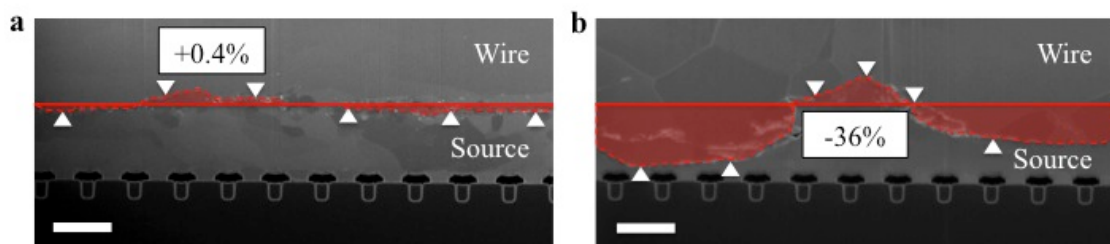
This measurement method takes in account the fact that the initial deformation is not uniform along the wire-metallization interface, that the interface is not straight, and that extrusion or compression of the metallization occurs during the bonding process. We can clearly see it in Fig. 10, showing two closed cross-sections of the Al metallization under the same bonding wire: in the first one (Fig. 10a) the wire-metal interface is almost straight without deformation, whereas in the second one (Fig. 10b) a severe plastic deformation significantly changes the interface profile, provoking a thinning of the metallization on the sides of the micrograph and a bulging in the middle. In the measured areas, the maximum deformation peaks to about 36%, both in depression or extrusion. Average deformation is about 10%, no matter the direction of deformation.

Fig. 10. FIB images of the wire-metallization interface in two closed areas under the same bonding wire. The images refer to a non-aged module. Scale bar $2.5 \mu m$.

The bonding between the metallization and the wire is characterized by initial imperfections, visible in white contrast in fig. 10 and 11a. Fig. 12 shows the EELS spectra from the wire (in blue), the metallization (in green) and the wire-metallization interface (in red). The spectrum at the wire-metallization interface reveals the presence of oxygen, proving that the initial imperfections are linked to the presence of Al oxide. The most probable explanation for this presence is that this native oxide is not fully broken during the bonding process.

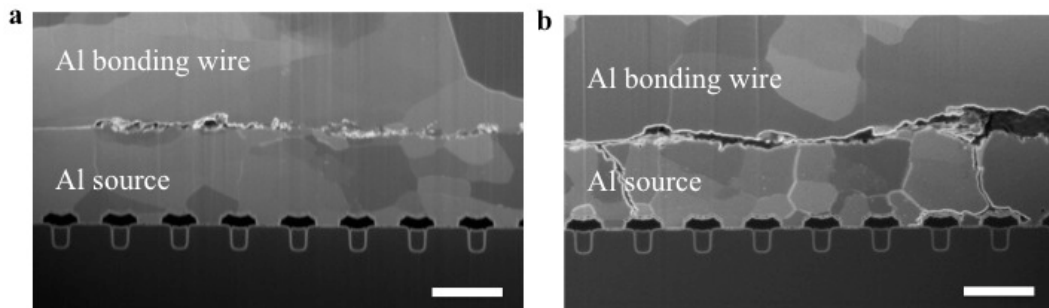
Fig. 11. FIB images of the wire-metallization interface in (a) an as-processed module and in (b) an aged one (at $25 \text{ }^\circ\text{C}$). Scale bar $2.5 \mu m$.

During aging, cracks propagate along these imperfections (Fig. 11b), causing a reduced contact between the wire and the metallization or, at worst, the wire lift-off. Cracks also run perpendicularly to the interface under the wires, as in the metallization away from the bonding area.

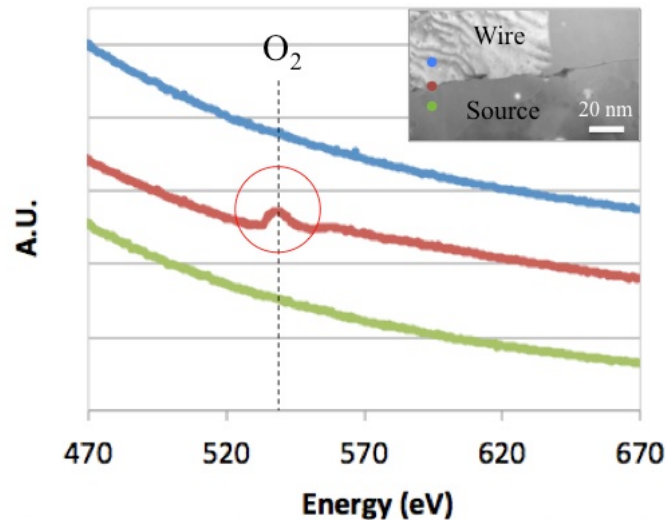
Fig. 12. EELS spectra from the wire (in blue), the metallization (in green) and the wire-metallization interface (in red). The red spectrum at the wire-metallization interface reveals the presence of oxygen.

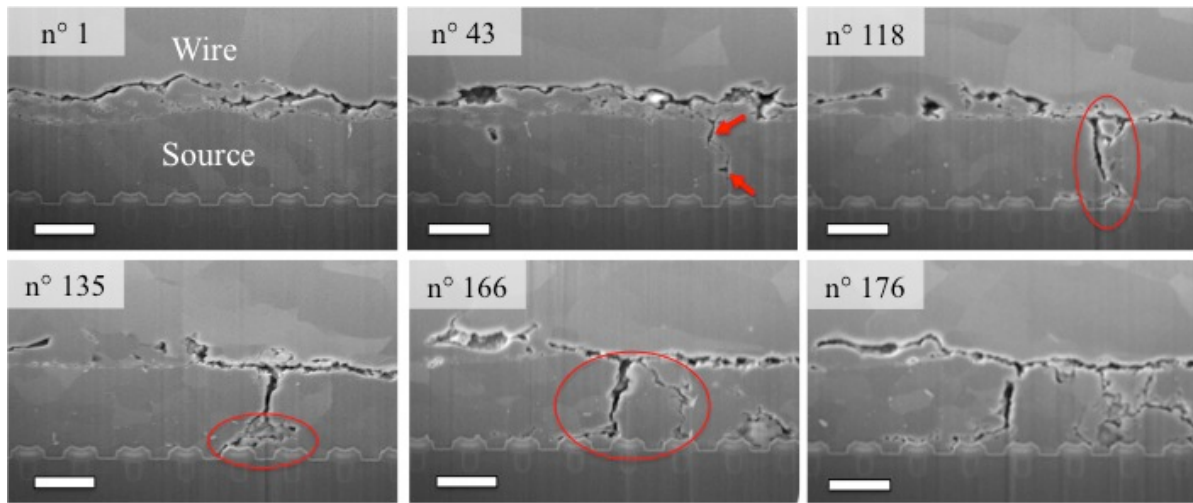
Crack propagation upon aging is investigated by FIB-tomography experiments. In Fig. 13, a series of six (non consecutive) SEM images from the wire-metallization interface of a 70 °C aged module are shown. In the analyzed area, the contact between the wire and the metallization is severely affected by the electro-thermal aging (image n° 1). A measure of the horizontal delamination surface using the complete stack of tomographic SEM sections leads to a delamination ratio of 78% over the tested volume. If we assume that about 33% of the wire was attached to the metallization (see paragraph 3.2), then delamination affected another 10% of the expected contact during aging. Of course, the volume tested by FIB is too small to make robust statistics, but we have gathered convergent observations showing that a significant delamination occurs between the wire and the metallization it's attached to. Going through the metallization volume, one can note some cavities appear (image n° 43) and subsequently constitute a single crack running from the bond interface to the transistor area (image n° 118). This crack splits in two new cracks (images n° 135 and 166) that propagate in the Al metallization (image n° 176). The high density of metal breaks revealed by the tomography stack can explain the increase of the R_{dson} , which implies that subsequent electrical pulses will generate more heat, thus more deformation, and crack propagation.

Fig. 13. Selection of six non consecutive SEM images from the data stack of the wire-metallization interface of a 70 °C aged device (slicing distance 50 nm). Scale bar 2.5 μm .

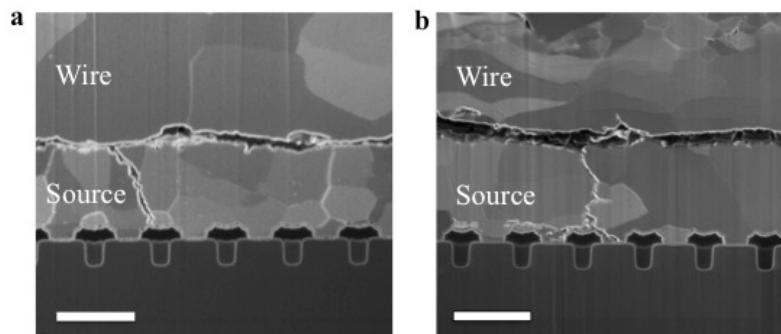
The same aging mechanisms are observed in devices tested at 25 °C and 70 °C. Fig. 14 shows the comparison between two cross-section images of a 25 °C and 70 °C aged metallization under the bonding contact. In both cases, cracks propagate horizontally along the wire-metallization interface and perpendicularly to the surface down to the transistor region. However a higher test temperature can accelerate this behavior, explaining the lower life-time of the components aged at 70 °C. In these tests, the self passivation of the Al layers are observed as the thickness of the

initial oxide keeps increasing upon aging, which is in agreement with the observation of oxygen content increase in the metallization of diodes undergoing electro-thermal aging [20]. However, contrary to what has been observed by these authors, this growth does not prevent the propagation of cracks.

Fig. 14. FIB images of the wire-metallization interface of a device aged at 25 °C and 70 °C. Scale bar 2.5 μm .
