EXPERIMENTAL ANALYSIS OF FAILURES IN FILLED HOLE COMPRESSION TESTS OF CARBON/EPOXY LAMINATE

Bruno Castanié, Serge Crézé, Jean-Jacques Barrau, Frederic Lachaud,
Laurent Risse

Bruno Castanié, Serge Crézé, Jean-Jacques Barrau, Frederic Lachaud, Laurent Risse. EXPERIMENTAL ANALYSIS OF FAILURES IN FILLED HOLE COMPRESSION TESTS OF CARBON/EPOXY LAMINATE. *Composite Structures*, 2010, 92 (5), pp.1192-1199. hal-02048231

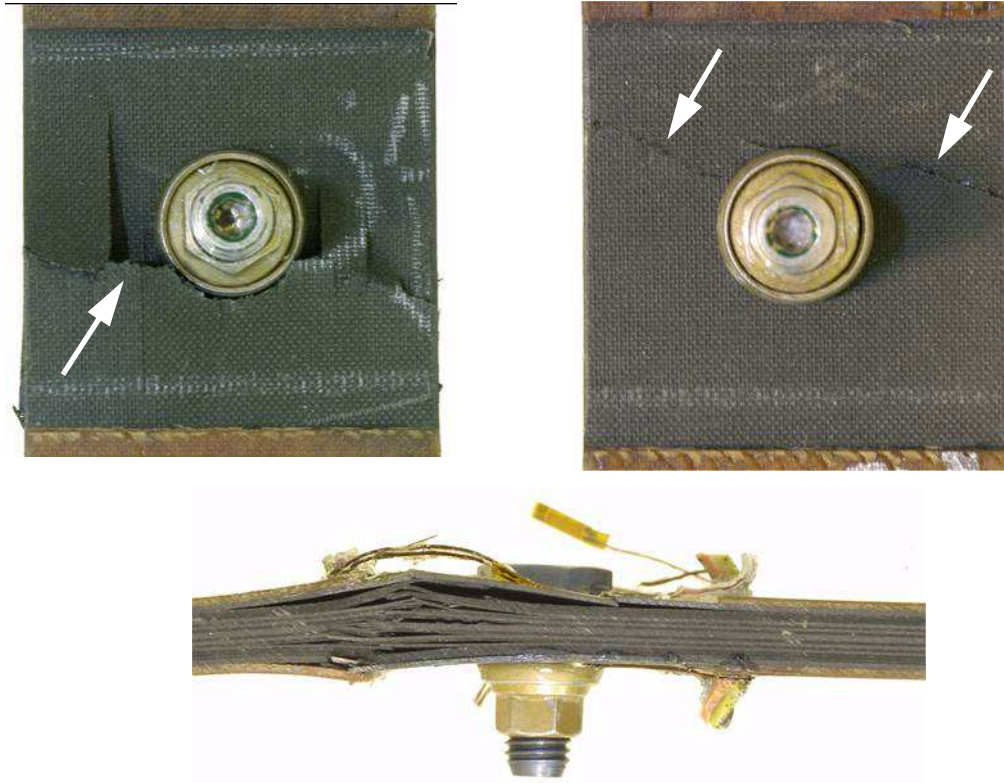
Sample of failures patterns for [10/4/4/2] specimens are shown Figure N° 7 (tightened bolt)

and Figure N° 8 (no lateral constraint). Several failure modes are superimposed with net section compression failure and cleavage. On the edges of the specimens, delamination are also observed. Generally speaking, the pattern is different between the kind of specimen and one can assume that the failure scenario is different. Sample of failures patterns for [2/4/4/10] specimens are shown Figure N° 9. Unlike the previous tests, it is not necessary to make a difference between tightened or not specimens. For all the specimens, fracture lines are clearly visible in the net section (Specimen A) or in off-set sections (specimens B and C). Nevertheless, for tightened specimens the fracture line is always tangent to the bolt. On the edges of the specimens, delaminations are also visible (Specimen C). The different fracture line patterns are summarized in Figure N° 10.

Figure N°7: Post-mortem failure patterns of [10/4/ 4/2] specimens with tightened bolts.

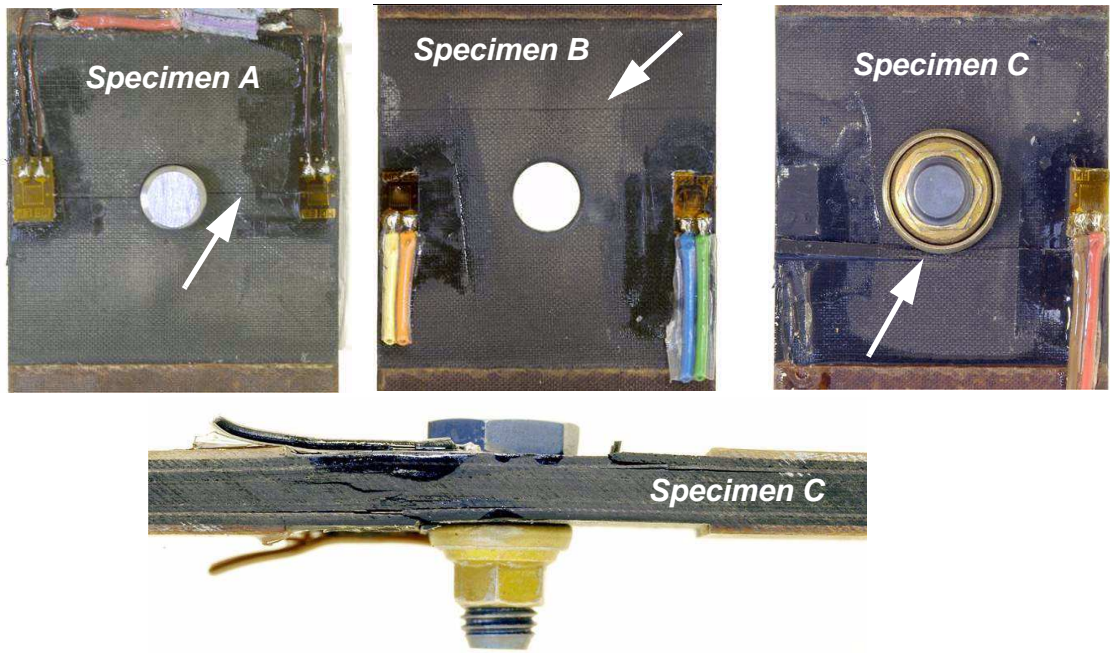
Figure N°9: Post-mortem failure patterns of [2/4/4/10] specimens A,B and C.

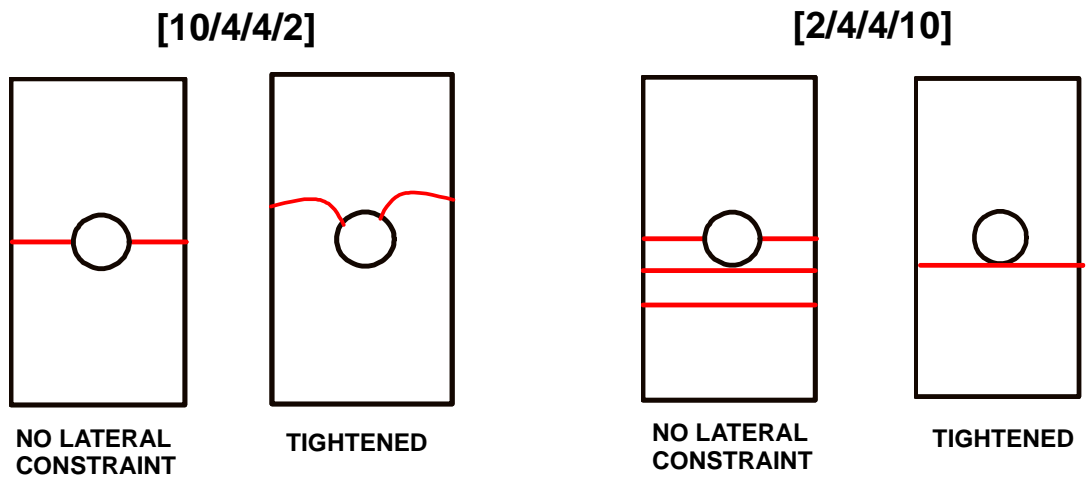
For specimens with no lateral constraint, the wave depends on the delamination which initiates randomly along the edge of the specimen. Thus the tip of the wave can be located anywhere, even in the net section as described Figure N° 10. So for this configuration, the off-set failures cannot be attributed to bearing by-pass failures, as in reference [2]. The off-set failures are due to a specimen effect. It is noticeable that the same scenario was identified for off-axis specimens. A delamination initiates in the edges of the specimens and a local buckling occurs afterwards generating off-axis and off-set fracture lines.

Figure N°10: Fracture line locations.

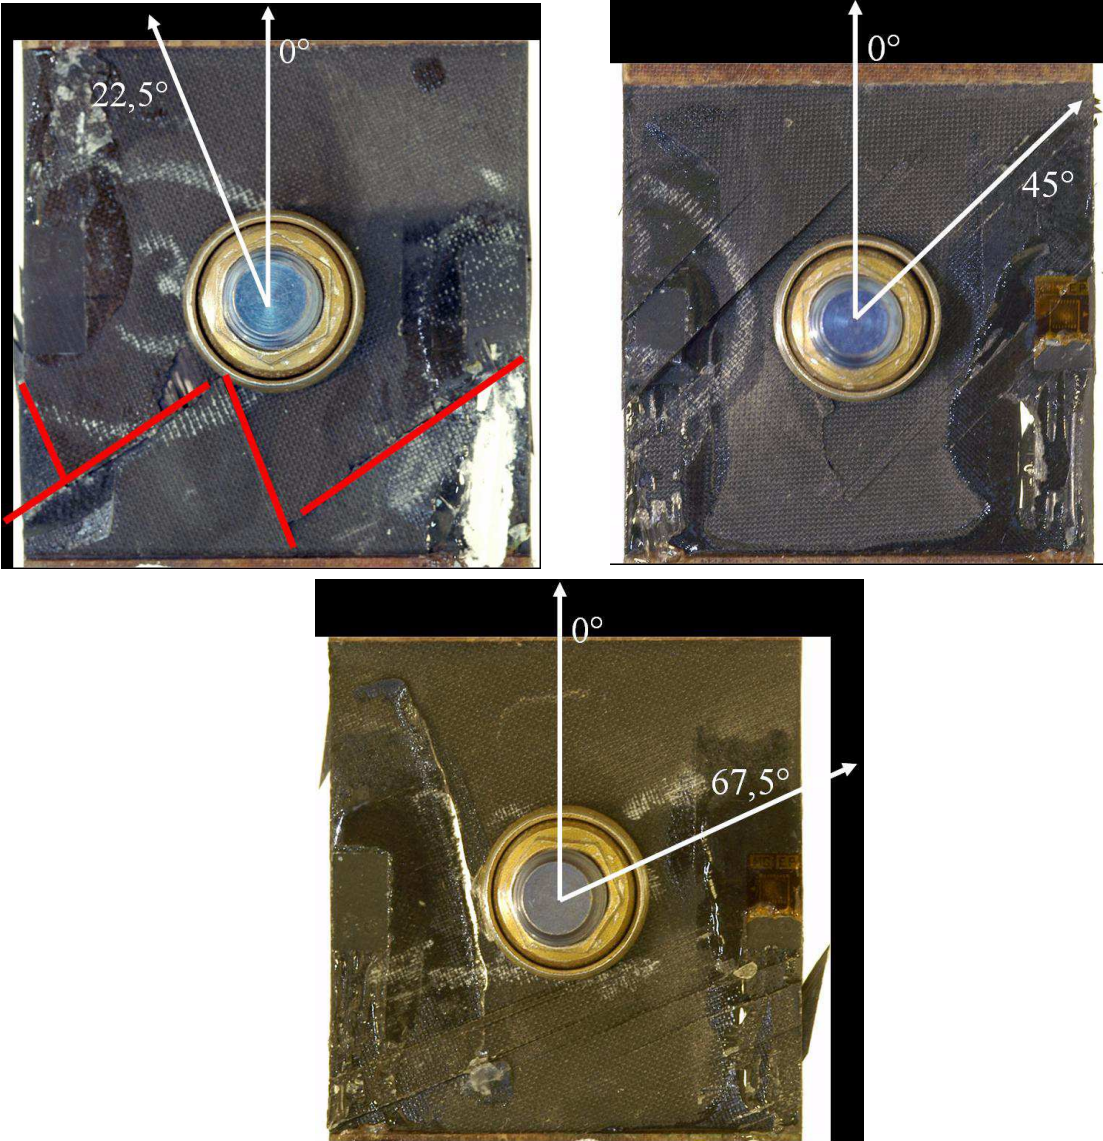
The failure patterns for the off-axis specimen are showed Figure N° 11. The fracture lines follow the main direction of the axis and are not located in the net section. For this original failure pattern, one can speak of "generalized off-set failure".

Figure N°11: Failure pattern of off-axis specimens .

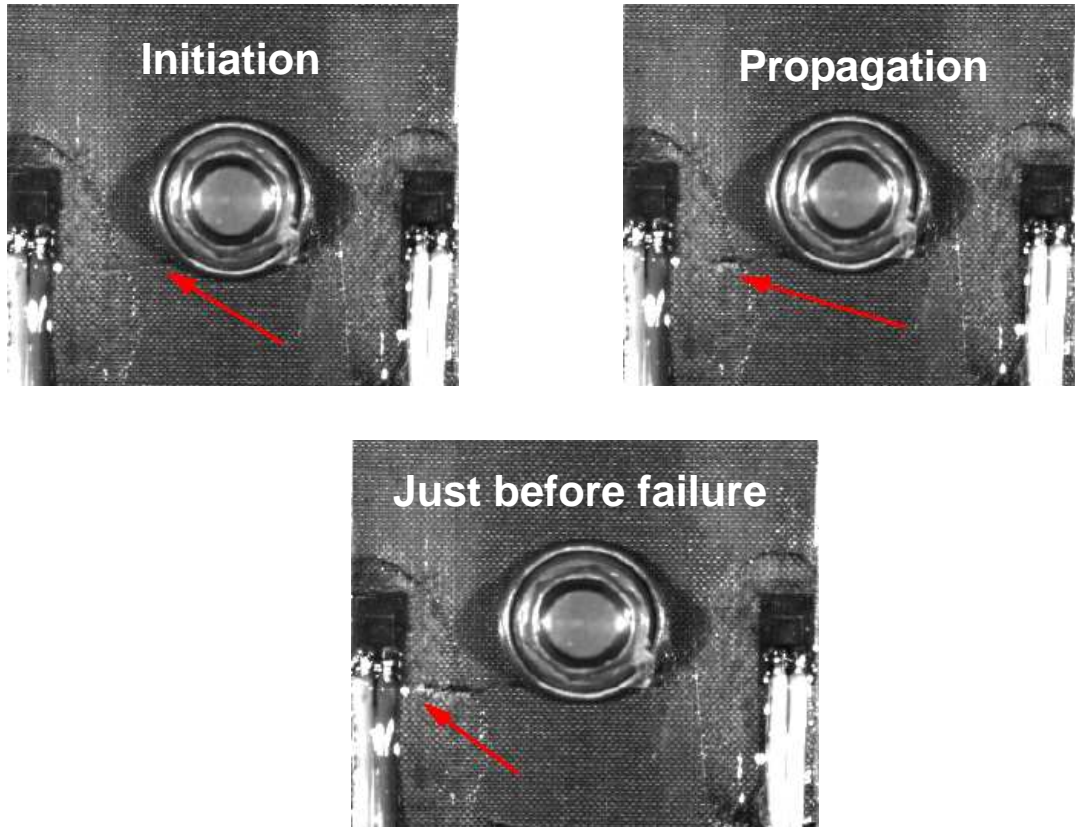
When tested, all the specimen failed in an explosive way and no difference could be visually observed. However, using high speed camera, different failure sequences and speeds were recorded: from 1/100th to 1/10000th second. The three pictures of Figure N° 12 show the failure sequence in a [10/4/4/2] specimen with a tightened bolt. The crack initiates at the periphery of the bolt for all the specimens with a little off-set from the net section. It then propagates relatively slowly (within several 1/1000th second) to the edge of the specimen.

Figure N°12: Failure of a [10/4/4/2] specimen with a tightened bolt.

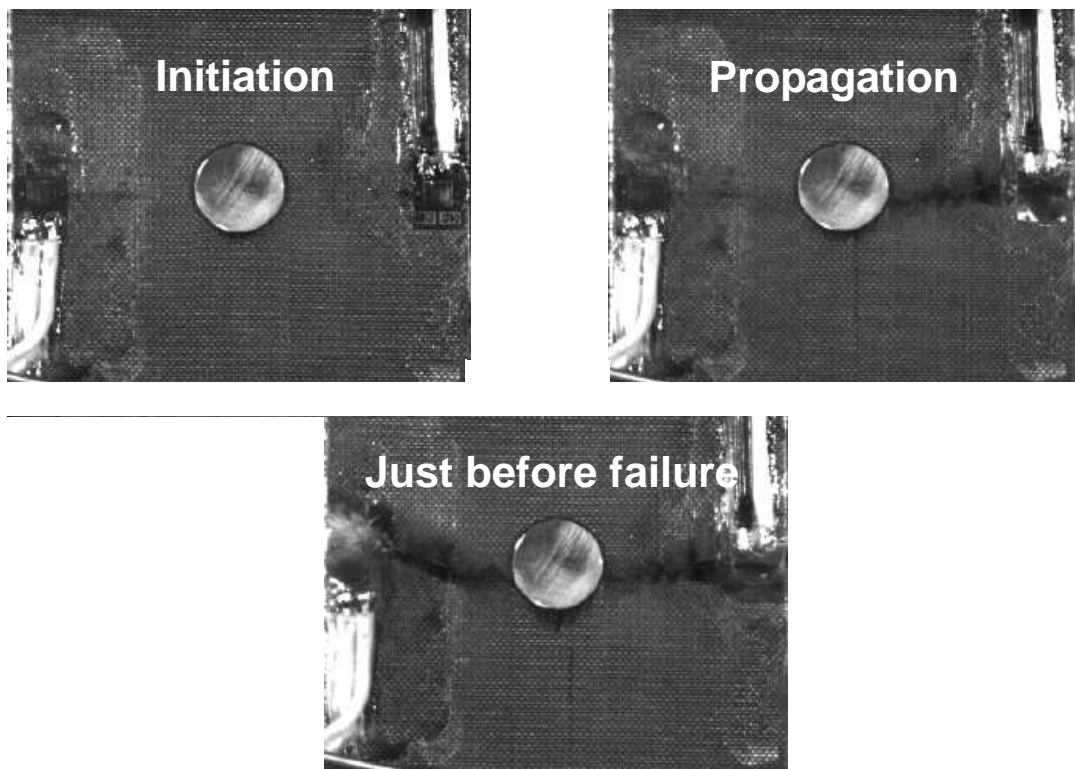
The three pictures of Figure N° 13 show the crack propagation of a [10/4/4/2] specimen with no lateral constraint. The crack initiates in the net section near the bolt and propagates in an explosive way. Therefore, the three pictures were taken every 1/10000th second. For both cases, the final failure mode is a static failure of the upper ply oriented at 0°. However, the presence of the nut has however an effect on the location of the initiation of the crack. As the failure seems to be a pure static failure, the bearing stresses and the delaminations may not have any influence. So the tightening modifies the local triaxial stress concentration and load transfer between the hole and the bolt and can explain the difference observed in the failure

Figure N°13: Failure of a [10/4/4/2] specimen with no lateral constraint.

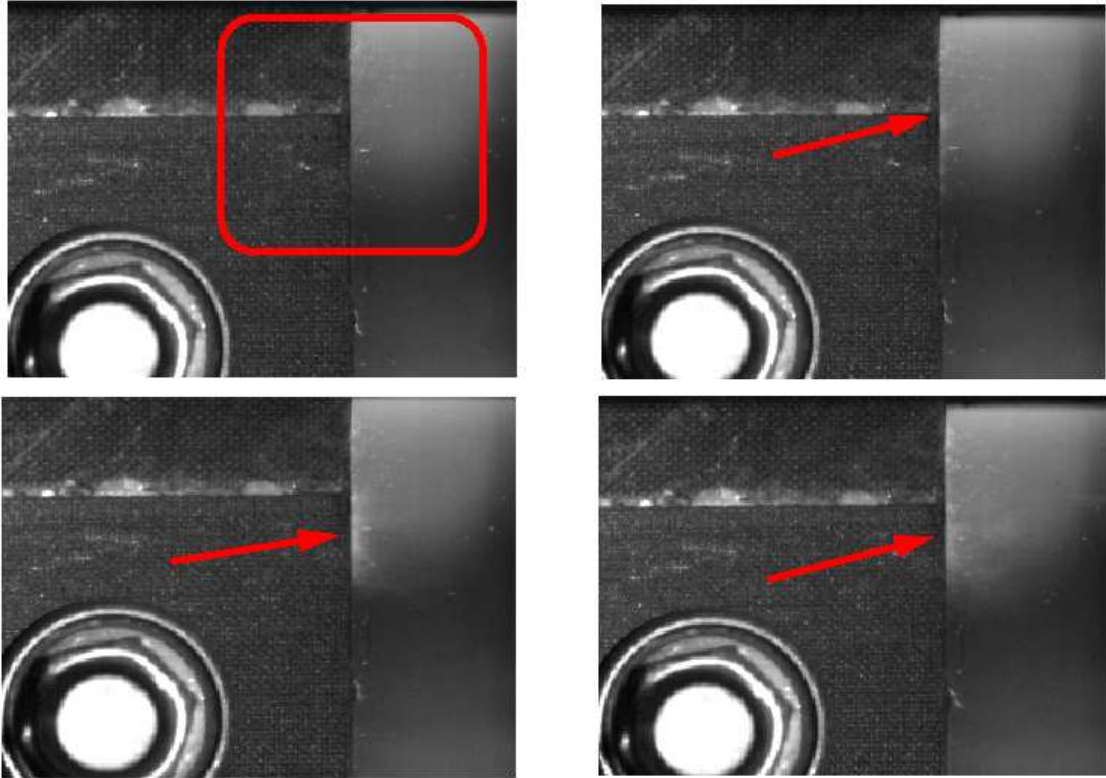
In the sequence of pictures given Figure N° 14, a phenomenon of material ejection is showed. It is localized in the edge of a [2/4/4/10] stacking specimen. This phenomenon was observed only for this stacking and for all the configuration of bolts. The four pictures were taken every 1/10000th second, so it is nearly explosive. Moreover, the location of the ejection was never in the net section. It occurs prior to any apparent damage and nothing was detected on the load/displacement curves. In order to identify the mechanisms, some mirrors were installed as described in paragraph 2 and Figure N° 5.

Figure N° 14: Material ejection phenomenon of [2/4/ 4/10] stacking specimen.

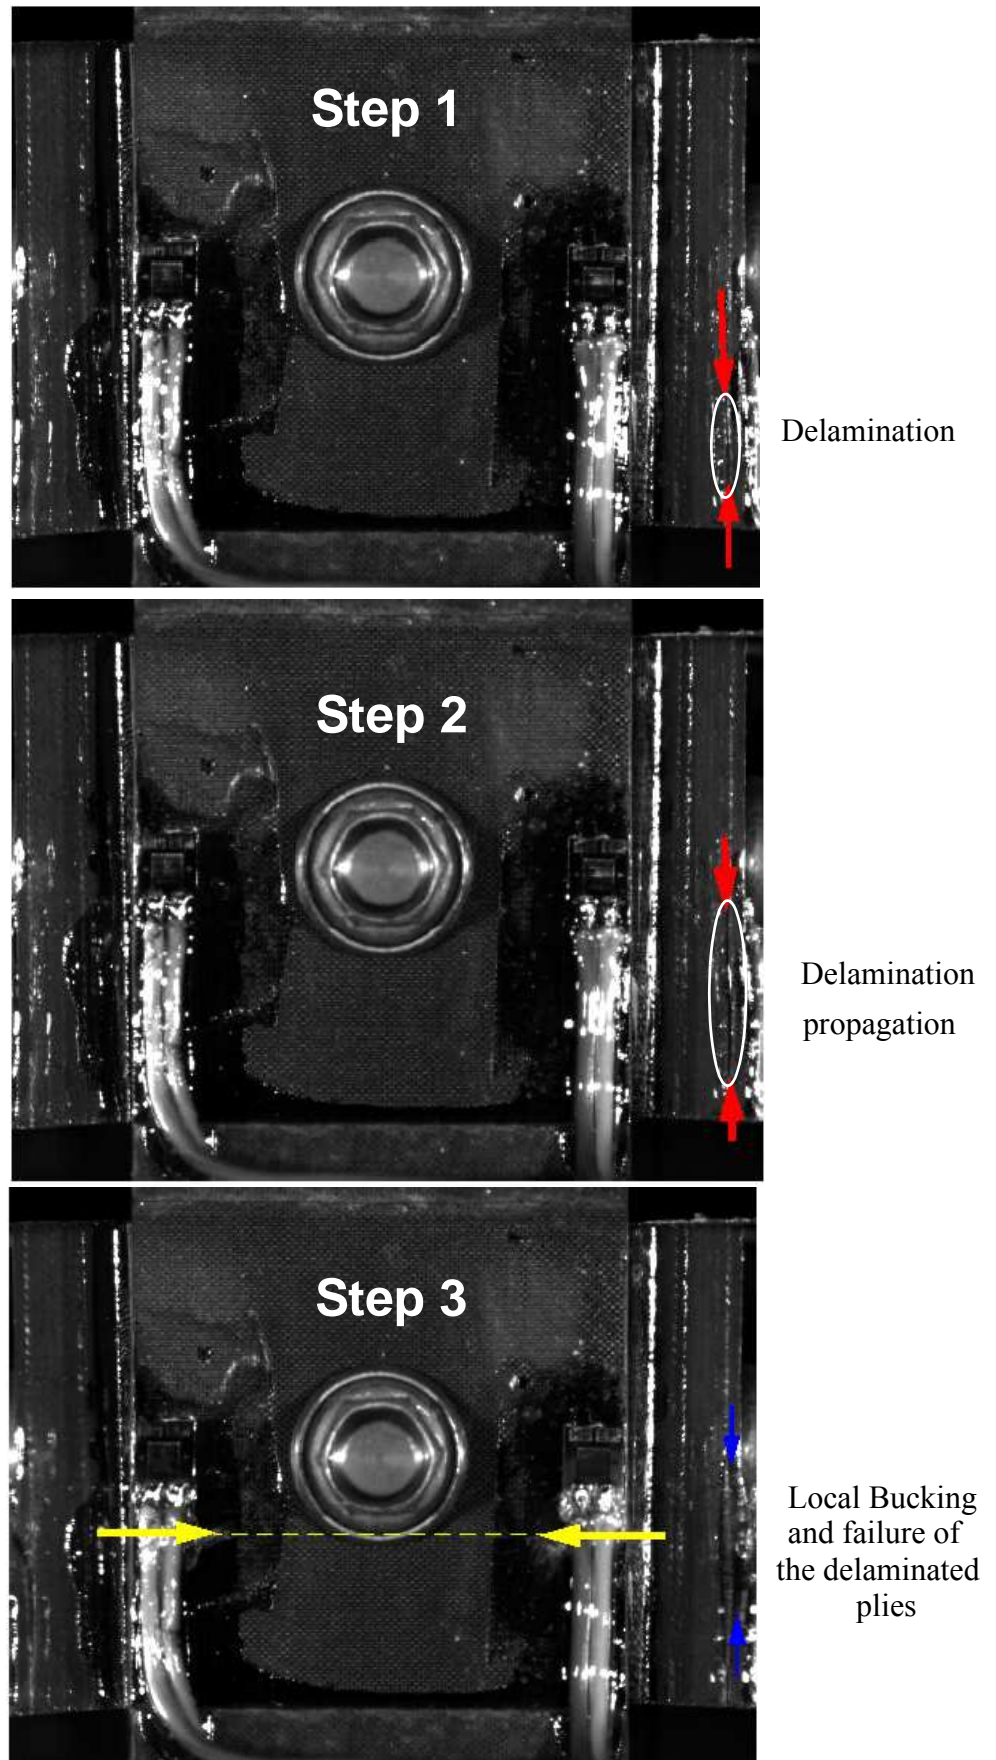
In the sequence of pictures given Figure N° 15, the failure scenario for [2/4/4/10] specimen is showed. Thanks to the mirror, the apparition of a delamination in the edge can be observed (Step 1). Clearly, interlaminar normal and shear stresses occurring in the region near the free edge due to high stress gradients can cause this delamination [18]. Moreover, this observation is consistent with the previous phenomenon of material ejection which seems to correspond to the onset of delamination (Figure N° 14). Afterwards, the delamination propagates relatively slowly (Step 2). The sequence takes about 1/100th second. When the delamination area is large enough, a local buckling of the upper plies occurs (Step 3), and a net failure at the tip of the wave happens immediately (Step 3). It is this fracture line which can be observed in the post-mortem pattern (Figure N° 9 and Figure N° 10). This scenario explains the fact that due to a tightened bolt, the buckling wave is always located at the same place. Thus, the stress concentration occurs at the periphery of the bolt and the fracture line initiates only at this place.

Figure N°15: Failure scenario for [2/4/4/10] stacking specimens.
