Crack arrest capabilities of AA2024 and AA7175 aluminum alloys under impact loading

Gunasilan Manar, Patrice Longère

Gunasilan Manar, Patrice Longère. Crack arrest capabilities of AA2024 and AA7175 aluminum alloys under impact loading. *Engineering Failure Analysis*, 2019, 10.1016/j.engfailanal.2019.06.075 . hal-02164321

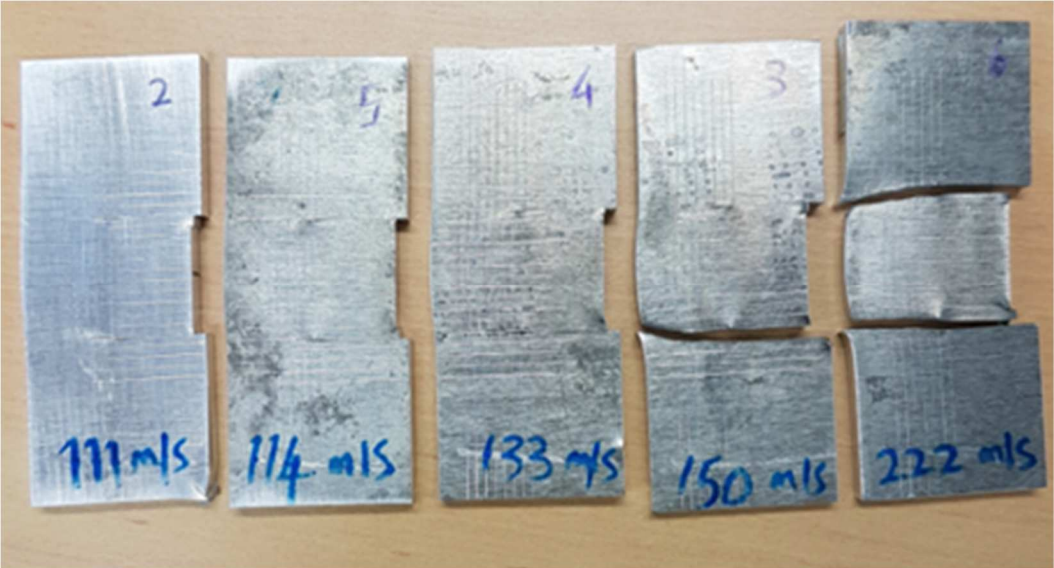
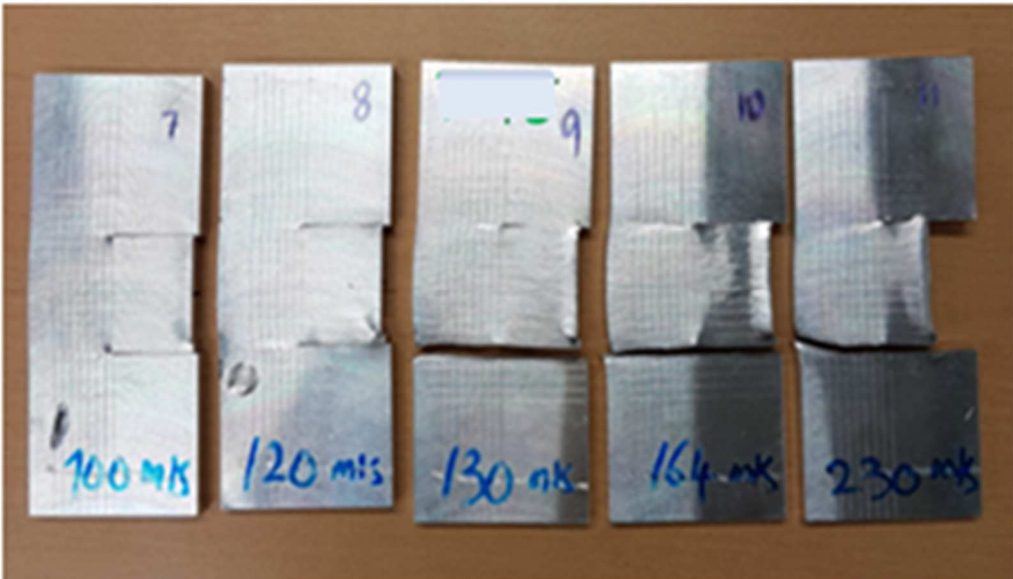
Fig.11 : Post-mortem specimens after impact at various speeds

For both alloys, the different types of damage involved by the projectile impact speed are reported in Tables 3 and 4 in terms of speed and speed range, respectively. In the range from 100 to 120 m.s⁻¹, no significant damage is observed for both alloys. For the range of 121 to 140 m.s⁻¹ AA 7175 is subject to partial fracture. For the range of 141 to 160 m.s⁻¹ and 161 to 180 m.s⁻¹ both alloys are subject to partial fracture. For the range of 181 to 230 m.s⁻¹, AA 2124 was fully fractured at upper and lower notches whereas AA 7175 was only partially fractured.

For AA2024, at impact speed of 111 m.s⁻¹, 114 m.s⁻¹ and 133m.s⁻¹, the crack arrests inside the structure. From 150m.s⁻¹, the specimen is split in two or three parts.

For AA7175 the crack propagates and arrests inside the structure at impact speed of 100 m.s⁻¹ and 120 m.s⁻¹. At impact speed of 130 m.s⁻¹ the plate fully fractures.

The critical impact speed at complete fracture is higher for AA2024 (close to 150 m.s⁻¹) and lower for AA7175 (close to 130 m.s⁻¹).

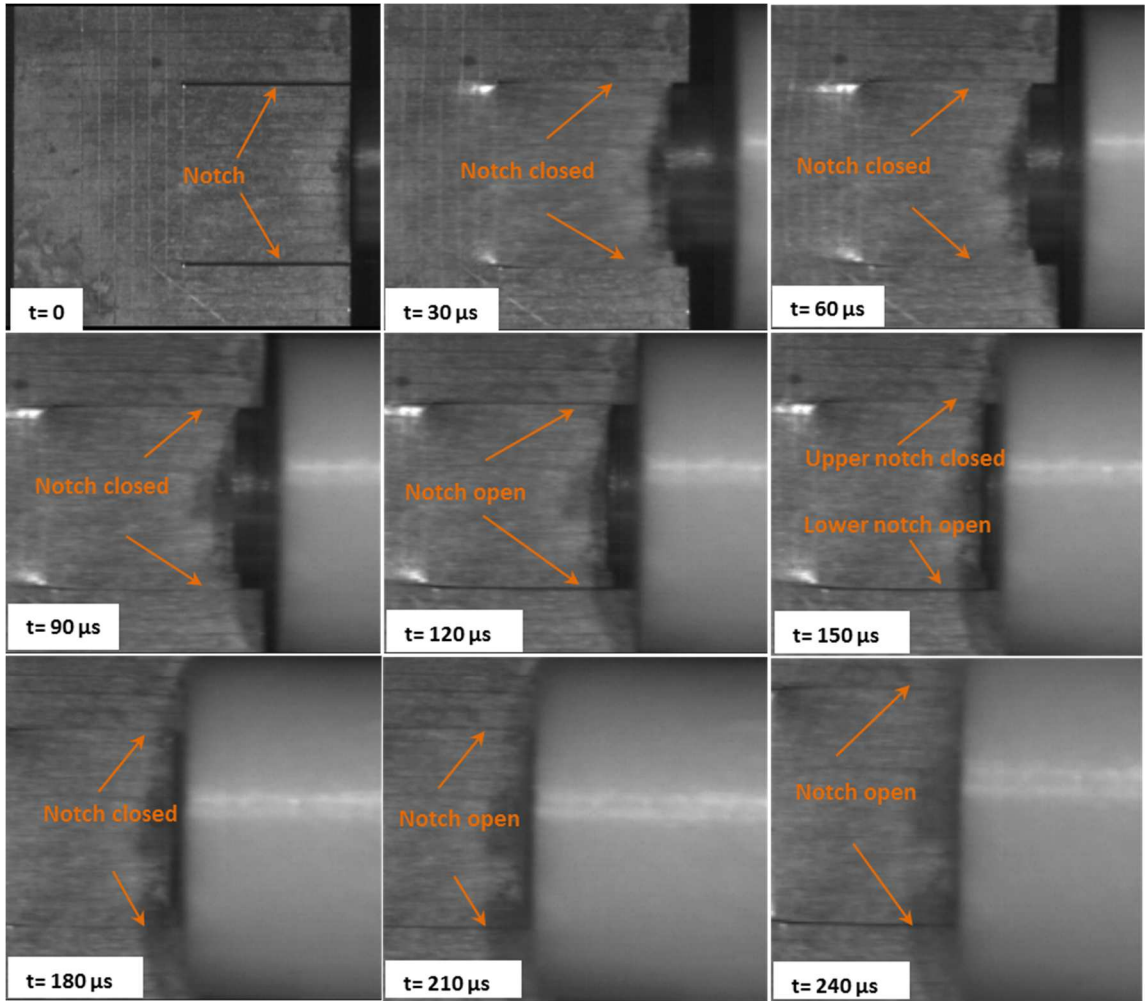
Fig.12 : Kinematics of the plate-specimen interaction. AA2024 - 114 m.s^{-1}

- between $t=0$ and $t=30\mu\text{s}$: a compression wave propagates throughout the part of the plate impacted by the projectile leading to the formation of a shear wave at both notch tips; notches are open and cracks initiate symmetrically (i) from the upper part of lower notch tip and (ii) from the lower part of upper notch tip.

- between $t=30\mu\text{s}$ and $t=120\mu\text{s}$: due to Poisson-like effect the compression of the part of the plate impacted by the projectile leads progressively to the closure of the gap between notch lips; for the upper notch, the lower lip thus hits the upper lip yielding the propagation of a compression wave in the part of the plate above the upper notch; the compression wave propagates towards the upper free edge of the plate; the symmetric phenomenon occurs for the lower notch; meanwhile, cracks initiated from the notch tips slightly propagate under predominant shear Mode II, i.e. along a direction close to the notch direction.

- between $120\mu\text{s}$ and $t=150\mu\text{s}$: the gap closure-induced compression waves reflecting from upper and lower free edges of the plate in the form of tension waves cause a re-opening of the gap between notch lips and tension stresses on crack lips; cracks propagate or arrest under combined shear Mode II and opening Mode I.

- beyond $t=150\mu\text{s}$: notches undergo cyclic gap closures and openings as cracks undergo cyclic compression and tension superposed on shear.

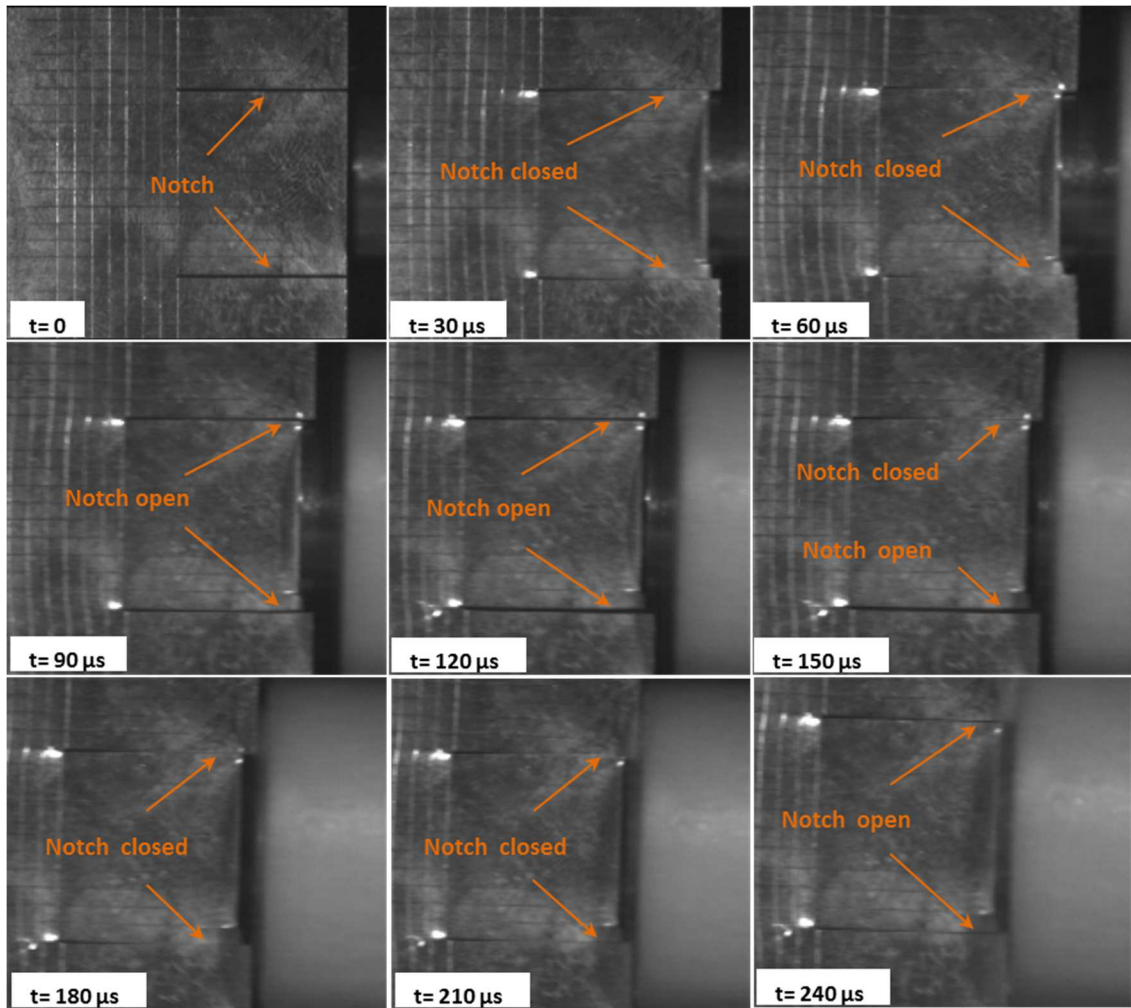
Fig.13 : Kinematics of the plate-specimen interaction. AA7175 - 100 m.s^{-1}

The same scenario, which is depicted in Fig.14, is observed in Fig.13 for AA7175. Fig.14(a) schematically depicts the projectile and plate before interaction. In Fig.14(b), it is shown that compression wave was generated inside the impacted part of the plate. This compression wave was transformed into a predominant shear wave at the notch tip. Due to Poisson effect-induced gap closure, a compression wave is generated which reflects as tension wave from the free edge of the plate, see Fig.14(c) [5].

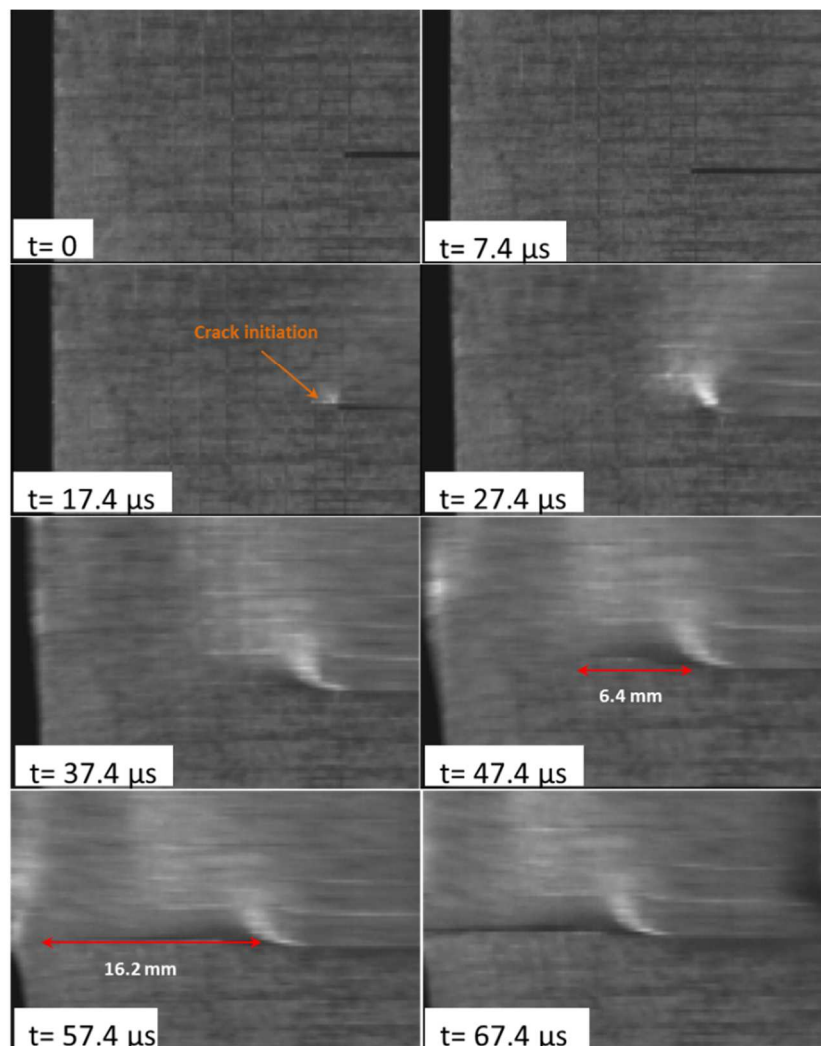
Fig.15 : Lower part of the AA 2024 plate during impact at 222 m.s^{-1}

Fig.15 depicts the chronology for AA2024 plate at impact speed of 222 m.s^{-1} with one frame every $10 \mu\text{s}$. The following steps can be observed:

- between $t=0$ and $t=17.4\mu\text{s}$: a compression wave propagates throughout the part of the plate impacted by the projectile leading to the formation of a shear wave at the notch tips; the crack initiates.
- between $t=17.4 \mu\text{s}$ and $t=37.4\mu\text{s}$: due to Poisson-like effect the compression of the part of the plate impacted by the projectile leads progressively to the closure of the gap between notch lips. For the lower notch the upper lip thus hits the lower lip yielding the propagation of a compression wave of the part of the plate above the lower notch; the compression wave propagates towards the lower free edge of the plate.
- between $t=37.4 \mu\text{s}$ to $t=47.4 \mu\text{s}$ the crack propagates and measures 6.4 mm
- the crack reaches the length of 16.2 at $t=57.4 \mu\text{s}$

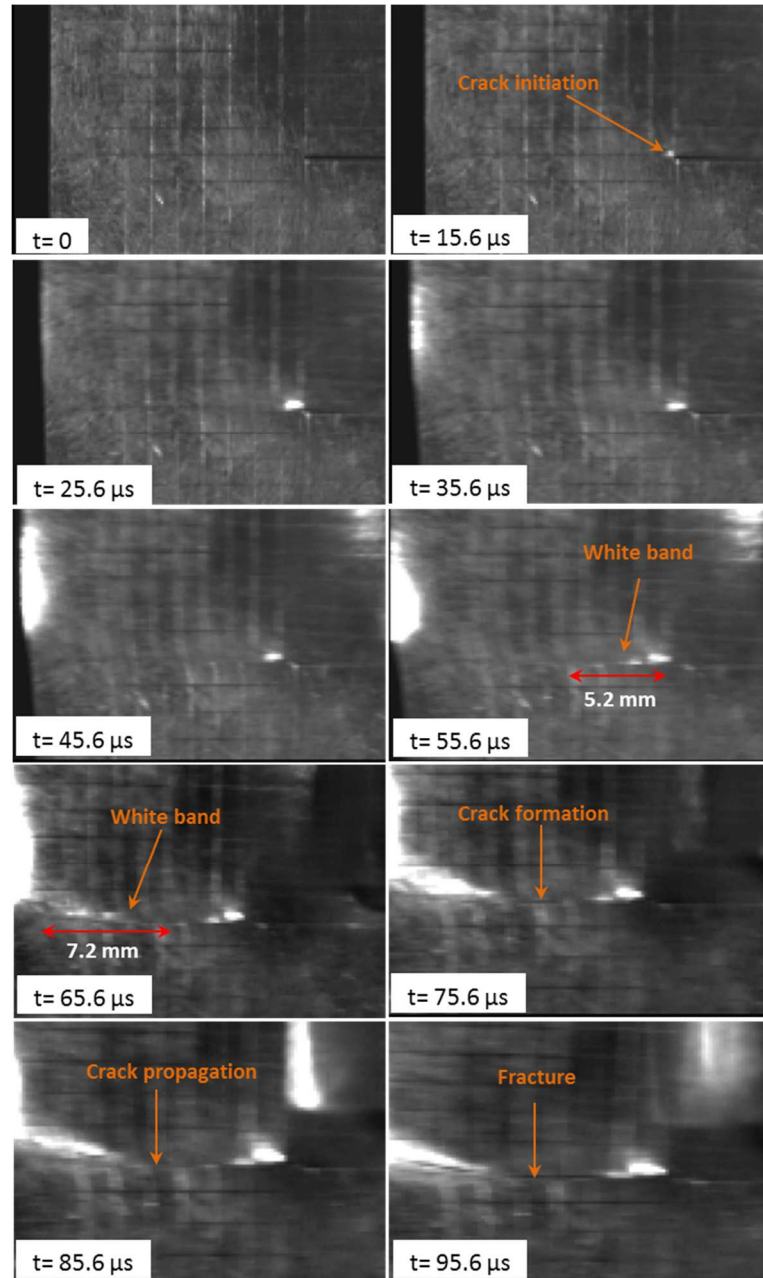
Fig.17 : Lower part of the AA 7175 plate during impact at 230 m.s^{-1}

Fig.17 depicts the chronology for AA7175 plate at impact speed of 230 m.s^{-1} with one frame every $10\mu\text{s}$. The same observation as discussed for AA 2024 in Fig.15 was observed except for the formation of white band as precursor of the crack and which does not exist for AA 2024.

- At $t=55.6\mu\text{s}$ a white band appears at notch tip and propagates about 5.2 mm. This white band further propagates to the left collinearly to the notch direction then with an angle of 15° upwards.
- the length of this white band is about 12.4 mm at $t=65.6\mu\text{s}$.
- between $t=75.6\mu\text{s}$ and $85.6\mu\text{s}$ the crack is indeed propagating but cannot be seen clearly not only due to less resolution but also due to the possible Poisson-like effect where the compression of the part of the plate impacted by the projectile leads progressively to the closure of the gap between notch lips.

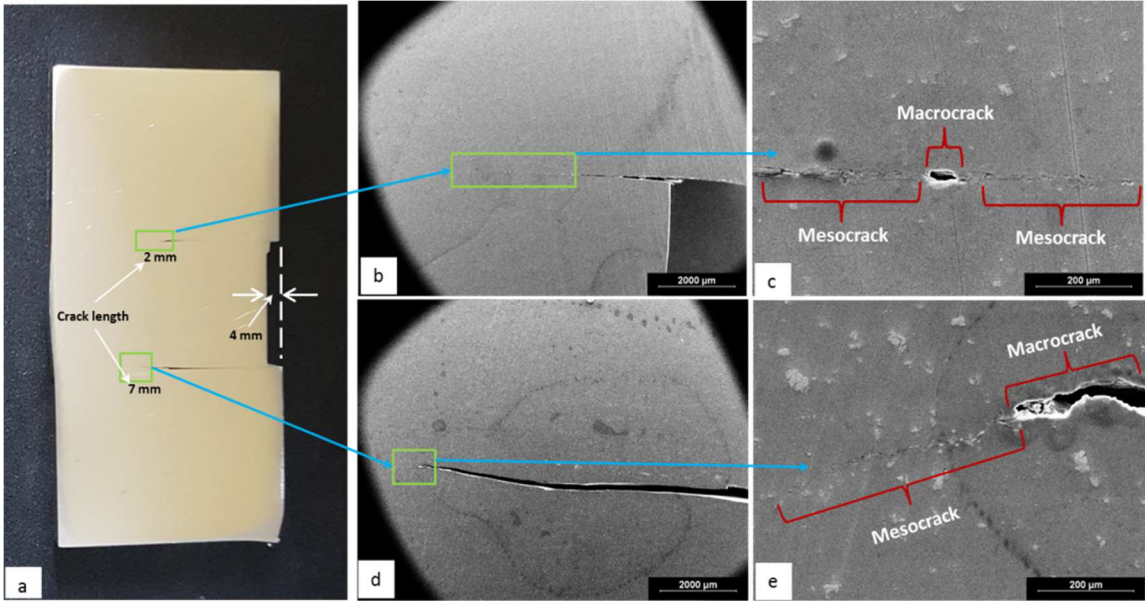
Fig.20 : Post-mortem AA 2024 specimen after impact at 111 m.s⁻¹

For impact speed of 111 m.s⁻¹, lower notch crack is longer than upper notch, see Fig.20 (a-c). Lower notch crack length is 7 mm and upper notch crack length is 2 mm, see Fig.20 (a). The depth of the impacted indentation is about 4 mm, see Fig.20 (a). The cracks are composed of a succession of macro-cracks (in minority) and meso-cracks (in majority), see Fig.20 (c-d).

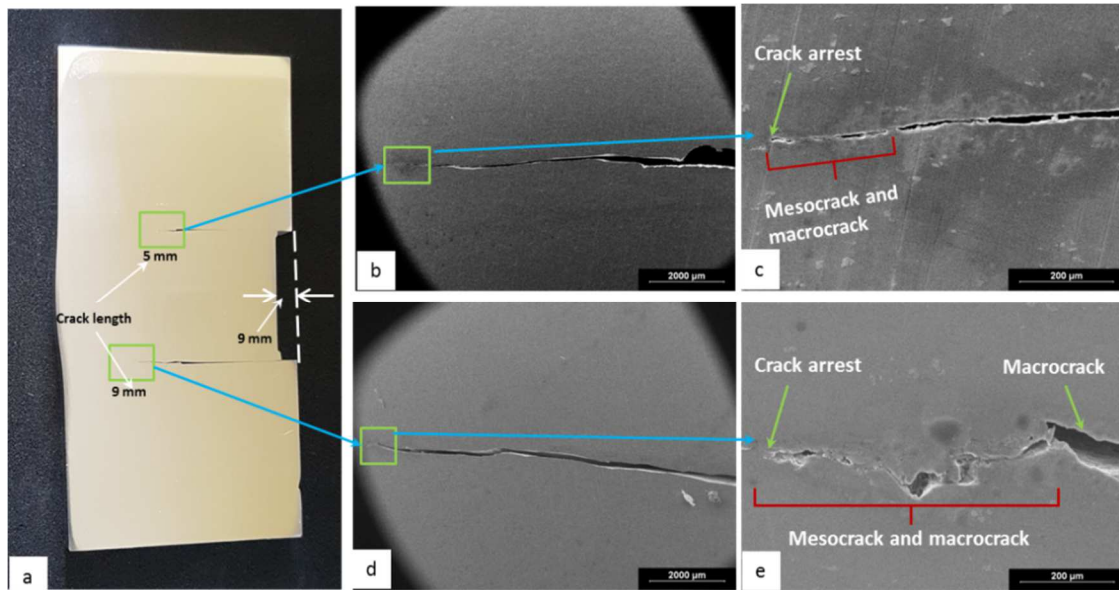
Fig.21 : Post-mortem AA 2024 specimen after impact at 133 m.s^{-1}

For impact speed of 133 m.s⁻¹, upper notch crack and lower notch crack length is 5 mm and 9 mm respectively, see Fig. 3.21 (a-c). Impacted indentation depth is 9 mm, see Fig 3.21 (a). The cracks are composed of a succession of macro-cracks (in majority) and meso-cracks (in minority), see Fig.21 (c-d).

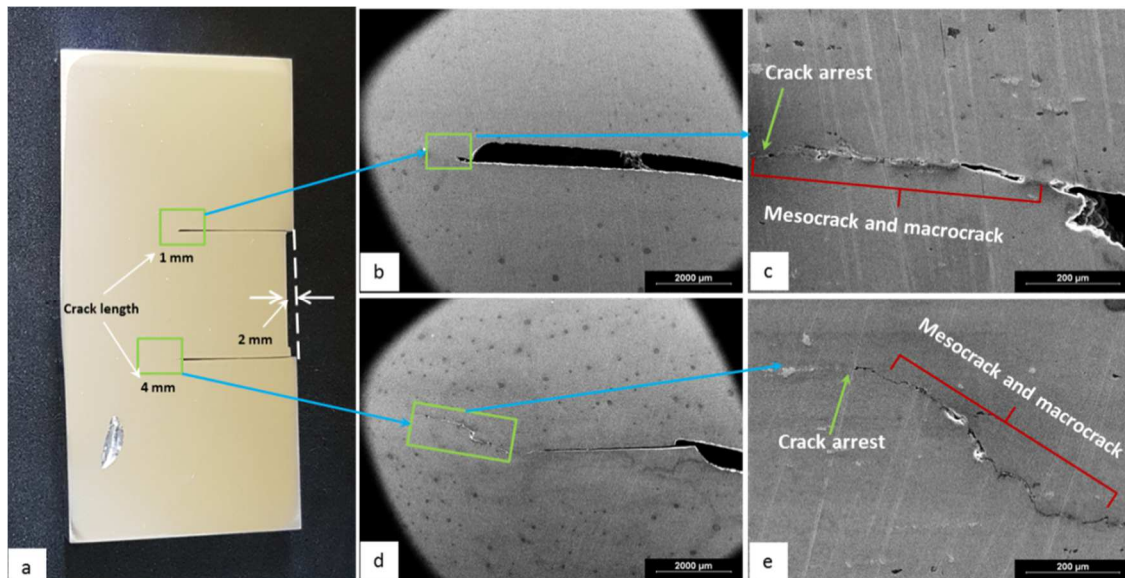
Fig.22 : Post-mortem AA 7175 specimen after impact at 100 m.s^{-1}

Fig.22 shows specimen AA 7175 after impact at speed of 100 m.s^{-1} . Crack lengths of upper and lower notch are 1 mm and 4 mm respectively, see Fig.22 (a). The indentation after impact is 2 mm, see Fig.22 (a). Fig.22 (b) and (c) shows the propagation of the cracks along the notch tip for lower and upper notch respectively. Meso-crack appears along with macro-crack at both notches as shown in Figs.22(c) and (e).

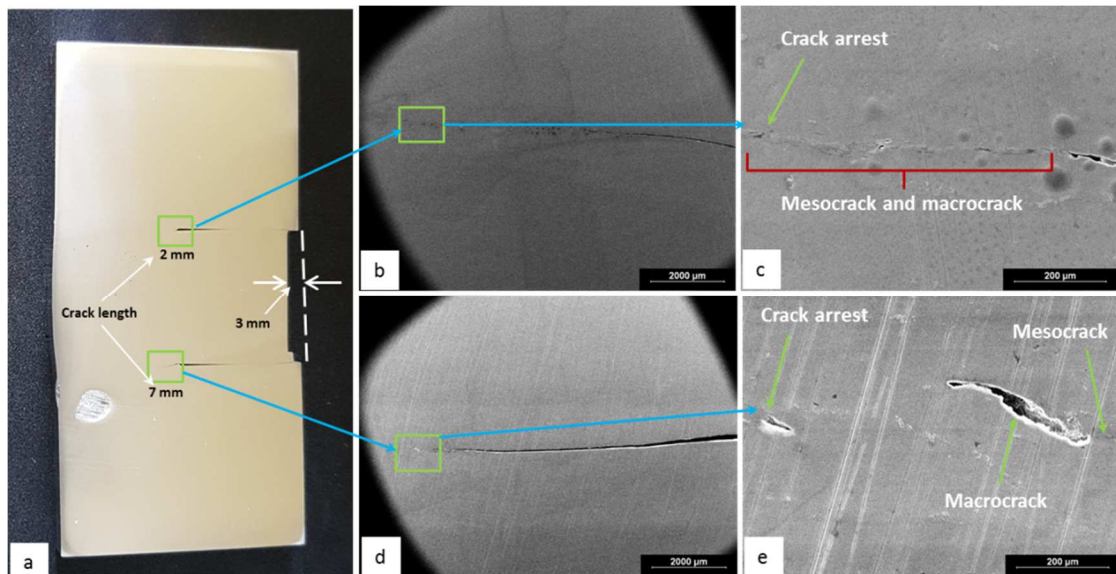
Fig.23 : Post-mortem AA 7175 specimen after impact at 120 m.s^{-1}

Fig.23(a) shows the specimen AA 7175 after impact at speed of 120 m.s^{-1} with crack length for both upper and lower notches of 2 mm and 7 mm respectively. The indentation depth is 3 mm, see Fig.23 (a). Crack propagation is depicted in Fig.23 (b) and (d) for upper and lower notch respectively. There are meso-cracks and macro-cracks appearing in both crack tips, see Fig.23(c) and (e).

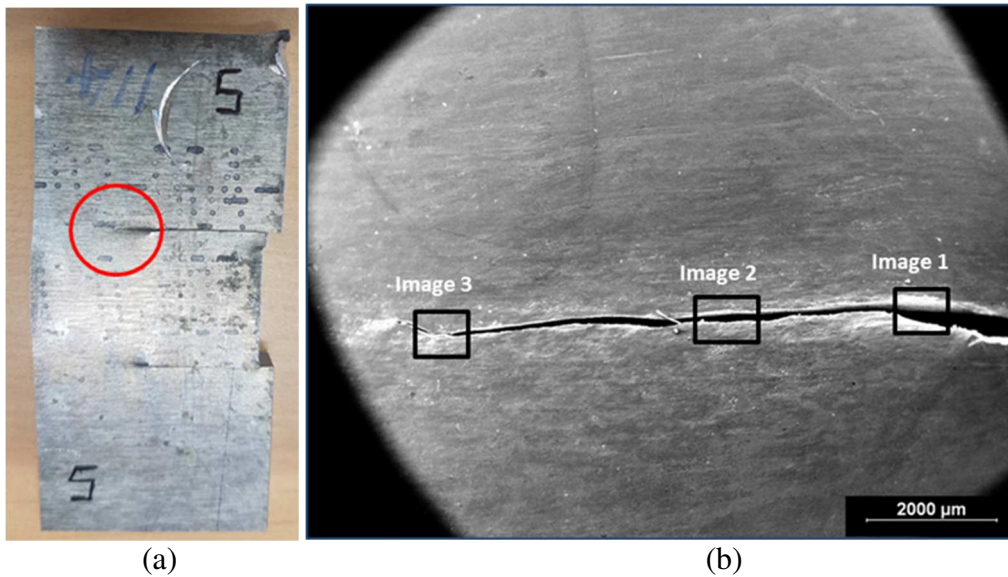
Fig.24 : (a) Post impacted AA 2024 double notch plate at 114m.s^{-1} (b) Macroscopic view of crack after surface polishing

Fig.24(a) shows the crack propagation for AA2024 KW specimen impacted at speed of 114 m.s^{-1} . The upper part of the crack was chosen for analyze because of its longer crack length. Total length of crack is about 7 mm.

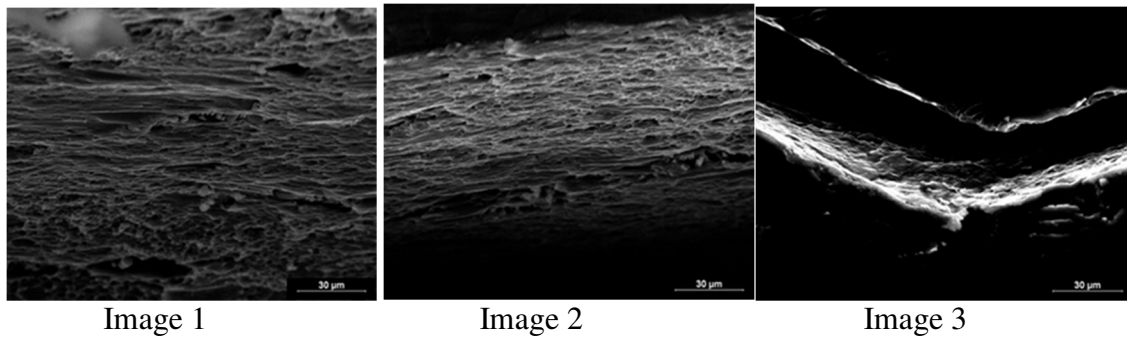
Fig.25 : Microstructure of crack for AA 2024 after impact speed of 114 m.s^{-1}

The crack was analyzed at 3 zones as shown in Fig.24(b). Fig.25 shows the detail of microstructure of the three zones. Image 1, Fig.25 shows that the initiation of crack from the notch tip is characterized by flat shear and elongated dimples. The beginning of crack propagation proceeds by predominant shear Mode II due to the surface is characterized by flat shear and elongated dimple, see image 2, Fig.25. Image 3, Fig.25 shows crack bifurcation characterized by changes in the loading mode. It is worth noting that the crack bifurcates upwards, i.e. according to clockwise rotation. The microstructure inside the bifurcation zone depicts the combination of flat shear and dimple cluster, as a consequence of the combination of tension loading in opening Mode I and shear loading induced Mode II.

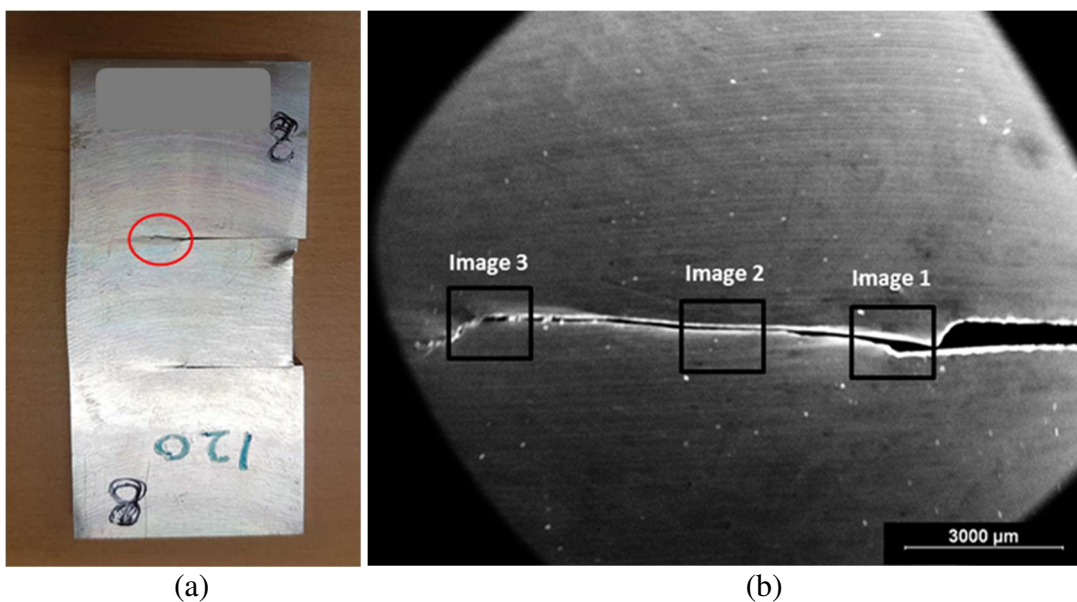
Fig.26 : (a) Post impacted AA 7175 double notch plate at 120 m.s^{-1} (b) Macroscopic view of crack after surface polishing

Fig.26(a) shows the crack arrest inside the AA7175 specimen for the impact speed of 120 m.s^{-1} . Fig.26 (b) shows the macroscopic view of the crack. The total length of the crack is close to 8 mm.

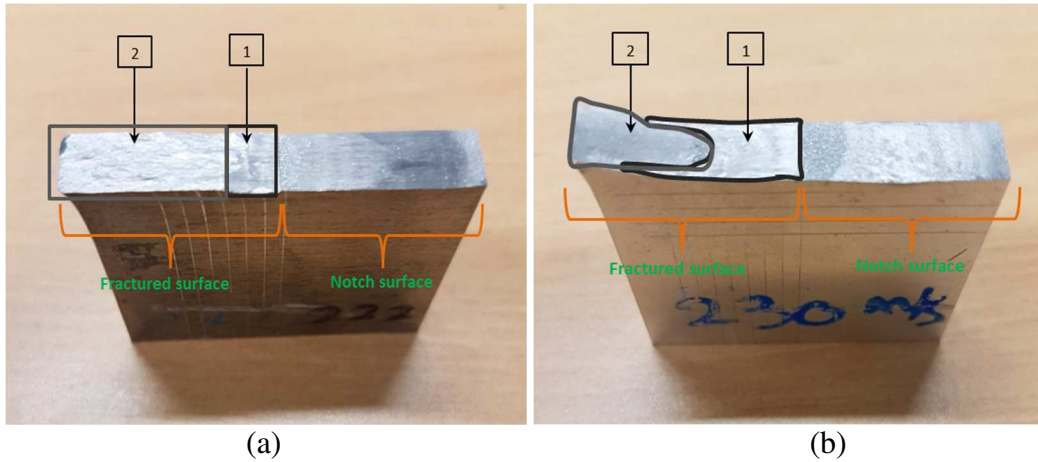
Fig.31 : Fractography of ruptured surface (a) AA2024 at impact speed of 222 m.s⁻¹ (b) AA7175 at impact speed of 230 m.s⁻¹

According to Fig.31 (a) two different fractured zones can be seen. Zone 1 shows the surface at crack initiation and zone 2 shows the crack propagation which leads to full fracture of the structure.

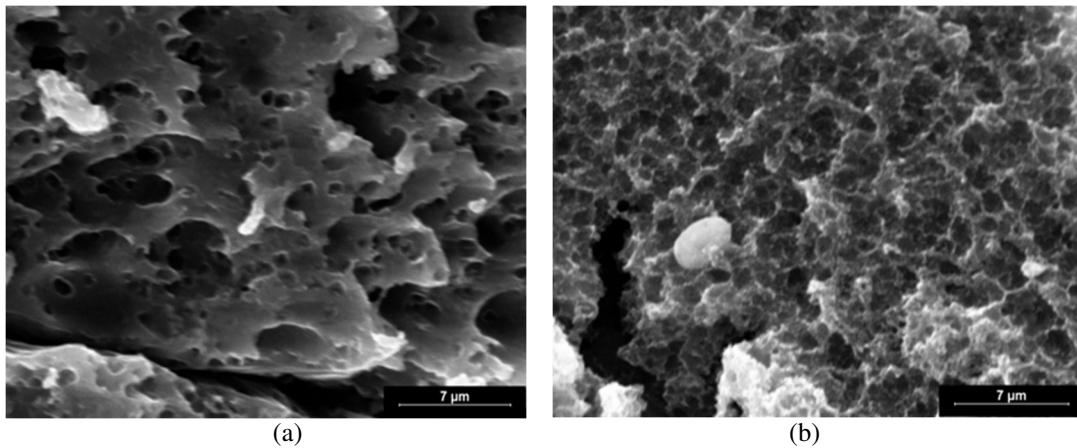
Fig.32 Microstructure view of AA2024 at ruptured surface (a) Flat shear (b) Dimple cluster

Fig.32 shows the microstructure of AA2024 for both zones of ruptures. Microstructural view for AA2024 shows, first zone is flat shear (Mode II) and second zone is opening mode where microstructural view shows a dimple cluster (Mode I) for AA2024.

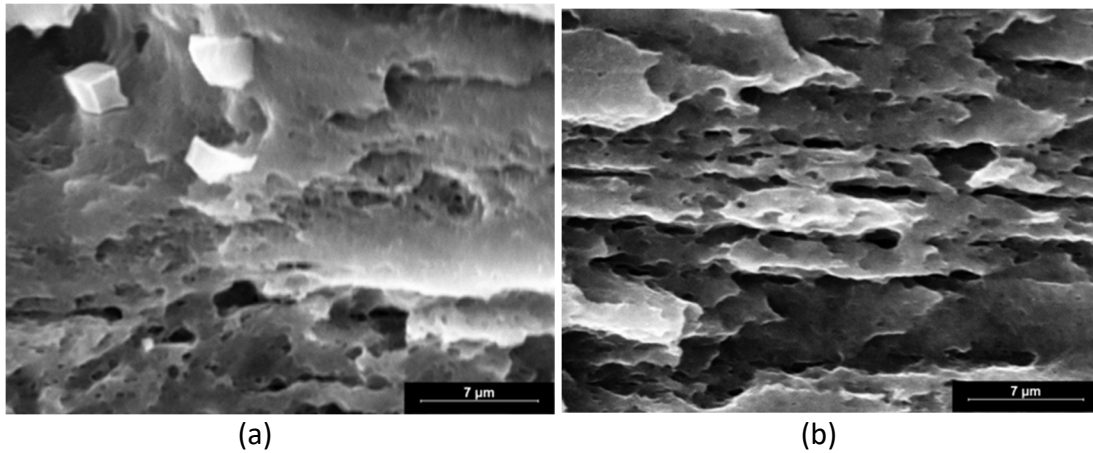
Fig.33 : Microstructure view of AA7175 at ruptured surface (a) Flat shear (b) Flat shear

For AA2024, there are evidences of zones of failures under Mode II and Mode I.
For AA7175, there are evidences of zones of failures under Mode II only.

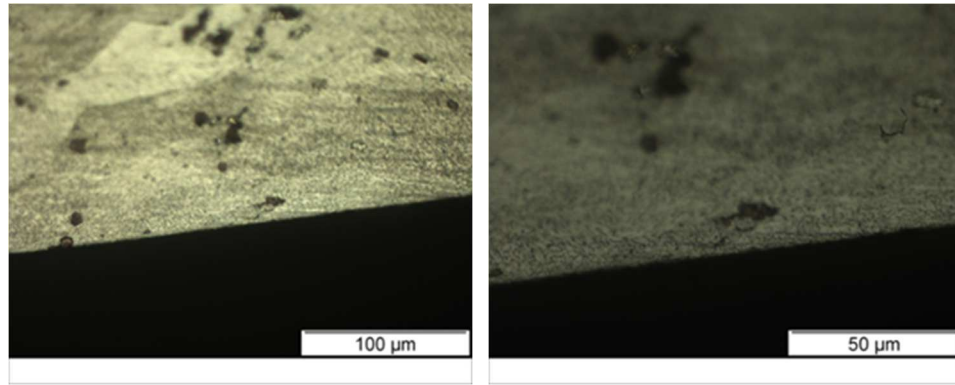
Fig.35 : Optical microscopic view of crack lip region for AA2024

For AA2024 crack lip analysis does not show any evidence of shear band see Fig.35, and on the other hand for AA7175 the adiabatic shear band with average width of $6\mu\text{m}$ is visible on the crack lips as shown in Fig.36.

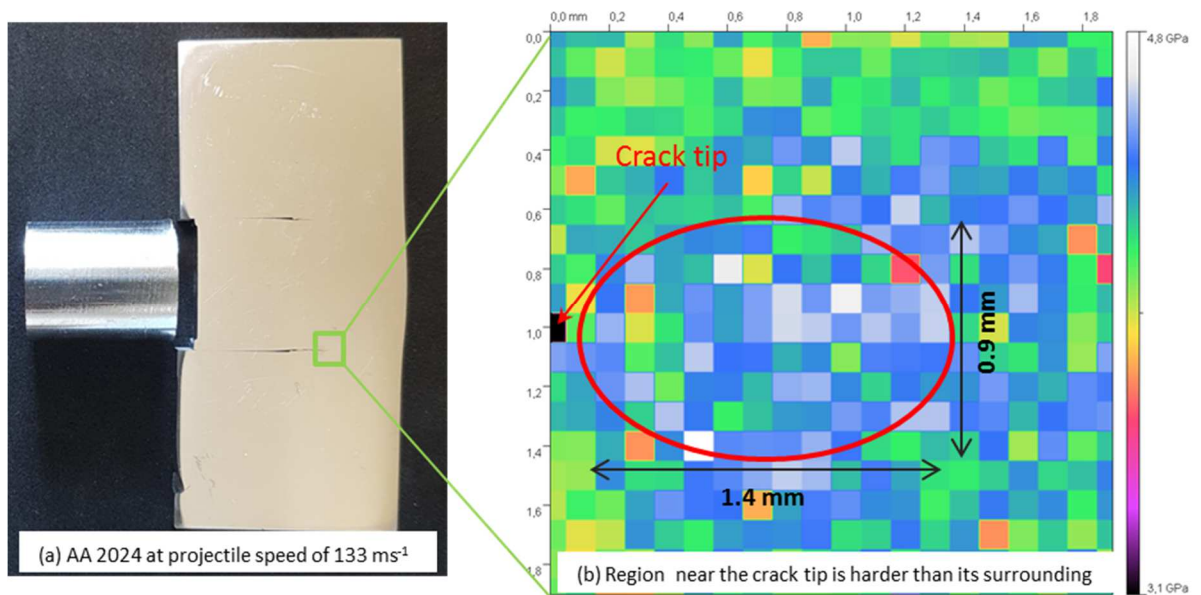
Fig.38 : Nanohardness of crack tip for AA 2024 at impacted speed of 133 m.s⁻¹. White for higher hardness value and black for lower hardness value.

Fig.38 shows the specimen and hardness mapping at impact speed of 133 m.s^{-1} . The region near the crack shows harder than its surrounding area. The average nano-hardness values inside and outside the process zone are 4.6 GPa and 4.0 GPa respectively.

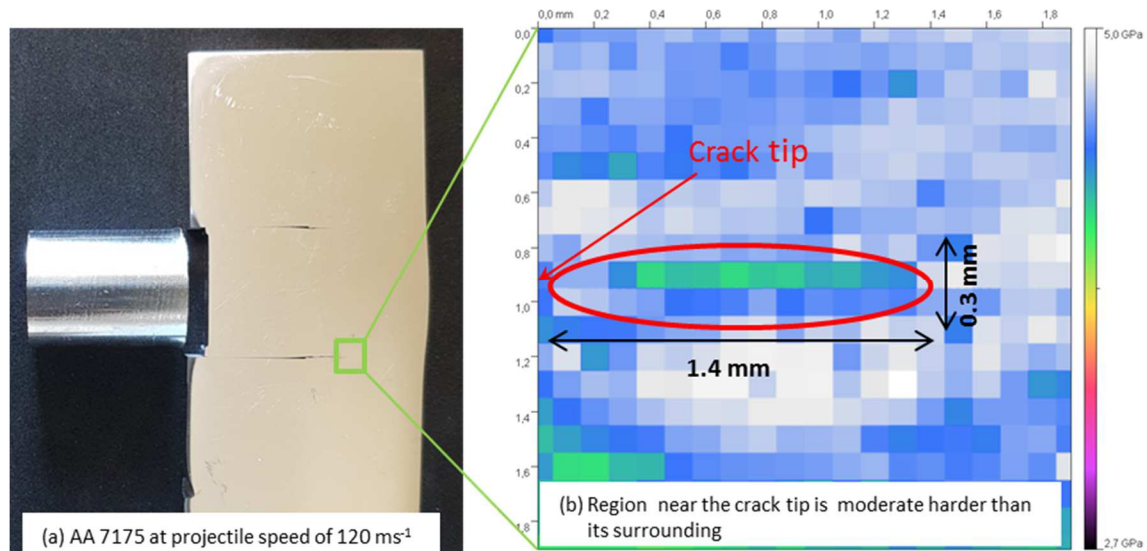
Fig.40 : Nanohardness of crack tip for AA 7175 at impacted speed of 120 m.s⁻¹. White for higher hardness value and black for lower hardness value.

Fig. 3.40 shows specimen after impact speed of 120 m.s⁻¹. The process zone is a line of pixels. The crack tip region also shows less hardness inside the process zone compared to its surrounding areas, with 4.2 GPa inside the process zone against 4.4 GPa outside.
