Acoustic monitoring of a prestressed concrete beam reinforced by adhesively bonded composite

Sylvain Chataigner, Laurent Gaillet, Yannick Falaise, Jean-François David, Richard Michel, et al.. Acoustic monitoring of a prestressed concrete beam reinforced by adhesively bonded composite. IC-CRRR 2018, International Conference on Concrete Repair Rehabilitation and Retrofitting, Sep 2019, Cape Town, South Africa. 8p, 10.1051/mateconf/201819909013 . hal-02289647v1

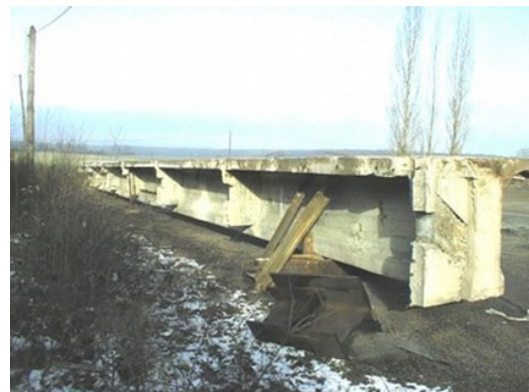
The used prestressed concrete beam comes from a viaduct over the river Doubs at Clerval that was erected between 1952 and 1954 and demolished in 2002 (Figure 1). This beam was 30 m long and 1.3 m high and it had two initial bend cracks with a maximum opening of 0.2 mm (sections S2 and S4). Prestressing cables are not straight and their position is not symmetric (Figure 2).

Fig. 1. Photo of the studied beam

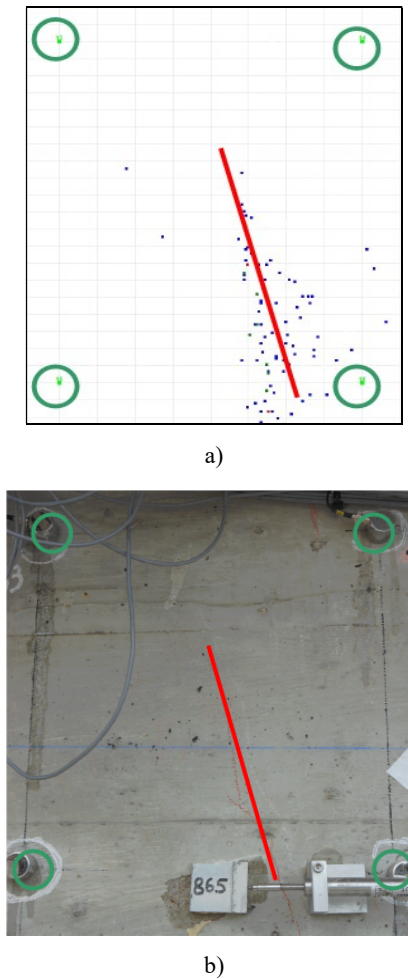
In the case of flexural tests, the localized acoustic emission system was mainly aimed at identifying the crack propagation in pre-determined cracked areas (sections S2 and S4 on figure 7a). Though, from calculation, during flexural test before reinforcement, crack propagation should have occurred first in section S2, it was proved that it actually started in section S4. This was detected both from acoustic emission, crack opening sensor and strain gage measurements. It was checked that the localization of acoustic events (Figure 8 a) was similar to the visual crack identification made after the initial flexural test (Figure 8 b). Sensors correspond to the green circles and acoustic to the dotted points. A red line materializes the crack.

Fig. 8. Comparison of 2D events-localization (a) with visual crack identification at S4 section during initial tests (b)

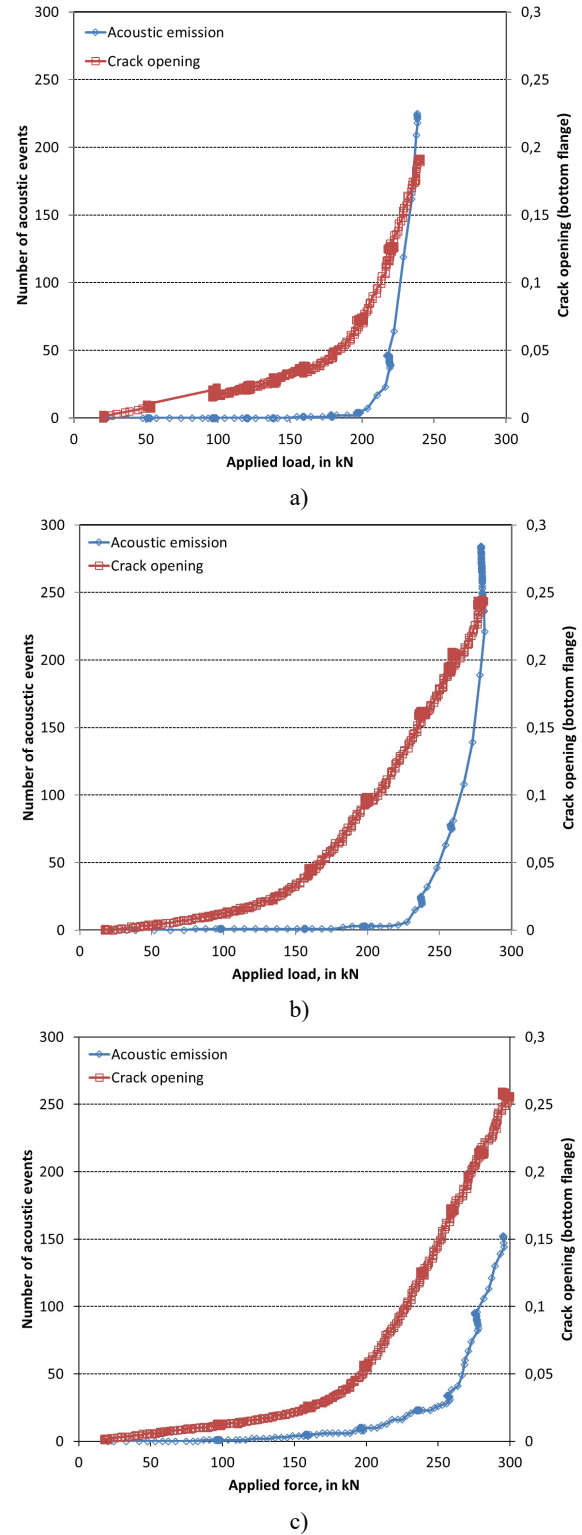
Fig. 9. Number of acoustic events and measured crack opening in function of the applied force before reinforcement (a), after first flexural reinforcement (b) and after final flexural reinforcement (c) at S4

Besides, for the three flexural phases, acoustic emission data was compared with crack opening measures made at the bottom flange (Figure 9). It can be seen that both are not always correlated. Acoustic emission allows following crack propagation, though crack opening measure may not induce crack propagation. Consequently, the slope modification point

of crack opening does not always occur at the same point than the start of acoustic emission. Both measurements may thus give complementary information on the state of the structure. It can also be seen that the reinforcement seems to have slightly delayed the onset of crack propagation. Acoustic emission technique is thus a good indicator to check the activity of a crack on-site and to detect the crack tip localization. It may also be used to assess the quality of reinforcement or repair.

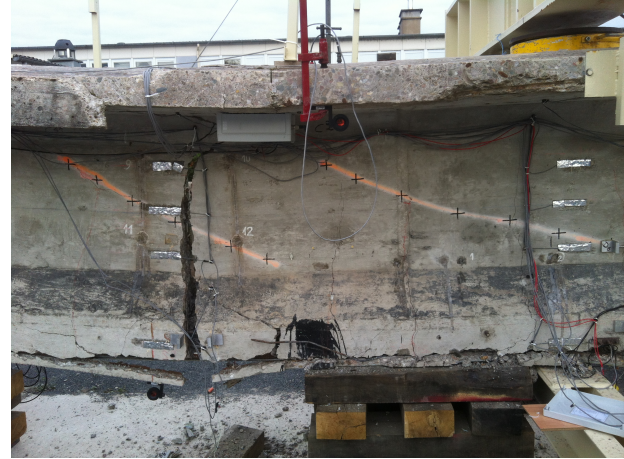
Fig. 10. Photos of the beam after the flexure test (overall beam: a; detail on failure closed to the load application: b)

- First events were detected from 400 kN to 480 kN in section S4 and in a section where corrosion was detected before the realization of the test. It seems that the encountered failures of prestressing steel wires induced a strong change in the behavior of the beam. This was correlated with crack measurements made in section S4.
- Then, several prestressing steel wires broke before the final failure that occurred at 615 kN closed to section S2 (Figure 10 b) (composite peeling-off). This was correlated with strain measurements made on one of the prestressing cables.
- From this moment, the applied force continued decreasing while the applied mid-span displacement increased. Numerous acoustic events occurred during this last step.

Acoustic survey allowed with the other monitoring devices to determine the failure process. All the detected acoustic events seem in that case to be attributed to prestressing steel wires failures.

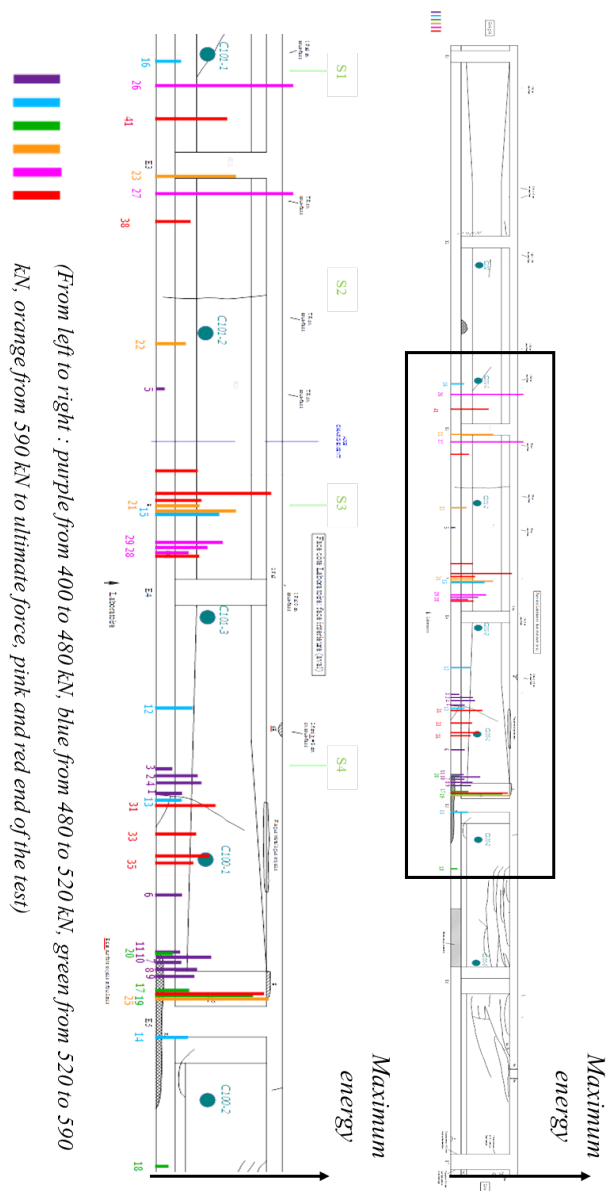
All the 1D localized events (Table 1) with the corresponding energy have been reported on the beam profile on figure 11:

Fig. 11. 1D acoustic events along the beam during flexure test

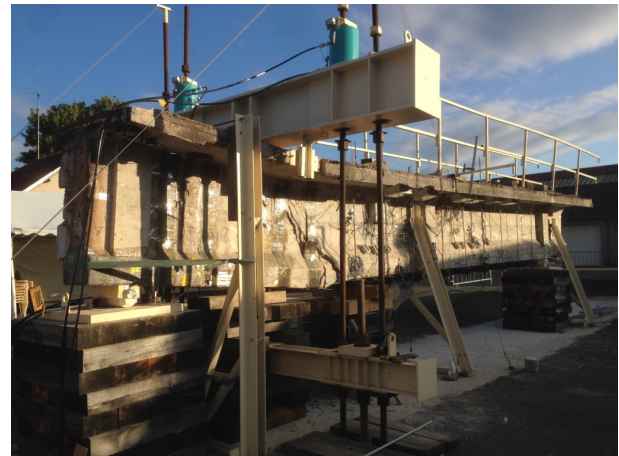
- During the first period up to 1700 kN, acoustic events mainly occurred under the load application demonstrating flexure damage rather shear damage. At the end of this period, flexural composite plates peeled-off (Figure 14 a);
- From 1700 kN to 1900 kN, most of acoustic events were detected in the corner close to the edge. This corresponds to a crack that was visually detected at the end of the test in this zone (Figure 14 b);
- From 1900 kN to the ultimate capacity (1970 kN), the acoustic emission was again localized under the applied load (Figure 14 c). At failure, a main inclined crack was observed from the applied load to the bottom flange out of the monitored zone using the localized device (Figure 12 and 13).

Fig. 12. Photo of the beam after the shear test up to failure

emission could be revealed under the bonded carbon sheets though high mechanical stresses have been measured on them using strain gages. Unexpectedly, the final crack occurred outside of the monitored area using the localized acoustic emission system (Figure 12).

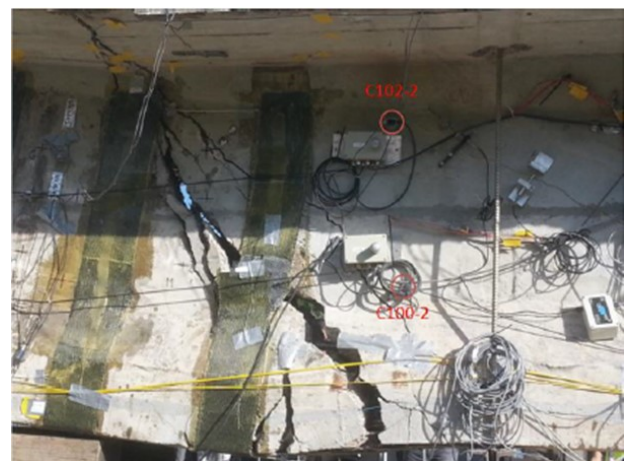
Fig. 13. Photo of the tested beam at the end of the shear test – detail of the main crack

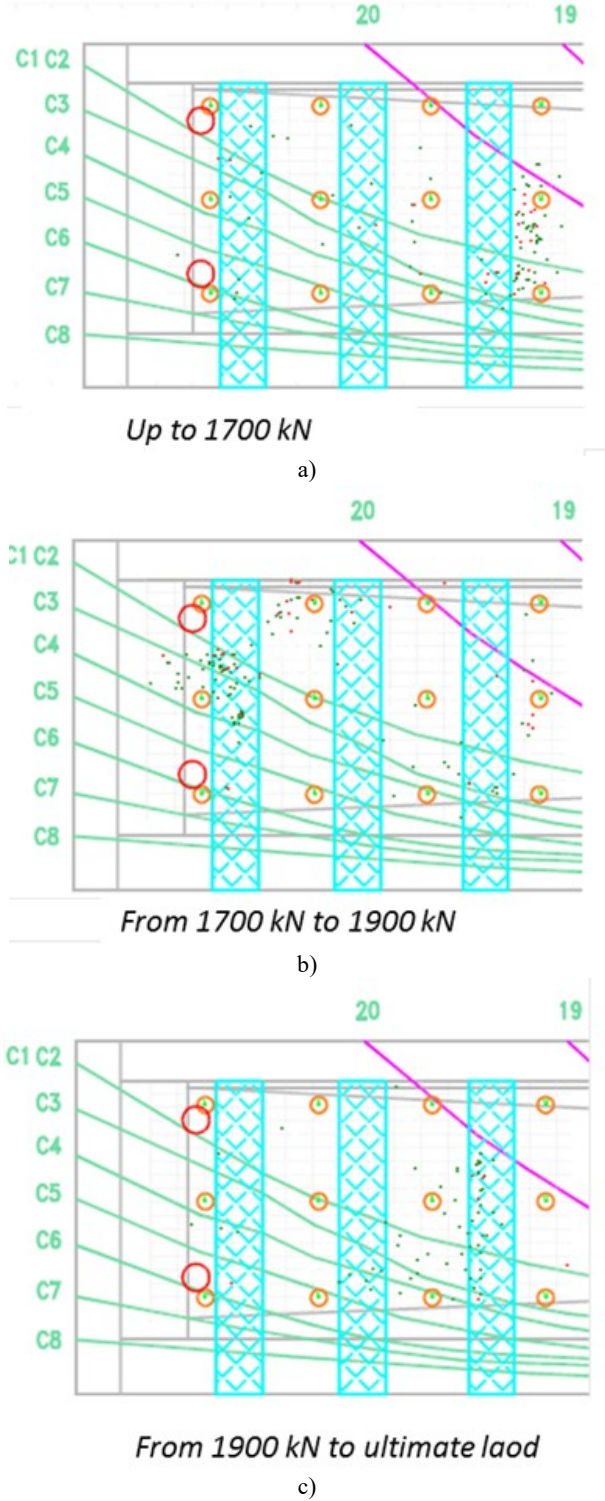
Three main periods were determined studying acoustic emission localization (Figure 14):

Fig. 14. Localized acoustic emission events during shear test up to failure (carbon sheets and prestressing cables are visualized) before 1 700 kN (a); between 1 700 and 1 900 kN (b) and from 1 900 kN to 1 970 kN corresponding to the ultimate load (c)

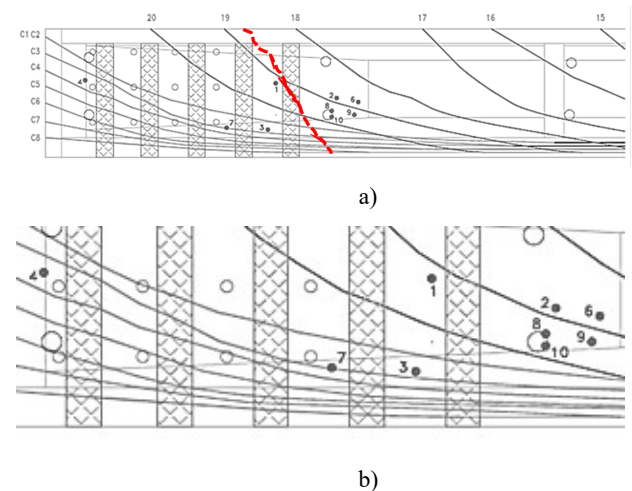
The detected events during the final shear test after CFRP reinforcement have been localized on the beam in 2D in Figure 14. A similar work to the one carried out in the case of the flexure test was done here for each of the detected events (Table 2) and adopting the proposed methodology in [7] based on the measured parameters (number of sensors detecting the event, wave speed, maximum amplitude).. The events 1, 2, 3, 4 and 7 proved to have too low propagation speed to be attributed to prestressing steel wire failure. They may be attributed to flexural composite peeling-off in flexure or high energy fretting. Events 6, 8, 9 and 10 may be attributed to prestressing steel wire failure. They are all localized in the same area (cable 19 closed to the final crack: Figures 12 and 15).

Fig. 15. 2D localization of acoustic events during shear test up to failure (whole beam with final crack: a; zoom on the events: b)
