Acoustic monitoring of a prestressed concrete beam reinforced by adhesively bonded composite

1 General introduction on “CLERVAL” project

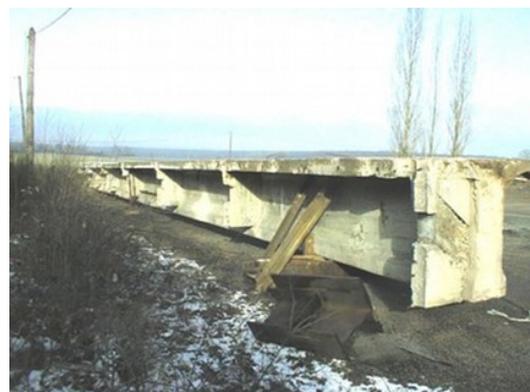
The used prestressed concrete beam comes from a viaduct over the river Doubs at Clerval that was erected between 1952 and 1954 and demolished in 2002 (Figure 1). This beam was 30 m long and 1.3 m high and it had two initial bend cracks with a maximum opening of 0.2 mm (sections S2 and S4). Prestressing cables are not straight and their position is not symmetric (Figure 2).

Fig. 1. Photo of the studied beam

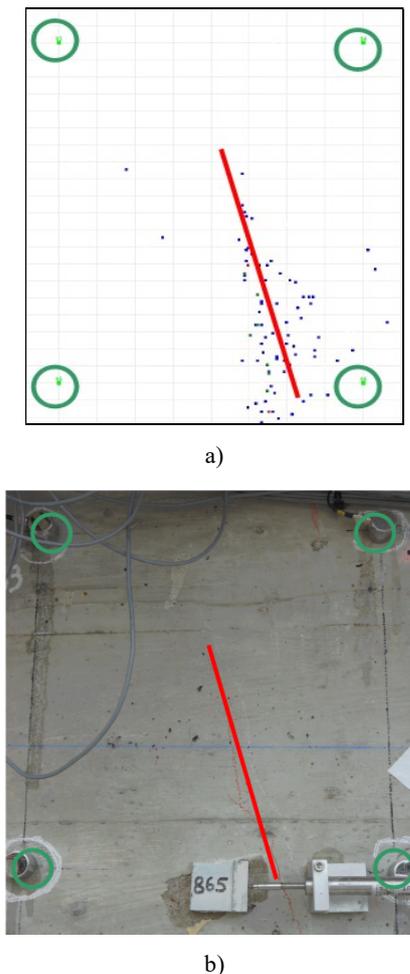
In the case of flexural tests, the localized acoustic emission system was mainly aimed at identifying the crack propagation in pre-determined cracked areas (sections S2 and S4 on figure 7a). Though, from calculation, during flexural test before reinforcement, crack propagation should have occurred first in section S2, it was proved that it actually started in section S4. This was detected both from acoustic emission, crack opening sensor and strain gage measurements. It was checked that the localization of acoustic events (Figure 8 a) was similar to the visual crack identification made after the initial flexural test (Figure 8 b). Sensors correspond to the green circles and acoustic to the dotted points. A red line materializes the crack.

Fig. 8. Comparison of 2D events-localization (a) with visual crack identification at S4 section during initial tests (b)

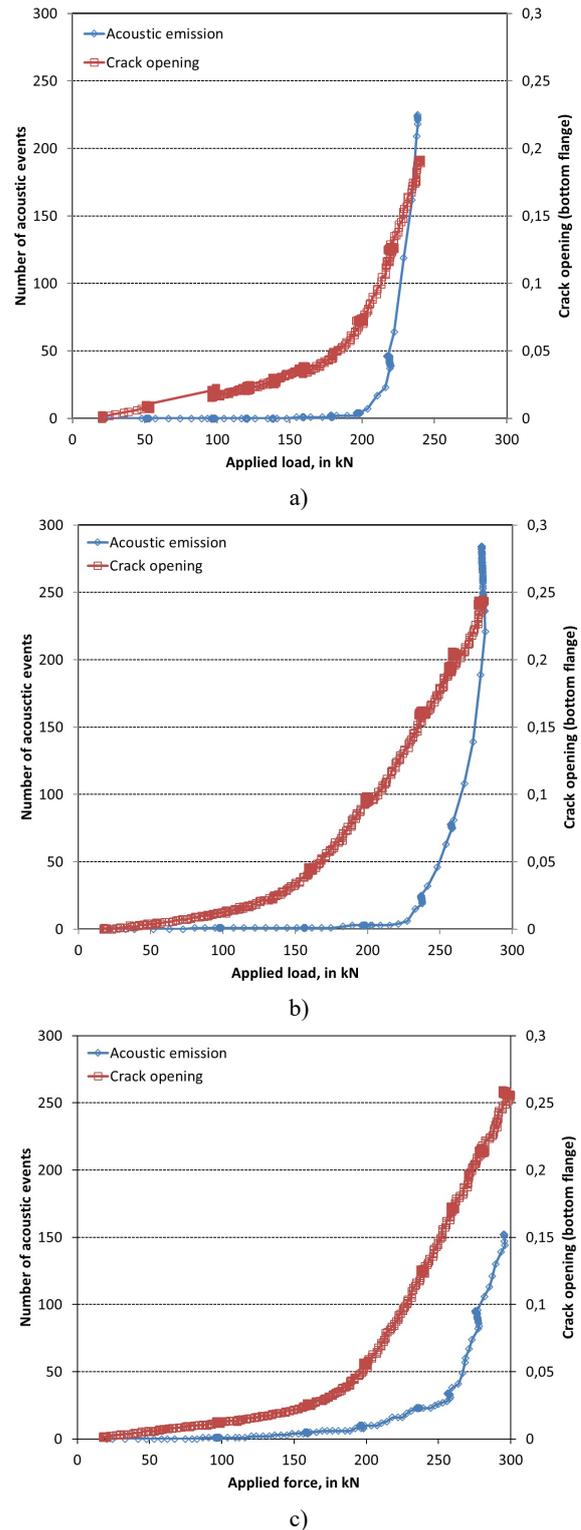
Fig. 9. Number of acoustic events and measured crack opening in function of the applied force before reinforcement (a), after first flexural reinforcement (b) and after final flexural reinforcement (c) at S4

Besides, for the three flexural phases, acoustic emission data was compared with crack opening measures made at the bottom flange (Figure 9). It can be seen that both are not always correlated. Acoustic emission allows following crack propagation, though crack opening measure may not induce crack propagation. Consequently, the slope modification point

of crack opening does not always occur at the same point than the start of acoustic emission. Both measurements may thus give complementary information on the state of the structure. It can also be seen that the reinforcement seems to have slightly delayed the onset of crack propagation. Acoustic emission technique is thus a good indicator to check the activity of a crack on-site and to detect the crack tip localization. It may also be used to assess the quality of reinforcement or repair.

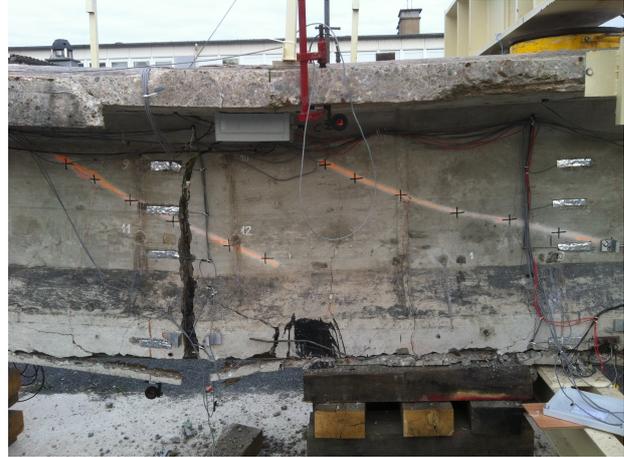
Fig. 10. Photos of the beam after the flexure test (overall beam: a; detail on failure closed to the load application: b)

- First events were detected from 400 kN to 480 kN in section S4 and in a section where corrosion was detected before the realization of the test. It seems that the encountered failures of prestressing steel wires induced a strong change in the behavior of the beam. This was correlated with crack measurements made in section S4.
- Then, several prestressing steel wires broke before the final failure that occurred at 615 kN closed to section S2 (Figure 10 b) (composite peeling-off). This was correlated with strain measurements made on one of the prestressing cables.
- From this moment, the applied force continued decreasing while the applied mid-span displacement increased. Numerous acoustic events occurred during this last step.

Acoustic survey allowed with the other monitoring devices to determine the failure process. All the detected acoustic events seem in that case to be attributed to prestressing steel wires failures.

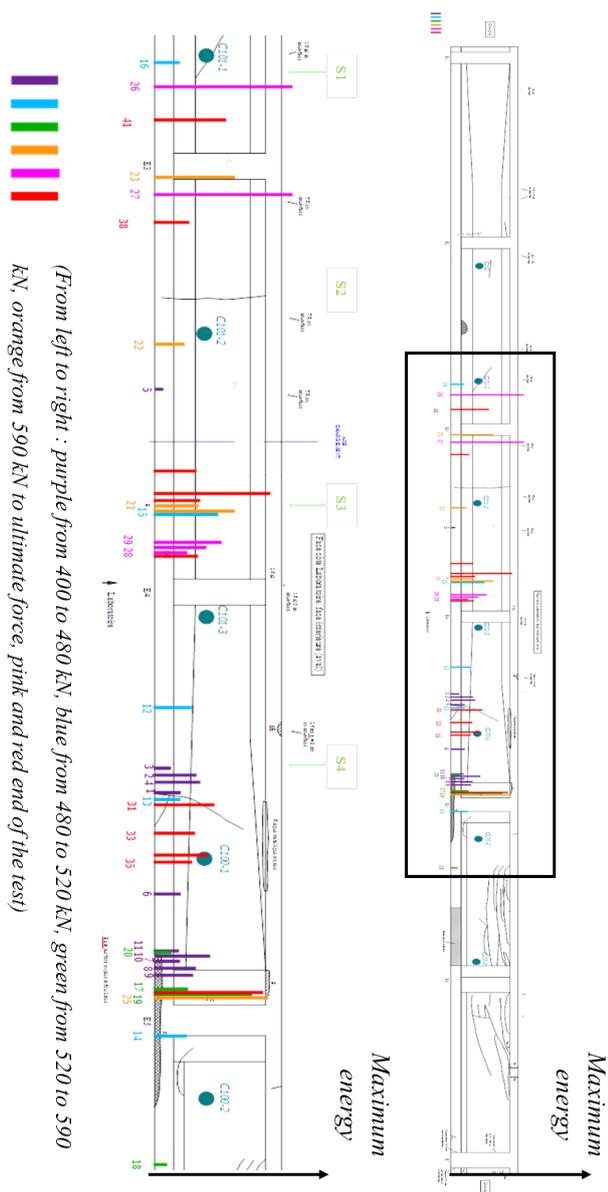
All the 1D localized events (Table 1) with the corresponding energy have been reported on the beam profile on figure 11:

Fig. 11. 1D acoustic events along the beam during flexure test

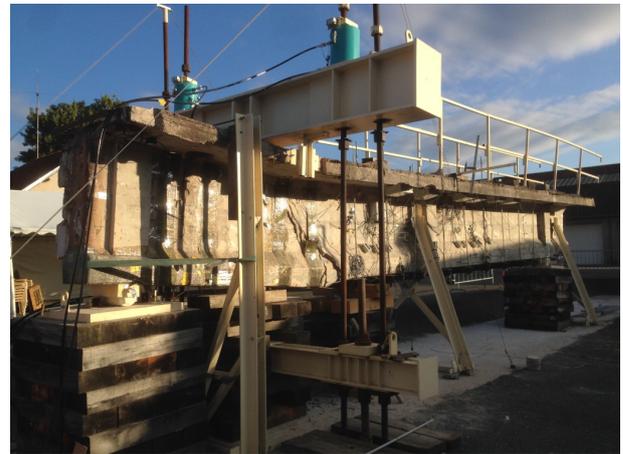
- During the first period up to 1700 kN, acoustic events mainly occurred under the load application demonstrating flexure damage rather shear damage. At the end of this period, flexural composite plates peeled-off (Figure 14 a);
- From 1700 kN to 1900 kN, most of acoustic events were detected in the corner close to the edge. This corresponds to a crack that was visually detected at the end of the test in this zone (Figure 14 b);
- From 1900 kN to the ultimate capacity (1970 kN), the acoustic emission was again localized under the applied load (Figure 14 c). At failure, a main inclined crack was observed from the applied load to the bottom flange out of the monitored zone using the localized device (Figure 12 and 13).

Fig. 12. Photo of the beam after the shear test up to failure

emission could be revealed under the bonded carbon sheets though high mechanical stresses have been measured on them using strain gages. Unexpectedly, the final crack occurred outside of the monitored area using the localized acoustic emission system (Figure 12).

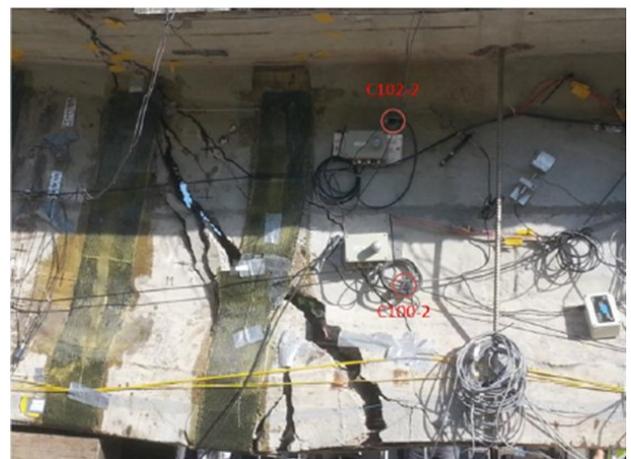
Fig. 13. Photo of the tested beam at the end of the shear test – detail of the main crack

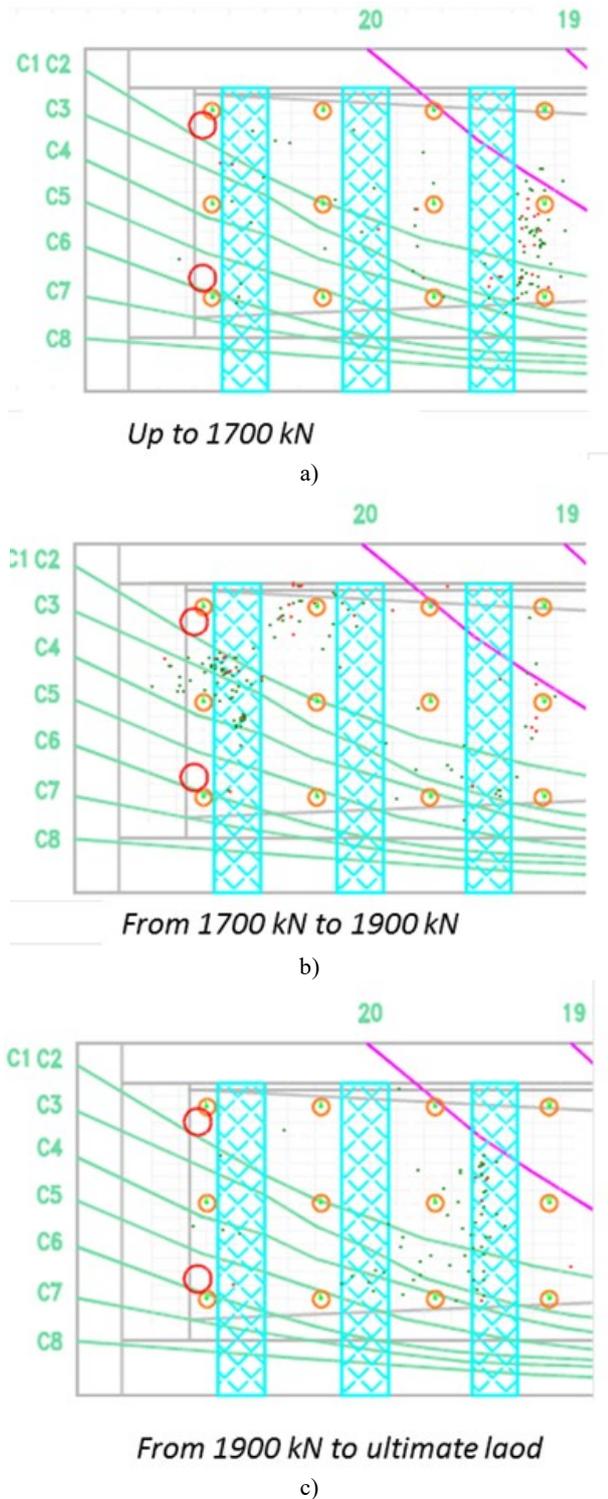
Three main periods were determined studying acoustic emission localization (Figure 14):

Fig. 14. Localized acoustic emission events during shear test up to failure (carbon sheets and prestressing cables are visualized) before 1 700 kN (a); between 1 700 and 1 900 kN (b) and from 1 900 kN to 1 970 kN corresponding to the ultimate load (c)

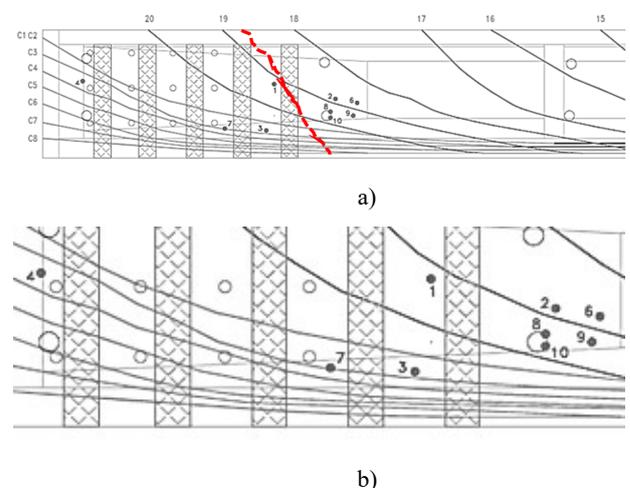
The detected events during the final shear test after CFRP reinforcement have been localized on the beam in 2D in Figure 14. A similar work to the one carried out in the case of the flexure test was done here for each of the detected events (Table 2) and adopting the proposed methodology in [7] based on the measured parameters (number of sensors detecting the event, wave speed, maximum amplitude).. The events 1, 2, 3, 4 and 7 proved to have too low propagation speed to be attributed to prestressing steel wire failure. They may be attributed to flexural composite peeling-off in flexure or high energy fretting. Events 6, 8, 9 and 10 may be attributed to prestressing steel wire failure. They are all localized in the same area (cable 19 closed to the final crack: Figures 12 and 15).

Fig. 15. 2D localization of acoustic events during shear test up to failure (whole beam with final crack: a; zoom on the events: b)
