# Preserving Aviation Heritage: The Need for an Approach Based on Materials Analysis

For several years, the research team has been following the renovation of a big carrier airliner – a Breguet 765 Sahara no. 504 64-PH (wing span: 45.5 m; length: 29 m; height: 10.15 m; dry weight: 15 t) – which is a part of the aircraft collection preserved by the Ailes Anciennes Toulouse association. This collection represents aeronautical adventure and local industrial history. The Breguet 765 (Figure 1a), a double-decker aircraft built in 1958 by the local industrialist Louis Breguet for military usage (Cochard 2016), is one of the most valuable aircraft in the collection: only four were built in 1959 due to drastic budget cuts by the French government. After its last flight in 1974, this aircraft was stored outside at the Evreux air base (Normandy, France). It was transported after partial dismantlement from Evreux to Toulouse by truck and was added to the collection of the Ailes Anciennes Toulouse association in 1984, since when it has been stored uncovered outdoors and subject to ongoing

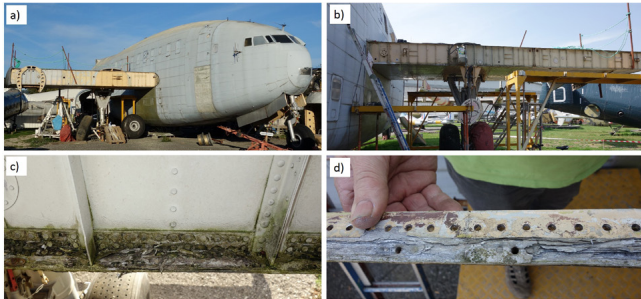
renovation. The aircraft has been suffering from severe corrosion for several decades. Figures 1c and 1d show an example of a corroded stringer made of aluminium alloy that had to be removed.

Figure 1. Photographs of (a) the Breguet 765; (b) the trailing edge; and (c) and (d) a corroded stringer on the centre wing section that was removed by a member of the association

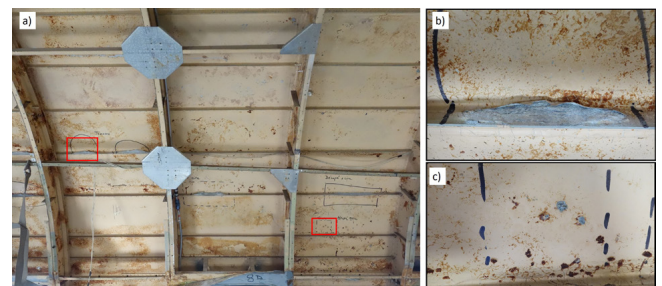
A first observation of the aircraft revealed that corrosion had affected the stringers in general, whereas the skin (the outer surface of an aircraft's fuselage and wings) was better conserved (Figure 2a).

Figure 2. Photographs of (a) the interior; (b) exfoliation corrosion on stringers; and (c) pitting corrosion on fuselage plates

For stringers, severe exfoliation is sometimes observed. This corrosion causes the aluminium alloy to delaminate and eventually turn into powder. For plates, whether structural (skin of the wings, fuselage) or non-structural (shields, cladding), corrosion in the form of pits is generally observed.

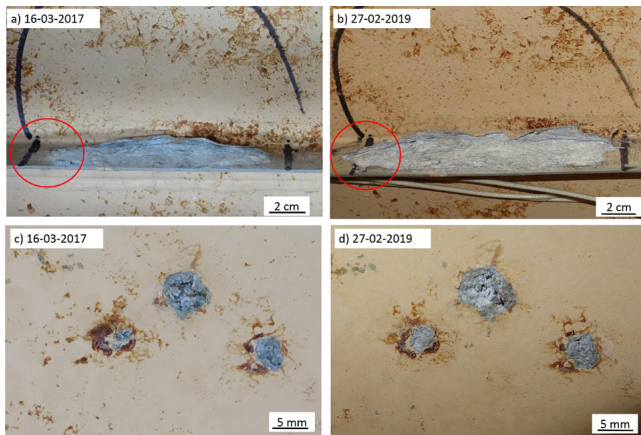
Figure 3. Photographs of (a) exfoliating corrosion on stringers (interior) and (b) pitting corrosion on the fuselage (interior) on March 2017 and after two years (b and d)

There is a clear sign of the development of corrosion on the stringers (about 1 cm per year), whereas for the plates the evolution is not so clear: pit diameters remain constant but with more corrosion products. According to these observations, stringers seem to have a lower resistance to corrosion than plates. To understand and appreciate the extent of these specific alterations, several stringers and plates were collected and studied.

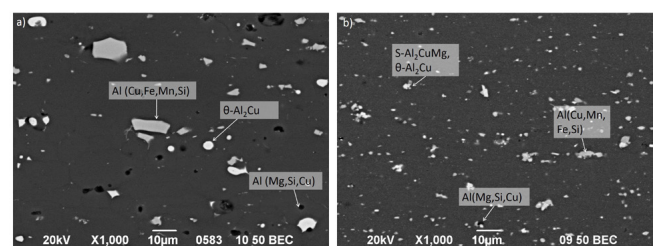
In the second step, the microstructure of the different alloys was studied. Figure 4 shows representative SEM images in backscatter mode for a plate made of A-U4G (Figure 4a) and a stringer made of A-U4G1 (Figure 4b). Coarse intermetallic particles analysed by EDS were identified as  $S\text{-Al}_2\text{CuMg}$ ,  $\text{AlCuMgSi}$ ,  $\theta\text{-Al}_2\text{Cu}$  and particles containing Al, Cu, Fe, Mn and Si with varying stoichiometry. It should be noted that in A-U4G alloys, where the magnesium content is lower, the  $S\text{-Al}_2\text{CuMg}$  phase is absent. Coarse intermetallic particles are deleterious to the macroscopic properties, potentially causing cracks and corrosion (Hughes et al. 2011, DeRose et al. 2013). It is therefore important to document them in terms of size and density to understand the alteration in old alloys. In stringers, particles are smaller and more numerous than in plates (see Table 2 for statistics).

Figure 4. SEM images (backscatter electron mode) of collected pieces: (a) plate made of A-U4G; (b) stringer made of A-U4G1

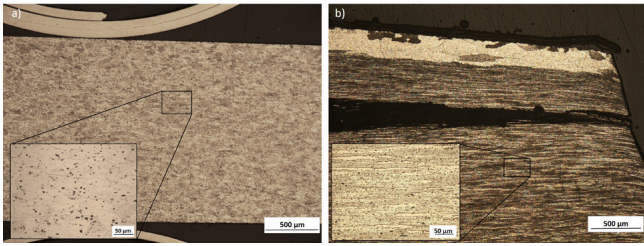
Figure 5. Optical microscope images after Keller's reagent etching: (a) plate; (b) stringer at 5x and 50x

The microstructure observed in the different parts can partially reveal the fabrication process. Plates have equiaxed grains (Figure 5a) typically obtained after successive rolling passes and heat treatments leading to recrystallisation, whereas stringers exhibit a highly oriented fibrous structure in the bulk and large grains on parts near the surface up to a depth of a couple of hundred microns (Figure 5b). This peculiar microstructure is linked to the manufacturing process where extruding generates severe plastic deformation giving rise to a very fine and oriented texture – the *presseffekt* (Herenguel and Scheidecker 1954, Devalay 1997) – to create higher mechanical resistance. In subsequent heat treatments, the microstructure undergoes an inhomogeneous recrystallisation with the formation of large grains on the cortex, as observed here. These large grains induce a reduction in mechanical properties and also influence resistance to corrosion.

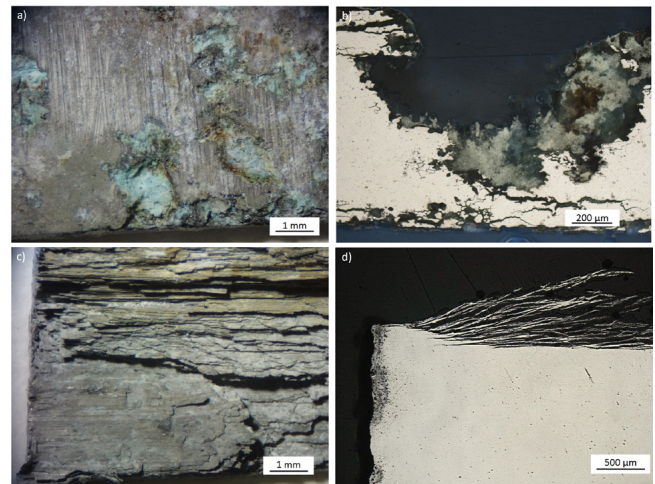
As mentioned above, two types of alterations (pitting and exfoliation) were identified macroscopically on the parts collected from the Breguet aircraft. These forms of corrosion are highly representative of outdoor corrosion of aluminium alloys (De Damborenea and Conde 1995, De La Fuente et al. 2007). Figure 6 shows pictures of the corrosion, via a top view and in cross section, on plates (Figures 6a and 6b) and on stringers (Figures 6c and 6d).

as well as aluminium sulfates (Graedel 1989). The blue colour comes from the copper ions released by the alloy. When observing these corrosion features on cross sections in larger scale with SEM (Figure 7), it is clear that intergranular corrosion has developed on both the plates and stringers. On the plates, the intergranular corrosion is coupled with evolving pitting in the crevices (Figure 6b), while on the stringers the intergranular corrosion further develops during exfoliation (Figure 6d).

Figure 6. OM images on plates: (a) top view; (b) cross section showing pitting corrosion; and on stringers: (c) top view, (d) cross section showing intergranular corrosion leading to exfoliation

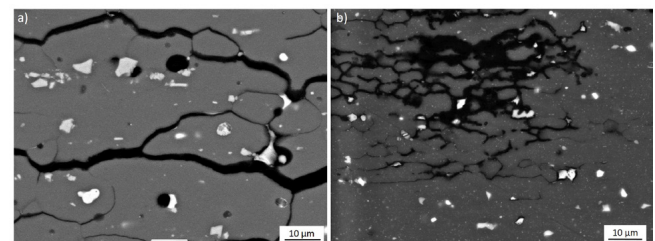
Figure 7. SEM images (backscatter electron mode) of corroded parts: (a) plate made of A-U4G; (b) stringer made of A-U4G1

In the case of the parts from the Breguet 765, intermetallic particles are more numerous and denser on stringers than on plates (Figure 7), which partly explains why corrosion is an issue on stringers. To explain why the intergranular corrosion transforms into exfoliation on stringers, an important factor is the microstructure linked to the manufacturing process and heat treatments. On plates, exfoliation does not occur because of the homogeneous microstructure obtained after recrystallisation annealing. On stringers, due to the particular oriented and fibrous microstructure mentioned above, the intergranular corrosion develops easily into exfoliation due to the growth of corrosion products which force metal to move away from the body of the material.
