# SiC tools for reliability study

**T. Phulpin \*, A. Jaffre\*, J. Alvarez\*, M. Lazar\*\***

**Abstract—** Understanding the failure mechanisms is essential to ensure reliability for a new technology of semiconductors. Amongst various existing tools dedicated to silicon-based devices, there is no consensual method for silicon carbide (SiC) devices. This semiconductor offers very interesting properties for power electronics in comparison with Si, but these failures are different and need to be studied. This paper will compare different methods applied to failures, focusing on lock-in thermography and micro-Raman analysis. Three devices have been evaluated, a vertical diode, a lateral diode and a MESFET.

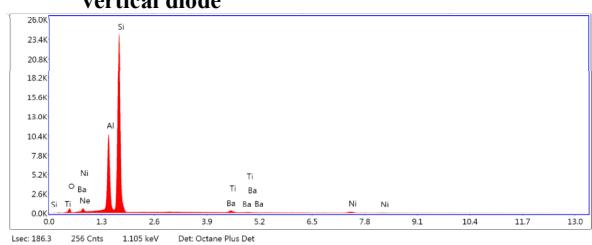
In this study, both FIB and Energy Dispersive X-ray (EDX) analyses were performed on vertical diode. Results suggested a melting of the metallization at the interface (Fig.11 and Fig.12). Comparing EDX response before and after stress, Aluminum Amplitude level decreased

significantly, whereas Silicon level increased and Nickel and Titan stayed stables (Fig.13 and Fig.14). This result can be explained by the lower melting temperature of Aluminum in comparison with Nickel and Titan. In addition, the FIB cut (Fig.13) showed that the defect remained on the surface and that SiC was not attacked (Fig. 14), explaining its relative proportion increase. As a result, internal resistance decrease -previously described in 3.- may only be due to the local modification of the metallization.

Fig. 13: EDX of Sic vertical diode before failure

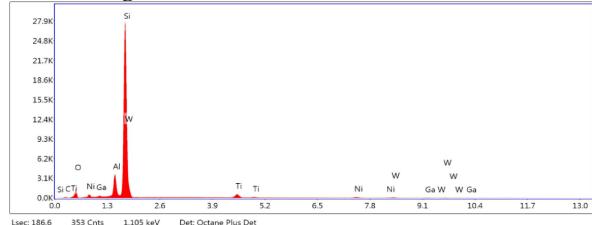
Fig. 14: EDX of Sic vertical diode after failure
