Characterization of intergranular corrosion defects in a 2024 T351 aluminium alloy

Marie-Laetitia de Bonfils-Lahovary, Lydia Laffont*, Christine Blanc

Université de Toulouse, CIRIMAT, CNRS/INPT/UPS, ENSIACET, 4 allée Emile Monso, BP 44362, 31 030 Toulouse Cedex 4, France

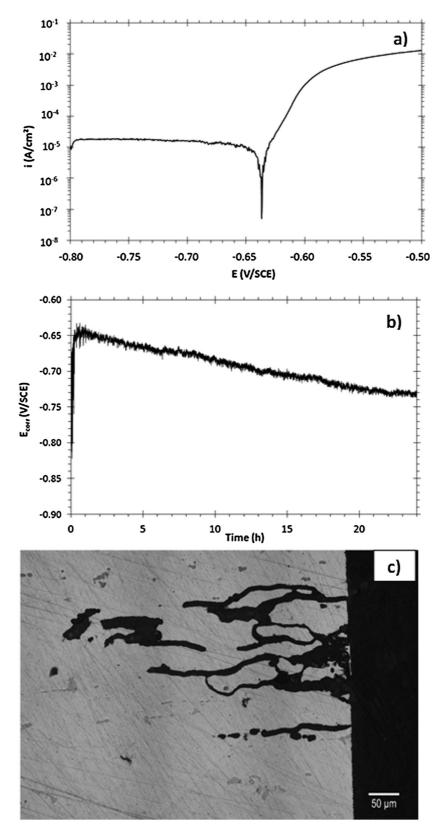
Fig. 1 shows a polarization curve (Fig. 1a) plotted for the AA2024 sample in 1 M NaCl solution: a sharp increase of the anodic current densities after the corrosion potential (E_{corr}) confirmed that the alloy was susceptible to localized corrosion at Ecorr in such an electrolyte. OM observations (not shown here) of the samples after the polarization test showed both pitting and intergranular corrosion. Therefore, we chose in this study to develop intergranular corrosion defects by performing continuous immersion tests at E_{corr}. Fig. 1b shows E_{corr} versus the exposure time to 1 M NaCl solution: a continuous decrease of E_{corr} was observed in agreement with the propagation of corrosion defects. Fig. 1c shows, as an example, intergranular defects grown after a 24h exposure at Ecorr in 1 M NaCl. TEM observations of these intergranular corrosion defects were performed for 3 FIB samples. Depending on the sample, several intergranular corrosion defects were present and characterized. Given that the general features observed were similar for all samples, we present here only results for one intergranular corrosion defect, for brevity. Fig. 2 shows a photomontage of TEM images of an intergranular corrosion defect of an AA2024-T351 sample exposed to a 1 M NaCl solution during 24 h and removed by using a FIB/SEM.

The defect is approximately 1 μ m wide and decorated by a chain of precipitates. EDX analyses allow to identify two types of precipitates: Al-Cu-Mg (80% Al - 17% Cu - 3% Mg, at.%) and Al-Cu-Mn (75% Al - 14% Cu - 11% Mn, at%). The presence of such precipitates was in agreement with literature data concerning the metallurgy of 2XXX alloys and the intergranular corrosion mechanism which attributes the susceptibility to intergranular corrosion of 2xxx alloys to the decoration of their grain boundary network with precipitates such as S phases (Al_2CuMg) or θ phases (Al_2Cu)[3–6]. Usually, the intergranular corrosion initiation is explained by a galvanic coupling between S and θ Cu-rich phases decorating the grain boundaries and the adjacent matrix.

Fig. 1. a) Polarization curve of the AA2024 sample in a 1 M NaCl solution, b) E_{corr} versus the exposure time to 1 M NaCl solution, c) Optical micrograph of intergranular corrosion defects formed after a 24 h exposure at E_{corr} in a 1 M NaCl solution.

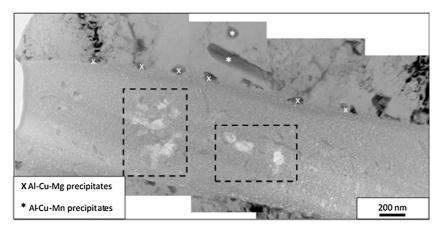
Observations also showed that the intergranular corrosion defect was completely filled with corrosion products which most probably corresponded to alumina. In addition, white flaws were observed inside the intergranular corrosion defect (black dashed squares in Fig. 2). They could be compared to those observed by Thompson et al. in their studies about anodization of Al-Cu model alloys, the authors describing the flaws as the results of an oxidation of Cu-rich impurities [23–26,38,39]. According to these authors, when an Al-Cu model alloy was anodized, Al was first oxidized due to the less negative Gibbs free energy per equivalent for the formation of copper oxide compared with that of alumina. This led to the formation of a few nanometers thick Cu-enriched layer at the interface alumina/model alloy inside the alloy. Inside this thin layer, Cu-rich precipitates, namely θ ' phases, were formed, their size depending on the interfacial coherency between the alu-

minium matrix and the Cu-rich layer [24]. Oxygen gas bubbles generated by the oxidation of Cu from these precipitates led to the formation of flaws inside the oxide film, similar to those observed in this study (black dashed squares in Fig. 2) [32]. The presence

of such flaws inside the intergranular corrosion defect formed for the industrial alloy suggested that the electrochemical processes occurring during the corrosion of the grain boundaries were similar to those observed during the anodization of an Al-Cu model

Fig. 2. Photomontage of Bright Field (BF) TEM images showing an intergranular corrosion defect in an AA2024-T351 after a 24 h immersion in a 1 M NaCl solution.

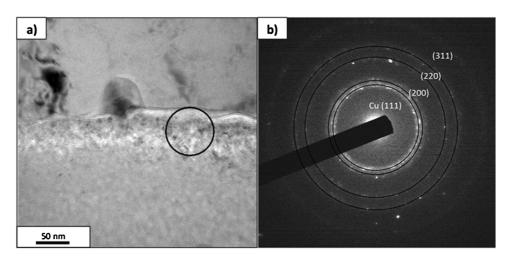
Fig. 3. a) BF TEM image showing a Cu-rich layer at the matrix-oxide interface inside the intergranular corrosion defect for an AA2024-T351 sample after a 24 h continuous immersion in a 1 M NaCl solution at room temperature. The black circle shows the area selected for the SAED pattern obtained in b).

alloy. In particular, the result suggested that, during the corrosion phenomena, a thin Cu-layer might be formed at the interface alumina, i.e. corrosion products inside the intergranular corrosion defect/alloy. Additional TEM observations showed a thin layer composed of nanoparticles of different contrast at the interface between the alloy and the oxide inside the intergranular corrosion defect, as shown in Fig. 3a: it was about 50 nm thick. Furthermore, in Fig. 3b, a SAED pattern characteristic of this layer showed diffraction circles representative of metallic nanoparticles of Cu (Fm-3m, a = 3615 Å) showing that this layer was enriched in metallic Cu species.

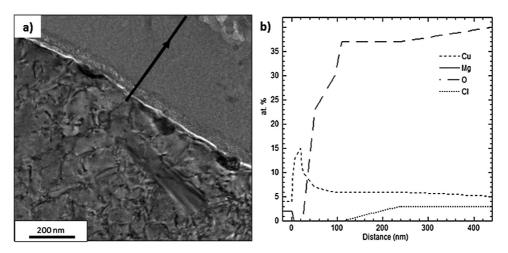
Further analyses were performed to complete these results and an EDX line profile was plotted perpendicularly to the alloy/oxide interface as it is showed in Fig. 4a. Fig. 4b shows the corresponding EDX profile obtained: for this analysis, the Mg signal was helpful to locate the alloy part while the oxygen signal allowed to identify the alumina film. The presence of a Cu-rich layer at the interface between the alloy and the oxide was clearly visible (Fig. 3b). In the first nanometers of the profile, the alloy composition was measured (4 at.% Cu and 2 at.% Mg); then, a Cu peak was observed with Cu content reaching a value of about 15 at.%. The Cu content rapidly decreased inside the alumina film but remained equal to 6-7 at.%. The presence of Cu species inside the alumina film was in agreement with the literature even though the Cu content was lower than that found for Al-Cu model alloys (approximately 40%) [17,21-25,30]. According to Thompson et al., the incorporation of Cu species inside the alumina film should contribute to explain the flaws observed in Fig. 2 [23-26]. Fig. 4b also showed the presence

of chloride species in the alumina film which was related to the exposure conditions certainly due to trapped electrolyte during intergranular corrosion propagation.

Fig. 4. LAADF STEM image (a) and EDX line profile (b) of the interface alloy/intergranular corrosion defect.

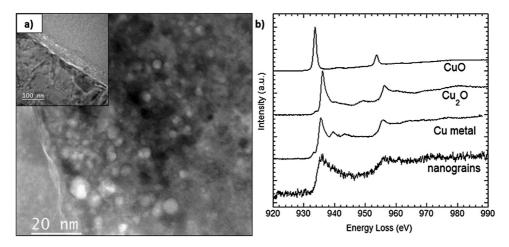
In order to determine precisely the chemical nature of the interfacial Cu-rich layer, EELS analyses in STEM mode were performed (Fig. 5). Fig. 5b represents the Cu-L_{2,3} edges of the interfacial nanoparticles layer compared to the Cu-L spectra of the CuO, Cu₂O and metallic Cu references [40]. Results showed that the spectroscopic signatures of Cu in this layer mainly corresponded to the EELS signature of metallic Cu. The presence of Cu₂O could not be excluded while it could be assumed that CuO was not present leading us to assume that the interfacial layer was mainly composed of metallic Cu nanoparticles [9,41].

Fig. 5. a) LAADF STEM images of the interface alloy/intergranular corrosion defect showing nanoparticles combined with b) EELS analysis of the Cu-L_{2,3} edges of the nanoparticles of the interfacial layer. Copper oxide references are given for comparison.

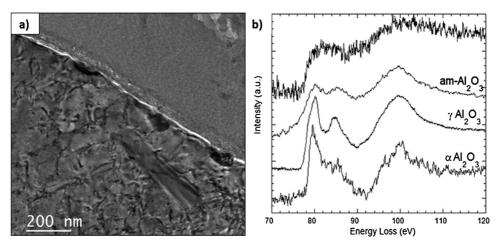
Concerning the chemical nature of the corrosion products inside the intergranular corrosion defect, a combination of STEM and EELS techniques was also used. This enabled to probe the Al-L_{2,3} edges at the nanometer scale (Fig. 6). The fingerprint approach was also used to determine the nature of the alumina, the reference spectra of both γ,α and amorphous alumina having been obtained in the same experimental condition for comparison. The different peaks related to Al-L_{2,3} edges for γ and α -Al₂O₃ have the same shape of those described by Bouchet [42]. Moreover, the EELS spectra obtained on the corrosion defect do not fit with the Al-L edge of aluminium (oxy) hydroxide as the boehmite γ - AlO(OH), the bayerite (α - Al(OH)₃) and the gibbsite (α - Al(OH)₃) obtained by XANES [43]. Results showed that the shape of the Al-L_{2,3} edges for the corrosion product layer corresponded to those of amorphous alumina showing

Fig. 6. a) LAADF STEM image with black spots inside the intergranular corrosion defect representing where b) EELS analysis of the Al - L_{2,3} edges was done. Spectra were compared to those of the reference α and γ alumina and amorphous alumina. For more clarity, only one spectrum corresponding to the analyzed oxide film was given.

that the intergranular corrosion defect was filled with amorphous alumina [44]. The nature of the amorphous phase is also confirmed by the lack of specific structure in HRTEM and a diffuse diffraction pattern. However, given that the sample had been dried prior to sectioning, it was likely that the amorphous alumina was a precipitate formed from either gelatinous Al corrosion products due to the

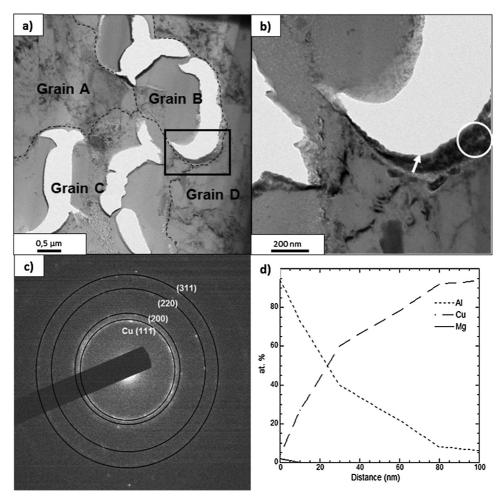
Attention was also paid at the chemistry of the tip of the intergranular corrosion defect: another FIB sample was thus prepared at this specific location as represented in the photomontage of bright field image in Fig. 7a. Corrosion was developed across the grain boundary and in the neighbouring grains. Due to the 3D configura-

tion of an intergranular corrosion defect, it was difficult to ascertain that the 'tip' observed was really an active anode. Therefore, several FIB samples were prepared at locations assumed to be the tip of an intergranular corrosion defect. Results obtained were similar and only the results obtained for one 'tip' sample are shown here. As previously (Fig. 2), a chain of precipitates identified by EDX as Al_2Cu was present all along the tip of the corrosion defect which was around 1 μm wide. A zoom on the tip (Fig. 7b) revealed the presence on a thin layer (almost 100 nm) at the interface between the alloy and the intergranular corrosion defect. A selected area diffraction pattern obtained for this layer (Fig. 7c) revealed the presence of diffraction circles representative of nanoparticles of metallic Cu (Fm-3m, a = 3615 Å). The EDX profile (Fig. 7d) confirmed the presence of the Cu-rich layer at the tip of the intergranular corrosion defect with a Cu content that can reach 90 at.%.

Fig. 7. a) Photomontage of bright field images of an intergranular corrosion defect with the delimited grain represented b) zoom on the tip of the corrosion defect associated with c) SAED pattern (selected area is represented by white circle in b) and d) EDX profile (line profile is represented by a white arrow in b).
