Tracing the seismic history of Sant'Agata del Mugello (Italy, Tuscany) through a cross-disciplinary approach

Tracing the seismic history of Sant'Agata del Mugello (Italy, Tuscany) through a cross-disciplinary approach.

Arnaud MONTABERT^{*1,4,5}, Hélène DESSALES², Andrea ARRIGHETTI³, Julien CLEMENT⁴, Maria LANCIERI⁵, and Hélène LYON-CAEN¹

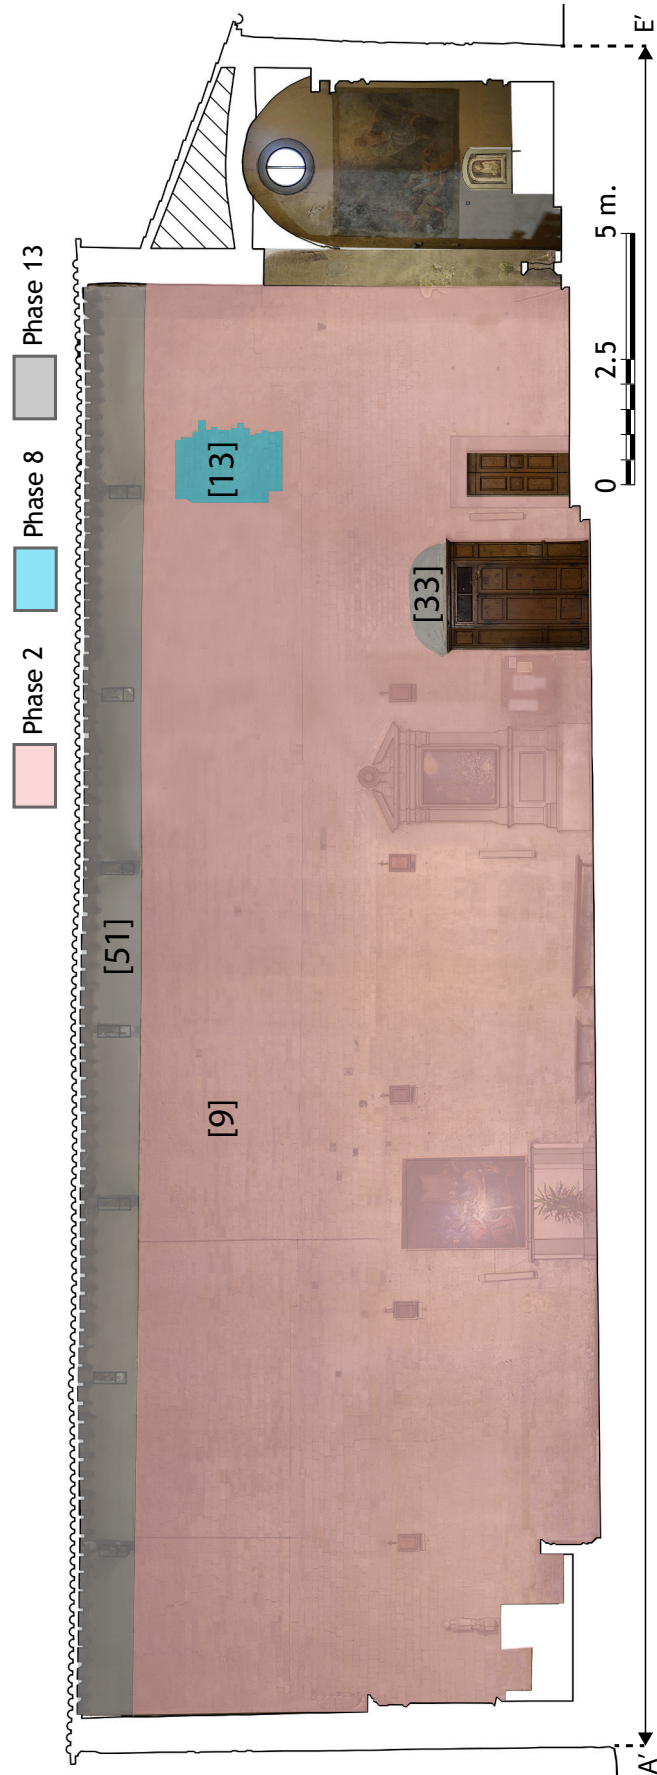
Figure 11: Stratigraphy of the internal north-facing of the church (MR14) including the nave (on the right), the bell tower (on the middle) and the north lateral chapel. Phase 2, phase 4, phase 7, phase 8, and phase 13 are identified.

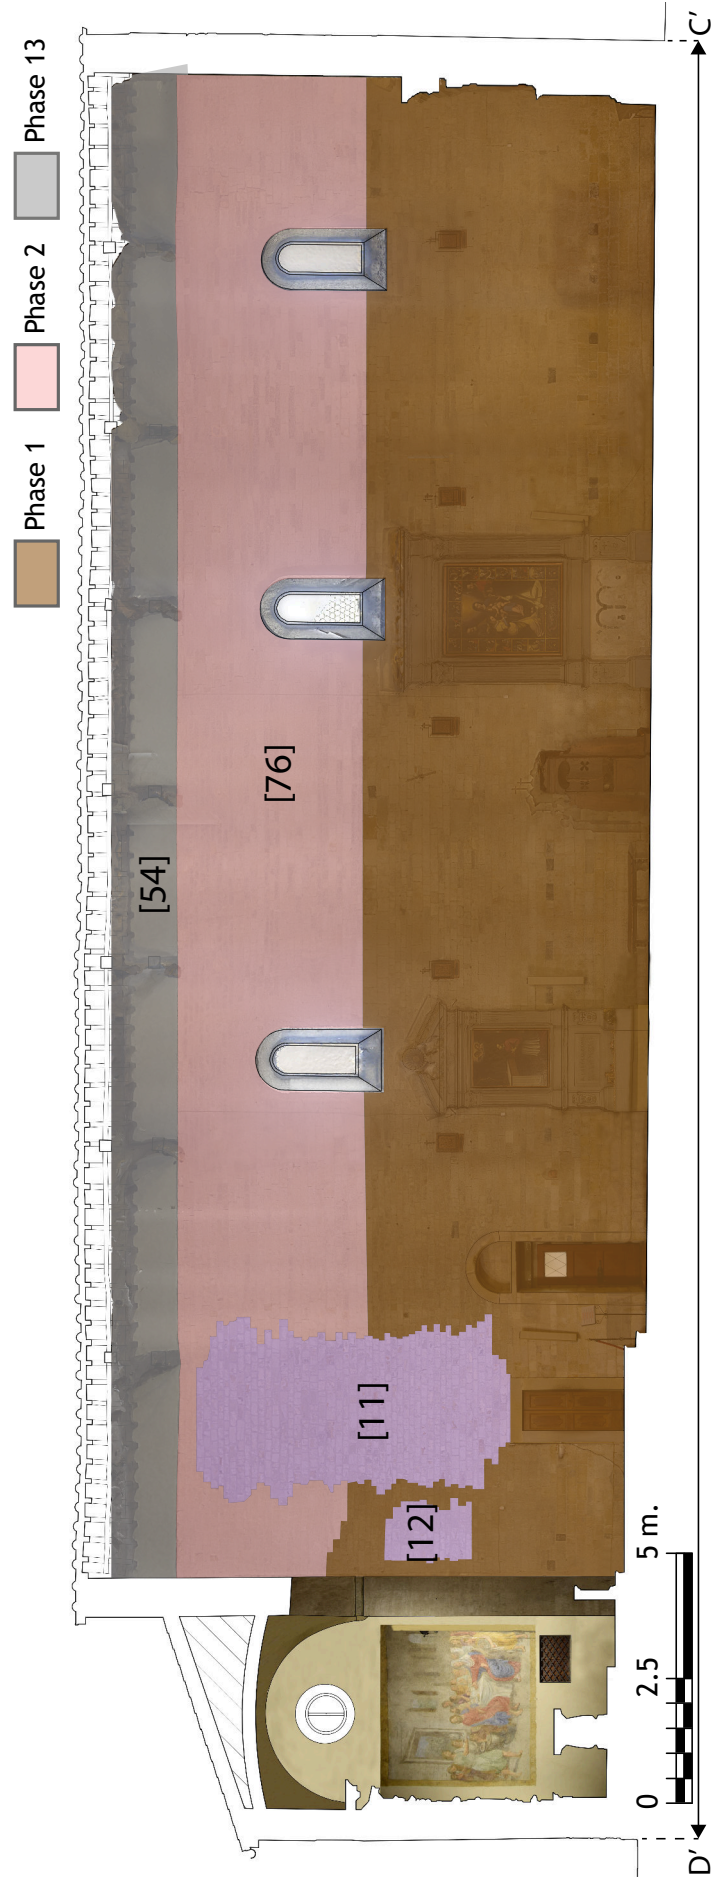
Figure 13: Stratigraphy of the internal south-facing of the church (MR2). Phase 1, phase 2, phase 7 and phase 13 are identified.

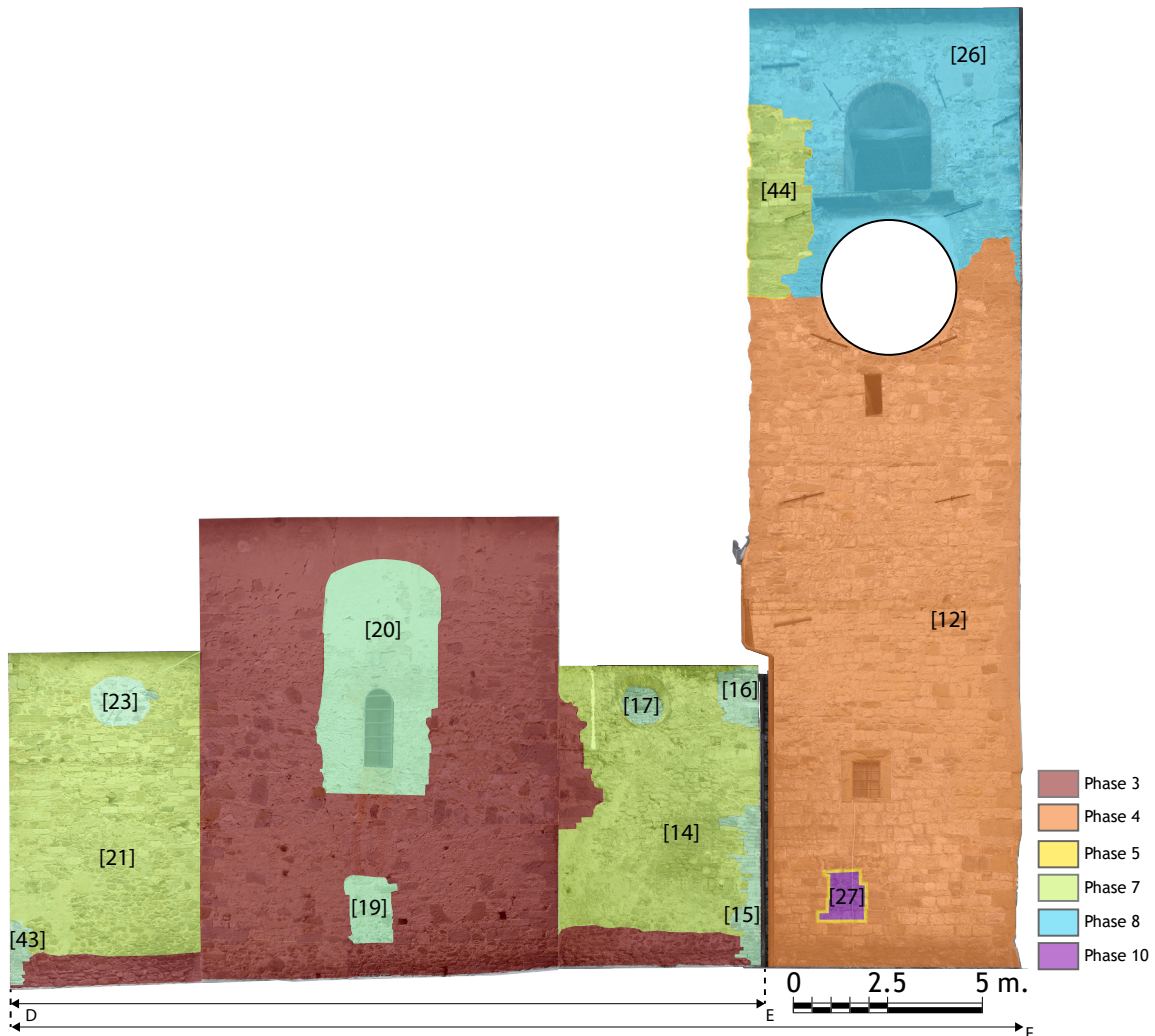
Figure 14: Stratigraphy of the external east-facing of the church (MR4, MR6, MR8) including the bell tower (on the right), the central apse and both lateral chapels. Phase 3, phase 4, phase 5, phase 7, phase 8, and phase 10 are identified.

According to R. Ajazzi [1887] the east door of the bell tower is embedded in 1659. This repair is still visible in Figure 14 (in purple) and corresponds to phase 10.

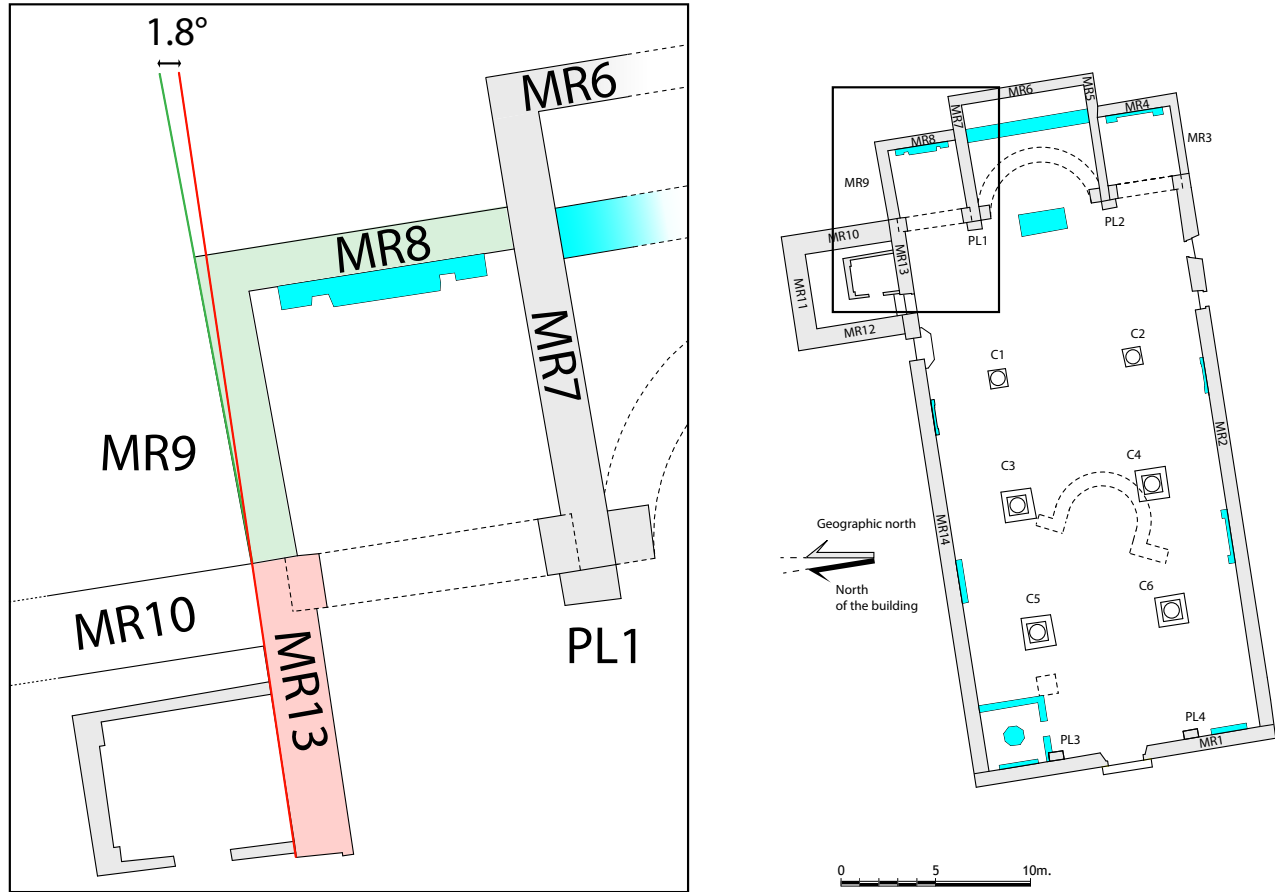
The delayed construction of both chapels is confirmed by the analysis of the church plan. In Figure 15, we firstly note the angular misalignment of 1.8° between the wall MR9 of the northern chapel and the wall MR13 of the nave (represented in red line and collinear to the central apse walls MR5 and MR7).

Figure 15: Zoom in the northeast lateral apse. A misalignment is observed between MR9 and MR13.

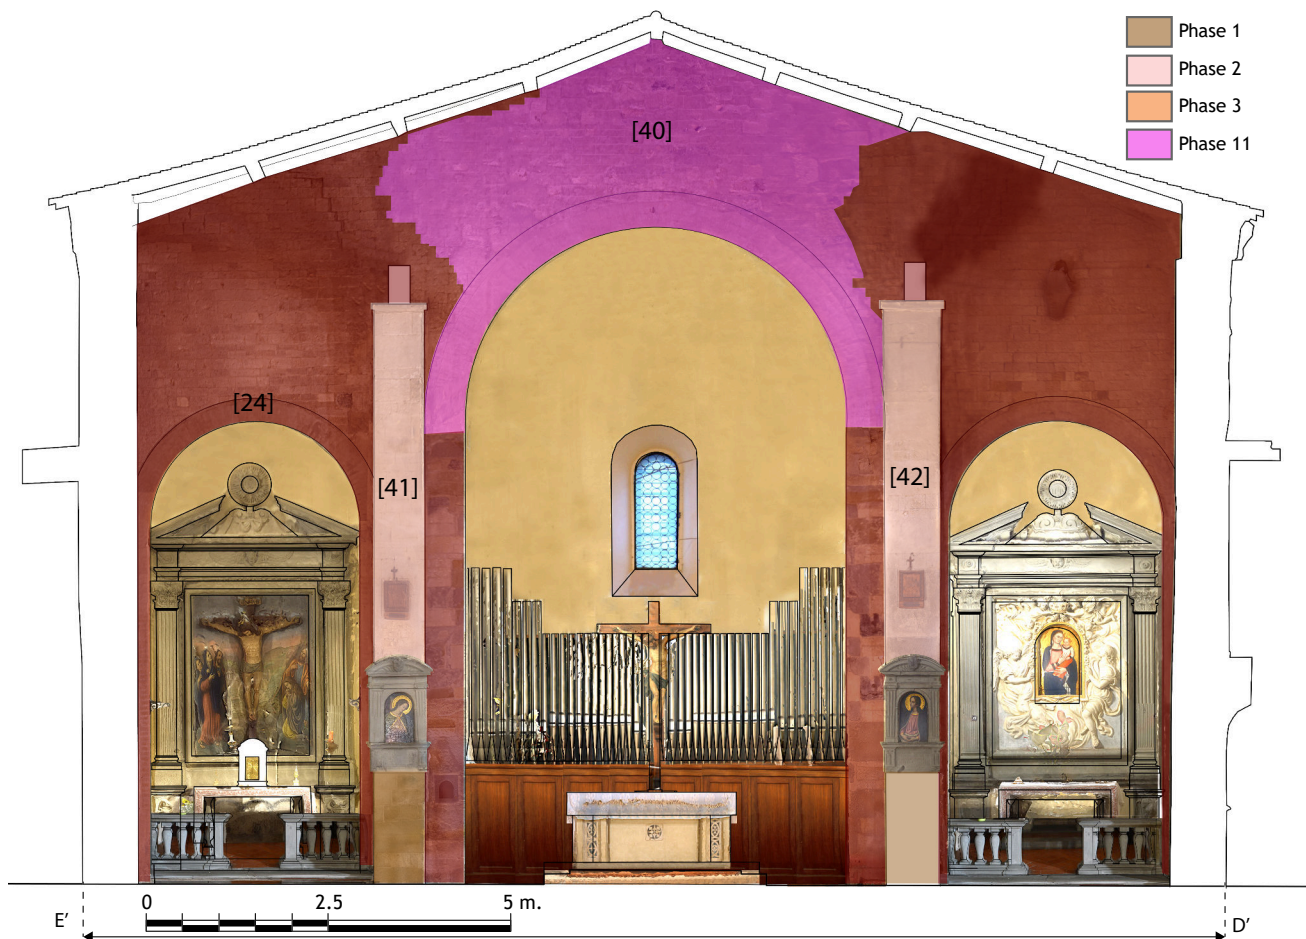
Figure 19: Stratigraphy of the inner east-facing of the church (MR4, MR6, MR8) showing phase 1, phase 2, phase 3 and phase 11. Phase 1 corresponds to the original construction of the Romanesque church. Phase 2 is identified as a repair of phase 1.

In 1819, some restoration works are done in the church choir corresponding to phase 11. The arc of the central apse (ARC2) is raised about 1.20 m (Brunori Cianti [2011]). This operation induced a partial destruction of the upper part of the choir. This restoration work is visible in pink in Figure 19. The two lateral apses are lengthened about 1.8 m (Brunori Cianti [2011]) but this work is no more visible because of the plaster on the walls.

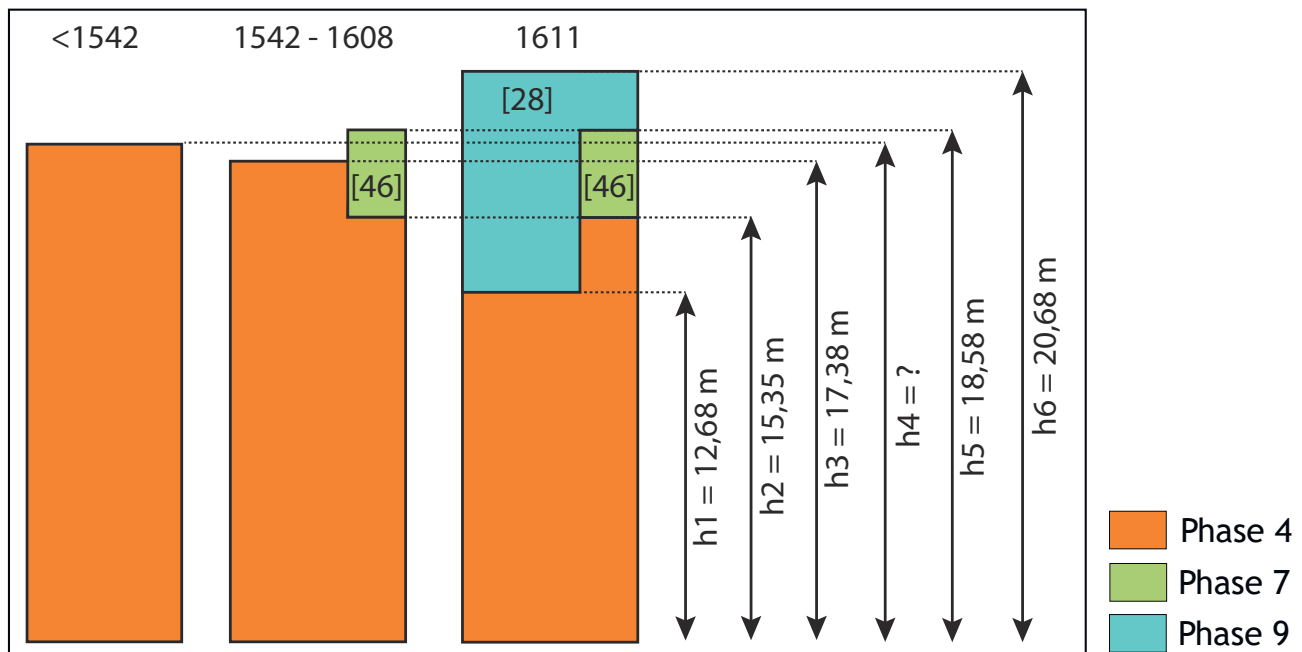
that the absence of historical documents would have made it impossible to identify such damage without a stratigraphic analysis. Phase 8 corresponds to the first repair work led by T. Nozzolini between 1608 and 1611 (Figure 24h) and is precisely described in his exceptional log book. The north penthouse is rebuilt and a new one is built along the south wall of the nave. Phase 9 is related with the repairs made by T. Nozzolini after the 1611 seismic event (Figure 24i). His log book as well as the stratigraphic analysis of the bell tower show a reconfiguration of the top of the building. The damaged walls were first reduced then raised up until the current configuration. The identified repairs as well as the historical description suggests a deep cracking of the bell tower (as shown in Figure 25b). The eastern door of the belltower is embedded during phase 10 (Figure 24j) as described by historical writings and corroborated by the stratigraphic analysis. In 1819, the central apse is raised up related to phase 11 (Figure 24k). Phase 12 corresponds to the infilling of the rose window and the repair of the front wall corner (Figure 24l). Modern restoration over the 20th century are done during phase 13. The dimensions of most structural elements over time are fairly well known (nave, side chapels, central apse). In the case of the height of the original bell tower (built during phase 4) we have no direct information since it was destroyed and rebuilt many times. However Figure 26 described how we constrained the original height (h4) from the identified successive repair units and the historical sources. Figure 26 focused on the west wall of the bell tower. The oldest limit is h2 (estimated at 15.35 m from orthophoto in Figure 8) corresponding to the height of the damaged bell tower just after the 1542 earthquake and on which people decided to rebuild the south wall of the bell tower. After the first repair of the bell tower (phase 7, OPUR 46) the maximal height (h5) of the south wall of bell tower is of 18.58m (deduced from stratigraphic analysis in Figure 8). Since only the south wall of the church has been rebuilt, we can give a first evaluation of the height of the belltower between h2 and h5 (i.e. between 15.35m and 18.58 m). Furthermore, this evaluation can be improved using additional information from Nozzolini’s notebook. Indeed the only Nozzolini’s work in the bell tower is the destruction of 4,7 m of the three walls until the still visible h1 limits. h3 is then deduced from h1 at 17,38 m which is inevitably lower than the original heighth h4. It is important to note that h2 and h3 are not necessary equal since a slight levelling probably had to be done in order to be able to build the south wall contrary to the three other walls of the bell tower. The original height h4 can thus be constrained between h3 and h5 (i.e. 17.38 m and 18.58 m).

Figure 26: Scheme of the west wall of the bell tower to discuss the evolution of its height over time. OPUR ID are specified in square brackets.

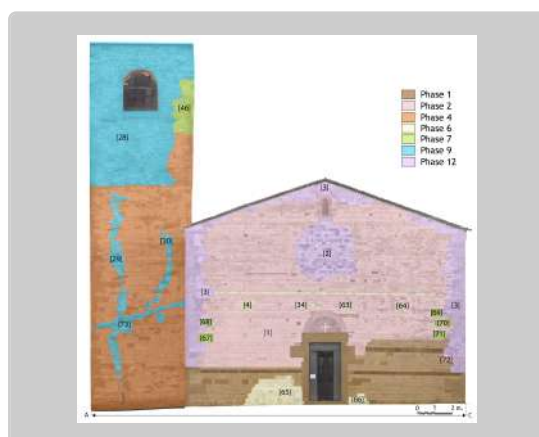
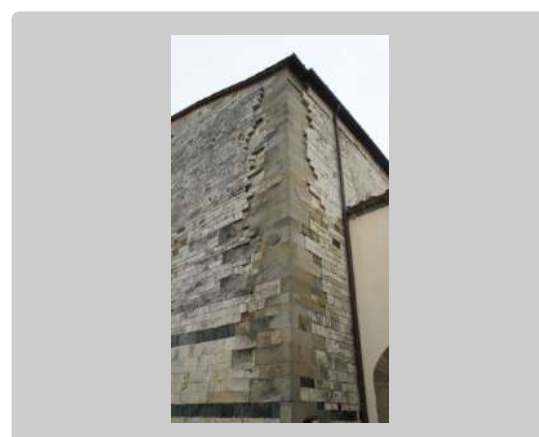
Identity **Intervention partial** - ACoR : TCM2
Repaired part(s) : North, South ; Upper part, Middle part

Hazard **Supposed collapse** (Rocking. Partial overturning of the wall with rotations axis at the floor level)
Ancient origin : undetermined - Probability of the event undetermined

Repair **Reconstruction**
Dimensions (cm) : Length 1500 (preserved), Width 1510, Height 1191
Masonry : Stone, Mortar [Lime and sand]

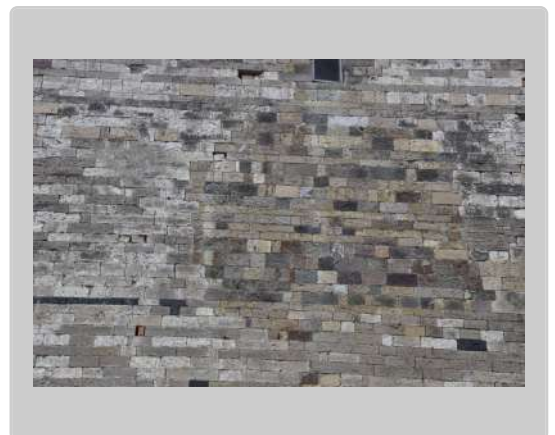
Id. OPUR 2

Identity **Intervention partial - ACoR** : TCM3
Repaired part(s) : North, South ; Upper part

Hazard **Settling**
Ancient origin : undetermined - Probability of the event undetermined

Repair **Reconstruction**
Dimensions (cm) : Lenght scanner, Width 339, Height 390
Masonry, Filling-in : Stone, Mortar [Lime and sand] [dimension of elements : about 10°-20 cm]

Other precisions External facing of the front wall of the church (MR1) : Infilling of the rose window.
Use of limestone (Pietra Alberese) and Serpentine course. Decimetric blocks.
Undetermined origin. Such an infilling of the previous rose window might be considered as a common reconfiguration work even if it is sometimes made as a postseismic repair.
