Tracing the seismic history of Sant'Agata del Mugello (Italy, Tuscany) through a cross-disciplinary approach

Tracing the seismic history of Sant'Agata del Mugello (Italy, Tuscany) through a cross-disciplinary approach.

Keywords— historical seismicity, historical sources, building stratigraphy, architecture, structural analysis, damage mechanisms, Central Italy

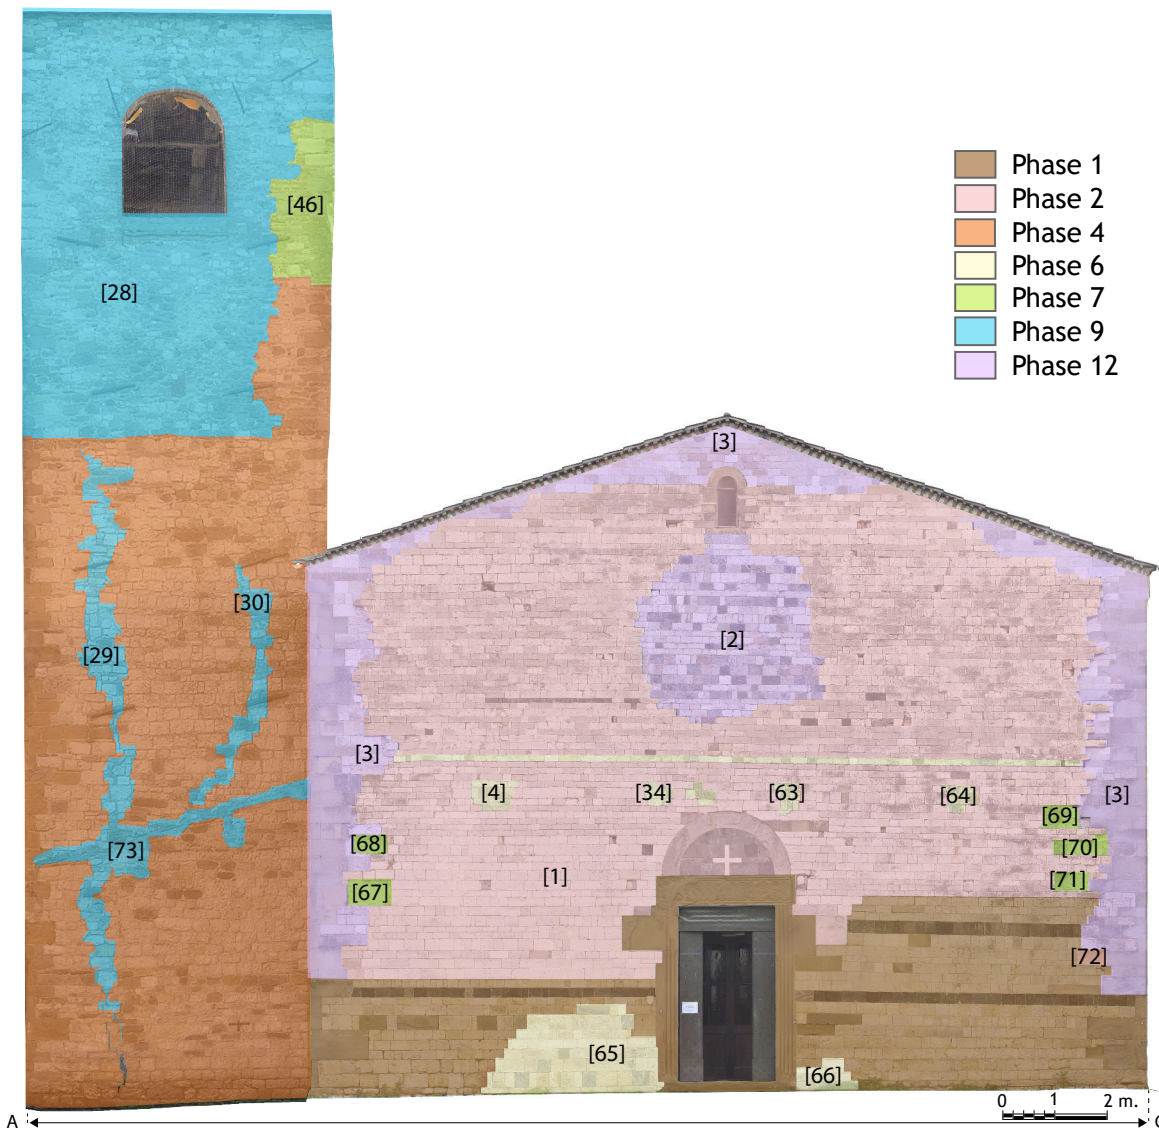
Figure 8: Stratigraphy of the front wall (MR1, external west-facing of the church and MR12, external west-facing of the bell tower) showing phase 1, phase 2, phase 7, phase 8 and phase 13. Phase 1 corresponds to the original construction of the current Romanesque church. Phase 2 is identified as a repair of phase 1.

In the external part, the wall as well as the corners quoins using technique TCM1 are repaired using technique TCM2 (Figure 8). We note the particular case of the south wall corner. The wall corner of phase 1 is repaired using a block of sandstone (in pink in Figure 8) belonging to phase 2. This quoin is nowadays isolated because of a third repair identified as phase 13 described below (phase 13 is associated with a second repair of the corner quoins). In the internal facing (MR1), such a limit is visible on the wall as well as on both pilasters PL3 and PL4 (Figure 9). The use of the technique TCM2 indicates the limit between the first and second constructive phase. Although the limit between phase 1 and phase 2 is mainly reported on the front wall, it is also observed in the external north facing wall of the nave (MR14 shown in Figure 10) at the bottom right. Phase 1 is not visible on the north wall inside the church (Figure 11) not only because the ground is higher but also because this part of the wall has not been repaired. This is an indication of the typology of masonry using the "sacco" technique (this technique corresponds to the filling between two wall claddings). Inside the church, we note that both columns C1 and C2 use TCM1 in the lower part and TCM2 in the upper part. Reminding that the technique of construction TCM2 is dated from the 13th century (Arrighetti [2017]), we date the second phase of the building between 984 and the 13th century. In the absence of historical data, it is difficult to determine an origin to such a deep reconstruction of the church (anthropogenic origin, fire, natural disaster, ...).

In the church, three chimneys collapsed, the cracks caused by the 1542 seismic event reopened and new cracks are detected. Such damage are visible in Figure 8. Because the belltower is particularly damaged, Nozzolini proposed a deep restoration of the building as described in its notebook (Brunori Cianti [2011], p 89).

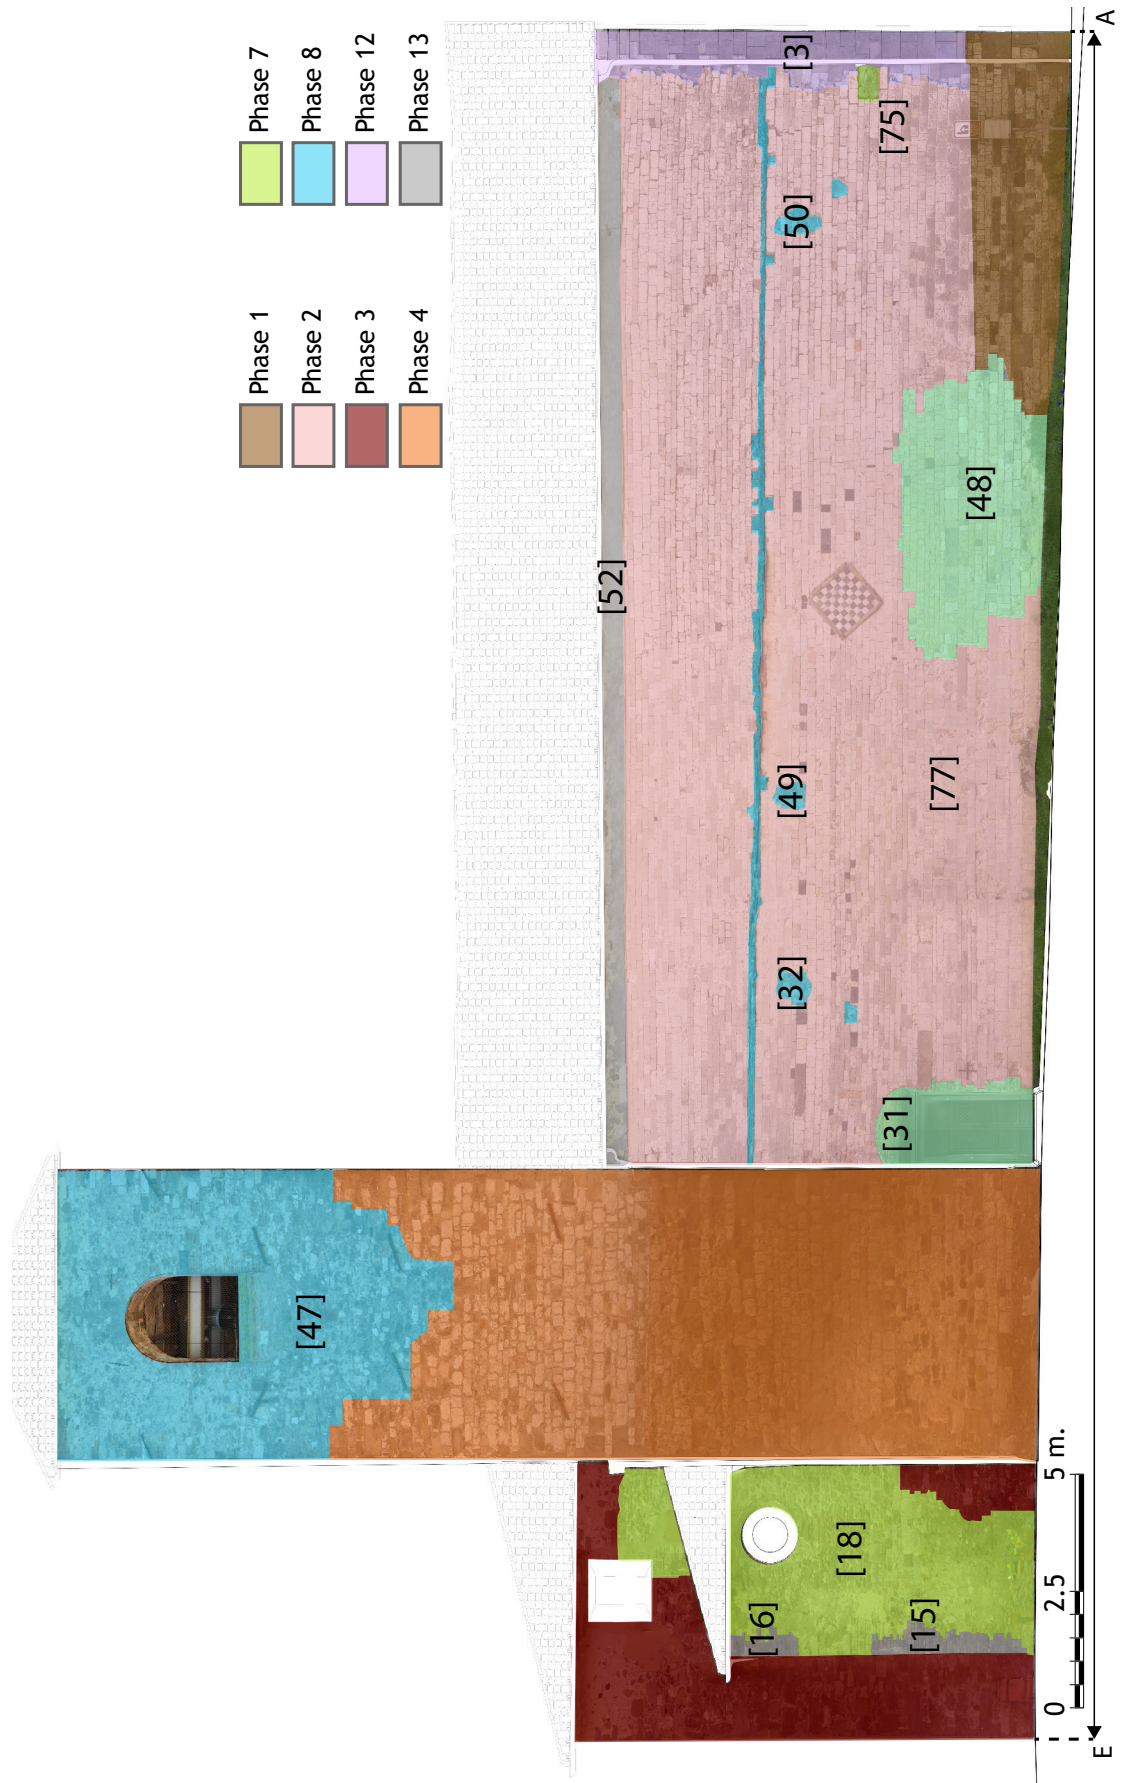
Figure 10: Stratigraphy of the external north-facing of the church (MR14) including the nave (on the right), the bell tower (on the middle) and the north lateral chapel. Phase 1, phase 2, phase 3, phase 4, phase 7, phase 8, phase 12, and phase 13 are identified.

Nozzolini describes the restoration of the roof of the church, as well as the porch of the bell tower. Even if the stratigraphic analysis detects the evidence of a previous porch along the north wall of the church (in blue in Figure 10) and the west wall of the bell tower (in blue in Figure 8), it does not correspond to the porch described by Nozzolini. We believe the so called porch was located against the east wall of the bell tower since a door existed at that time The priest also did some repairs in the dovecote (under the roof of the bell tower) (p. 87, Brunori Cianti [2011]) and he leveled also the ground of the church as it is nowadays observed (Brunori Cianti [2011], p 82) :

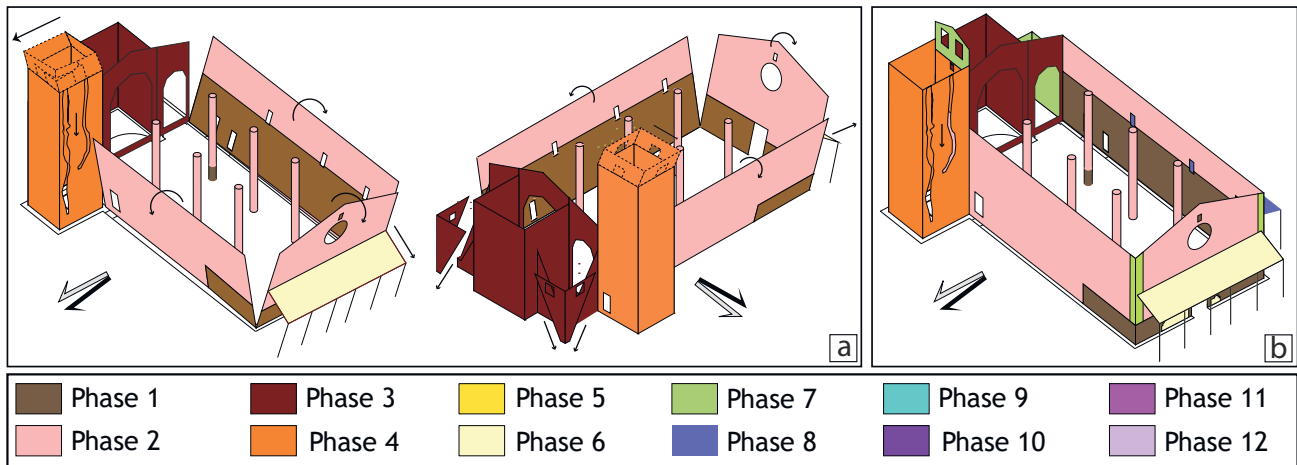
Figure 25: Sketches of the damage mechanisms identified for both, the 1542 (a) and 1611 (b) seismic event.

Archives as well as stratigraphic data show that the top of the bell tower probably collapsed. The north, east and west facing wall of the bell tower were directly covered with a roof (15,5 m high deduced by the bottom limit of OPUR 44, 45 and 46 which also preserved such a limit from other construction phases) while the south wall is raised up above the roof (19,7 m high deduced from opur 44, 45 and 46). The dimensions of the church after such repairs are deduced from Nozzolini's description since he leveled it off 4,7 m. The nave currently has titling walls. Even if the induced damage of the front wall were repaired again when Nozzolini arrived 66 years after the 1542 earthquake, the repairs of the corner quoins are still visible (in green in Figure 24). It induced a bending of the three walls of the nave (Figure 25a). Such a bending is still visible since the corner walls are vertical while the middle part of the nave is bending. An important repair of the two lateral chapel is detected only by stratigraphic analysis. The failure mechanism deduced from such repair is a collapse of both chapels (Figure 25a on the right). It is important to note

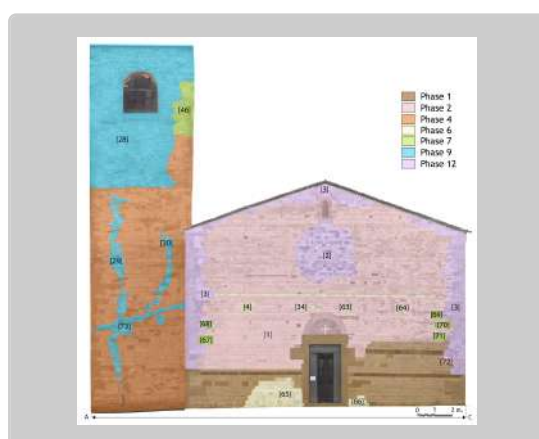
Identity **Intervention partial** - ACoR : TCM2
Repaired part(s) : North, South ; Upper part, Middle part

Hazard **Supposed collapse** (Rocking. Partial overturning of the wall with rotations axis at the floor level)
Ancient origin : undetermined - Probability of the event undetermined

Repair **Reconstruction**
Dimensions (cm) : Length 1500 (preserved), Width 1510, Height 1191
Masonry : Stone, Mortar [Lime and sand]

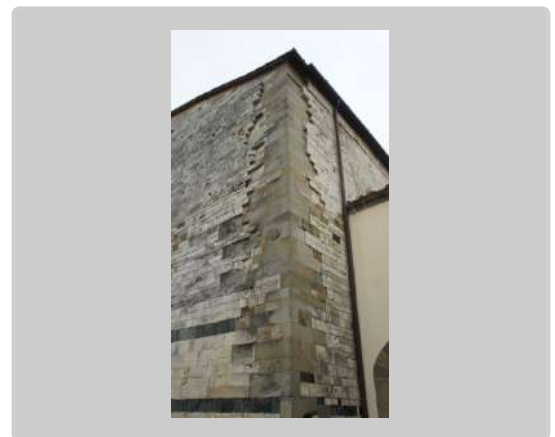
Id. OPUR 3

Identity **Intervention partial** - ACoR : TCM6
Repaired part(s) : North, South ; Middle part, Upper part

Hazard **Deformation** (Corner overturning)
Ancient origin : earthquake - Probability of the event strong

Other precisions Repair of the two corner quoins of the front wall (MR1) as well as the upper part of the wall. The repair is particularly visible because of a centimetric shift between opur 6 and opur 1.

We associated this repair with a seismic event. First it is a typical repair due to a global overturning of the front wall. Such a damage is secondly described in historical source (Tolomeo Nozzolini's log book).

Repair **Not indicated**
Dimensions (cm) : Width 123, Height 787
Masonry, Block : Stone, Mortar [Lime and sand] [dimension of elements : between 20 and 50 cm]
