## Tracing the seismic history of Sant'Agata del Mugello (Italy, Tuscany) through a cross-disciplinary approach

# Tracing the seismic history of Sant'Agata del Mugello (Italy, Tuscany) through a cross-disciplinary approach.

Arnaud MONTABERT<sup>\*1,4,5</sup>, Hélène DESSALES<sup>2</sup>, Andrea ARRIGHETTI<sup>3</sup>, Julien CLEMENT<sup>4</sup>, Maria LANCIERI<sup>5</sup>, and Hélène LYON-CAEN<sup>1</sup>

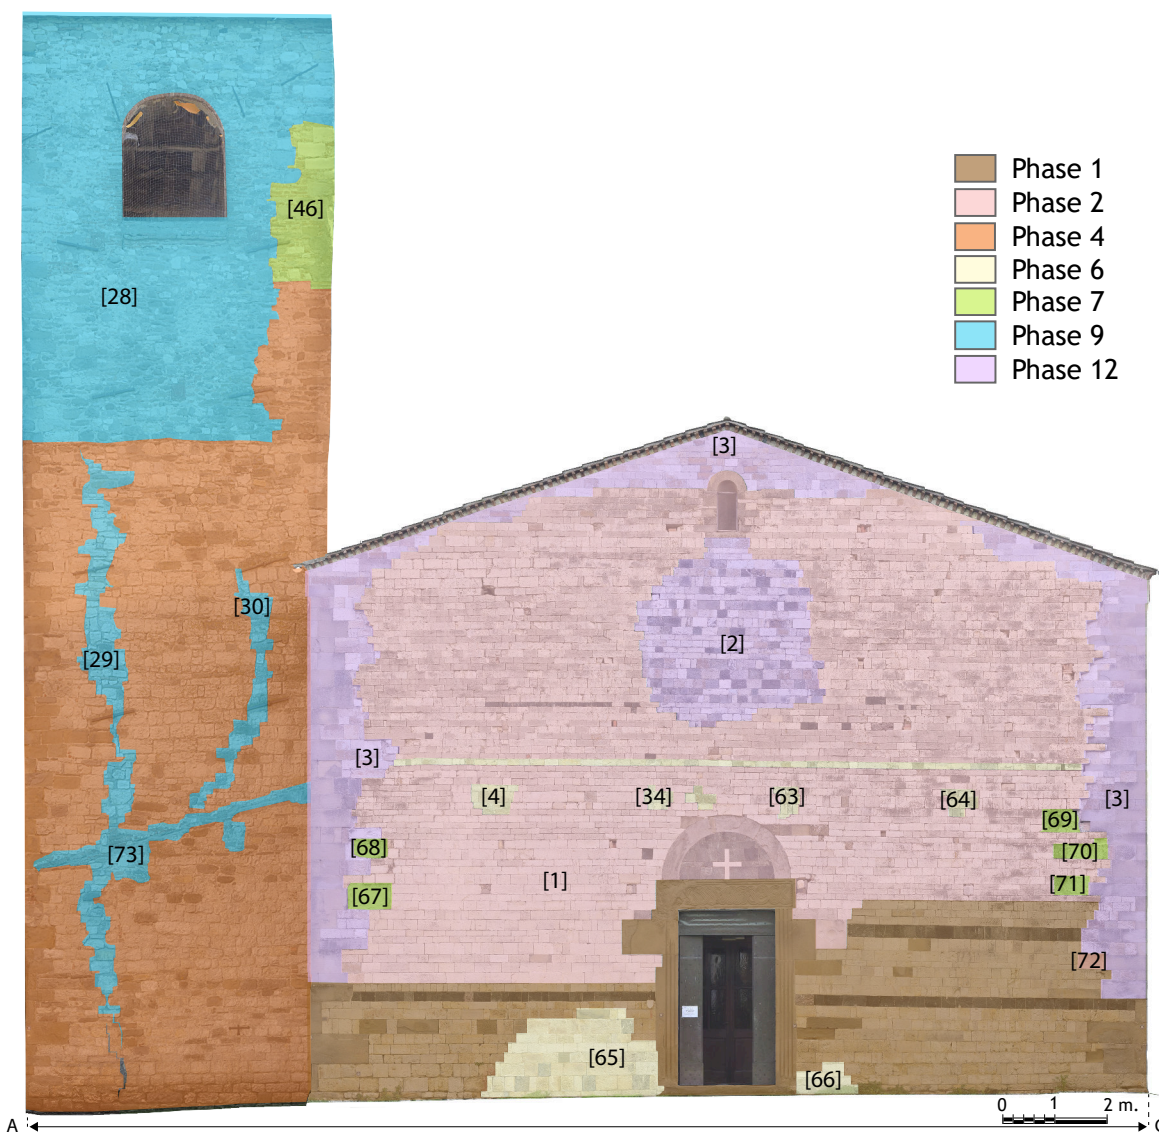
Figure 8: Stratigraphy of the front wall (MR1, external west-facing of the church and MR12, external west-facing of the bell tower) showing phase 1, phase 2, phase 7, phase 8 and phase 13. Phase 1 corresponds to the original construction of the current Romanesque church. Phase 2 is identified as a repair of phase 1.

In the external part, the wall as well as the corners quoins using technique TCM1 are repaired using technique TCM2 (Figure 8). We note the particular case of the south wall corner. The wall corner of phase 1 is repaired using a block of sandstone (in pink in Figure 8) belonging to phase 2. This quoin is nowadays isolated because of a third repair identified as phase 13 described below (phase 13 is associated with a second repair of the corner quoins). In the internal facing (MR1), such a limit is visible on the wall as well as on both pilasters PL3 and PL4 (Figure 9). The use of the technique TCM2 indicates the limit between the first and second constructive phase. Although the limit between phase 1 and phase 2 is mainly reported on the front wall, it is also observed in the external north facing wall of the nave (MR14 shown in Figure 10) at the bottom right. Phase 1 is not visible on the north wall inside the church (Figure 11) not only because the ground is higher but also because this part of the wall has not been repaired. This is an indication of the typology of masonry using the "sacco" technique (this technique corresponds to the filling between two wall claddings). Inside the church, we note that both columns C1 and C2 use TCM1 in the lower part and TCM2 in the upper part. Reminding that the technique of construction TCM2 is dated from the 13<sup>th</sup> century (Arrighetti [2017]), we date the second phase of the building between 984 and the 13<sup>th</sup> century. In the absence of historical data, it is difficult to determine an origin to such a deep reconstruction of the church (anthropogenic origin, fire, natural disaster, ...).

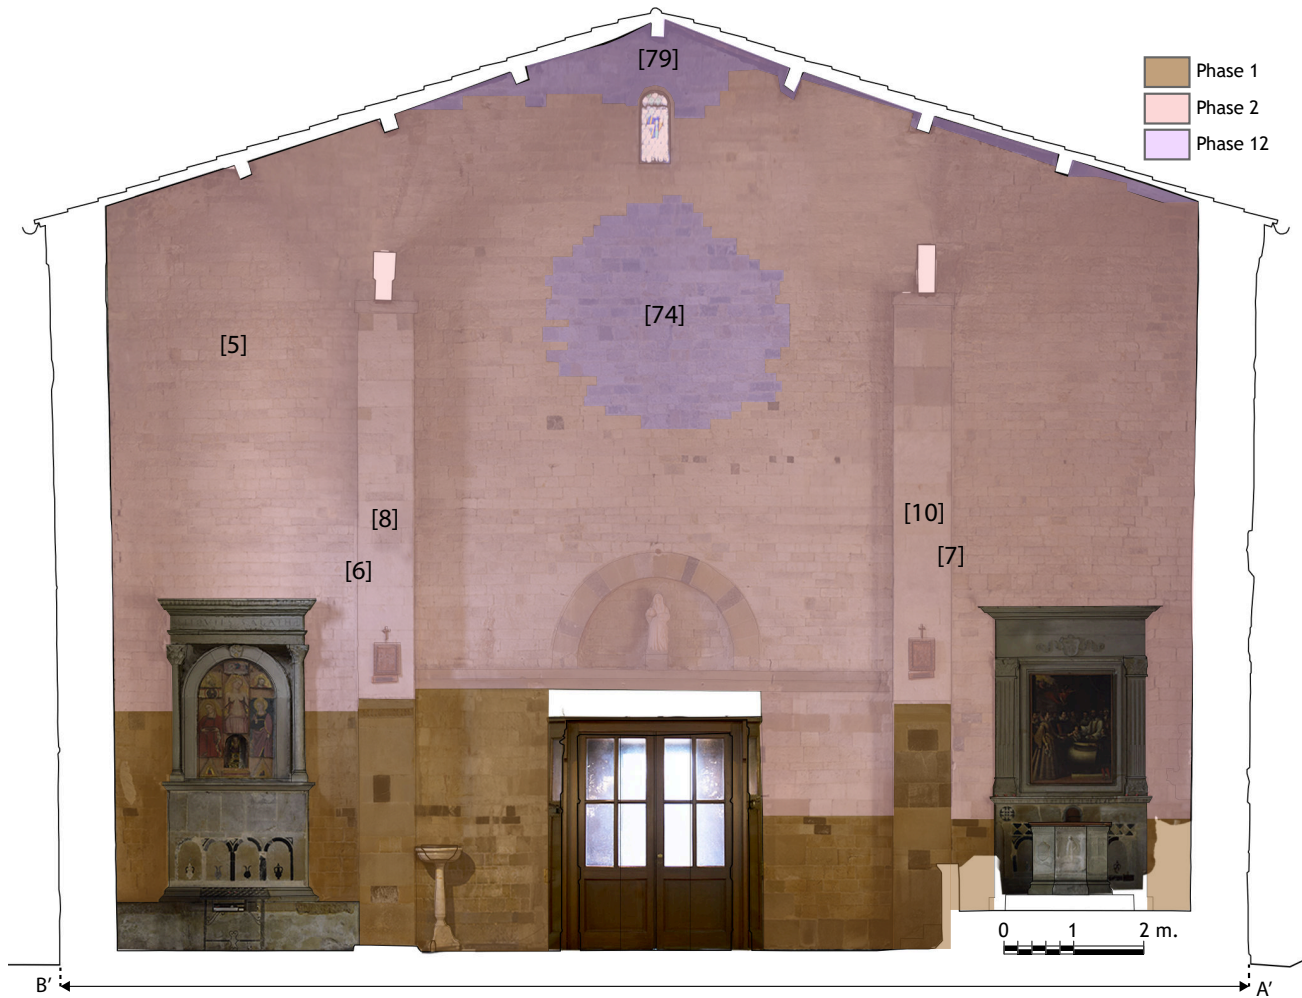
Figure 9: Stratigraphy of the facade (MR1, internal west-facing of the church) showing phase 1, phase 2 and phase 13. Phase 1 corresponds to the original construction of the Romanesque church. Phase 2 is identified as a repair of phase 1.

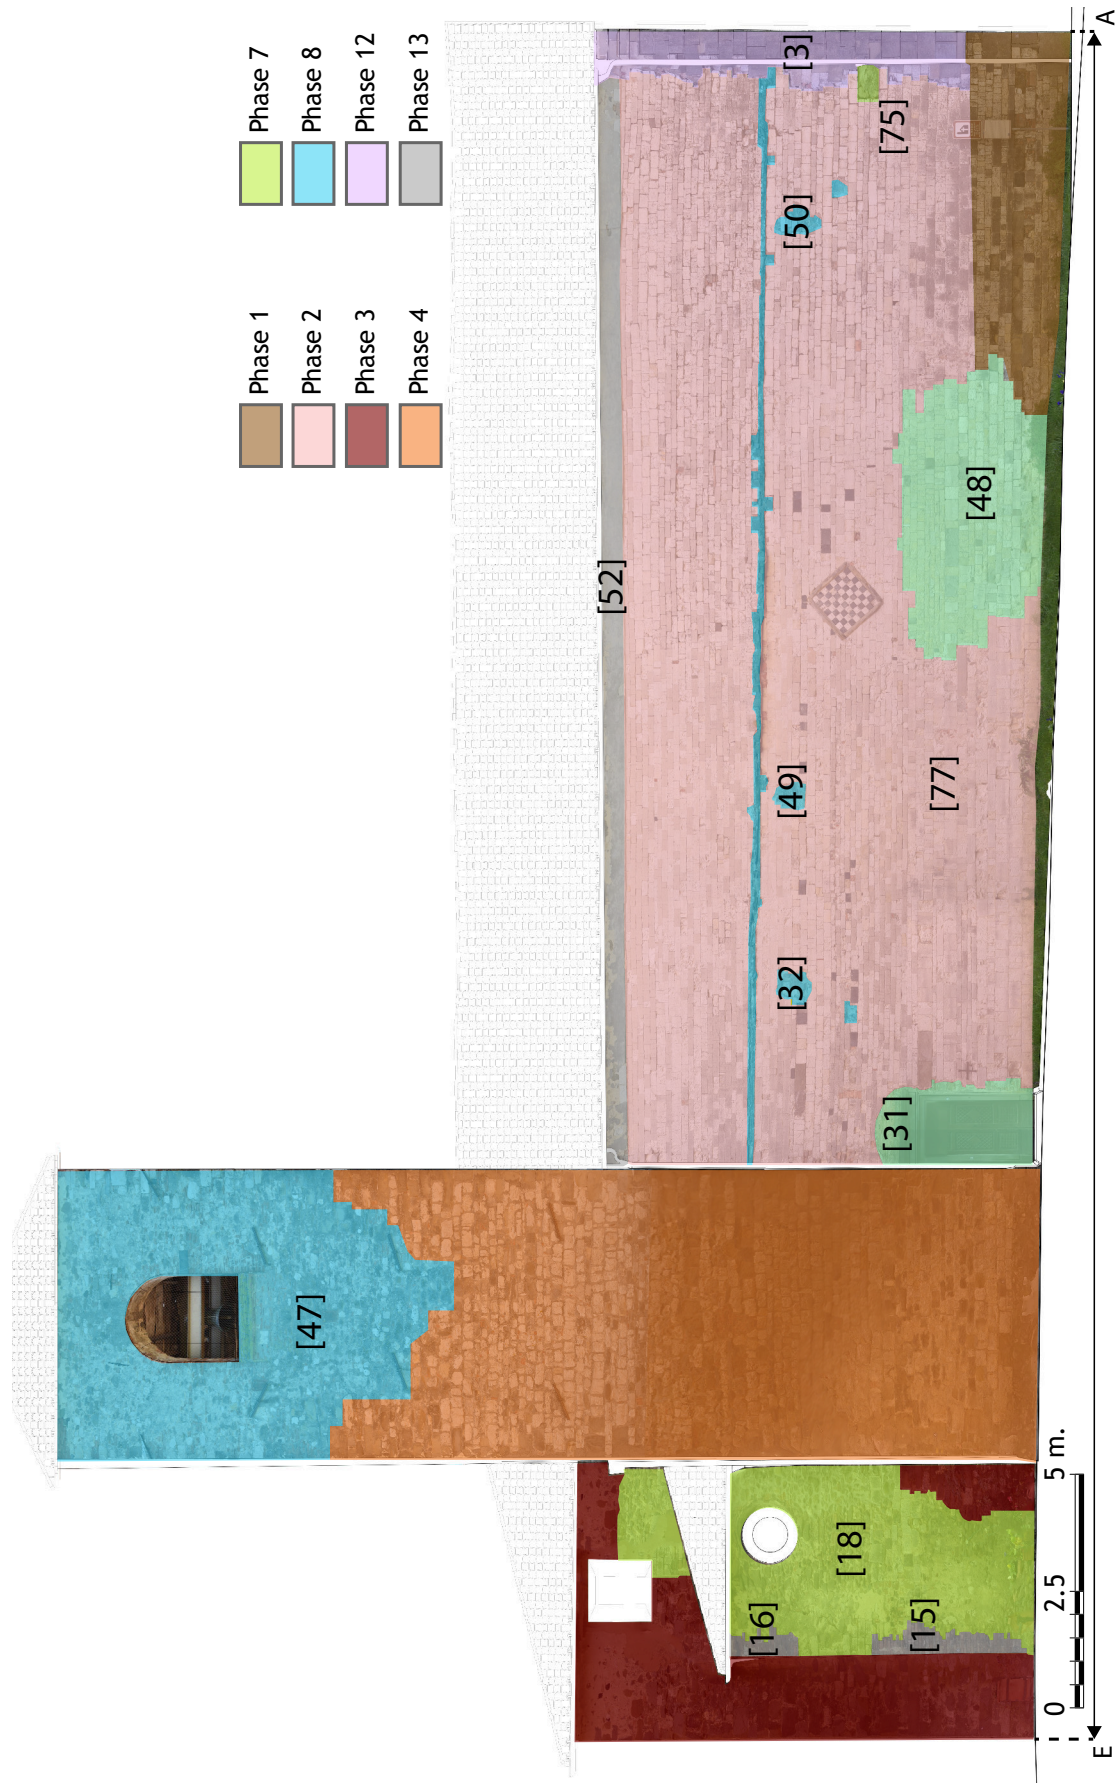
Figure 10: Stratigraphy of the external north-facing of the church (MR14) including the nave (on the right), the bell tower (on the middle) and the north lateral chapel. Phase 1, phase 2, phase 3, phase 4, phase 7, phase 8, phase 12, and phase 13 are identified.

Nozzolini describes the restoration of the roof of the church, as well as the porch of the bell tower. Even if the stratigraphic analysis detects the evidence of a previous porch along the north wall of the church (in blue in Figure 10) and the west wall of the bell tower (in blue in Figure 8), it does not correspond to the porch described by Nozzolini. We believe the so called porch was located against the east wall of the bell tower since a door existed at that time The priest also did some repairs in the dovecote (under the roof of the bell tower) (p. 87, Brunori Cianti [2011]) and he leveled also the ground of the church as it is nowadays observed (Brunori Cianti [2011], p 82) :

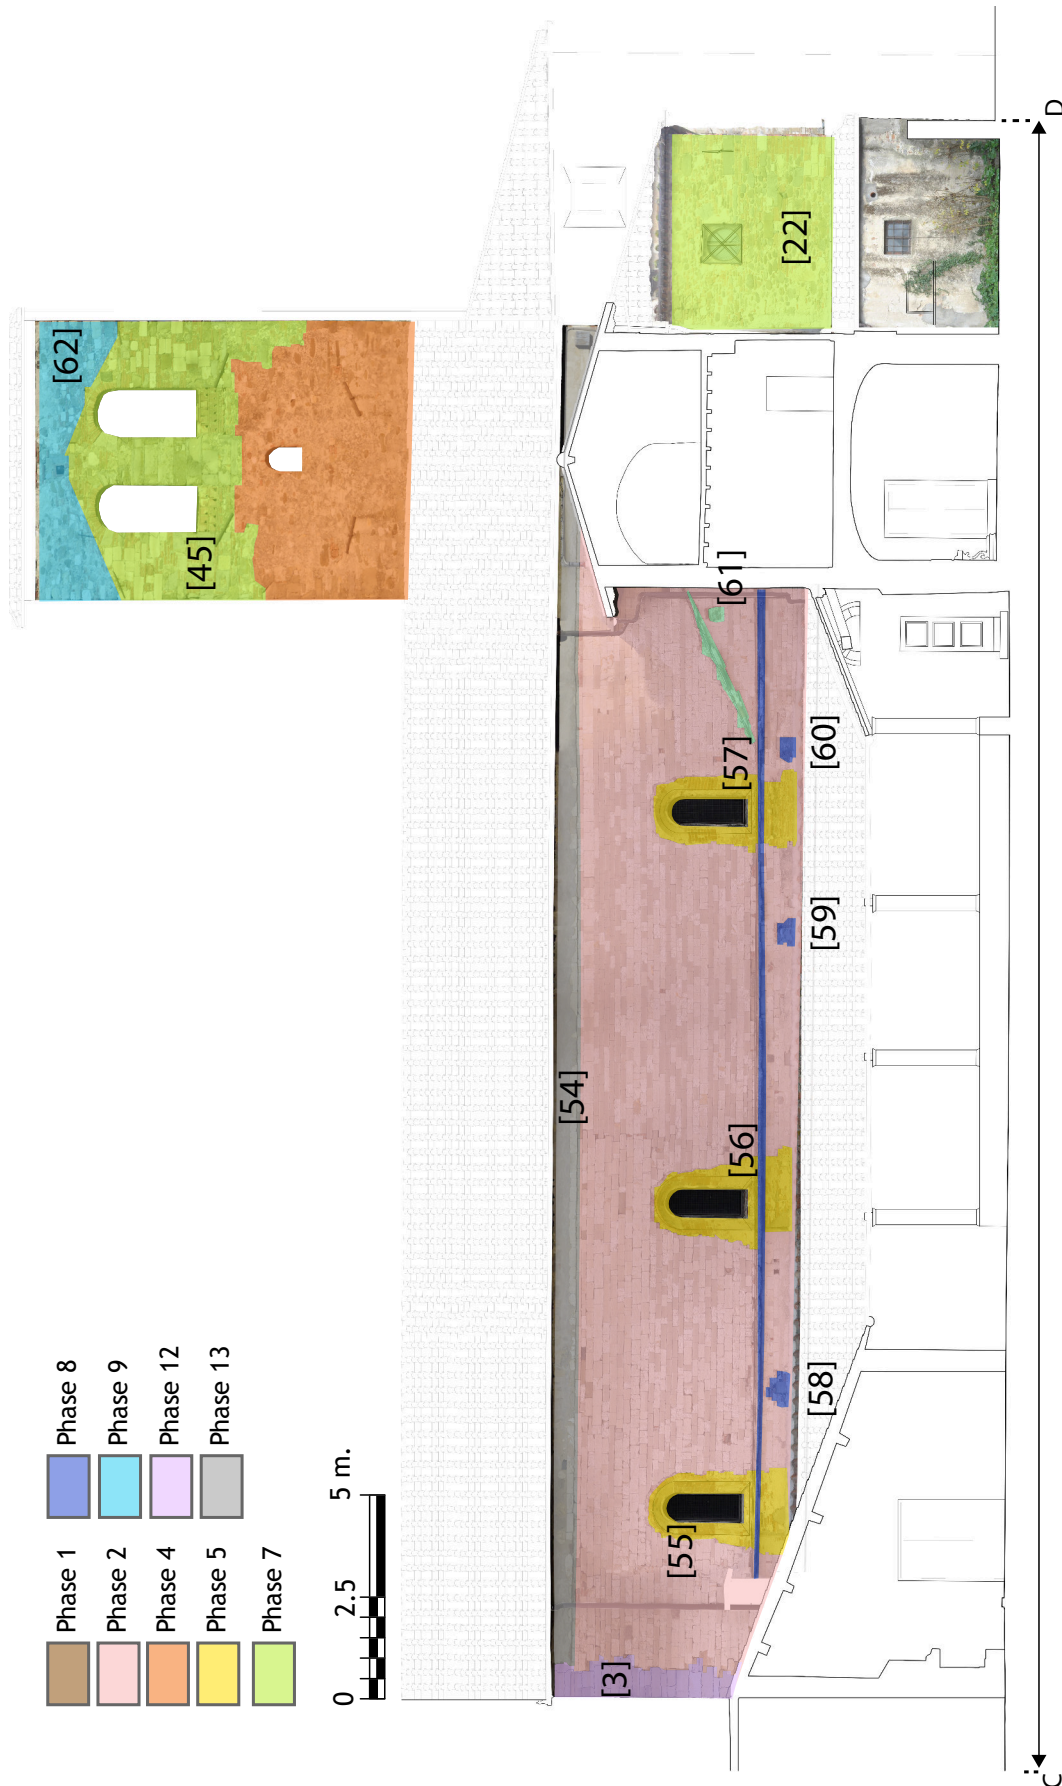
Figure 12: Stratigraphy of the external south-facing of the church (MR2) including the nave (on the left), the bell tower (on the middle) and the south lateral chapel. Phase 2, phase 4, phase 5, phase 7, phase 8, phase 9, phase 12, and phase 13 are identified.

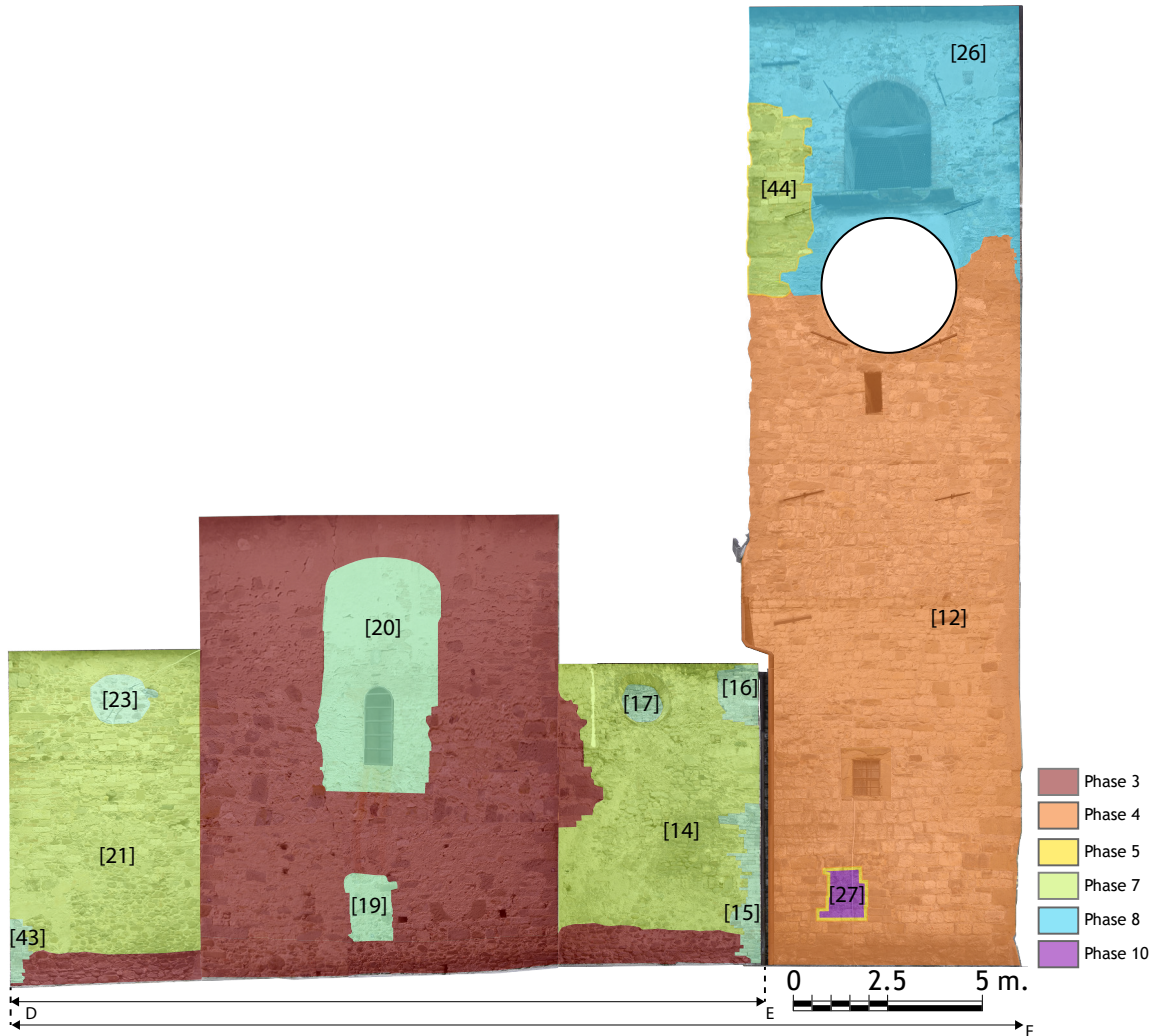
Figure 14: Stratigraphy of the external east-facing of the church (MR4, MR6, MR8) including the bell tower (on the right), the central apse and both lateral chapels. Phase 3, phase 4, phase 5, phase 7, phase 8, and phase 10 are identified.

According to R. Ajazzi [1887] the east door of the bell tower is embedded in 1659. This repair is still visible in Figure 14 (in purple) and corresponds to phase 10.

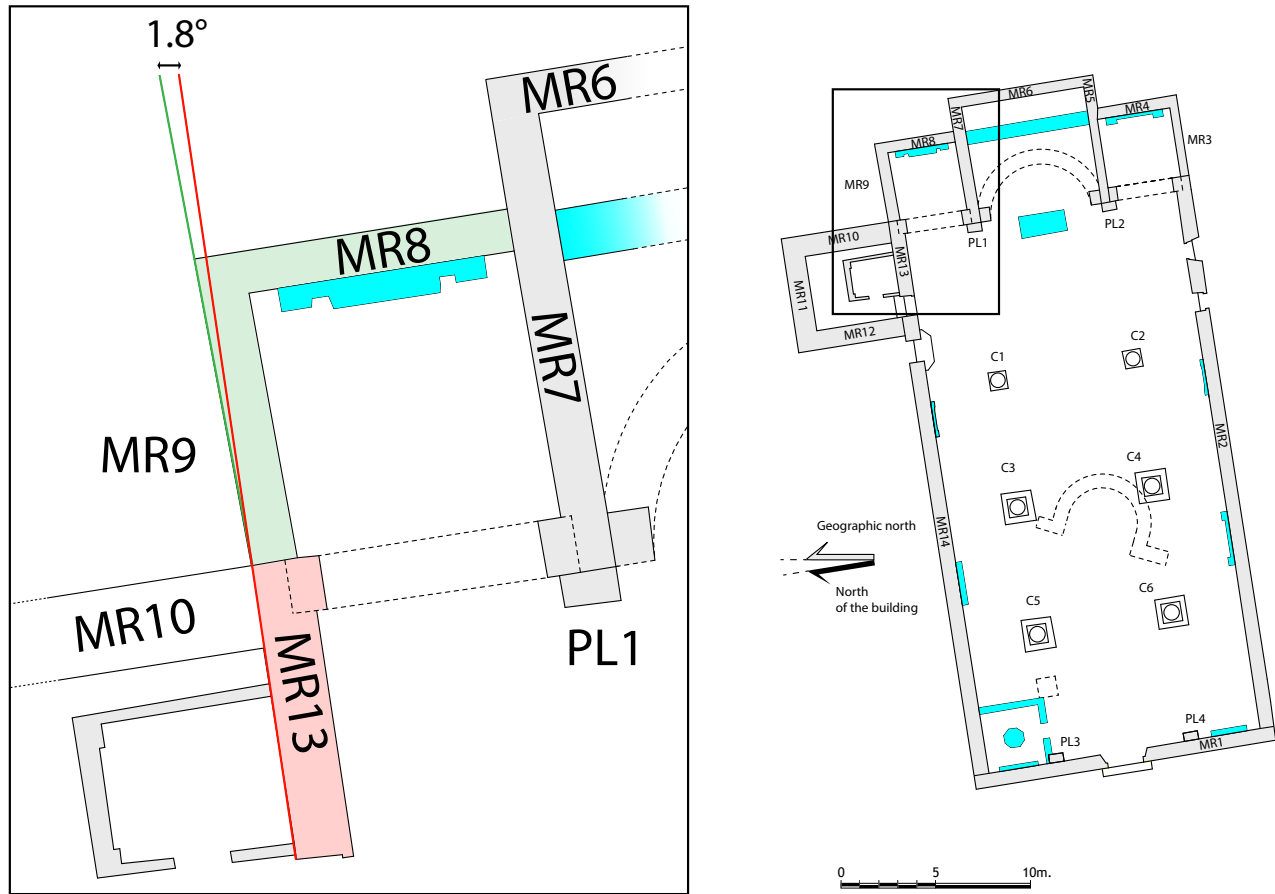
The delayed construction of both chapels is confirmed by the analysis of the church plan. In Figure 15, we firstly note the angular misalignment of 1.8° between the wall MR9 of the northern chapel and the wall MR13 of the nave (represented in red line and collinear to the central apse walls MR5 and MR7).

Figure 15: Zoom in the northeast lateral apse. A misalignment is observed between MR9 and MR13.

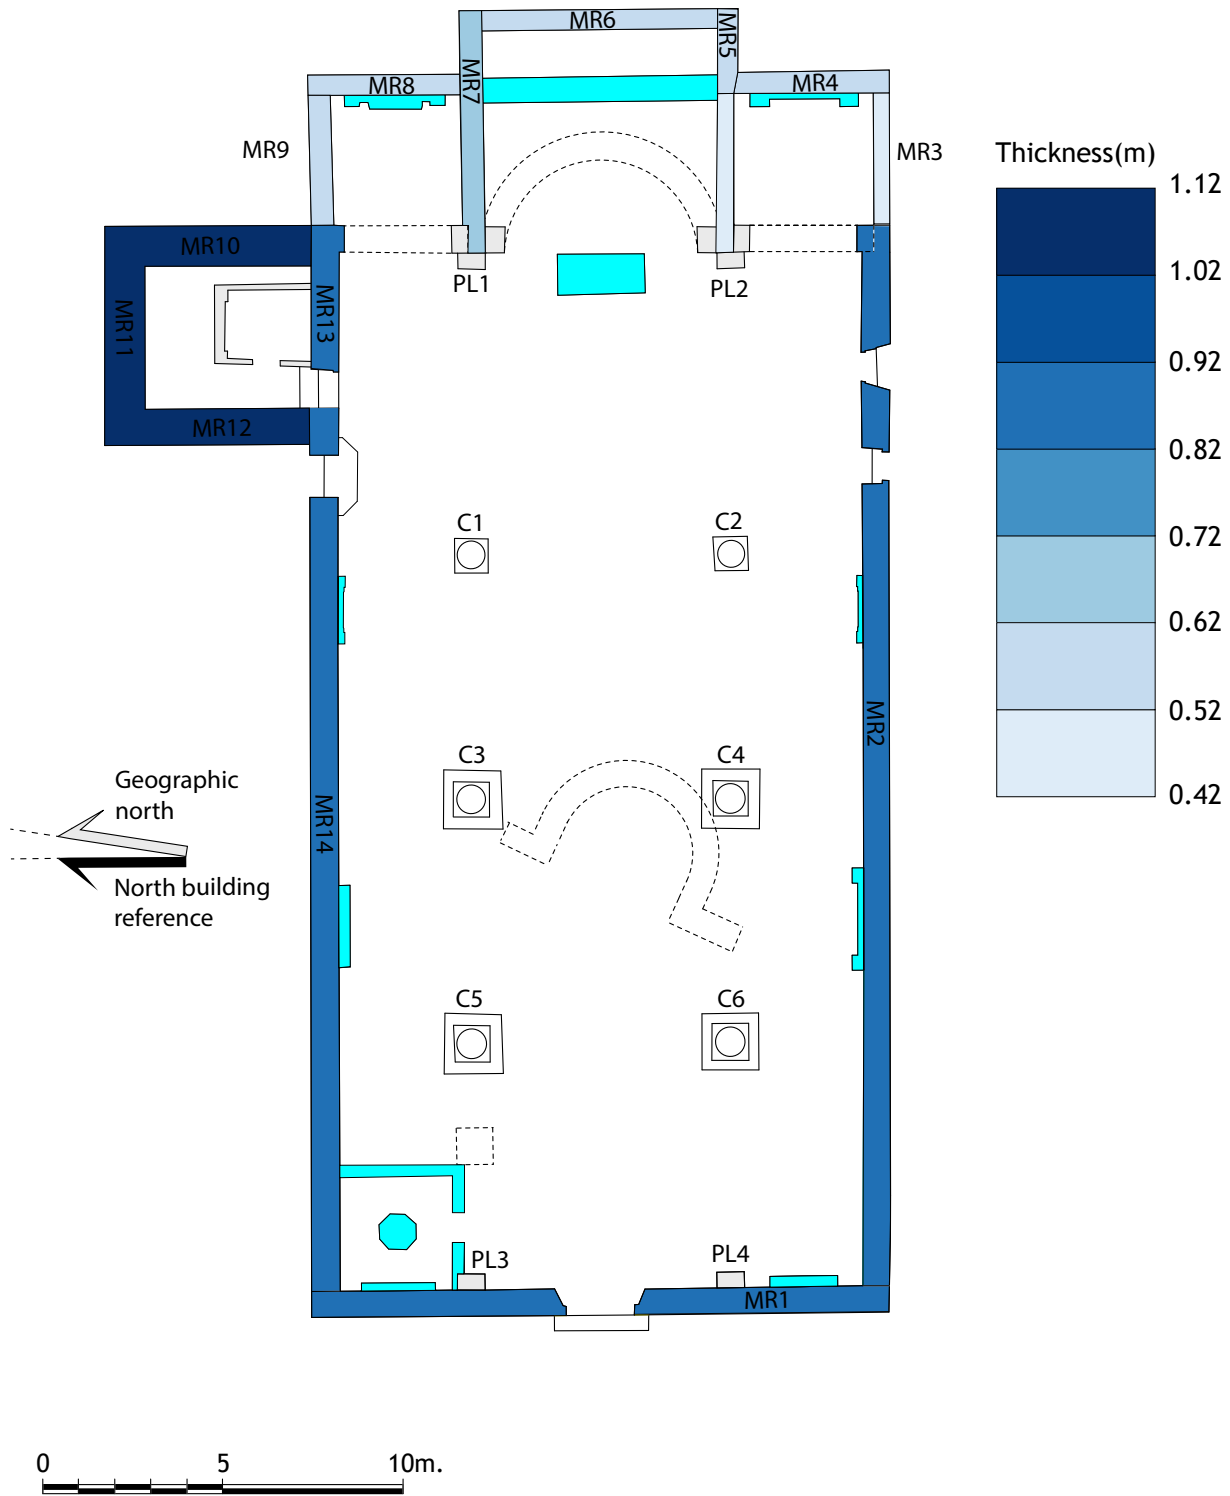
The thickness of both walls at the bottom is different as shown in Figure 16 (77 cm for MR13 and 61 cm for MR9).

Figure 16: Thickness of the church walls going from 0.42 m to 1.12 m. Such a difference characterizes the building evolution of the church over time.

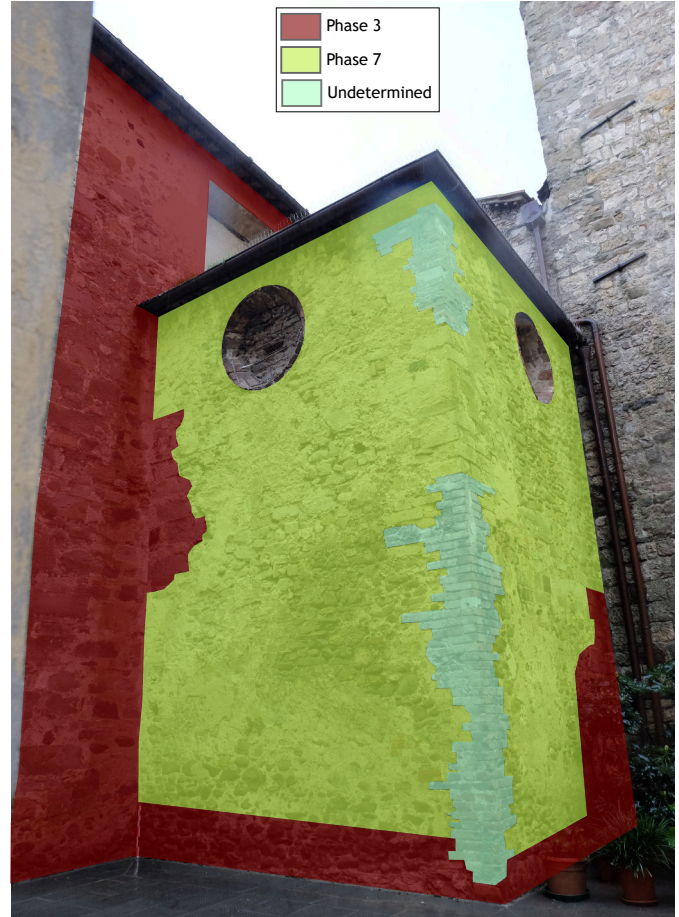
Figure 17: The north lateral chapel. The first phase of the building is colored in red. The green part corresponds to a repair of the first phase.

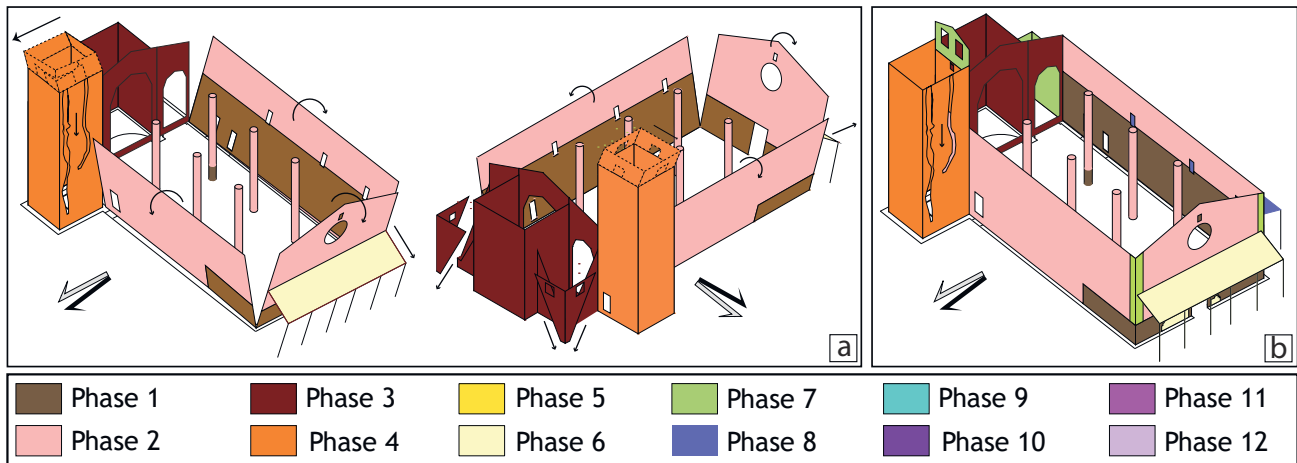
Figure 25: Sketches of the damage mechanisms identified for both, the 1542 (a) and 1611 (b) seismic event.

Archives as well as stratigraphic data show that the top of the bell tower probably collapsed. The north, east and west facing wall of the bell tower were directly covered with a roof (15,5 m high deduced by the bottom limit of OPUR 44, 45 and 46 which also preserved such a limit from other construction phases) while the south wall is raised up above the roof (19,7 m high deduced from opur 44, 45 and 46). The dimensions of the church after such repairs are deduced from Nozzolini's description since he leveled it off 4,7 m. The nave currently has titling walls. Even if the induced damage of the front wall were repaired again when Nozzolini arrived 66 years after the 1542 earthquake, the repairs of the corner quoins are still visible (in green in Figure 24). It induced a bending of the three walls of the nave (Figure 25a). Such a bending is still visible since the corner walls are vertical while the middle part of the nave is bending. An important repair of the two lateral chapel is detected only by stratigraphic analysis. The failure mechanism deduced from such repair is a collapse of both chapels (Figure 25a on the right). It is important to note

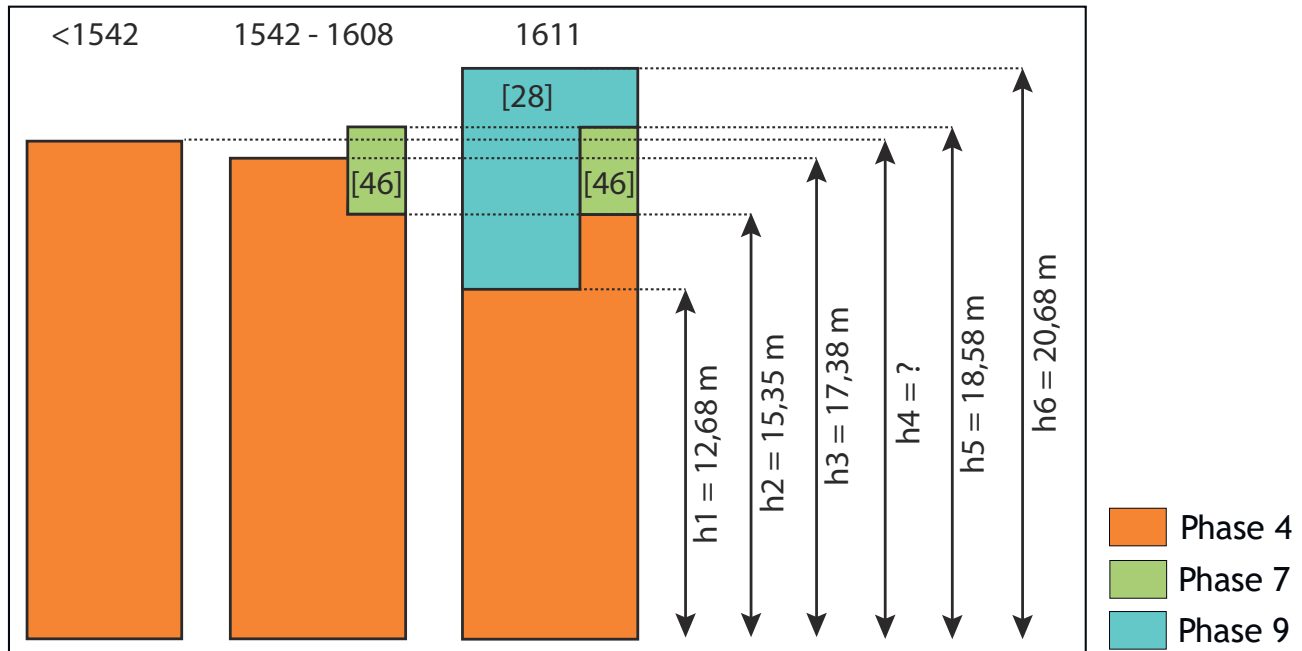
that the absence of historical documents would have made it impossible to identify such damage without a stratigraphic analysis. Phase 8 corresponds to the first repair work led by T. Nozzolini between 1608 and 1611 (Figure 24h) and is precisely described in his exceptional log book. The north penthouse is rebuilt and a new one is built along the south wall of the nave. Phase 9 is related with the repairs made by T. Nozzolini after the 1611 seismic event (Figure 24i). His log book as well as the stratigraphic analysis of the bell tower show a reconfiguration of the top of the building. The damaged walls were first reduced then raised up until the current configuration. The identified repairs as well as the historical description suggests a deep cracking of the bell tower (as shown in Figure 25b). The eastern door of the belltower is embedded during phase 10 (Figure 24j) as described by historical writings and corroborated by the stratigraphic analysis. In 1819, the central apse is raised up related to phase 11 (Figure 24k). Phase 12 corresponds to the infilling of the rose window and the repair of the front wall corner (Figure 24l). Modern restoration over the 20<sup>th</sup> century are done during phase 13. The dimensions of most structural elements over time are fairly well known (nave, side chapels, central apse). In the case of the height of the original bell tower (built during phase 4) we have no direct information since it was destroyed and rebuilt many times. However Figure 26 described how we constrained the original height (h4) from the identified successive repair units and the historical sources. Figure 26 focused on the west wall of the bell tower. The oldest limit is h2 (estimated at 15.35 m from orthophoto in Figure 8) corresponding to the height of the damaged bell tower just after the 1542 earthquake and on which people decided to rebuild the south wall of the bell tower. After the first repair of the bell tower (phase 7, OPUR 46) the maximal height (h5) of the south wall of bell tower is of 18.58m (deduced from stratigraphic analysis in Figure 8). Since only the south wall of the church has been rebuilt, we can give a first evaluation of the height of the belltower between h2 and h5 (i.e. between 15.35m and 18.58 m). Furthermore, this evaluation can be improved using additional information from Nozzolini’s notebook. Indeed the only Nozzolini’s work in the bell tower is the destruction of 4,7 m of the three walls until the still visible h1 limits. h3 is then deduced from h1 at 17,38 m which is inevitably lower than the original heighth h4. It is important to note that h2 and h3 are not necessary equal since a slight levelling probably had to be done in order to be able to build the south wall contrary to the three other walls of the bell tower. The original height h4 can thus be constrained between h3 and h5 (i.e. 17.38 m and 18.58 m).

Figure 26: Scheme of the west wall of the bell tower to discuss the evolution of its height over time. OPUR ID are specified in square brackets.

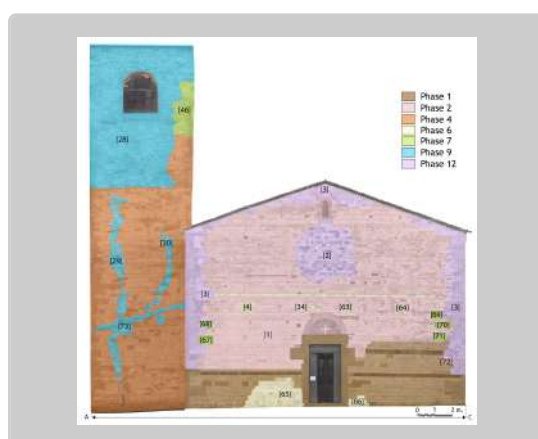
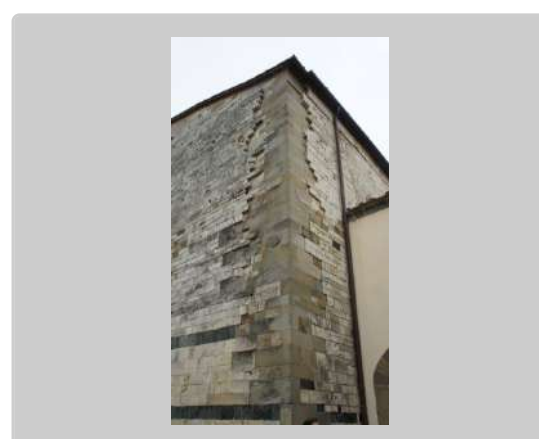
**Id. OPUR** 2

**Identity** **Intervention partial - ACoR** : TCM3  
Repaired part(s) : North, South ; Upper part

**Hazard** **Settling**  
Ancient origin : undetermined - Probability of the event undetermined

**Other precisions** External facing of the front wall of the church (MR1) : Infilling of the rose window.  
Use of limestone (Pietra Alberese) and Serpentine course. Decimetric blocks.  
Undetermined origin. Such an infilling of the previous rose window might be considered as a common reconfiguration work even if it is sometimes made as a postseismic repair.

**Repair** **Reconstruction**  
Dimensions (cm) : Length scanner, Width 339, Height 390  
Masonry, Filling-in : Stone, Mortar [Lime and sand] [dimension of elements : about 10°-20 cm]
