Tracing the seismic history of Sant'Agata del Mugello (Italy, Tuscany) through a cross-disciplinary approach

Tracing the seismic history of Sant'Agata del Mugello (Italy, Tuscany) through a cross-disciplinary approach.

Keywords— historical seismicity, historical sources, building stratigraphy, architecture, structural analysis, damage mechanisms, Central Italy

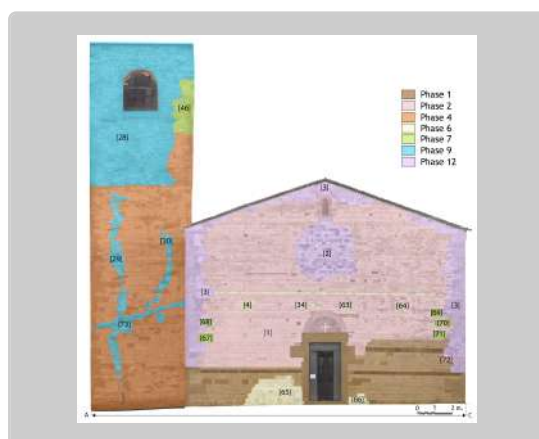
Identity **Intervention partial** - ACoR : TCM2
Repaired part(s) : North, South ; Upper part, Middle part

Hazard **Supposed collapse** (Rocking. Partial overturning of the wall with rotations axis at the floor level)
Ancient origin : undetermined - Probability of the event undetermined

Repair **Reconstruction**
Dimensions (cm) : Length 1500 (preserved), Width 1510, Height 1191
Masonry : Stone, Mortar [Lime and sand]

the technique that is being repaired(TCM1) :
Use of decimetric and quadrangular blocks of limestone (Pietra Albarese). Maximum length of the block : 25.5cm, Minimum length of the block : 12.3cm. Max width : 72cm, minimum width : 10.5 cm. Blocks edges are roughly cut. Course of serpentinite are used with an ornamental purpose. Dimension of joints : max : 1.2cm,

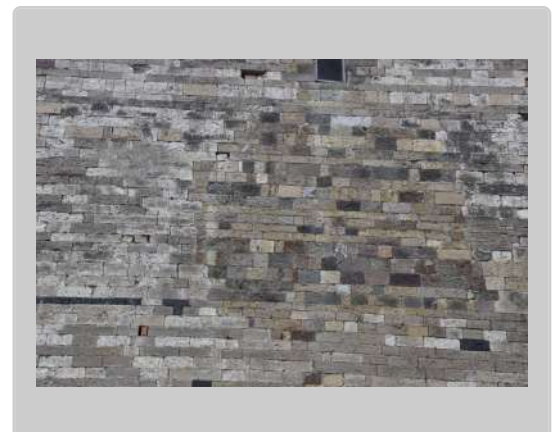
Id. OPUR 2

Identity **Intervention partial** - ACoR : TCM3
Repaired part(s) : North, South ; Upper part

Hazard **Settling**
Ancient origin : undetermined - Probability of the event undetermined

Repair **Reconstruction**
Dimensions (cm) : Lenght scanner, Width 339, Height 390
Masonry, Filling-in : Stone, Mortar [Lime and sand] [dimension of elements : about 10°-20 cm]

Other precisions External facing of the front wall of the church (MR1) : Infilling of the rose window.
Use of limestone (Pietra Alberese) and Serpentine course. Decimetric blocks.
Undetermined origin. Such an infilling of the previous rose window might be considered as a common reconfiguration work even if it is sometimes made as a postseismic repair.

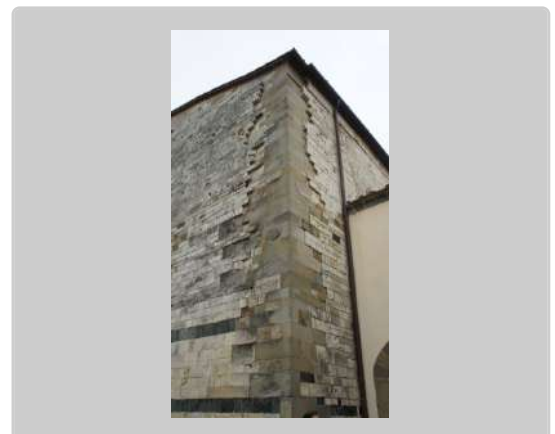
Id. OPUR 3

Identity **Intervention partial** - ACoR : TCM6
Repaired part(s) : North, South ; Middle part, Upper part

Hazard **Deformation** (Corner overturning)
Ancient origin : earthquake - Probability of the event strong

Repair **Not indicated**
Dimensions (cm) : Width 123, Height 787
Masonry, Block : Stone, Mortar [Lime and sand] [dimension of elements : between 20 and 50 cm]

Other precisions Repair of the two corner quoins of the front wall (MR1) as well as the upper part of the wall. The repair is particularly visible because of a centimetric shift between opur 6 and opur 1.

We associated this repair with a seismic event. First it is a typical repair due to a global overturning of the front wall. Such a damage is secondly described in historical source (Tolomeo Nozzolini's log book).
