Detection and evaluation of barely visible impact damage in woven glass fabric reinforced polyamide 6.6/6 composite using ultrasonic imaging, X-ray tomography and optical profilometry

Nada Miqoi, Pascal Pomarede, Fodil Meraghni, Nico Felicien Declercq,
Laurent Guillaumat, Gael Le Coz, Stéphane Delalande

Abstract

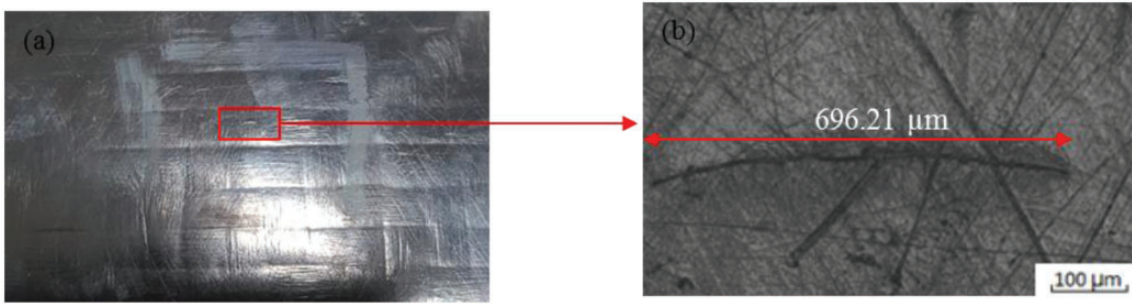
Figure 12. Images of the micro crack seen on the back of the plate damaged at 13.45 J: (a) naked eye observation (b) image obtained using an optical microscope.

The first observed damage stage is on the specimen impacted at an energy level of 13.45 J. This damage appeared as a small opening on the non-impacted side, barely visible to the naked eye. To investigate the small damage closely on the plate impacted at 13.45 J, an observation using the optical microscope is performed. Figure 12 exhibits the obtained images of the superficial damage with a dimension of 696.21 μm. However, on the samples impacted at 15.28 J and 17.60 J, cracks propagating longitudinally and transversely leading to fibre breakage are easily observed (Figure 13).

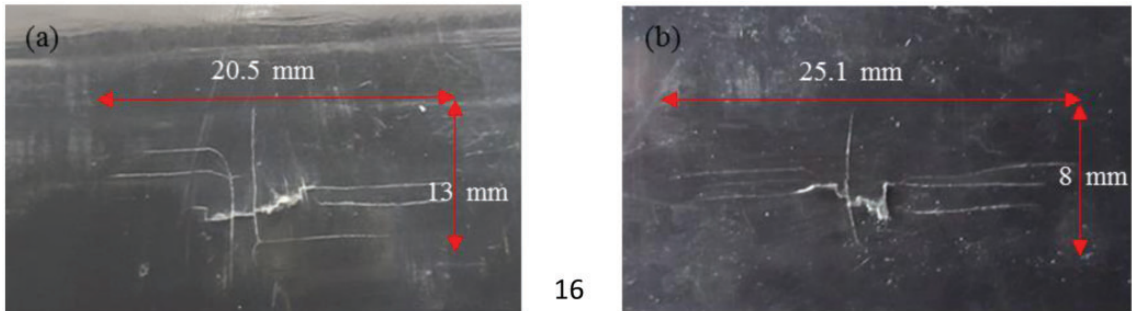
After the impact tests, no visible damage is observed on the specimen loaded at an energy level of 7.30 J. However, on the three other specimens, damage appearing on the non-impacted surface could be observed by the naked eye. It should be mentioned that all damage observed during this study occur on the non-impacted side of the specimens. Indeed, based on the literature (Abrat, 1998) for the case of thin plates, the damage is initiated on the bottom layer and propagate in a pine tree path caused by the bending stress and waves propagation.

Figure 13. Dimensions of the damage occurring on the impacted samples loaded at energy of (a) 15.28 J and (b) 17.60 J observed by naked eye.

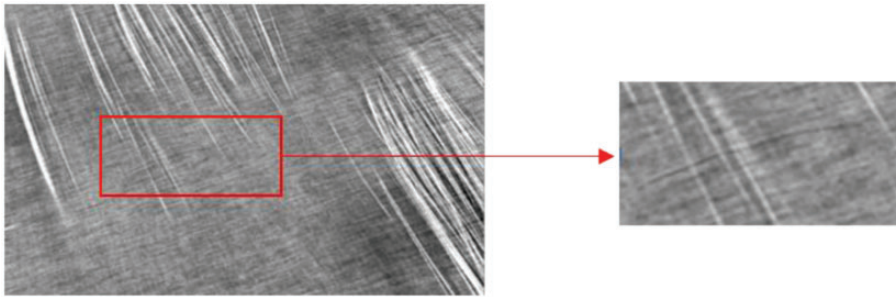
Figure 14. X-ray tomography observations performed on the samples impacted at an energy level of 13.45 J showing the matrix micro-crack.

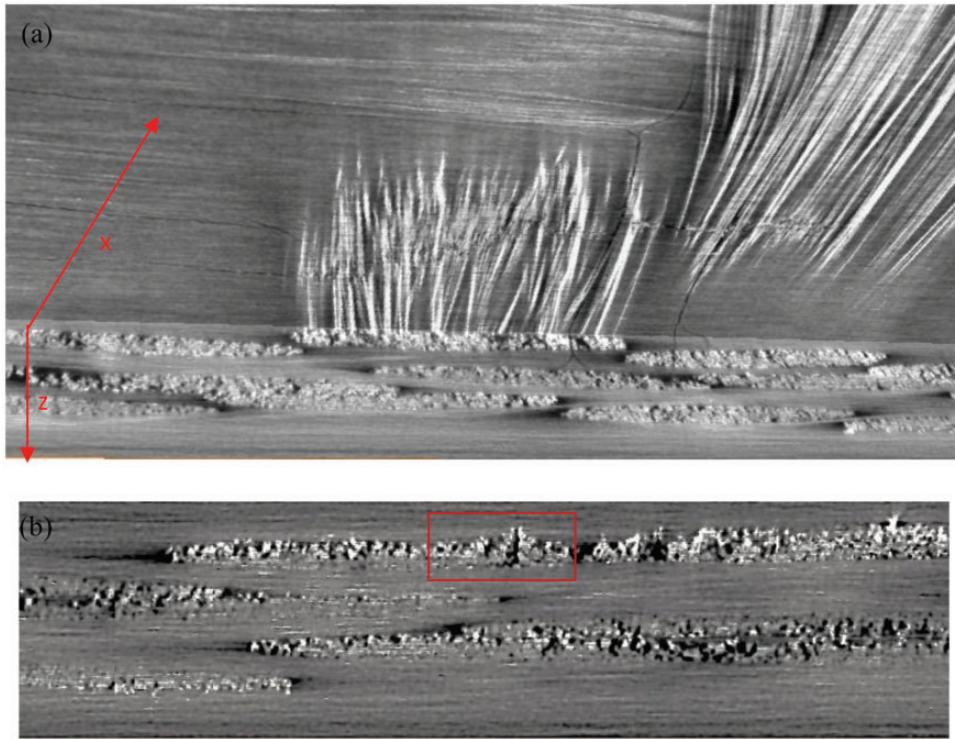
The primary damage mechanism detected for the plates impacted at 15.28 J and 17.60 J during X-Ray tomography investigation is matrix cracking. The cracks detected on the non-impacted side are propagated, in thickness, in the composite following the fibre orientation. These cracks diffuse into and along the yarns in a transversal and longitudinal path. After crossing the first ply and assuming that the propagation energy is high enough, the cracks could evolve and turn into

delamination that spread around the yarns. This damage mechanism is called pseudo-delamination. It is highly relevant to note that in a laminate composite made of plies having the same fibre orientation, no delamination could occur on the interface between the layers (Abrat, 1998). As shown in Figure 15, some cracks penetrate the yarns of the second ply but do not extend to the third layer. It should be highlighted that matrix cracks, and the resulting delamination engender defects inside the samples. The latter, when exposed to X-Rays, appear as black areas that constitute the crack network.

Figure 15. X-ray tomography observations performed on the samples impacted at an energy level of 15.28J showing (a) the crack network and (b) a transversal crack and delamination.

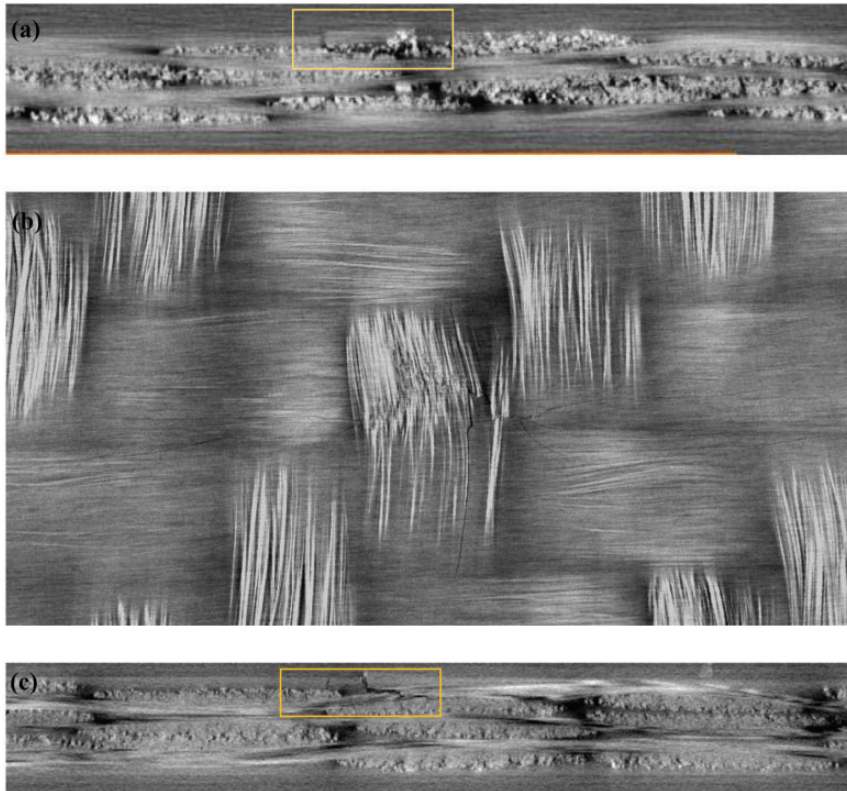
On the sample side containing visible damage, fibre breakage can be observed. When observing the fibre breakage area in the perpendicular plane, a slight lift of the broken zone is noticed. This uplift induces delamination that appears between transversal and longitudinal yarns inside the same ply.

Figure 16. X-ray tomography observations performed on the samples impacted at an energy level of 17.60 J showing (a) a local uprising of the fibres localized between two transversal crack, (b) the crack network and (c) delamination and stair-shape failure.

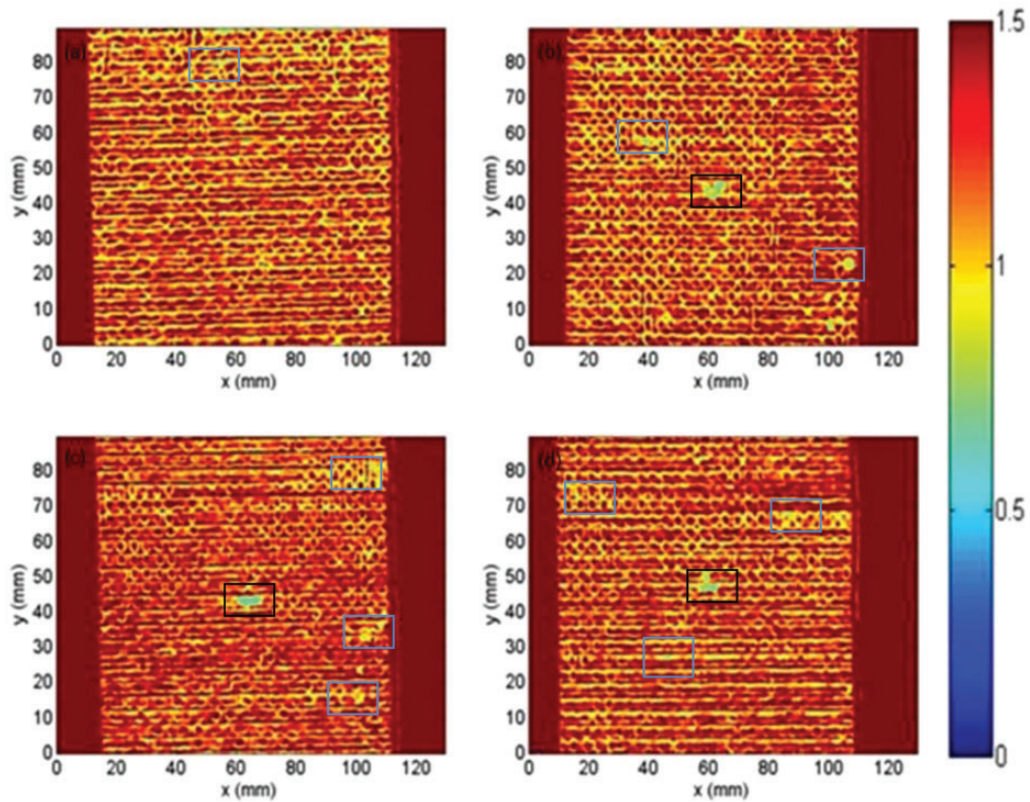
Figure 17 demonstrates the results of C-scans in transmission. Relatively small areas at the edges and inside the plates showed an attenuation that indicates a low amount of damage. It can be presumed that the latter was introduced during the cutting process or manufacturing. Thus, it is considered irrelevant and is neglected in the sequel.

For the sample submitted to a 7.30 J impact, no potential damage is noticed on the scan image. At 13.45 J, 15.28 J and 17.60 J impact energies, all C-scan in transmission images exhibited signal attenuation that is localized near the impact region. No difference in term of damage dimension is observed. That said, it is highly challenging to differentiate between the three plates.

Figure 17. Transmission C-scan results for the four samples damaged respectively at: 7.30 J (a), 13.45 J (b), 15.28 J (c) and 17.60 J (d) using the 10 MHz transducers.

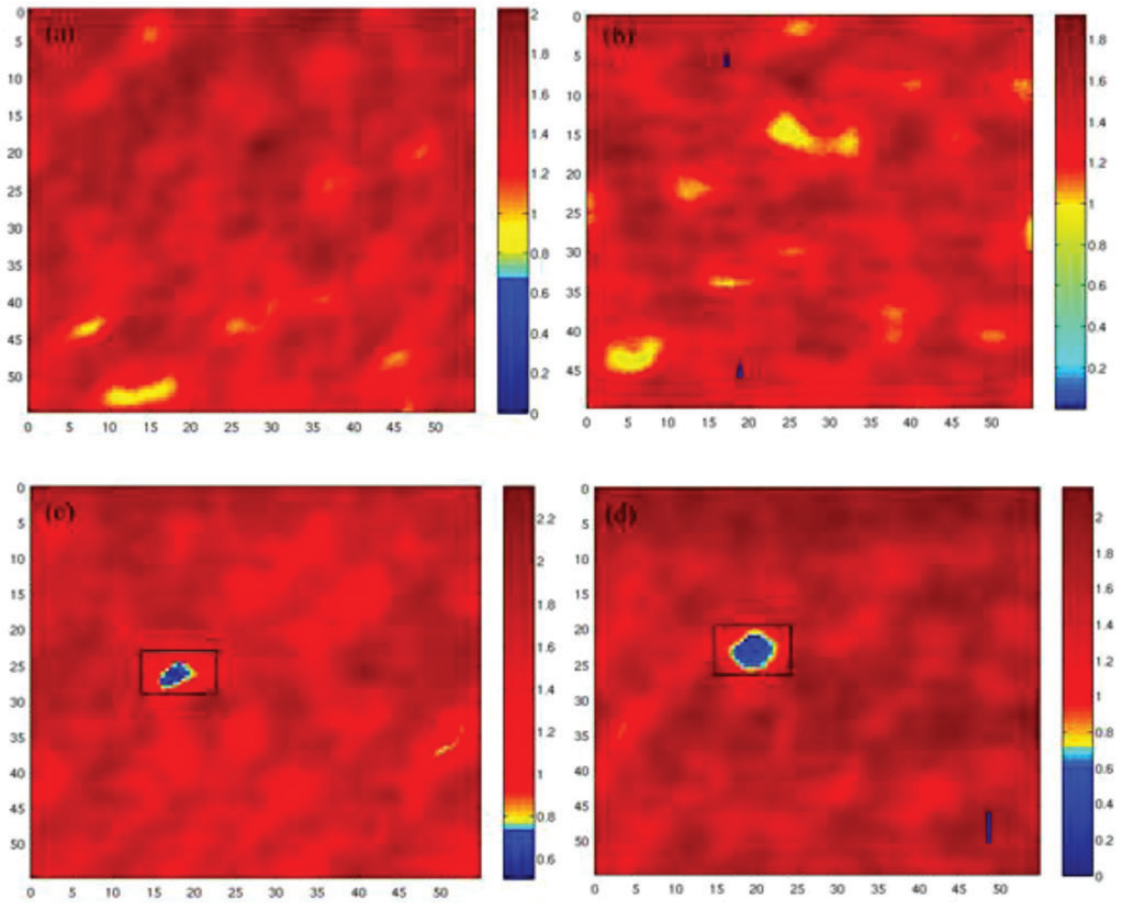
Figure 18 shows the results of reflection C-scans. The color scale is adjusted to focus more on the areas of amplitude attenuation. Pulse/echo C-scan results (Figure 18(c) and (d)), for 15.28 J and 17.60 J as energy level) presented damage surface evolution when the impact energy increased. On

the other hand, no defect is detected for the two samples damaged at 7.30 J and 13.45 J. In Table 4, the detected defect dimensions are shown. For an energy level of 15.28 J, the damaged area observed on the C-scan image corresponds to a dimension of 5 mm, while for the plate corresponding to an energy level of 17.60 J, the dimension is 7 mm. These given measures might only represent the area with severe damage due to the limited spatial resolution of such imaging method (300 μm).

Figure 18. Pulse/echo C-scan results for the four impacted samples: (a) 7.30 J, (b) 13.45 J, (c) 15.28 J and (d) 17.60 J using a 10 MHz transducer.

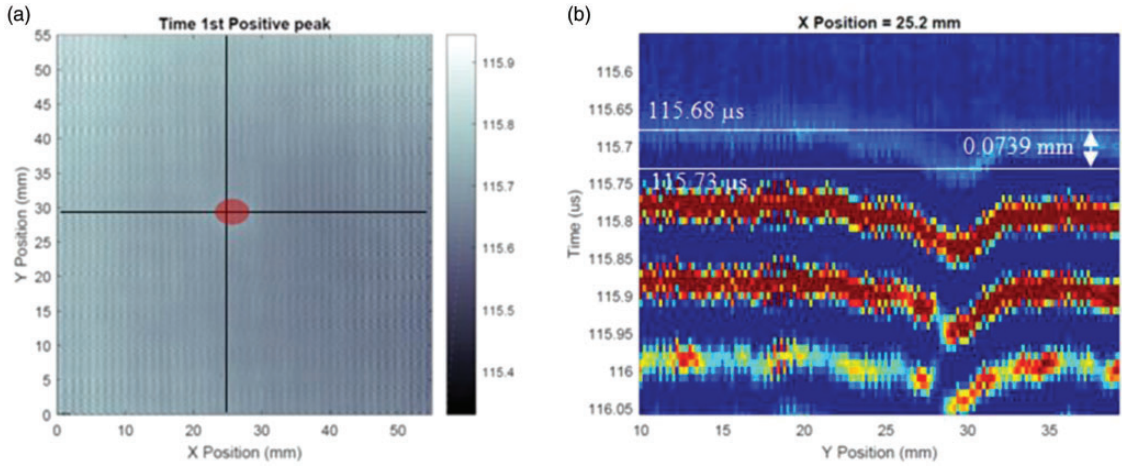
Figure 20. (a) Representation of the cartography corresponding to the time of arrival of the first positive peak, (b) B-scan on the impacted at an energy level of 17.60 J.

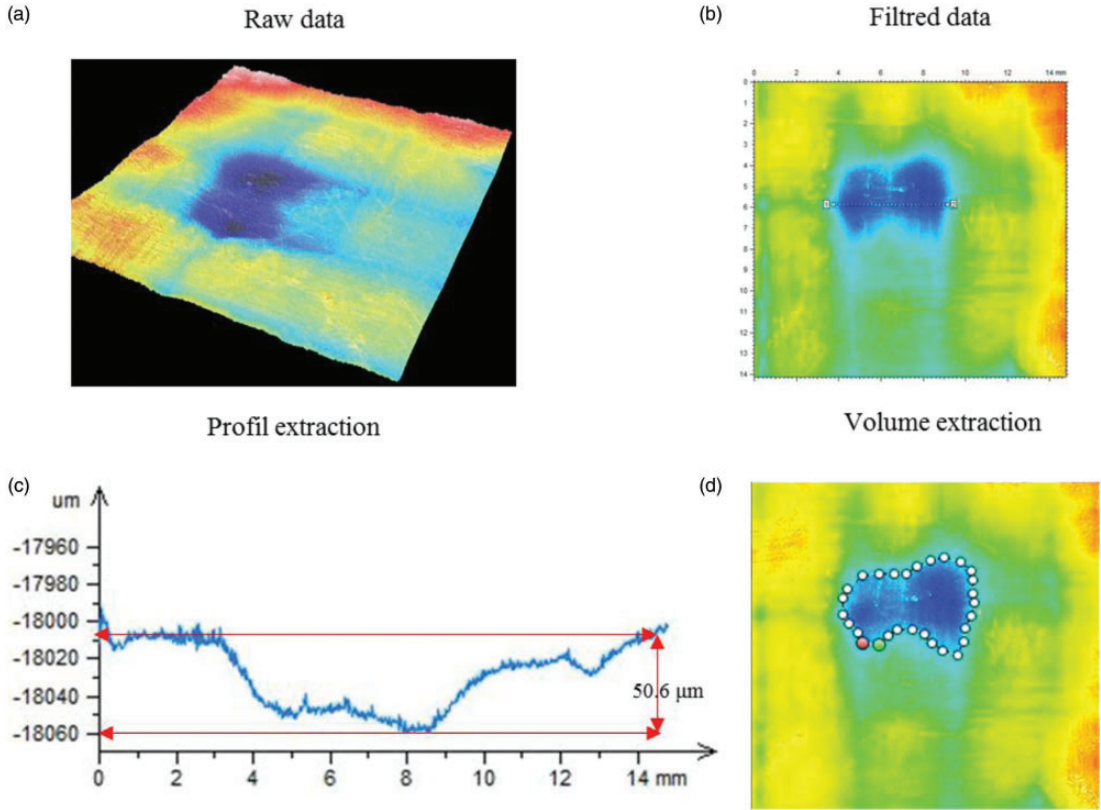
Figure 21. Detailed processing procedure using Leica Maps performed on the plate impacted at 15.28J: (a) raw data, (b) filtered data, (c) profile extraction and (d) volume extractions.

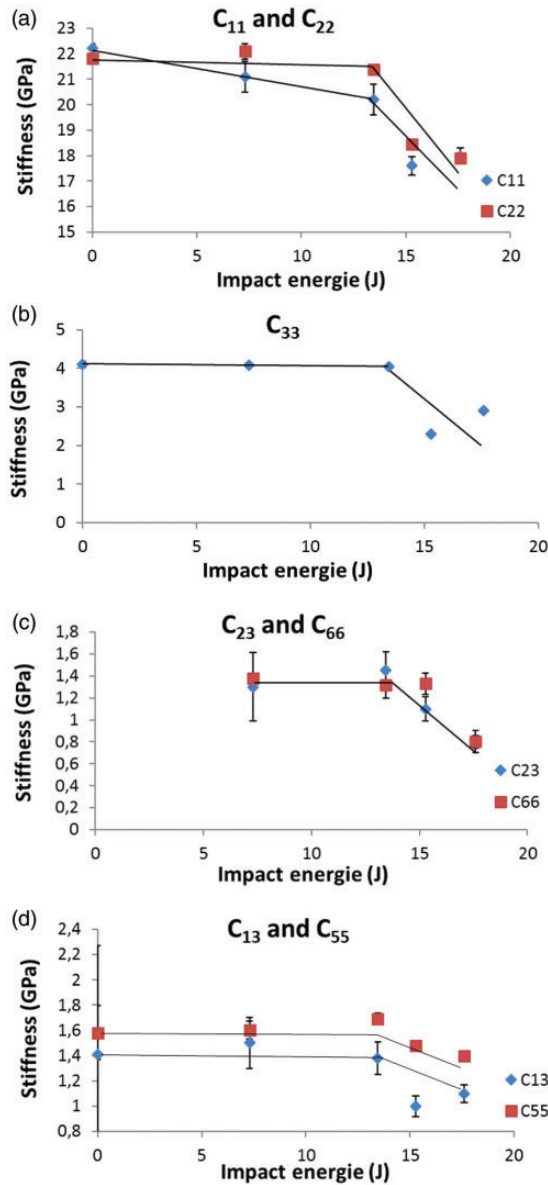
Figure 23(a) to (d) represent the experimentally determined stiffness components for the four studied samples. An overall decrease of the stiffness components is noticed starting from 15.28 J. The results are in agreement with those obtained using other techniques. Indeed, one can notice that all the components, namely: C_{11} , C_{22} , C_{33} , C_{13} , C_{55} , C_{23} and C_{66} exhibit a distinguished decrease starting from the energy of 15.28 J. Furthermore, the stiffness reduction of the components C_{11} and C_{13} is more pronounced between 15.28 J and 17.60 J rather than between 7.30 J and 13.45 J.

Figure 23. Experimental stiffness components for the samples impacted at energies of 7.30J, 13.45J, 15.28J and 17.60J showing: (a) C_{11} and C_{22} , (b) C_{33} , (c) C_{23} and C_{66} and (d) C_{13} and C_{55} .
