# Impact Damage Characterization in Hybrid Fiber Composites Using Terahertz Imaging in the Time and Frequency Domains

**Abstract**— A hybrid fiber composite laminate with impact damage has been studied via terahertz imaging. Terahertz C-scan and B-scan images are obtained in both the time and frequency domains. Factors including the terahertz polarization, fiber orientation and arrangement are considered to compare and analyze the images in an impact-damaged sample.

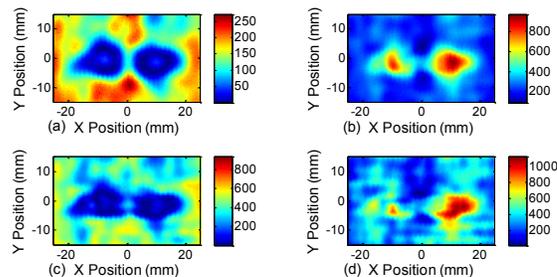
**Fig. 3.** Frequency domain C-scans with polarization perpendicular to the direction of carbon fibers at (a) 0.22, (b) 0.3, (c) 0.38, (d) 0.48 THz.

Frequency domain C-scan images with different polarization are shown in Fig.3 and Fig.4. With the increase of frequency, the penetration depth will decrease. Therefore, C-scan images at different frequencies can provide a method to evaluate the impact damage in different depth.

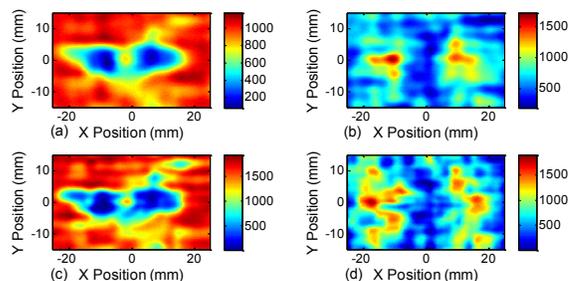
**Fig. 4.** Frequency domain C-scans with polarization parallel to the direction of carbon fibers at (a) 0.2, (b) 0.28, (c) 0.36, (d) 0.46 THz.
