# Mechanical and laser impact effects on woven composites with hemp or glass fibres

**Purpose** - The aim of this paper is to study the damage induced in 'green' and synthetic composites under impact loading.

**Design/methodology/approach** - The study was focused on epoxy based composites reinforced with woven hemp or glass fibres. Six assessment techniques were employed in order to analyse and compare impact damages: eye observation, back face relief, terahertz spectroscopy, laser vibrometry, X-ray micro-tomography and microscopic observations.

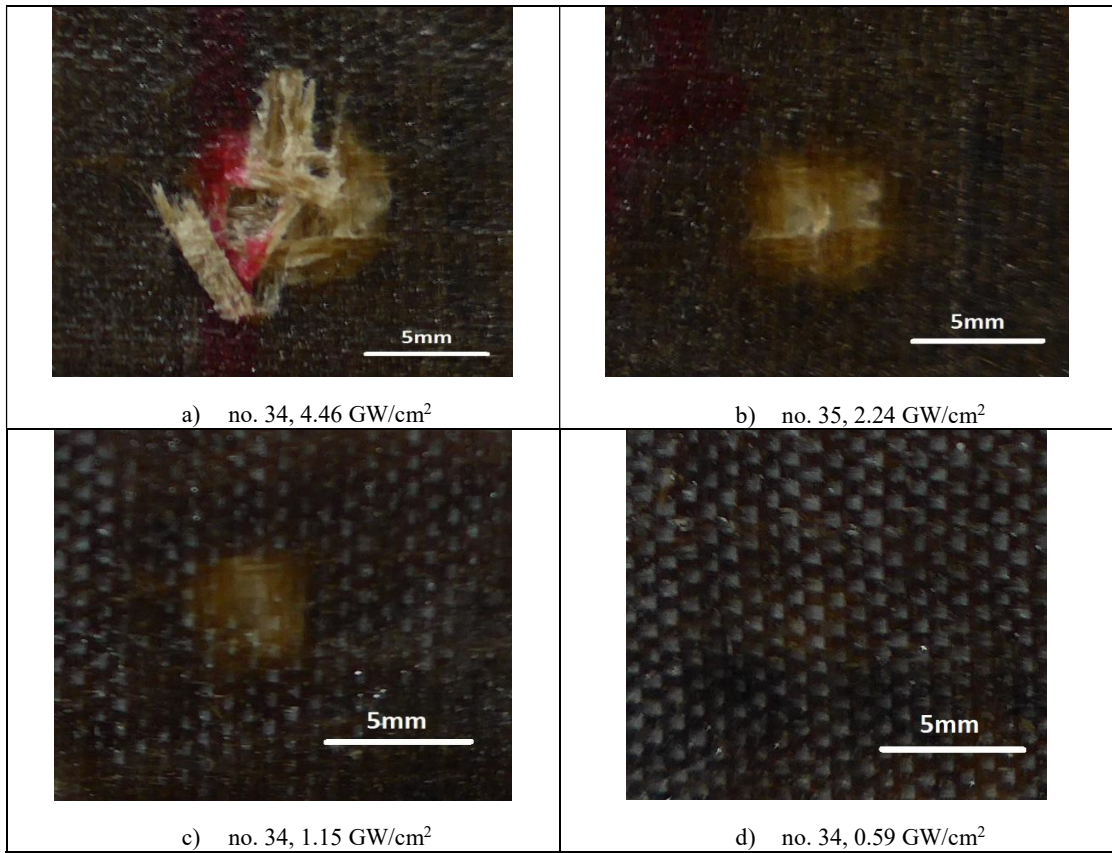
back surfaces after laser impact are presented in Fig. 5 and 6. Eye observations show visible circular internal damage for HE1 and GE1 samples, in particular from 1.15GW/cm<sup>2</sup>. In general, HE1 presents larger damage than GE1 (Fig. 7). Moreover, HE1 presents spallation at 4.46GW/cm<sup>2</sup> (Fig. 5a, Fig. 7).

**Figure 5. Back face pictures after laser impact on HE1 sample**

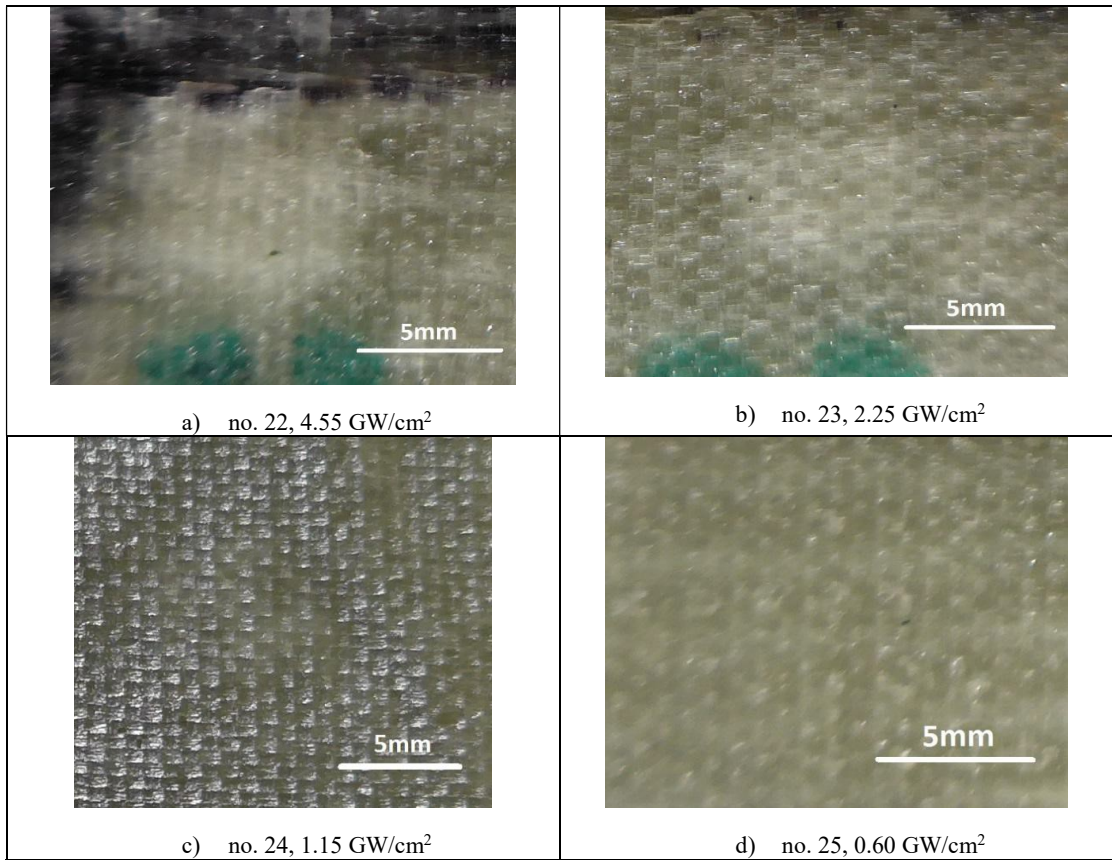
**Figure 6. Back face pictures after laser impact on GE1 sample**

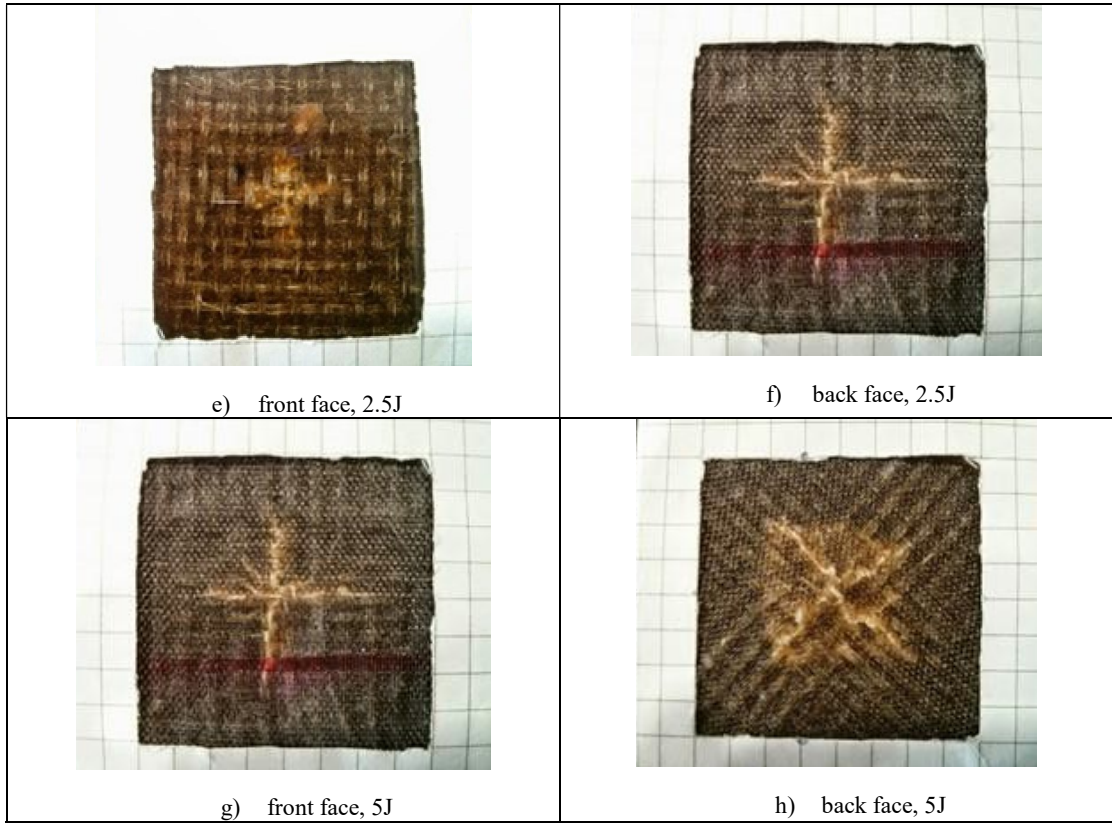
Relevant pictures of front and back faces after mechanical impact are presented in Fig. 8 (for HE1) and Fig. 9 (for GE1). Damage with circular shape appears on the HE1 front face after the impact at 2.5 J, due to the permanent indentation of the impacted surface under the impactor tip. In the HE1 sample impacted with 5 J impact energy, the front face shows a cross shaped damage. For HE1 composite, back face always shows a cross-shaped damage at all impact energy. Damage path proceeds in 0° and 90° directions, in accordance with the yarn orientation in the fabric (Vasconcellos *et al.*, 2014). On the contrary, GE1 samples showed a white-coloured area denoting internal damage in both back and front surfaces, as a result of a limited damage of the composite.

**Figure 8. Front and back face pictures after mechanical impact on HE1 sample**

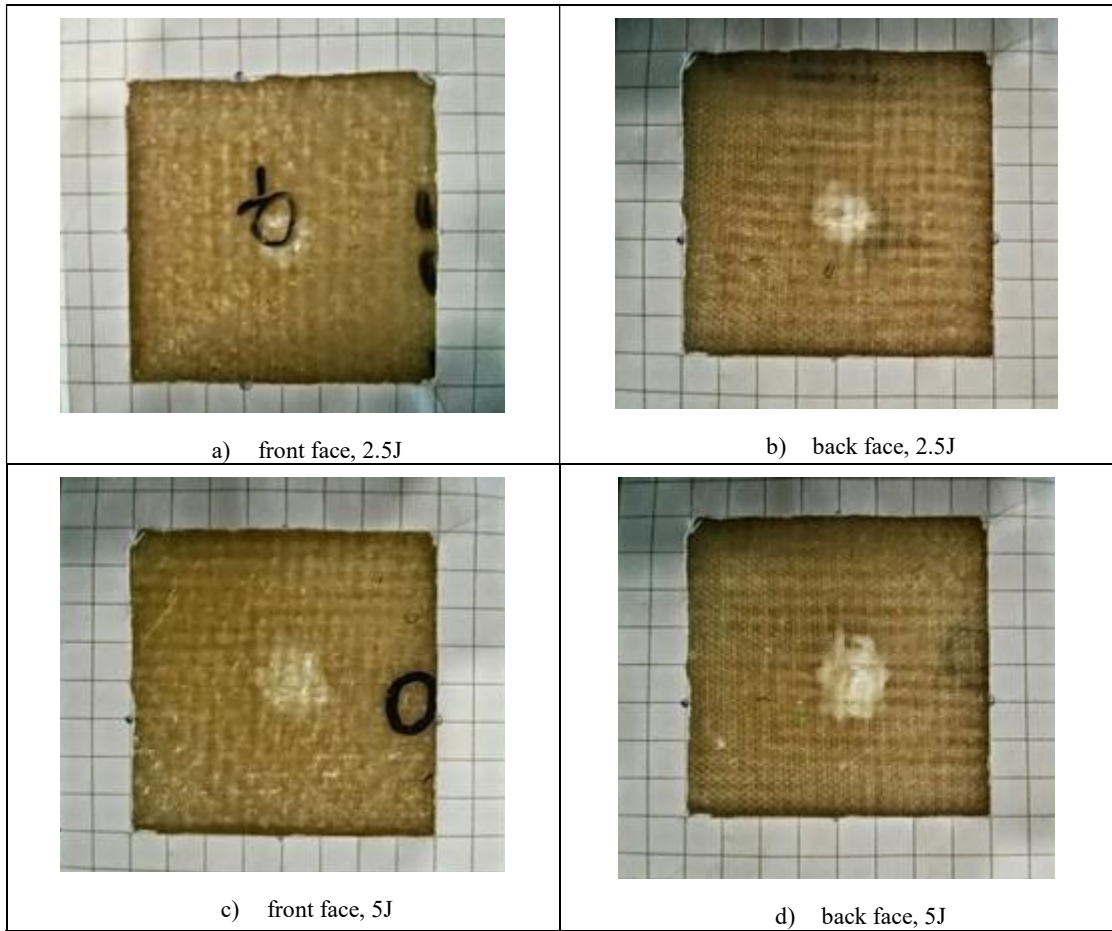
**Figure 9. Front and back face pictures after mechanical impact on GE1 sample**

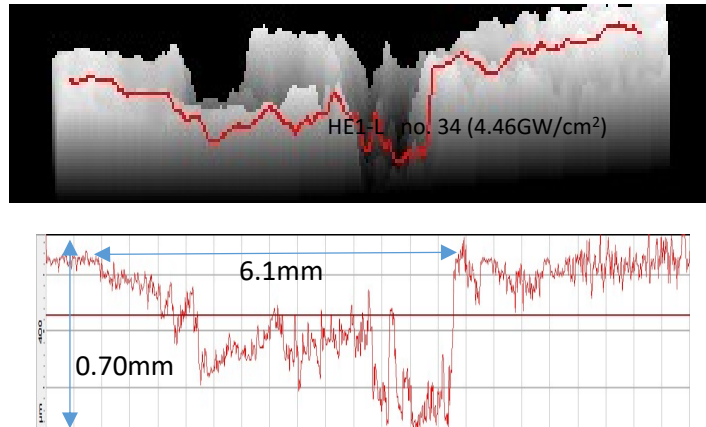
Multidimensional images for selected impacts have been captured in order to visualize the 3D surface profiles of back face damage. After laser impact, there is no measurable back face relief (BF relief) in GE1 sample. HE1 after laser impact presents measurable damage only in the case of spallation. The corresponding 3D reconstruction and damage profile are shown in Fig. 11a. Length and maximum height measured in back face relief are plotted as a function of laser impact energy in Fig. 12a and 12b.

HE1 and GE1 after mechanical impacts show an irregular geometry after the impact at 5J, while no detectable changes in depth after the impact at 1J were detected (Fig. 11b). GE1 was the only system showing some detectable change in back face depth after the impact at 2.5 J, while HE1 did not show appreciable variations. This can be probably due to the different thickness of HE1 and GE1 samples (4 mm and 2 mm respectively), which can affect the back face impact response. Length and maximum height measured in back face relief are plotted as a function of mechanical impact energy in Fig. 12c and 12d.

Figure 11. a) 3D reconstruction and z(x) back face profile of laser impact HE1-L no.34 (4.46GW/cm<sup>2</sup>),  
 b) z(x) back face profiles of HE1 and GE1 samples after mechanical impacts.

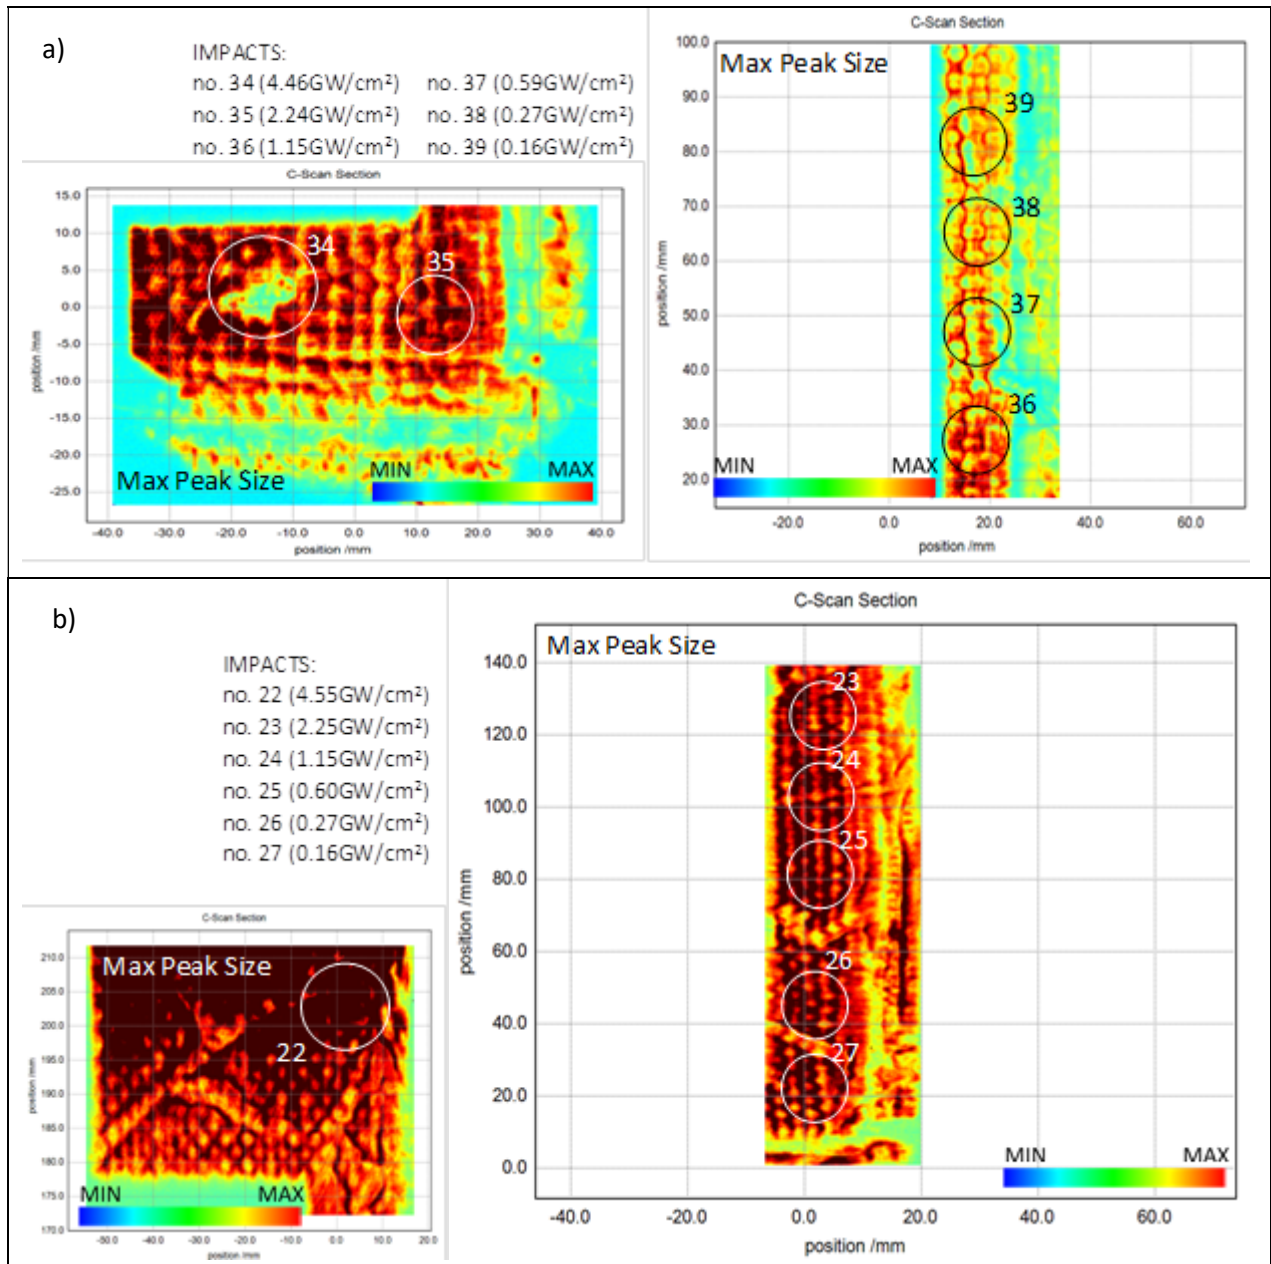
Relevant C-Scan images of laser impacted samples are presented in Fig. 13a (HE1 sample) and Fig. 13b (GE1 sample). Impacted areas are evidenced with circles. This technique did not allow the identification of any impact point in either GE1 or HE1 system. Only the impact at  $4.46\text{GW}/\text{cm}^2$  (no. 34; HE1 sample) was detected.

Figure 13. Terahertz C-Scan sections after laser impacts of a) HE1 sample, b) GE1 sample.

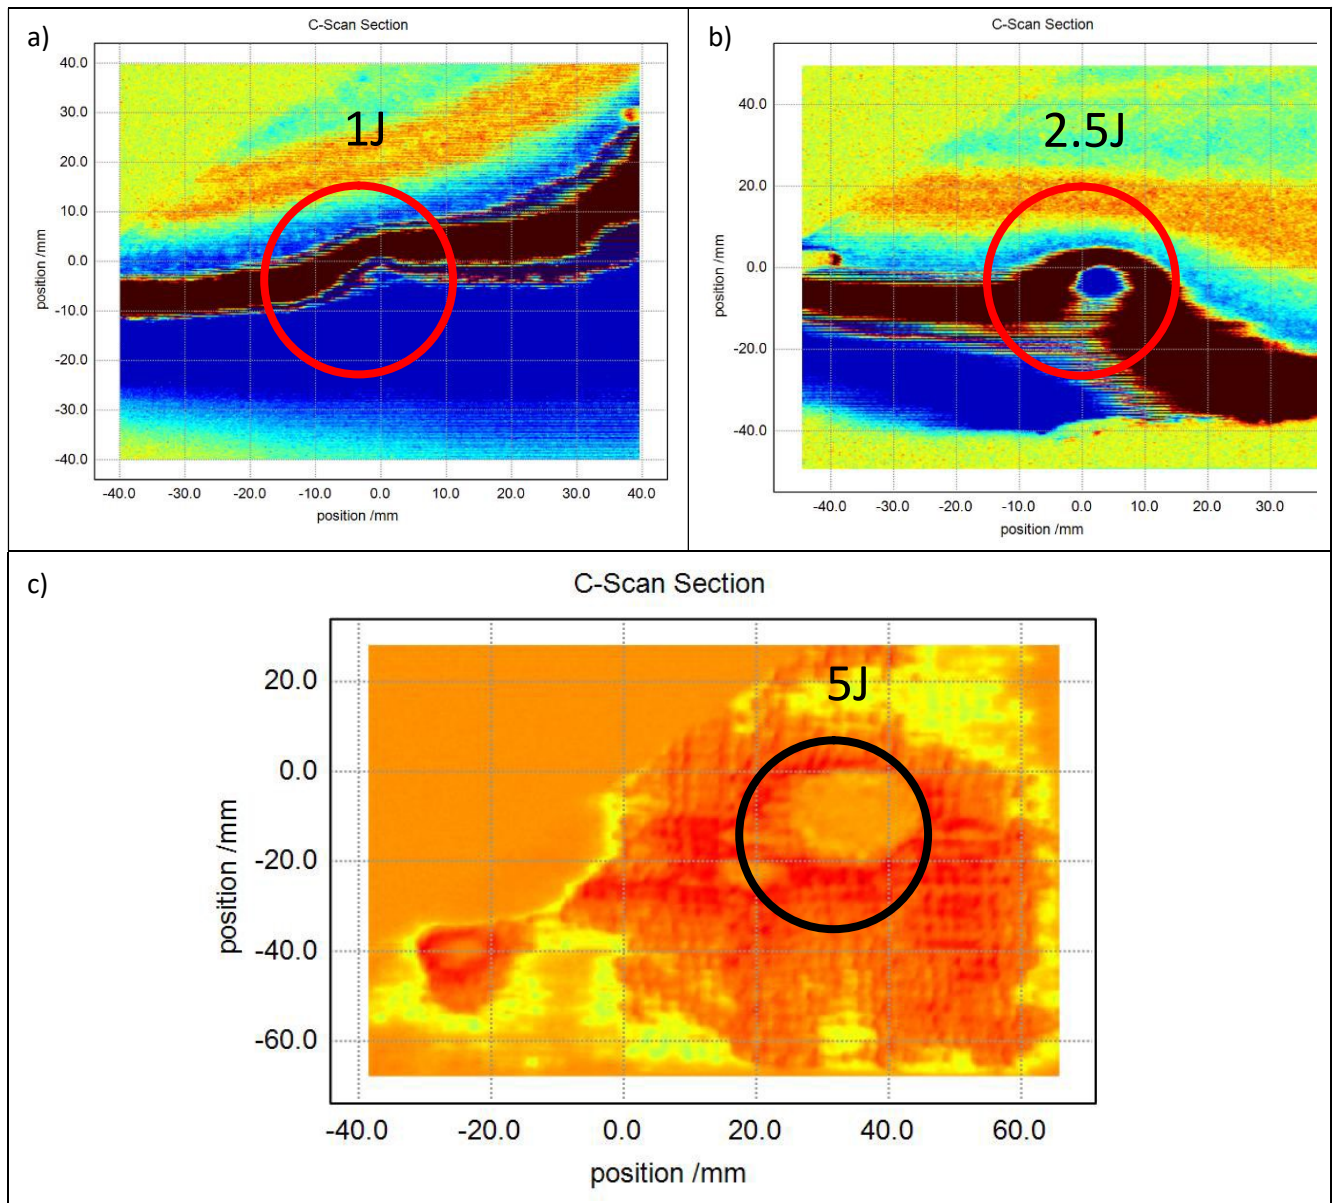
The analysis performed on mechanically impacted samples clearly identified the impact points. In particular, in Fig. 14, C-scans at selected time slices for HE1 samples show the experimental evidences of damaging after all impacts.

Figure 14. Terahertz C-Scan sections of HE1 at a) 1J impact area, b) 2.5J impact area and c) 5J impact area.

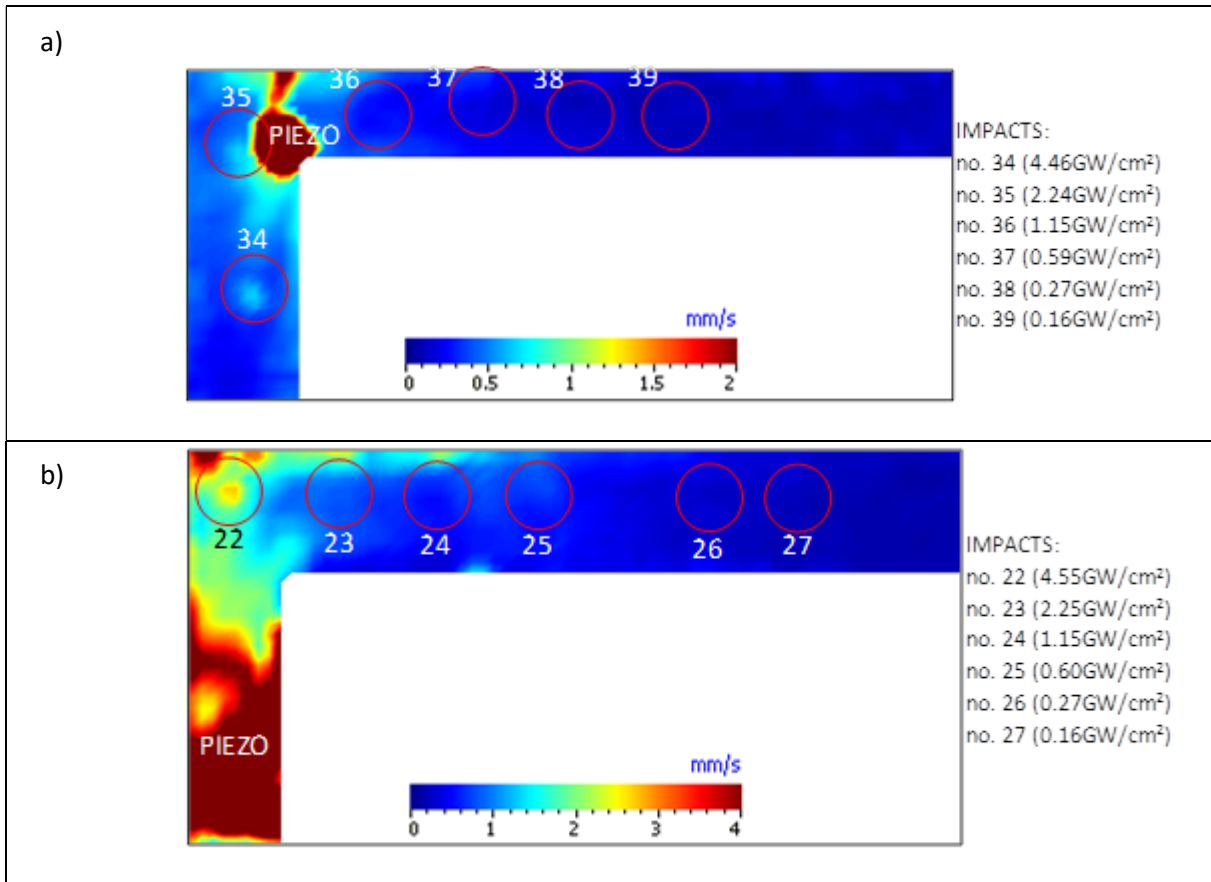
RMS values for laser impacted samples are depicted in Fig. 15a and 15b for HE1 and GE1 samples, respectively. The highest RMS values are located in the vicinity of the piezoelectric sensors, being the source of waves. There are some impact areas with noticeable changes in RMS values, which indicates the presence of damage. Besides, in some impact areas without variations in RMS map the wave propagation animation shows little alterations, revealing the existence of small damages. In case of HE1 sample, the impact no. 34 was clearly detected while the impact no. 35 gave only a slight variation of the small response. In the case of the GE1 sample, only the highest intensity impact (no. 22) was detected.

Figure 15. RMS values for a) HE1 sample (frequency of excitation: 100 kHz, voltage: 400 Vpp), b) GE1 sample (frequency of excitation: 200 kHz, voltage: 400 Vpp).

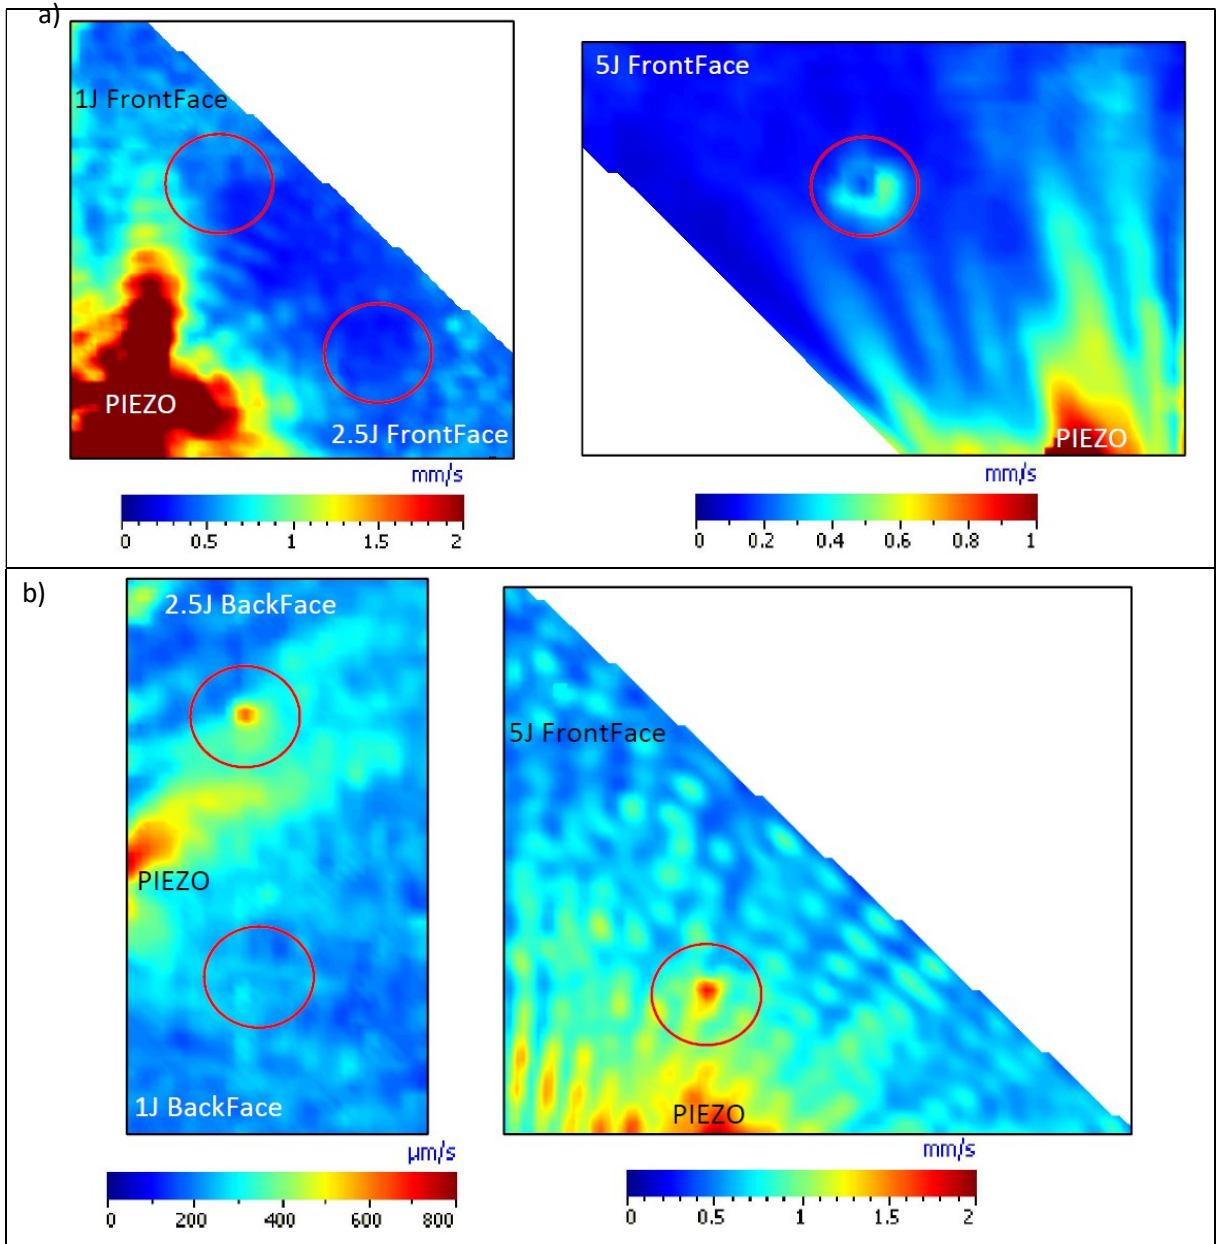
The laser vibrometry results for mechanically impacted samples are presented in Fig. 16a and 16b for HE1 and GE1 samples, respectively. The highest RMS values still indicate the piezoelectric sensor location. For both materials, the 5 J impact was detected, while the 2.5J is visible only for GE1 sample.

Figure 16. RMS values for a) HE1 samples, b) GE1 samples (frequency of excitation: 100 kHz, voltage: 200Vpp).

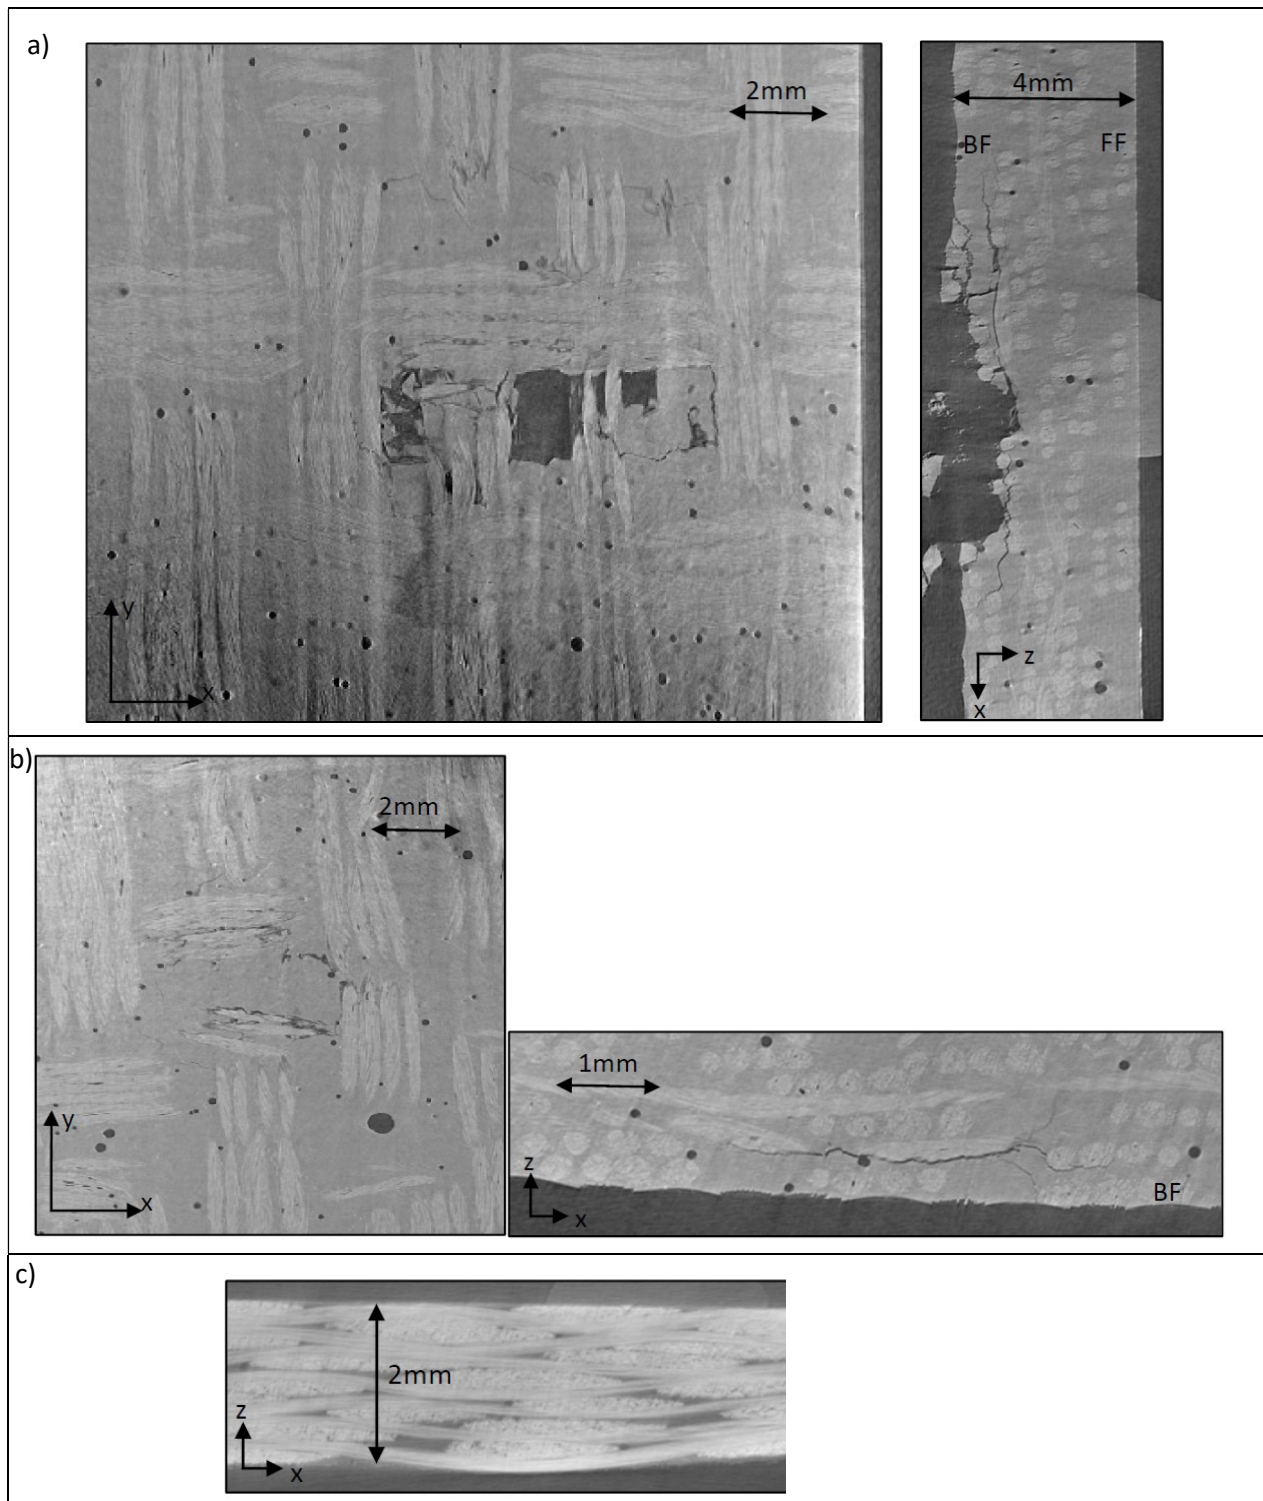
Laser impacted HE1 sample presents spallation at 4.46GW/cm<sup>2</sup> (impact no. 34). Matrix cracks, fibre failure and cracks at the yarn/matrix interface have been detected in the tomographic images (Fig. 17a). In the case of the 2.24GW/cm<sup>2</sup> impact (no. 35) matrix cracks and cracks at the yarn/matrix interface have been observed near the back face (Fig. 17b). Tomographic images of laser impacted GE1 samples were performed for several levels of intensity (no. 22 for 4.55GW/cm<sup>2</sup>, no. 23 for 2.25GW/cm<sup>2</sup>, no. 24 for 1.15GW/cm<sup>2</sup>, no. 25 for 0.60GW/cm<sup>2</sup>). In all cases no damage has been clearly detected (Fig. 17c).

Figure 17. Tomographic images after laser impacts: a) HE1 impact no. 34 (4.46GW/cm<sup>2</sup>) – Z (left) and Y (right), b) HE1 impact no. 35 (2.24GW/cm<sup>2</sup>) – Z (left) and Y (right), c) GE1 impact no. 22 (4.55GW/cm<sup>2</sup>) –Y direction.

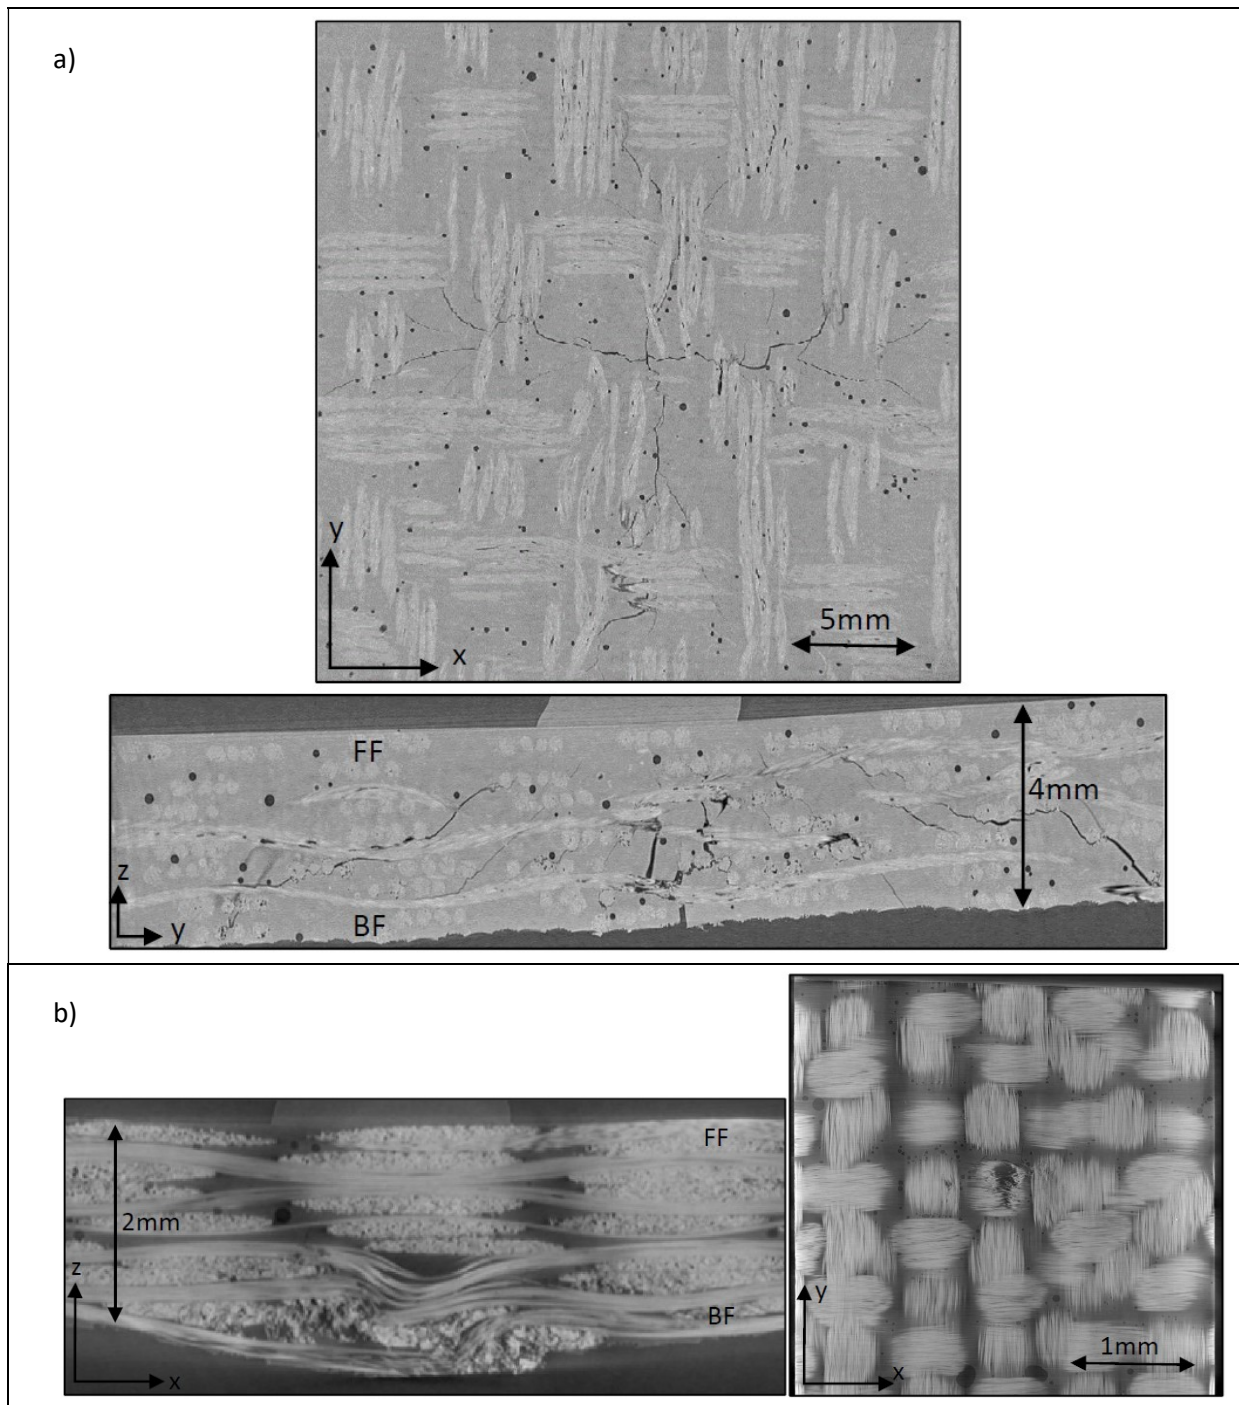
Among all mechanically impacted samples, HE1 and GE1 at 2.5J were analysed (Fig. 18). For the HE1 sample (Fig. 18a), the tomographic image in the X-Y plane shows that damage proceeds in preferential directions, along the warp and weft directions of the woven fabric. In accordance with literature (Shyr and Pan, 2003; Petit *et al.*, 2007), a conical pattern

of damage in the thickness direction has been detected, enlarging from the impacted front face towards the back face. Fig. 18a also shows the presence of matrix cracks and debonding at the fibres/matrix interface. Furthermore, a yarn failure near back face can be observed. In the case of the GE1 sample impacted at 2.5J, tomographic images present a clear damage near the back face while fibre breakage and matrix cracks can be observed in the Z-direction of the reconstructed volume (Fig. 18b).

Figure 18. Tomographic images of mechanically impacted samples at 2.5J: a) HE1 images: Z (top), X (bottom), b) GE1 images: Y (left), Z (right).

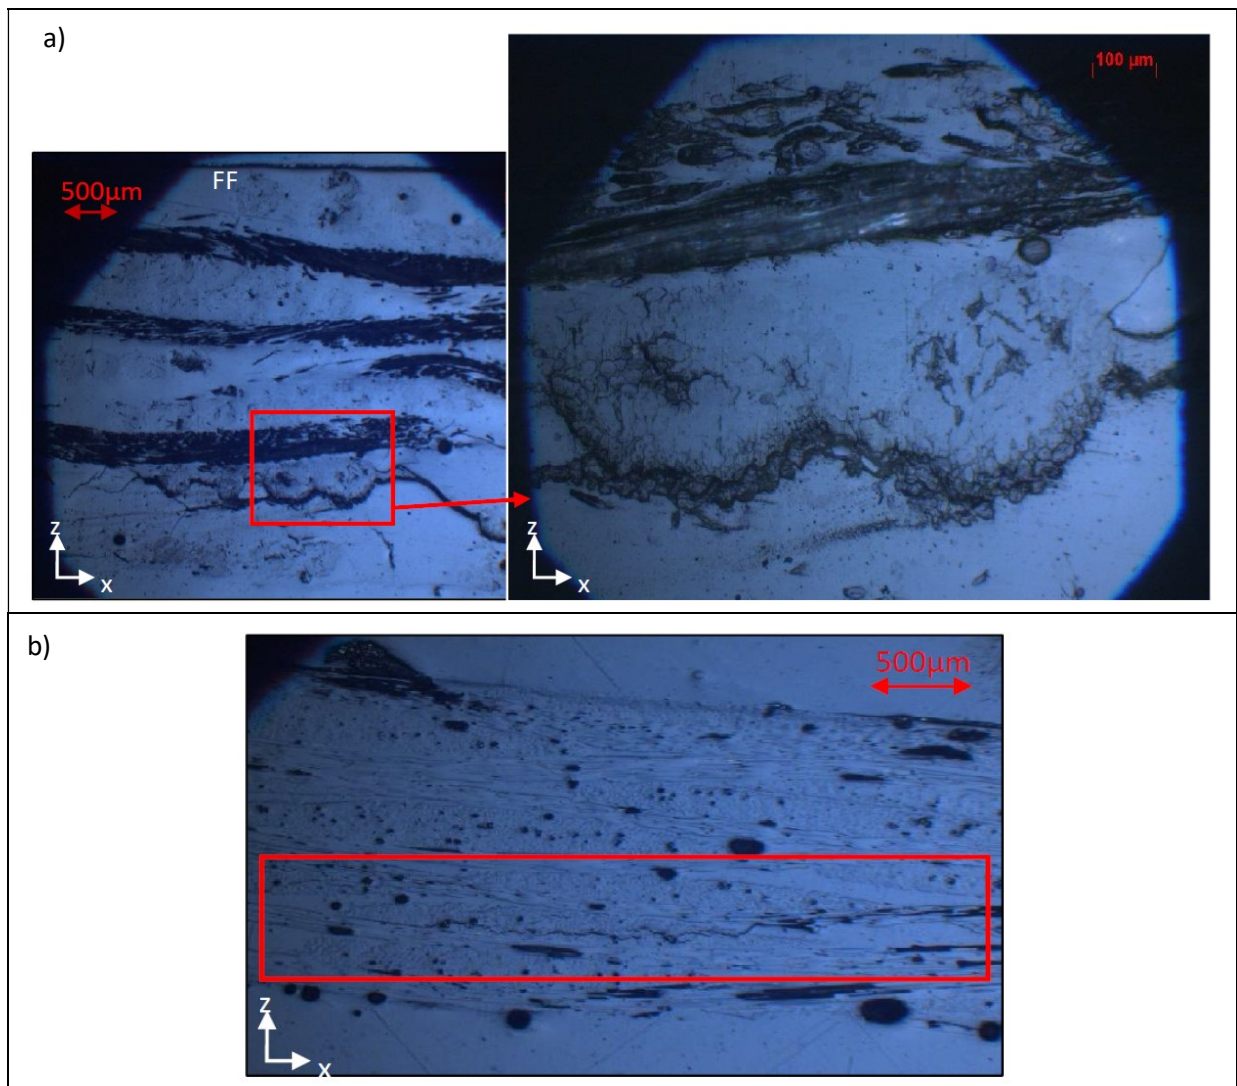
HE1 sample, damaged by means of the laser shock wave technique set at  $2.24\text{GW}/\text{cm}^2$  (no. 35), showed matrix cracks and cracks at the yarn/matrix interface near the back face (Fig. 19a). Microscopic observations carried out on the GE1 sample performed on the no. 22 impact (executed at  $4.55\text{GW}/\text{cm}^2$ ), showed debonding at the fibres/matrix interface and delaminations (Fig. 19b).

Figure 19. Microscopic observations after laser impact: a) HE1 impact no. 35 ( $2.24\text{GW}/\text{cm}^2$ ), b) GE1 impact no. 22 ( $4.55\text{GW}/\text{cm}^2$ ).

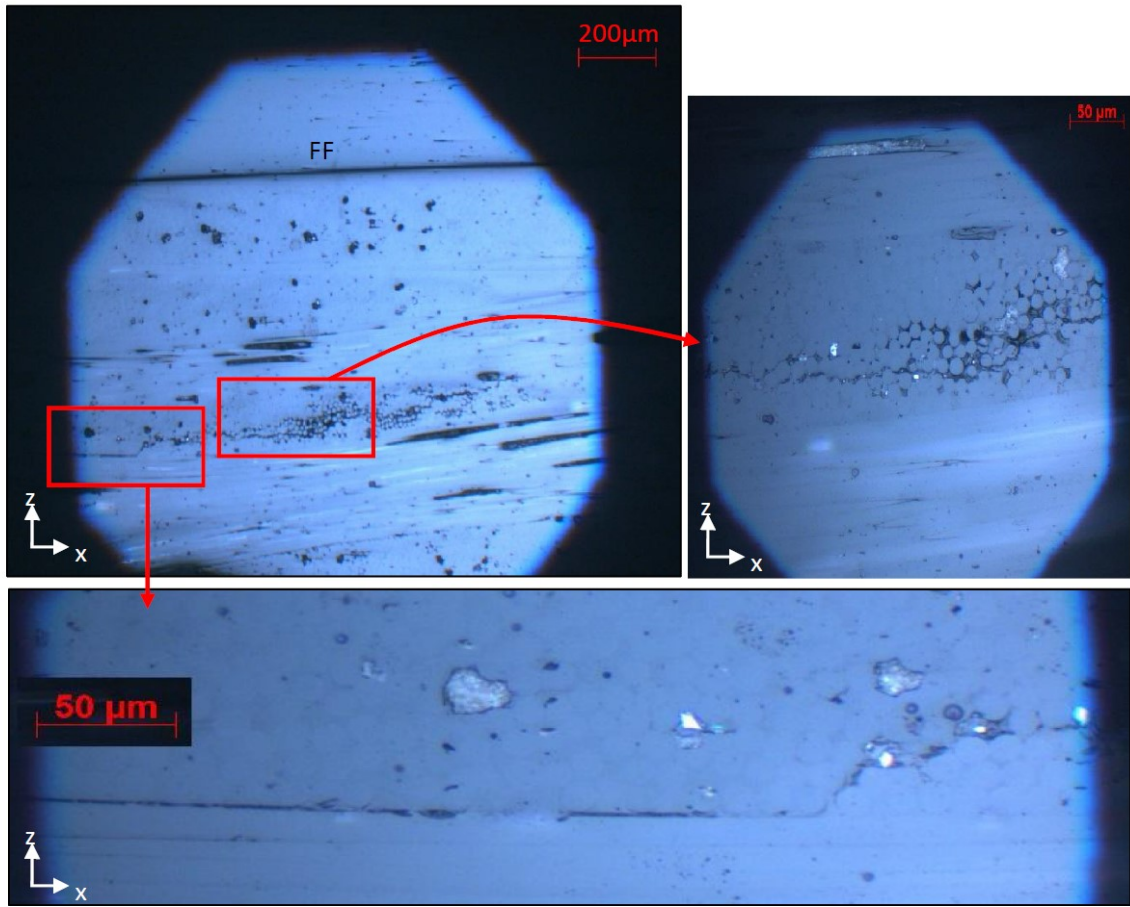
Microscopic observations were also carried out on the mechanically impacted GE1 sample at 1J (Fig. 20). Areas with cracks at the fibres/matrix interface and delamination were largely identified. Near back face, no damage was detected.

Figure 20. Mechanically impacted GE1 sample at 1J – microscopic observations

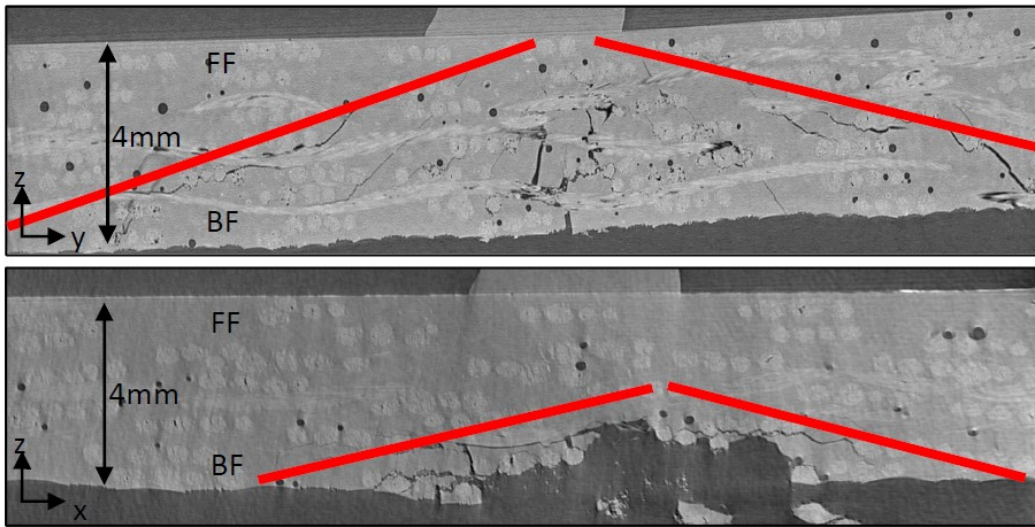
In mechanically impacted samples, damage appears close to the front face and then propagates towards the back face (Fig. 22). The observed damage mechanisms were instead similar for both types of impacts. In fact, both mechanical and laser impacted composites exhibited matrix cracks, fibre failure, debonding at the fibres/matrix interface and delamination. The shape of the damage on the back surfaces is similar after mechanical or laser impacts. There are white circular areas denoting internal damage. The exception is the mechanically impacted HE1 sample, which presents a cross-shaped damage propagating in  $0^\circ$  and  $90^\circ$  (orientation of the fibres). This behaviour could be due to the different types of loading occurring in the composite structures during the impact events. In fact, because of the very short duration of the laser shock, the stress during laser impacts is essentially due to the shock wave, while a complex combination of stresses created by the shock wave and structural effects (as the bending phenomenon) are induced in the sample by the indenter during mechanical impacts.

Figure 22. Tomographic images: X of HE1 at 2.5J (up) and Y of HE1 at 4.46GW/cm2 (no. 34) (down).
