## Characterization of an aluminum conductor steel reinforced (ACSR) after 60 years of operation

# Characterization of an aluminum conductor steel reinforced (ACSR) after 60 years of operation

An aluminum conductor steel reinforced (ACSR) extracted from an overhead power line operated in Northern France during more than 60 years was characterized together with a more recent equivalent conductor. Visual inspection, local observation and chemical analysis by Scanning Electron Microscope (SEM) and Energy Dispersive Spectroscopy (EDS) as well as Raman spectroscopy were used to characterize the microstructure of the strands and to evidence signs of corrosion or potential degradation. Analysis of the grease was done by Fourier Transform InfraRed Spectroscopy (FTIR). The mechanical properties of the strands were evaluated by constant strain rate tensile test at ambient temperature. Hardness was measured as well. Partial oxidation of the steel galvanization layer, degradation of the grease – especially oxidation due to ageing – and atmospheric corrosion pits on the external layer of aluminum strands were evidenced. The mechanical properties of the galvanized steel strands were still in a

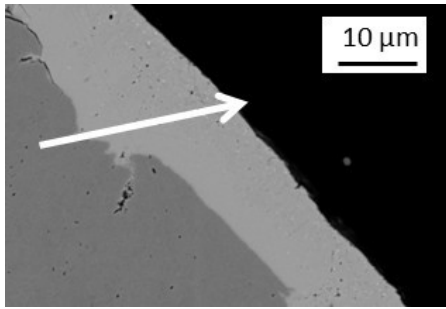
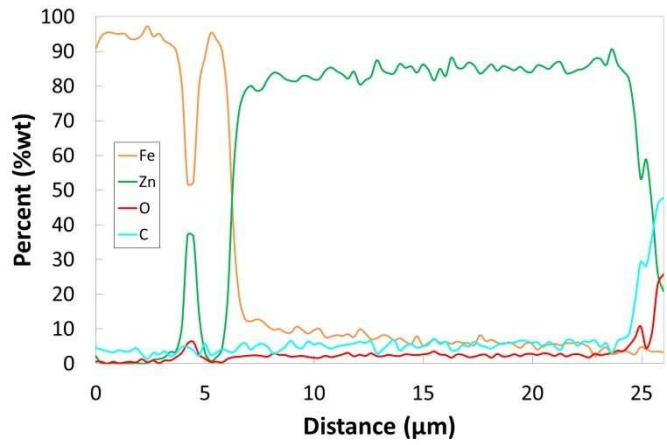
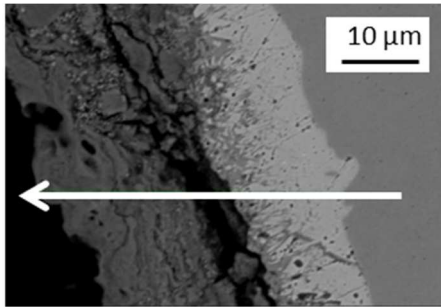
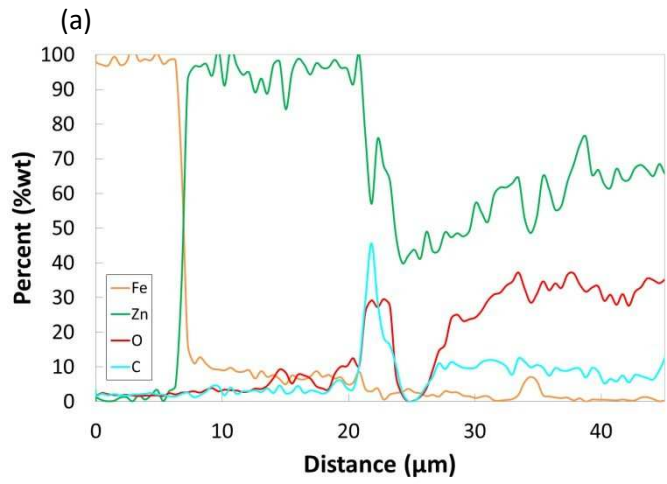
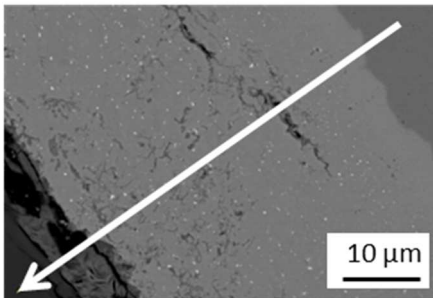
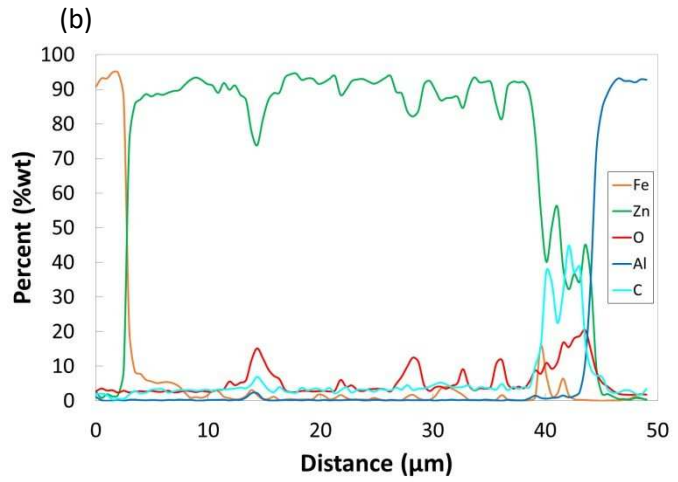
The galvanization layer of the GHW conductor presented different features depending on the studied strand and location. In most cases, the average thickness of the galvanization layer was lower than 20  $\mu\text{m}$  and no pure zinc outer sublayer was observed (Figure 3(a)). The innermost sublayer was the delta phase, with a maximum iron content of 10 wt%. Its thickness was low: between 2 and 5  $\mu\text{m}$ . The iron content of the second sublayer was between 4 and 6 wt%, which corresponded to the zeta phase.

On some strands of the outer layer of the steel part of the conductor, the galvanization layer was locally thicker (up to 30  $\mu\text{m}$ ) than in the general case described previously and presented a supplementary outer sublayer which appeared darker on SEM observations (Figure 3 (b)). EDS analysis showed that this sublayer contained mainly zinc and oxygen. However, the amount of carbon detected by EDS, which was most probably linked to the presence of grease, complicated the identification of this oxide. It was consequently characterized by Raman spectroscopy, which showed that this layer was amorphous or slightly crystallized ZnO with the three following characteristic peaks [31]: 165  $\text{cm}^{-1}$ , 435  $\text{cm}^{-1}$  and 565  $\text{cm}^{-1}$  (Figure 4). Figure 3 (b) also indicated the partial oxidation of the zeta phase.

In some areas, the steel strands of the outer layer of the steel part of the conductor were locally embedded in their neighboring aluminum strand. In these areas, the galvanization layer was even thicker (up to 40  $\mu\text{m}$ ) and EDS analysis indicated the presence of unoxidized eta phase (Figure 3(c)).

Figure 3: SEM images and EDS analysis of cross sections of the galvanization layer of the GHW conductor. (a) General case, (b) partially oxidized layer and (c) in the areas that are embedded in an aluminum strand. Iron is represented in orange, zinc in green, oxygen in red, carbon is in cyan and aluminum is in blue.

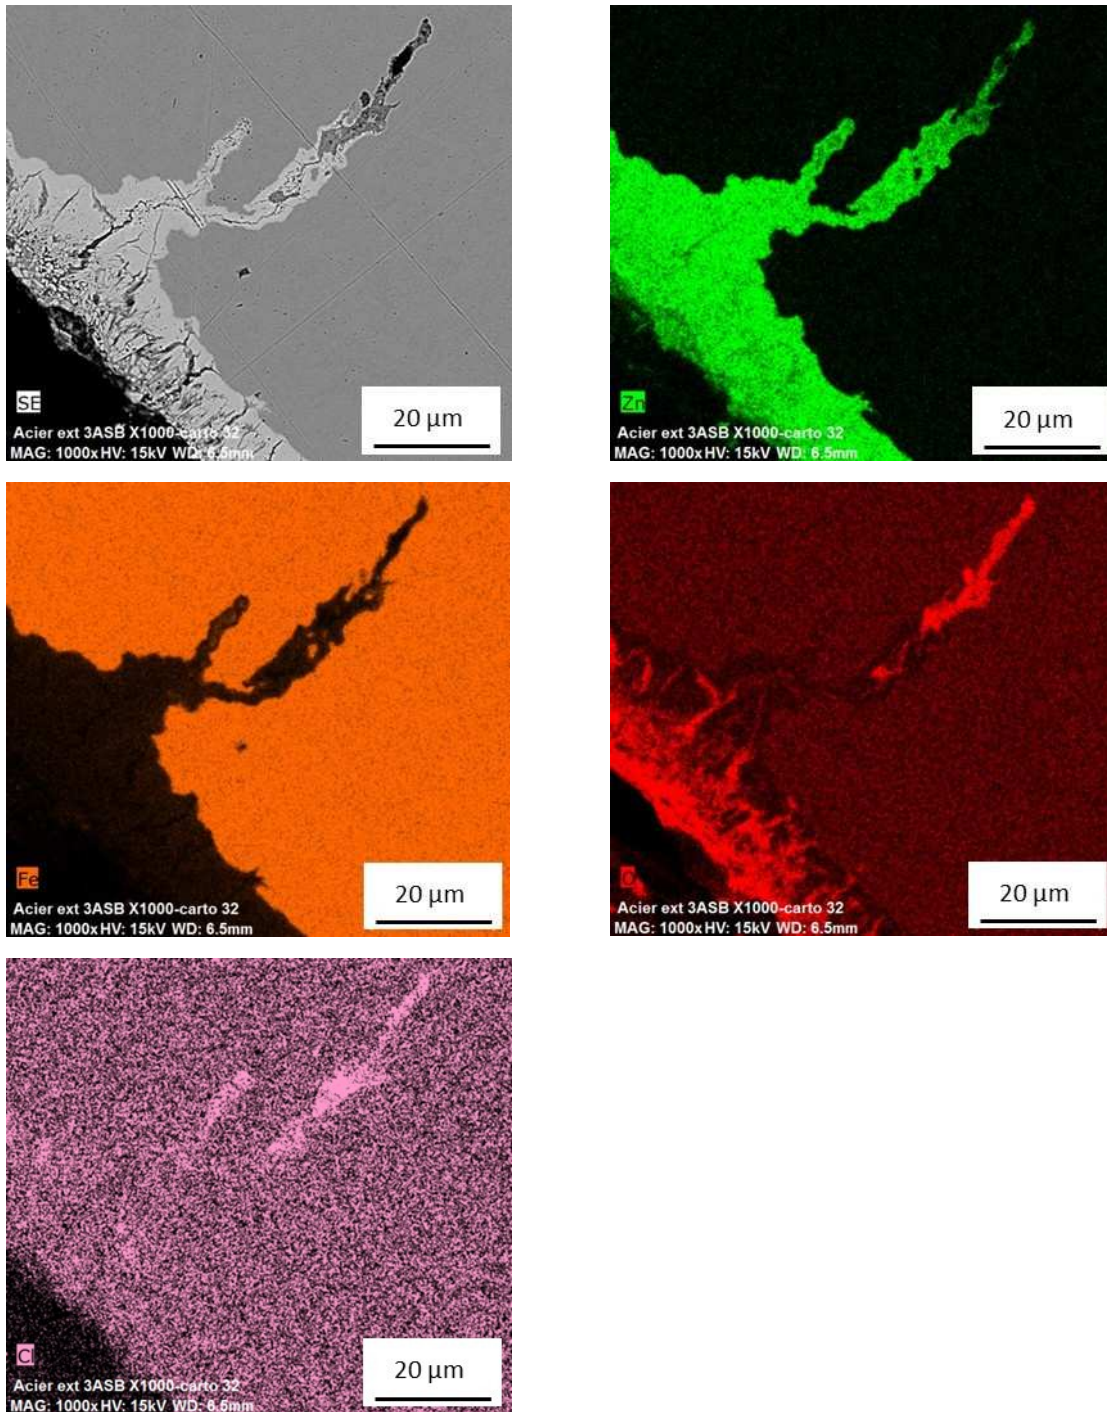
Cracks were noticed on the cross section of some of the studied strands. Few and short ( $< 15 \mu\text{m}$ ) for the modern conductor, their apparent length varied from 10 to 800  $\mu\text{m}$  for the GHW conductor (Figure 5). SEM analysis revealed the presence of zinc along the length of the crack, indicating that cracks were present prior to the galvanizing. They were therefore considered as wire drawing defects. For the GHW conductor, inside the cracks, the galvanization layer was micro-cracked. Some of these micro-cracks appeared to connect the crack tip to the surface. However, the cross section sample showed that the steel did not appear corroded. In addition to oxygen, significant amount of chlorine were found along these cracks, and were more important in areas where the grease rose by capillarity at the studied surface.

Figure 5: SEM images in secondary electrons mode and EDS analysis of a cross section of a crack near the surface of a galvanized steel strand of the GHW conductor, zinc in green, iron in orange, oxygen in red and chlorine in pink.

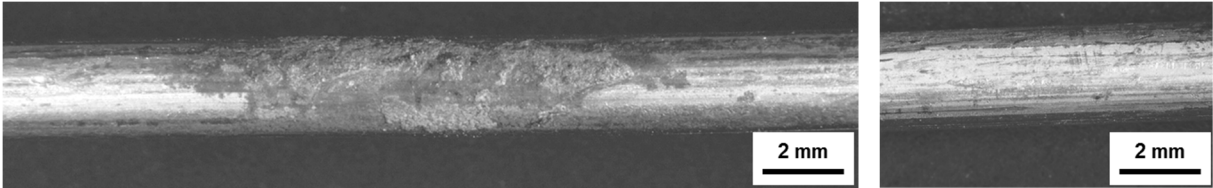
Before the tensile tests, the diameter of the galvanized steel strands was measured:  $2.39 \pm 0.01$  mm and  $2.40 \pm 0.02$  mm, for those extracted from the GHW and the modern conductor, respectively. Visual examination of the strands evidenced some corrosion marks. They were much more pronounced on the GHW conductor (Figure 6) than on the modern one (Figure 7). They were also more numerous on the external strands than on the central strands. On every strand extracted from either the GHW conductor or the modern one, periodic marks due to the interaction with neighboring strands were also noticed (left picture in Figure 7).

Figure 6: Photographs of galvanized steel strands of the GHW conductor before tensile tests; left: corrosion mark on the external layer strand; right: lower degree of corrosion of the central strand.

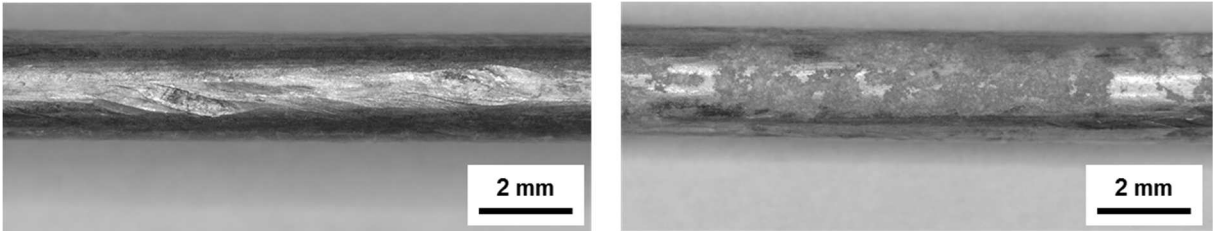
Figure 7: Photographs of a galvanized steel strand from the internal layer of the modern conductor before tensile tests; left: periodic marks due to interaction with the neighboring strands; right: corrosion mark.

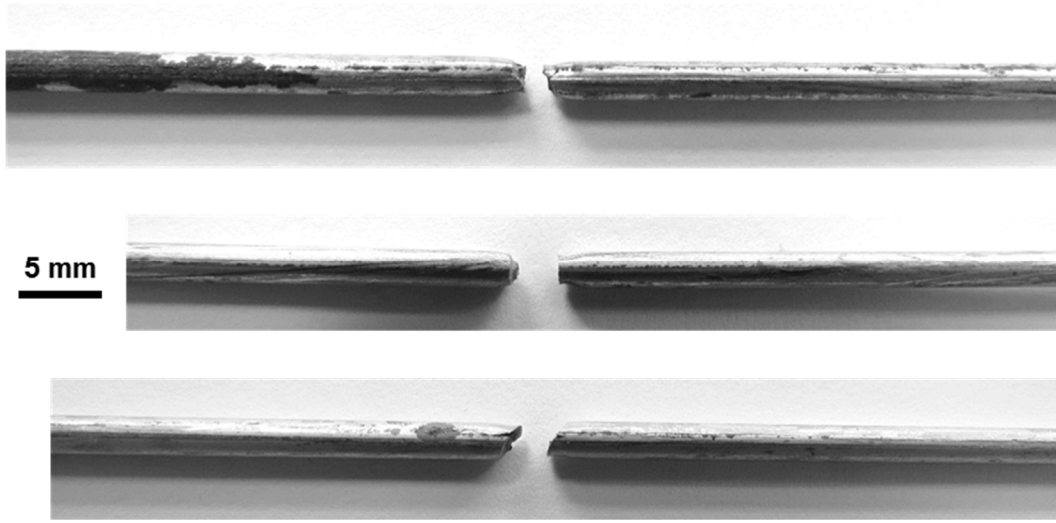
After the tensile tests, fractured strands were observed by optical means and by SEM. Figure 9 indicates that the fracture of the galvanized steel strands extracted from the GHW conductor did not initiate on the corrosion marks. All the tested galvanized steel strands – extracted either from the GHW conductor or the modern one – fractured following a typical “cup-cone” ductile fracture mechanism. The central area of the fracture surface was globally oriented perpendicular to the tensile direction and consisted of numerous dimples (Figure 10). This area was surrounded by a ring-shaped slanted area, which consisted of sheared dimples. As the other tested strands, the central galvanized steel strand extracted from the GHW conductor presented a “cup-cone” fracture. It also presented a wire drawing defect appearing as a crack in the radial-longitudinal plane, which is noticeable on the bottom left image in Figure 10. The apparent crack length in the transversal plane was  $800 \mu\text{m}$ . Due to its orientation – parallel to the tensile direction – the effect of this crack on the strength of the strand was *de facto* limited but its effect on the reduction of area at fracture distinctly appeared.

Figure 9: Photographs of the galvanized steel strands of the GHW conductor after tensile tests; top: fracture of the external layer strand initiated away from the main corrosion mark; middle: internal layer strand; bottom: central layer strand.

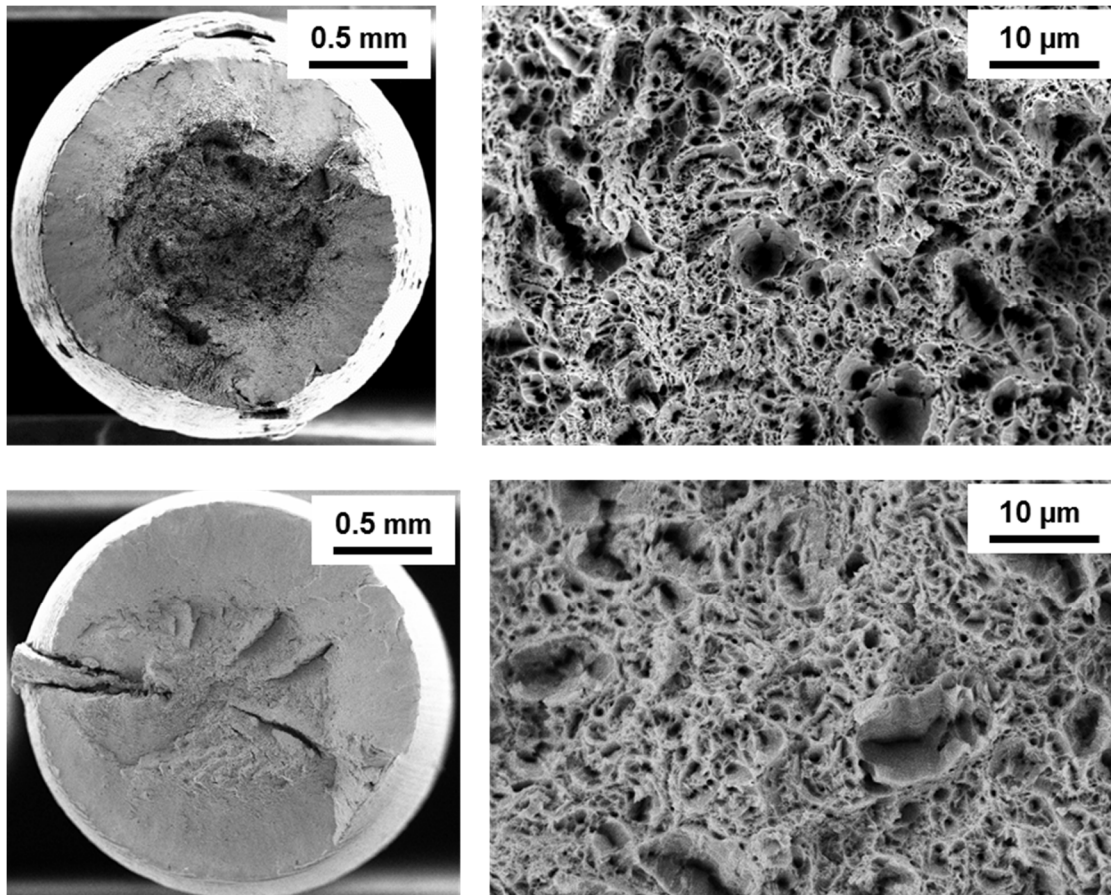
**Figure 10: SEM images of the fracture surface of galvanized steel strands extracted from the GHW conductor; top: external layer strand; bottom: central layer strand; left: general views; right: detailed view of the numerous dimples located in the central area.**

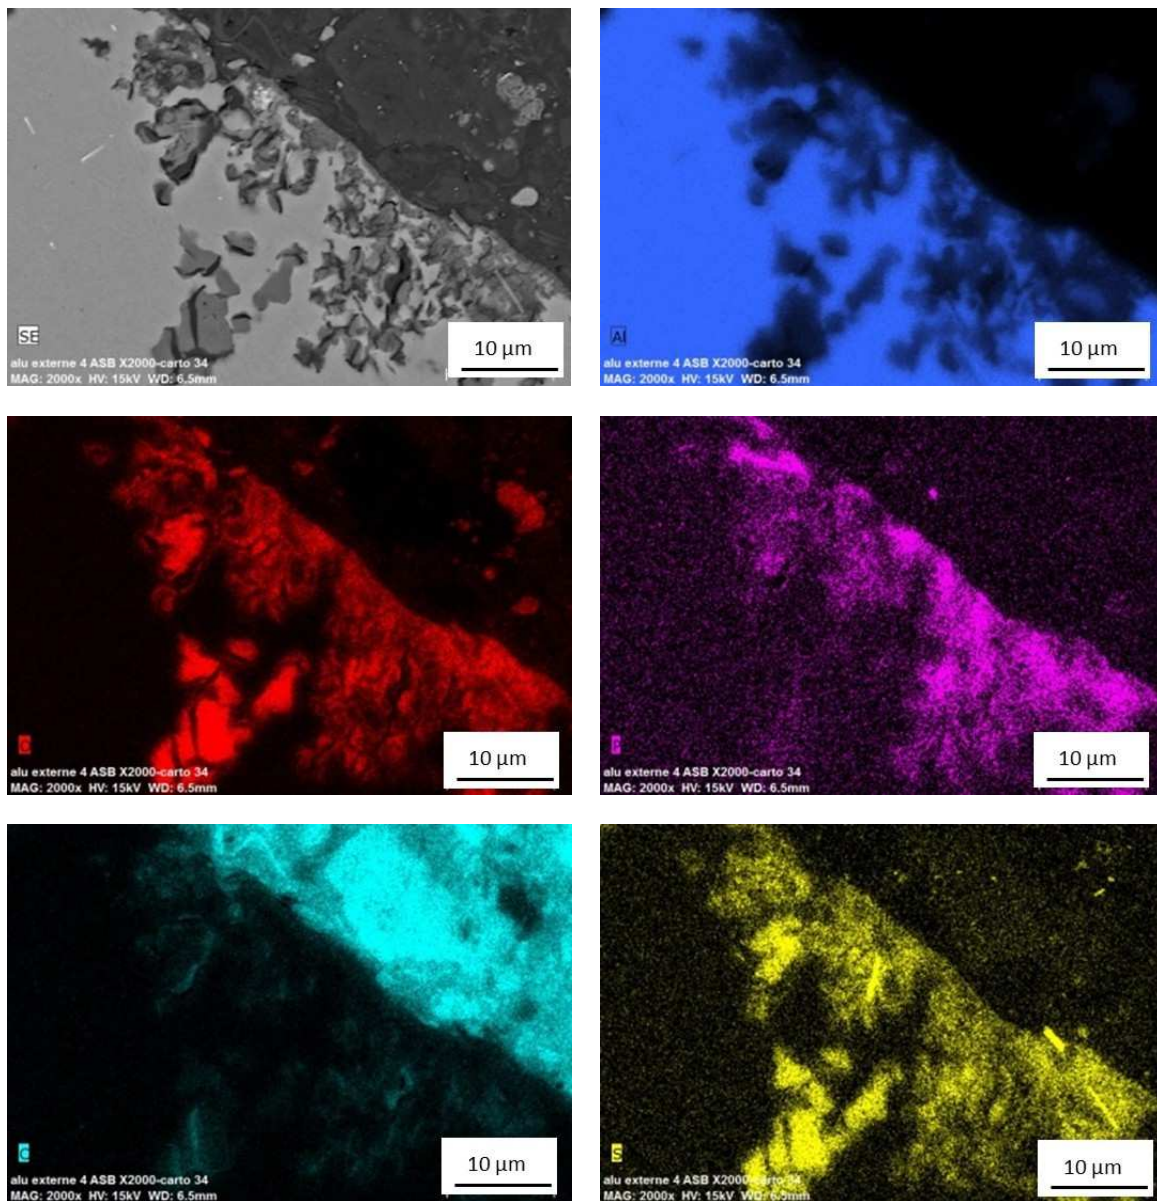
The external layer strands of the modern conductor strands had a native smooth passivated surface. Concerning the GHW external strands, the zone exposed to the environment exhibited signs of atmospheric corrosion with the presence of pits. Some of these pits were filled with cracked aluminum oxide containing phosphorus and sulfur (Figure 11). The depth of the pits was inferior to 100  $\mu\text{m}$ . Some areas presented an oxide layer, which had a maximum thickness of 5  $\mu\text{m}$ . It was generally associated with corrosion pits.

Figure 11: SEM image and EDS analysis of a cross section of an external aluminum strand extracted from the GHW conductor. Aluminum is in blue, oxygen in red, carbon in cyan, sulfur in yellow and phosphorus in pink.

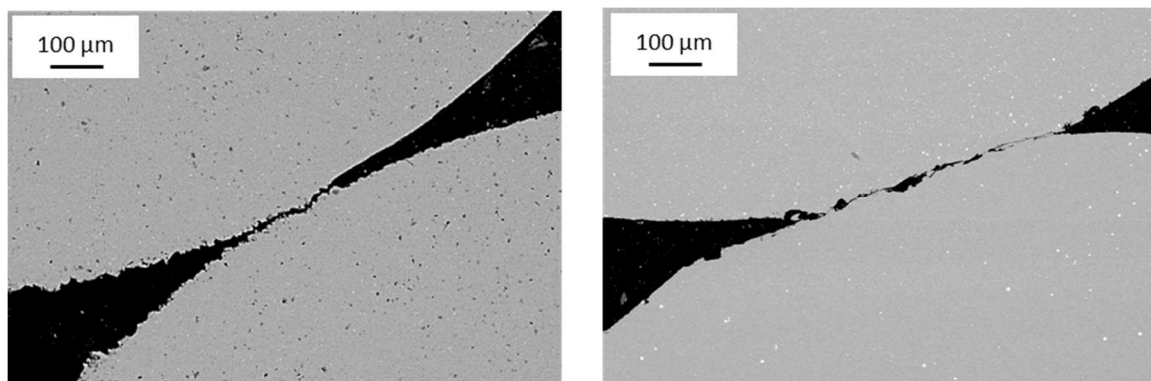
For both the GHW and the modern conductors, no sign of corrosion was detected on the inner strands or on the zones that were not exposed to the environment on the external layer. On every aluminum strand, signs of plastic deformation were noticed due to the interaction with the neighboring strands, made of either aluminum or galvanized steel (Figure 12).

Figure 12: SEM images of cross sections of internal aluminum strands; left for the modern conductor; right for the GHW conductor.

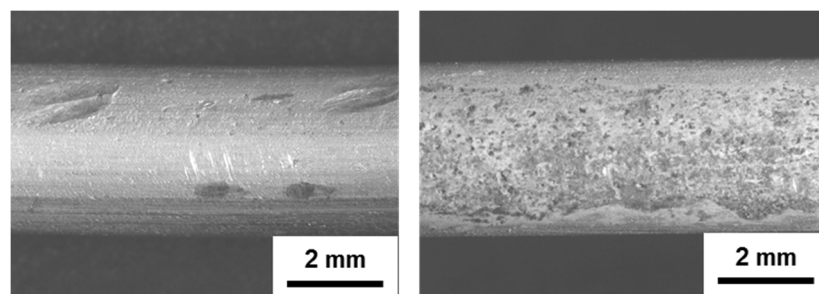
Before the tensile tests, the aluminum strands were visually examined and their diameter was measured:  $3.54 \pm 0.01$  mm and  $3.55 \pm 0.01$  mm, for those extracted from the GHW and from the modern conductor, respectively. Noticeable on every strand were the periodic marks due to the interaction with the neighboring steel or aluminum strand layers (left picture in Figure 13 and in Figure 14). The periodic marks on the modern conductor strands were as pronounced as the ones on the GHW, indicating that they originated from the manufacturing process rather than from a potential degradation during operation. Visual examination also confirmed the presence of numerous atmospheric corrosion pits all along the external part of the external layer strands of the GHW conductor (right picture in Figure 13). The diameter of these pits was approximately 0.1 mm. The inner part of the external layer strands and the inner layer strands were exempt of pits. In places, the external part of the external layer strands also presented some squashing marks (right picture in Figure 14).

**Figure 13: Photographs of aluminum strands of the GHW conductor before tensile tests; left: periodic marks on the internal layer I strand due to interaction with the neighboring steel strands; right: numerous corrosion pits on the external surface of the external layer A strand.**

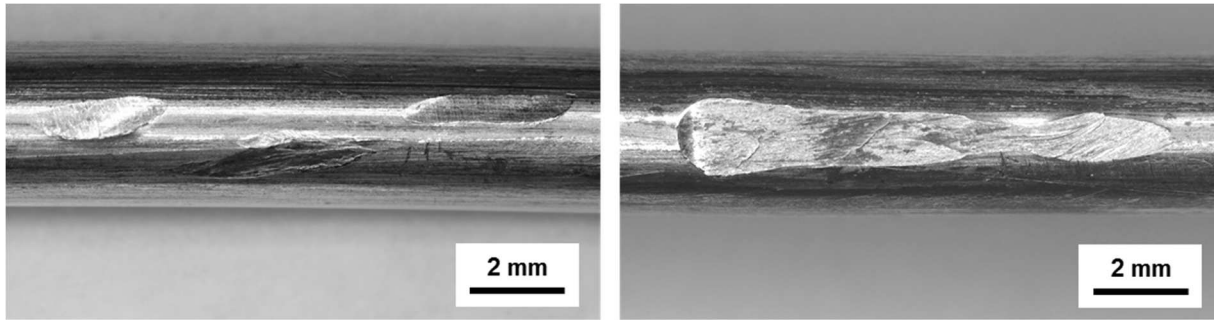
Figure 14: Photographs of aluminum strands of the modern conductor before tensile tests; left: periodic marks on the internal layer H strand due to interaction with the neighboring steel strands; right: mark on the external surface of the external layer K strand.

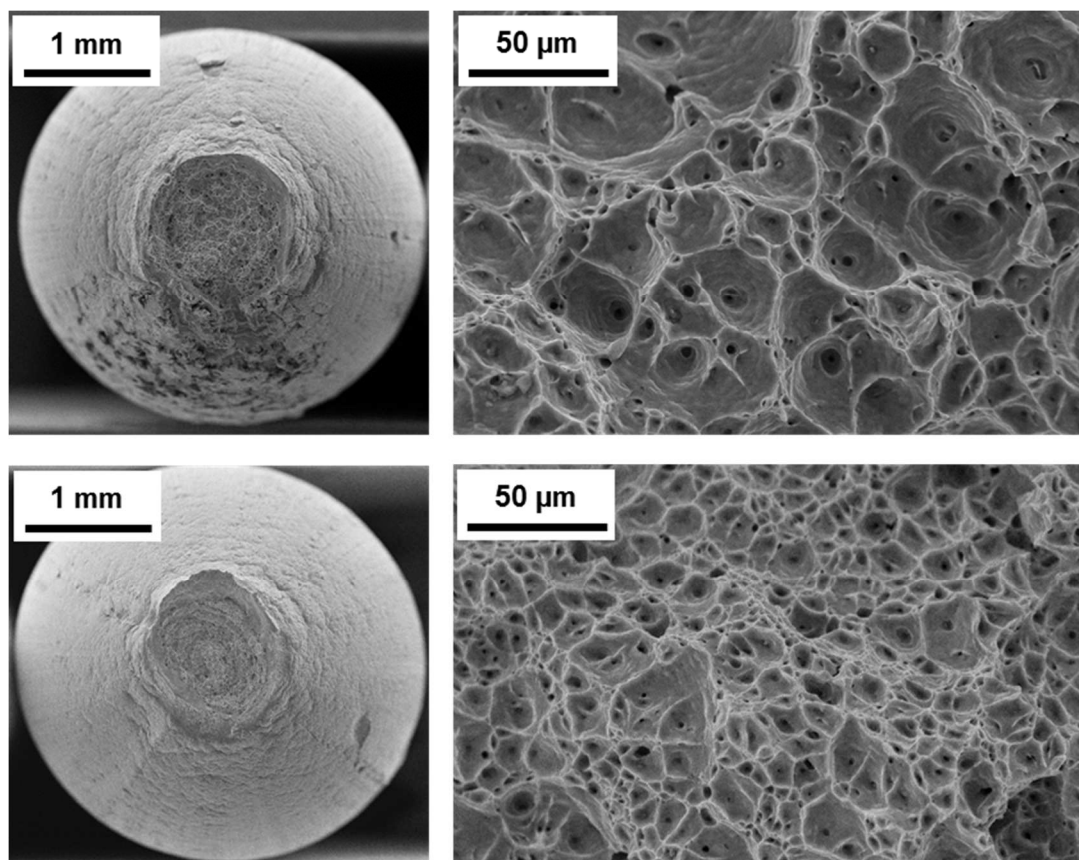
Post-test observations by optical means and by SEM indicated that the fracture was in all cases completely ductile with an important reduction in area and numerous dimples on the fracture surfaces (right part of Figure 16). Atmospheric corrosion pits were noticed on the external part of the aluminum external layer strands of the GHW (top left image in Figure 16). Apart from these pits, SEM images of the modern conductor aluminum strands – not reported here – presented features similar to the ones of the GHW conductor. As shown in Figure 17, the fracture of the aluminum external layer K strand of the modern conductor was initiated on the squashing mark observed before fracture (right picture in Figure 14), whereas the fracture of the other studied external layer strand was not related to any mark. Nevertheless, the mechanical properties of these two strands were very close (Figure 15 and Table 3). Consequently, this mark was slight enough not to have impaired the mechanical properties of the strand.

**Figure 16: SEM images of the fracture surface of aluminum strands extracted from the GHW conductor; top: external layer J strand; bottom: internal layer I strand; left: general views; right: detailed view of the numerous dimples located in the central area.**

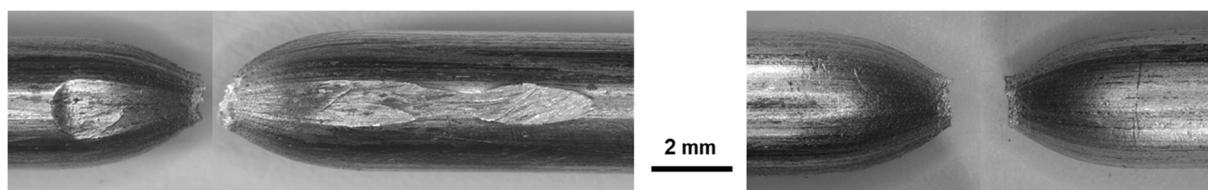
**Figure 17: Photographs of the aluminum strands of the modern conductor after tensile tests; left: fracture of the external layer K strand initiated on the mark observed before the test (Figure 14); right: fracture of the external layer M strand.**
