Characterization of an aluminum conductor steel reinforced (ACSR) after 60 years of operation

F. LEQUIEN^{1*}, Q. AUZOUX¹, G. MOINE¹, M. ROUSSEAU¹, S. PASQUIER-TILLIETTE¹,
A. HOLANDE¹, S. AMMI², S. HEURTAULT² and P. PRIEUR²

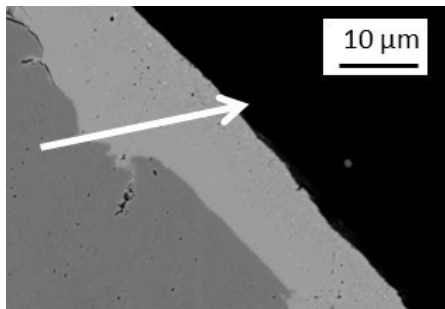
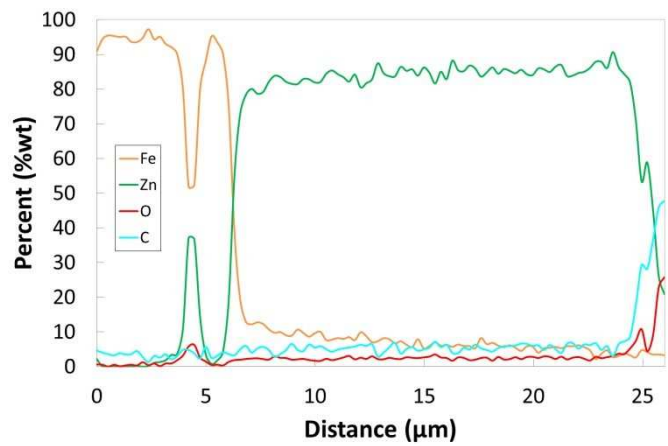
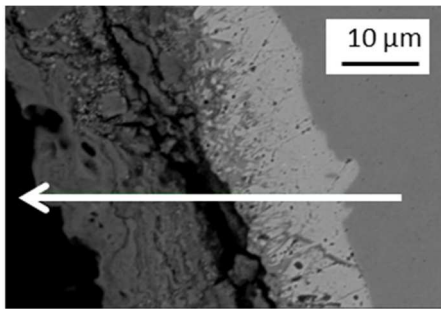
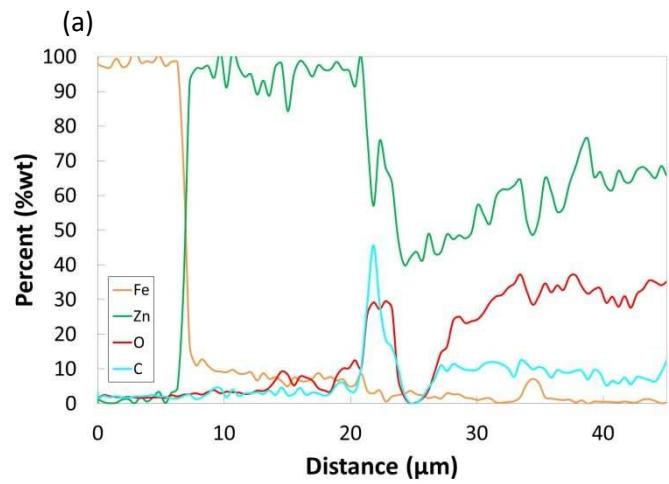
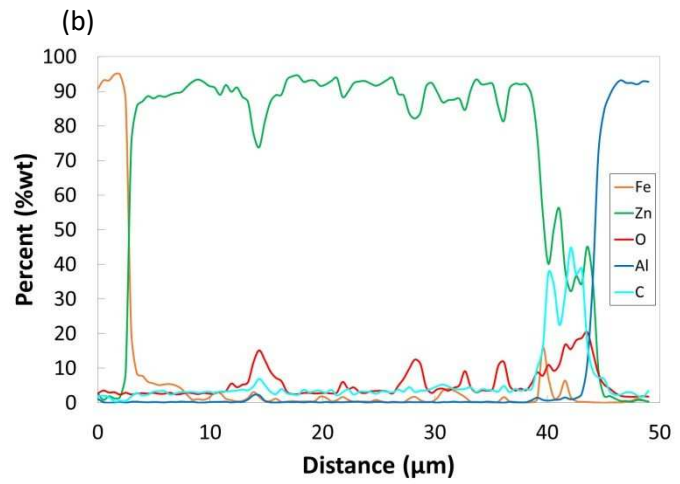
The galvanization layer of the GHW conductor presented different features depending on the studied strand and location. In most cases, the average thickness of the galvanization layer was lower than 20 μm and no pure zinc outer sublayer was observed (Figure 3(a)). The innermost sublayer was the delta phase, with a maximum iron content of 10 wt%. Its thickness was low: between 2 and 5 μm . The iron content of the second sublayer was between 4 and 6 wt%, which corresponded to the zeta phase.

On some strands of the outer layer of the steel part of the conductor, the galvanization layer was locally thicker (up to 30 μm) than in the general case described previously and presented a supplementary outer sublayer which appeared darker on SEM observations (Figure 3 (b)). EDS analysis showed that this sublayer contained mainly zinc and oxygen. However, the amount of carbon detected by EDS, which was most probably linked to the presence of grease, complicated the identification of this oxide. It was consequently characterized by Raman spectroscopy, which showed that this layer was amorphous or slightly crystallized ZnO with the three following characteristic peaks [31]: 165 cm^{-1} , 435 cm^{-1} and 565 cm^{-1} (Figure 4). Figure 3 (b) also indicated the partial oxidation of the zeta phase.

In some areas, the steel strands of the outer layer of the steel part of the conductor were locally embedded in their neighboring aluminum strand. In these areas, the galvanization layer was even thicker (up to 40 μm) and EDS analysis indicated the presence of unoxidized eta phase (Figure 3(c)).

Figure 3: SEM images and EDS analysis of cross sections of the galvanization layer of the GHW conductor. (a) General case, (b) partially oxidized layer and (c) in the areas that are embedded in an aluminum strand. Iron is represented in orange, zinc in green, oxygen in red, carbon is in cyan and aluminum is in blue.

The absence of the pure zinc η phase sublayer on most galvanized steel strands from the GHW conductor showed that the galvanization layer had degraded during operation. The characterization indicated that this degradation was due to a corrosion phenomenon. Indeed, some corrosion products (ZnO) located on the external surface of the galvanization layer were observed (Figure 3(b)) and identified by Raman spectroscopy (Figure 4). They did not appear very adherent to the layer and contained many cracks.

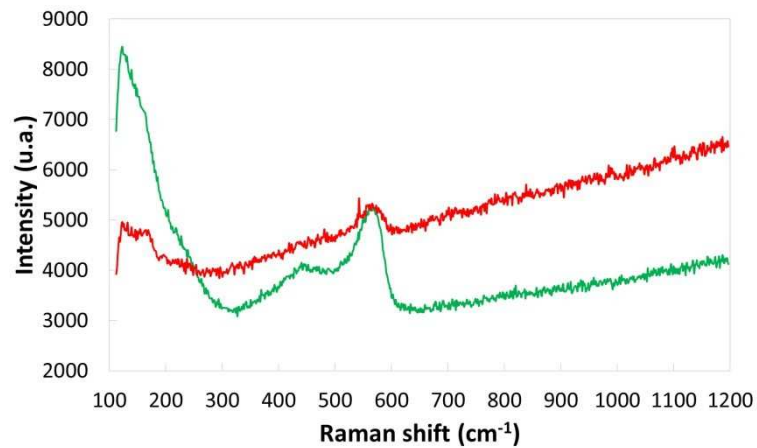
Figure 4: Raman spectra obtained on the galvanization layer of a strand from the outer layer of the steel part of the GHW conductor, in the partially oxidized inner sublayer (in red) and in the oxidized outer sublayer (in green).

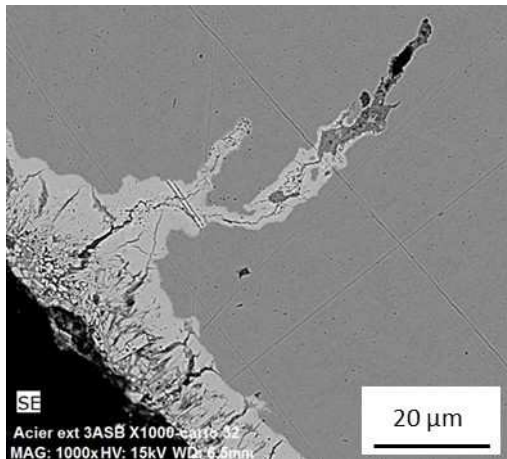
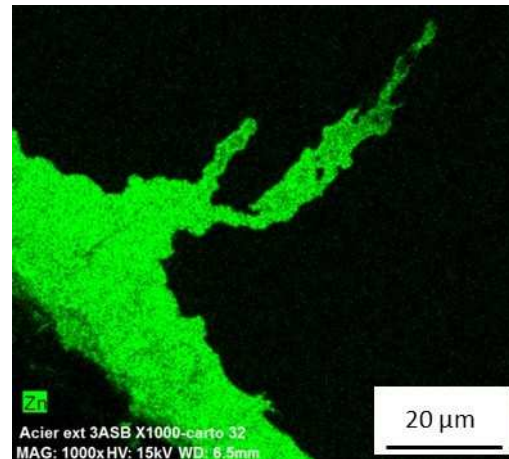
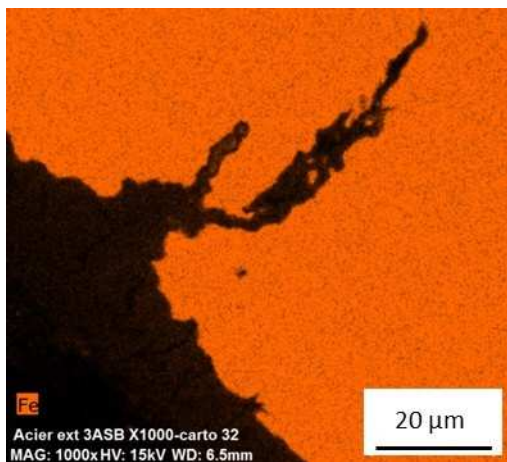
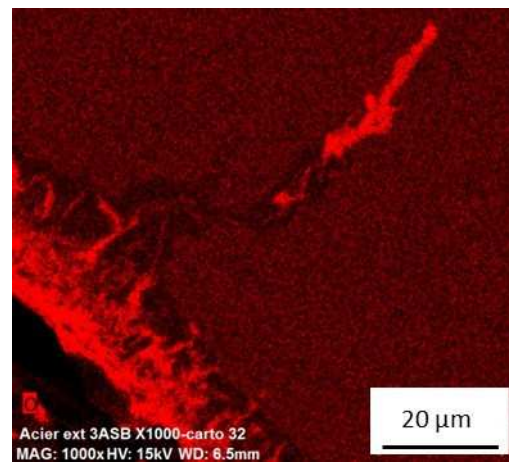
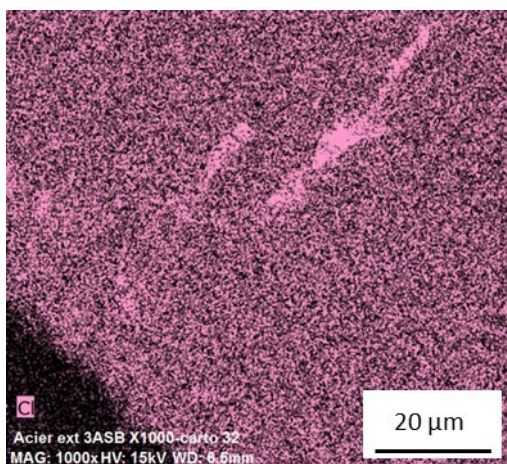
Cracks were noticed on the cross section of some of the studied strands. Few and short ($< 15 \mu\text{m}$) for the modern conductor, their apparent length varied from 10 to 800 μm for the GHW conductor (Figure 5). SEM analysis revealed the presence of zinc along the length of the crack, indicating that cracks were present prior to the galvanizing. They were therefore considered as wire drawing defects. For the GHW conductor, inside the cracks, the galvanization layer was micro-cracked. Some of these micro-cracks appeared to connect the crack tip to the surface. However, the cross section sample showed that the steel did not appear corroded. In addition to oxygen, significant amount of chlorine were found along these cracks, and were more important in areas where the grease rose by capillarity at the studied surface.

Figure 5: SEM images in secondary electrons mode and EDS analysis of a cross section of a crack near the surface of a galvanized steel strand of the GHW conductor, zinc in green, iron in orange, oxygen in red and chlorine in pink.

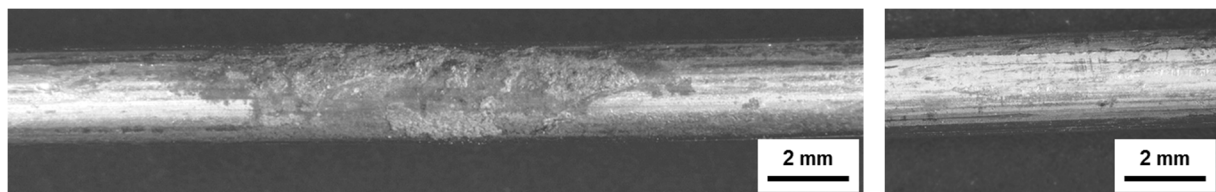
Before the tensile tests, the diameter of the galvanized steel strands was measured: 2.39 ± 0.01 mm and 2.40 ± 0.02 mm, for those extracted from the GHW and the modern conductor, respectively. Visual examination of the strands evidenced some corrosion marks. They were much more pronounced on the GHW conductor (Figure 6) than on the modern one (Figure 7). They were also more numerous on the external strands than on the central strands. On every strand extracted from either the GHW conductor or the modern one, periodic marks due to the interaction with neighboring strands were also noticed (left picture in Figure 7).

Figure 6: Photographs of galvanized steel strands of the GHW conductor before tensile tests; left: corrosion mark on the external layer strand; right: lower degree of corrosion of the central strand.

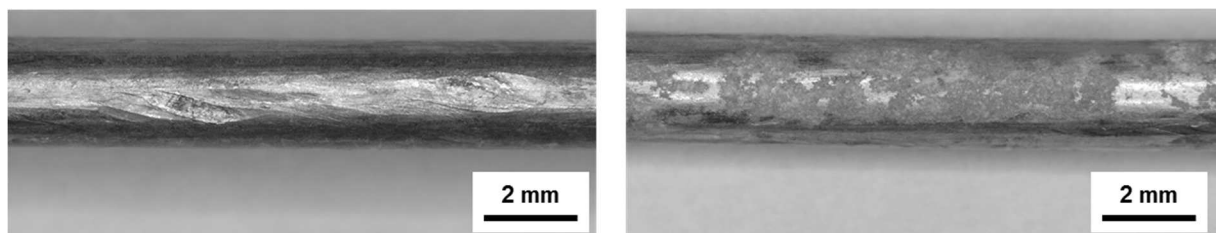
Figure 7: Photographs of a galvanized steel strand from the internal layer of the modern conductor before tensile tests; left: periodic marks due to interaction with the neighboring strands; right: corrosion mark.

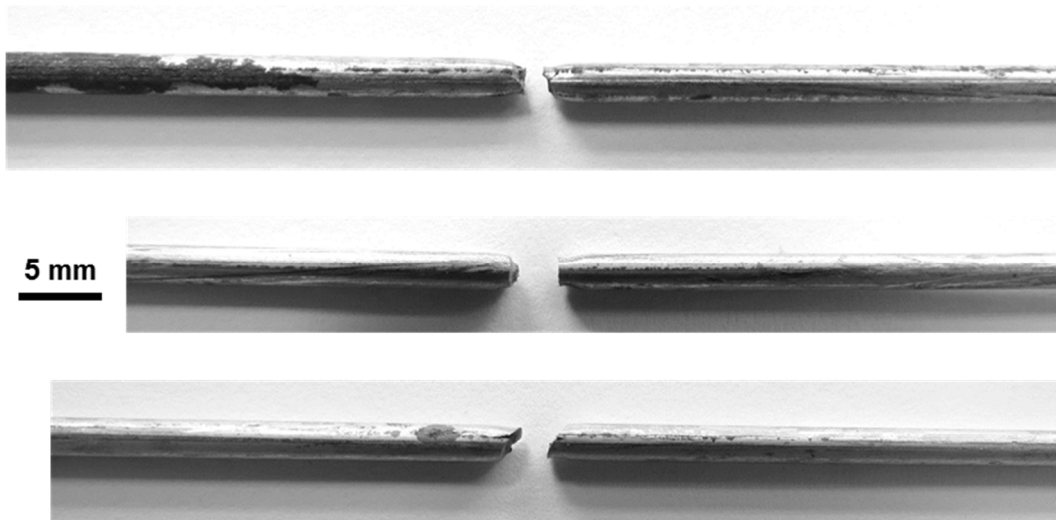
After the tensile tests, fractured strands were observed by optical means and by SEM. Figure 9 indicates that the fracture of the galvanized steel strands extracted from the GHW conductor did not initiate on the corrosion marks. All the tested galvanized steel strands – extracted either from the GHW conductor or the modern one – fractured following a typical “cup-cone” ductile fracture mechanism. The central area of the fracture surface was globally oriented perpendicular to the tensile direction and consisted of numerous dimples (Figure 10). This area was surrounded by a ring-shaped slanted area, which consisted of sheared dimples. As the other tested strands, the central galvanized steel strand extracted from the GHW conductor presented a “cup-cone” fracture. It also presented a wire drawing defect appearing as a crack in the radial-longitudinal plane, which is noticeable on the bottom left image in Figure 10. The apparent crack length in the transversal plane was $800\text{ }\mu\text{m}$. Due to its orientation – parallel to the tensile direction – the effect of this crack on the strength of the strand was *de facto* limited but its effect on the reduction of area at fracture distinctly appeared.

Figure 9: Photographs of the galvanized steel strands of the GHW conductor after tensile tests; top: fracture of the external layer strand initiated away from the main corrosion mark; middle: internal layer strand; bottom: central layer strand.

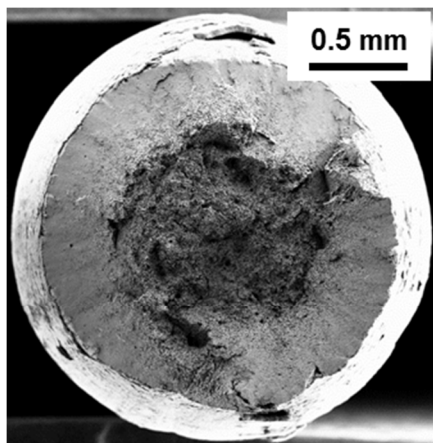
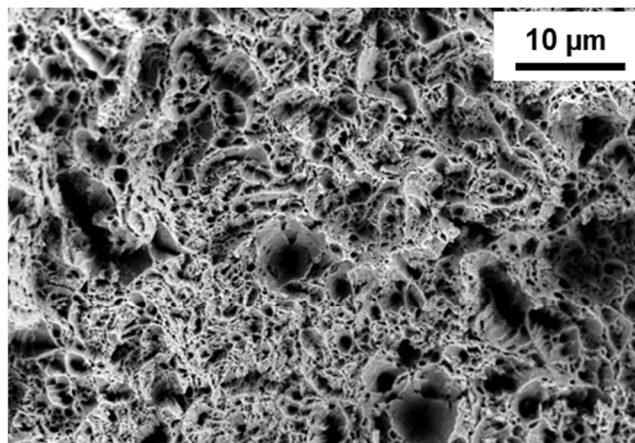
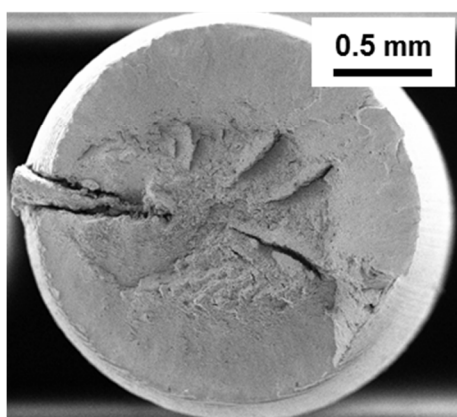
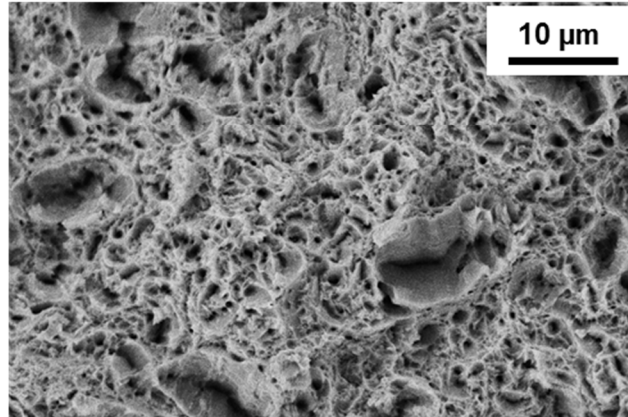
Figure 10: SEM images of the fracture surface of galvanized steel strands extracted from the GHW conductor; top: external layer strand; bottom: central layer strand; left: general views; right: detailed view of the numerous dimples located in the central area.

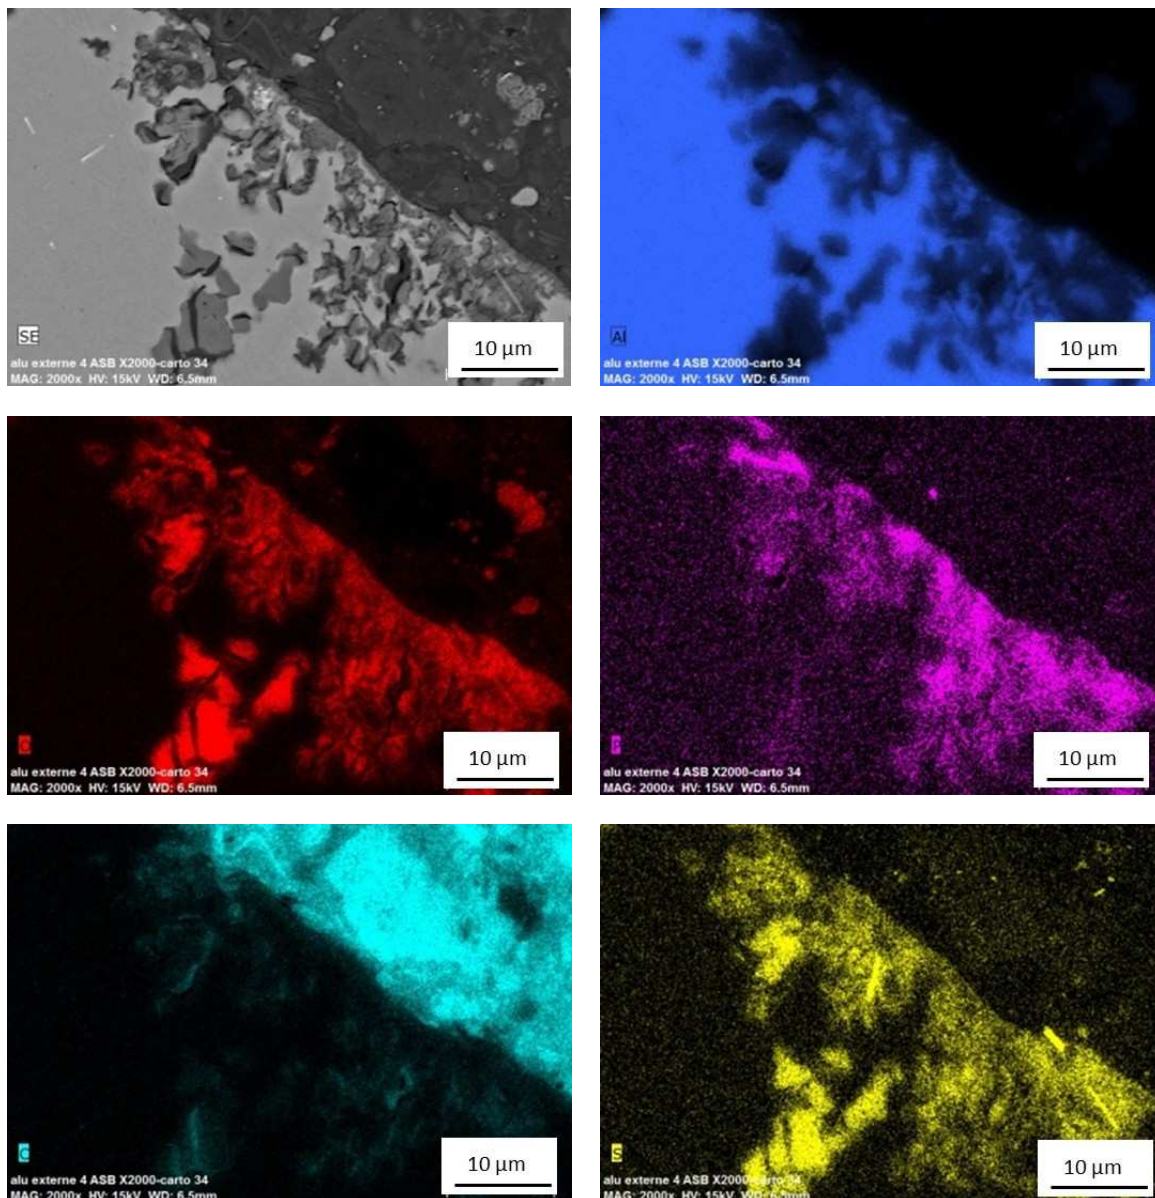
The external layer strands of the modern conductor strands had a native smooth passivated surface. Concerning the GHW external strands, the zone exposed to the environment exhibited signs of atmospheric corrosion with the presence of pits. Some of these pits were filled with cracked aluminum oxide containing phosphorus and sulfur (Figure 11). The depth of the pits was inferior to 100 μm . Some areas presented an oxide layer, which had a maximum thickness of 5 μm . It was generally associated with corrosion pits.

Figure 11: SEM image and EDS analysis of a cross section of an external aluminum strand extracted from the GHW conductor. Aluminum is in blue, oxygen in red, carbon in cyan, sulfur in yellow and phosphorus in pink.

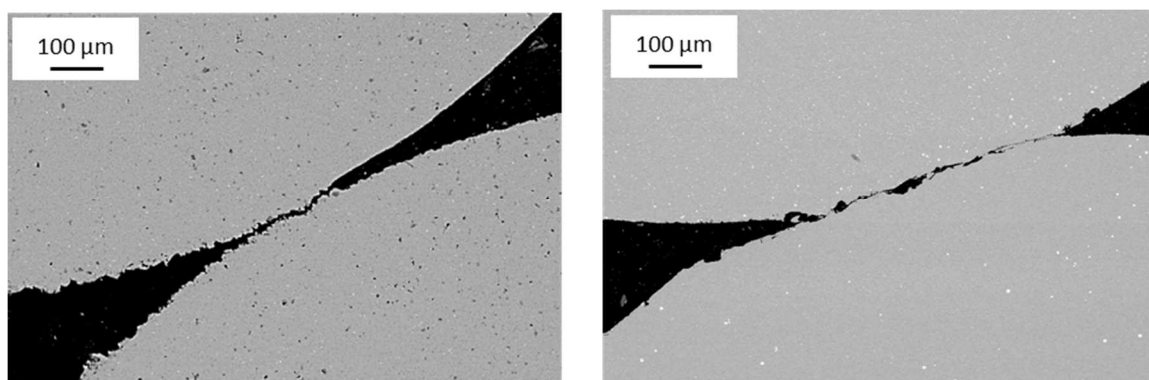
For both the GHW and the modern conductors, no sign of corrosion was detected on the inner strands or on the zones that were not exposed to the environment on the external layer. On every aluminum strand, signs of plastic deformation were noticed due to the interaction with the neighboring strands, made of either aluminum or galvanized steel (Figure 12).

Figure 12: SEM images of cross sections of internal aluminum strands; left for the modern conductor; right for the GHW conductor.

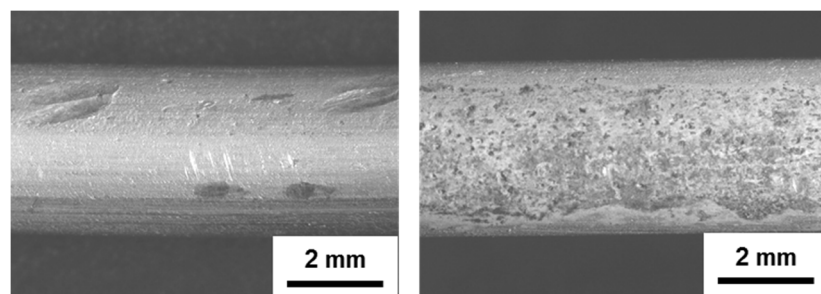
Before the tensile tests, the aluminum strands were visually examined and their diameter was measured: 3.54 ± 0.01 mm and 3.55 ± 0.01 mm, for those extracted from the GHW and from the modern conductor, respectively. Noticeable on every strand were the periodic marks due to the interaction with the neighboring steel or aluminum strand layers (left picture in Figure 13 and in Figure 14). The periodic marks on the modern conductor strands were as pronounced as the ones on the GHW, indicating that they originated from the manufacturing process rather than from a potential degradation during operation. Visual examination also confirmed the presence of numerous atmospheric corrosion pits all along the external part of the external layer strands of the GHW conductor (right picture in Figure 13). The diameter of these pits was approximately 0.1 mm. The inner part of the external layer strands and the inner layer strands were exempt of pits. In places, the external part of the external layer strands also presented some squashing marks (right picture in Figure 14).

Figure 13: Photographs of aluminum strands of the GHW conductor before tensile tests; left: periodic marks on the internal layer I strand due to interaction with the neighboring steel strands; right: numerous corrosion pits on the external surface of the external layer A strand.

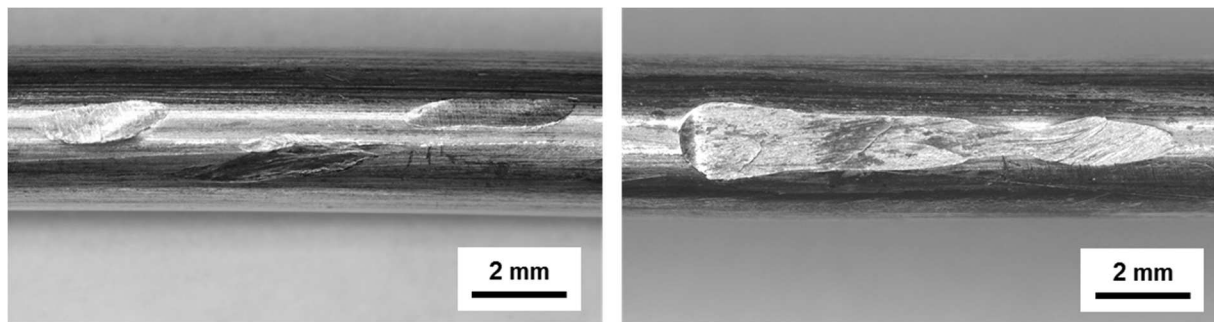
Figure 14: Photographs of aluminum strands of the modern conductor before tensile tests; left: periodic marks on the internal layer H strand due to interaction with the neighboring steel strands; right: mark on the external surface of the external layer K strand.

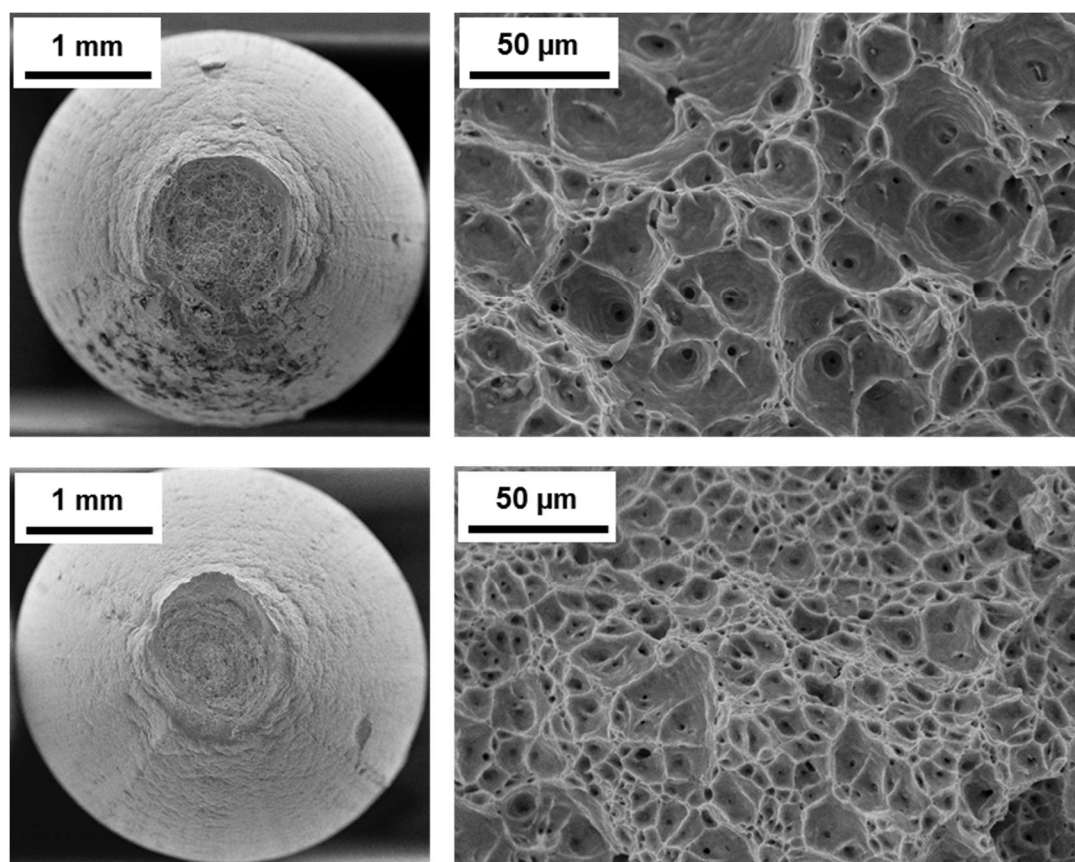
Post-test observations by optical means and by SEM indicated that the fracture was in all cases completely ductile with an important reduction in area and numerous dimples on the fracture surfaces (right part of Figure 16). Atmospheric corrosion pits were noticed on the external part of the aluminum external layer strands of the GHW (top left image in Figure 16). Apart from these pits, SEM images of the modern conductor aluminum strands – not reported here – presented features similar to the ones of the GHW conductor. As shown in Figure 17, the fracture of the aluminum external layer K strand of the modern conductor was initiated on the squashing mark observed before fracture (right picture in Figure 14), whereas the fracture of the other studied external layer strand was not related to any mark. Nevertheless, the mechanical properties of these two strands were very close (Figure 15 and Table 3). Consequently, this mark was slight enough not to have impaired the mechanical properties of the strand.

Figure 16: SEM images of the fracture surface of aluminum strands extracted from the GHW conductor; top: external layer J strand; bottom: internal layer I strand; left: general views; right: detailed view of the numerous dimples located in the central area.
