Metal-as-Insulation HTS Insert for Very-High-Field Magnet: A Test Report After Repair

Metal-as-Insulation HTS Insert for Very-High-Field Magnet: A Test Report after Repair

Abstract—This study is a sequel to our previous study on a 38 mm diameter cold bore metal-as-insulation (MI) HTS insert that reached 32.5 T in a 18 T background magnetic field. For refurbishing, 7 MI double-pancake (DP) coils were re-wound with used REBCO tapes to just replace the damaged HTS pieces by new ones at inner junctions. 2 DP coils were fully fabricated using new REBCO tapes. The new assembled insert was then tested under various background magnetic fields at 4.2 K. The key focuses of this paper are: 1) the damages in the DP coils; 2) their repair; 3) the characteristics resistance change of the insert; 4) the resistance value of each DP coil; 5) the maximum field of the HTS-resistive hybrid magnet; and 6) the field stability estimation of the hybrid by NMR characterization.

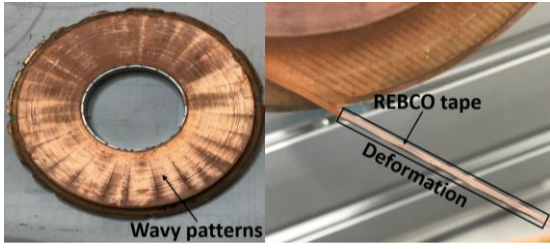
The I_c , α and R values of each DP coil were measured at 77 K in SF after disassembling the MI insert. The DP coils were unwound and their conductors were closely examined for deformation or burn. Fig. 1 shows the top surface and conductor of DP9 which is the top DP of the insert. As seen in Fig. 1, a wavy pattern formed on the surface of DP9, and the edge part of the conductor was deformed according to this pattern. The height of the winding being 0.2 mm higher than that of the stainless steel (SS) inner ring used as mandrel, this area without mechanical support has been deformed repetitive high magnetic field charging or quenching. Except for DP9 and DP1 located at the top and bottom of the insert respectively, the conductors of the 7 other DP coils were not deformed. To evaluate the damage on conductor of DP9, I_c distribution was measured by Theva using a TapeStar quality control device.

Fig. 1. Photographs of surface and conductor of DP9 after disassembling.

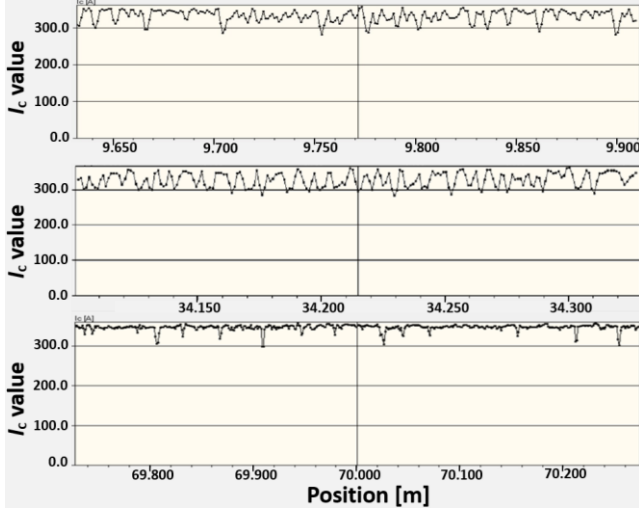
Fig. 2. I_c distribution along the conductor length of DP9 showing regular defects.

Fig. 2 shows the I_c distribution along the conductor length of DP9. The I_c values are regularly degraded at deformed areas by about 15 %. Fig. 3 shows the photographs of the inner most turn (joining area) and the joining pieces of DP coils. The middle part of the HTS joining pieces for inner and outer electrical junctions is kinked due to high magnetic pressures generated by charging and quench events despite uniaxial preloading prior to soldering and the use of Belleville washers. In addition, the inner most turns of the DP coils were delaminated.

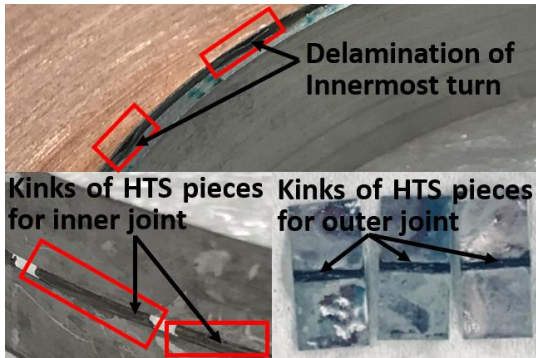
Fig. 3. Photographs of the inner most turn and the kinked HTS joining pieces for inner and outer electrical junctions after two quenches.

7 DP coils out of a total number of 9 DP coils were re-wound with used REBCO tapes and just the damaged HTS pieces were replaced at inner junctions. Although the repaired DP9 shows electrical resistance close to the original one, because the conductor deformation was obvious and we fear a more severe degradation under high magnetic field, we decided to replace DP9 and DP1 by DPs fully manufactured using brand new REBCO tapes. During repairing process of DP coils, a sapphire plate was inserted for electrical insulation and thermal conduction between the SP coils to enhance the cooling condition inside each DP coil [5]. Fig. 4 shows test results of original, dismantled and repaired MI DP at 77 K in SF. The R values of DP 2~8 with just inner joints replaced were 0.32, 0.17, 0.23, 0.6, 0.33, 0.12 and 0.12 $\mu\Omega$, respectively. The R values of the DP coils were significantly reduced by making new inner junctions. The nine DP coils were mounted on a support structure and an axial preload pressure of 10 MPa was applied using Belleville washers. For better cooling between DP coils, 0.3 mm thick copper plates insulated by 0.2 mm G-10 sheets, one on each side, were inserted in between DP-DP coils. Each pancake coil was so-called over-banded by about 45 turns of 75 μm thick 316L SS tape. 3 turns of REBCO tape were wound onto the middle of over-banding to eventually reduce induced voltages, currents and unbalance forces generated by quench events. The method of our construction technique for the MI insert has already been described in detail in a previous paper [4]. Table II lists the specifications of the repaired MI insert.

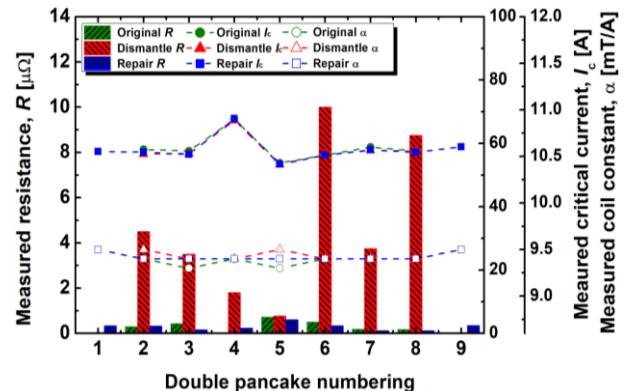
Fig. 4. Measured critical current (I_c), electrical resistance (R) and coil constant (α) of original, dismantled and repaired DP coils at 77 K in self-field.

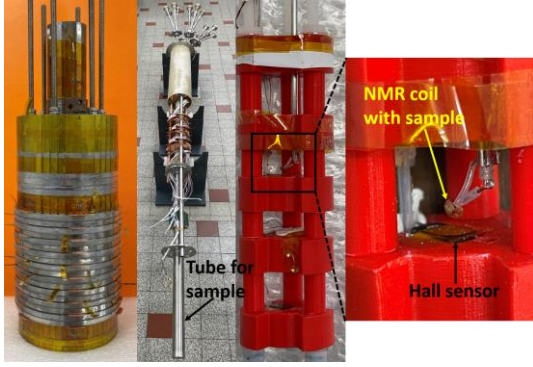
Fig. 5. The photographs of the repaired MI insert, new probe and homemade insert supporting five Hall sensors (Arepec) and NMR coil with an ^{27}Al sample.

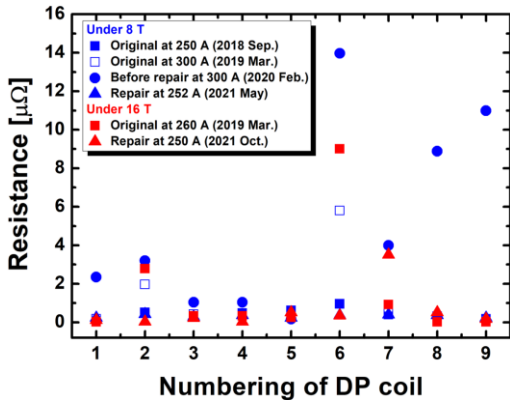
Fig. 8 shows the R value of each DP coil under $B_{\text{ext}} = 8$ and 16 T. All DP coils but DP5 were highly resistive (1.1 ~ 14.1 $\mu\Omega$) before repair comparing to the original values at the operating current (I_{op}) of 300 A under $B_{\text{ext}} = 8$ T. After repairing the DP coils, they show a much lower R value (210 ~ 520 n Ω) under both $B_{\text{ext}} = 8$ and 16 T except DP7, indicating that most of repaired DP coils are operated well at 4.2 K under very high magnetic field. The damages occurring at quench are mainly localized at the inner and outer electrical junctions made by soldering. The DP coils themselves are well protected by our passive HTS protection scheme comprising the MI winding technique and the over voltage mode of our power supply. We removed the external dump circuit and the breaker prone to create signal spikes. The high electrical resistance at the repaired DP7 occurs because the conductor near the outer junction for a DP-DP junction was damaged during joining process. This damage is localized and can be repaired with sufficient care.

Fig. 8. Electrical resistance values of original, dismantled and repaired DP coils under $B_{\text{ext}} = 8$ and 16 T at 4.2 K.
