## **Galvanic corrosion over World War II aircraft wrecks**

Cesar Adolfo Escobar Carlos, Cecilia Velino, Magali Brunet, Luc Robbiola,  
Elena Bernardi, Carla Martini, Cristina Chiavari, Andrea Balbo, Élodie  
Guilminot

Cesar Adolfo Escobar Carlos, Cecilia Velino, Magali Brunet, Luc Robbiola, Elena Bernardi, et al..  
Galvanic corrosion over World War II aircraft wrecks. Eurocorr 2022, Aug 2022, Berlin, Germany.  
hal-03881520

### **Ancient metals in marine environments: corrosion mechanisms and protective treatments**

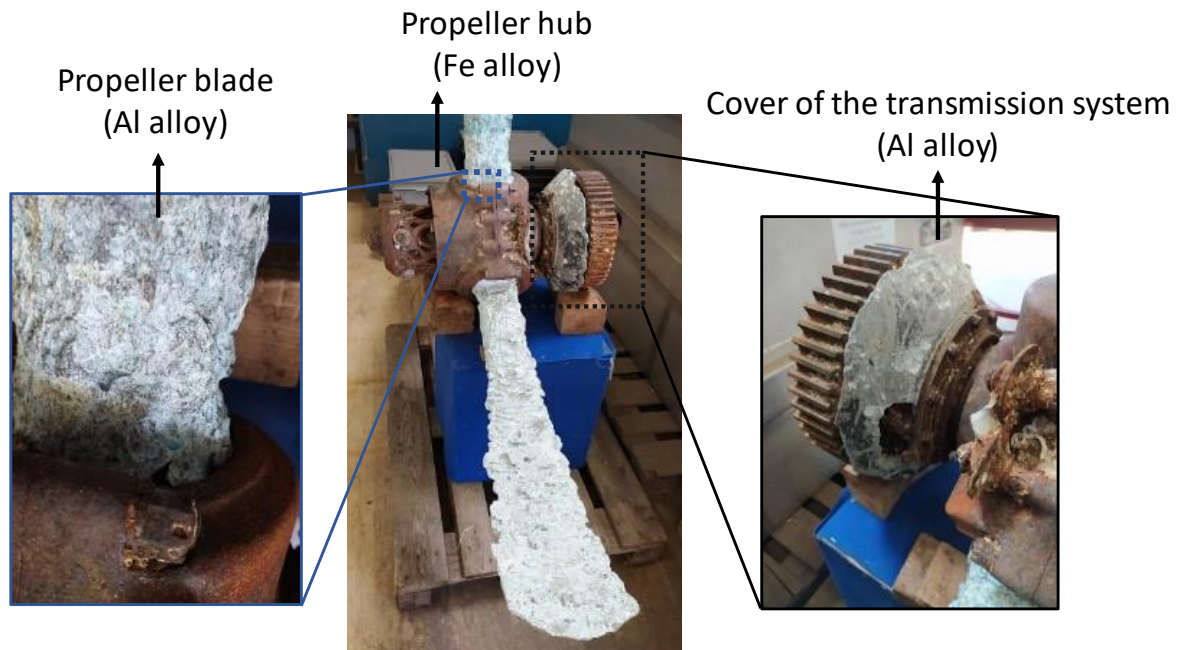
**Fig. 1** Aircraft propeller (blade length 130 cm and maximum chord 26 cm) found in Fécamp (French city seaside to the English Channel), indicating the degradation state of the different components. The Fe/Al area ratio in this object is among 0.4-1, according to the Al piece evaluated.

As shown in Fig. 1. the propeller blades are in an advanced state of corrosion. covered by white and blue-green corrosion products. They are known to be hydrated variants of aluminium or copper-aluminium oxides and hydroxides [4]. In addition, intergranular and exfoliation (lamellar) corrosion features are observed in Fig 4a. These types of corrosion are usually exhibited in archaeological elements made from aluminium alloys containing between 3.5 and 5.5% Cu. which is generally recognised as a harmful constituent of these alloys from a corrosion standpoint [12].

Generally, when the galvanic coupling between Fe alloys and Al is established, the dissolution of Al is accelerated, and the rate of this acceleration is controlled in part by the cathode/anode area ratio. The higher this ratio is, the higher the corrosion rate will be, which could be one of the reasons why the Al parts of the propeller suffered more aggressive corrosion due to their galvanic coupling with the big ferrous part (Propeller hub and transmission system).

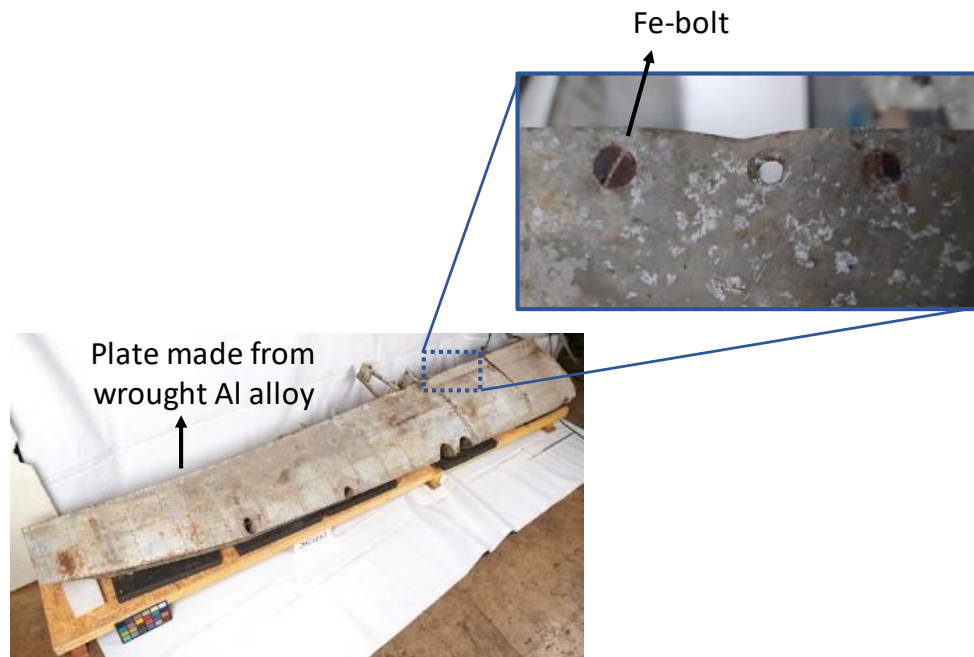
**Fig. 2** Wreck of a Supermarine Spitfire wing (length 436 cm and maximum chord 67 cm) discovered in 1988 near the Plérin coast (French city seaside to the English Channel). The zooming area shows the bolt's degradation and the Al surrounding area. The Fe/Al area ratio between the Fe-bolt and the Al plate is close to 0.1.

Contrary to the deterioration state of the aluminium parts from the propeller, where it was almost impossible to find evidence of the original protective paint film, the Spitfire wing shows a better conservation state, even after a long exposure time to the marine environment (Fig. 2). On the aluminium plate were observed regions with the remains of the protective paint, approximately 20 µm thick, measured through SEM (Fig 4c). Moreover, evidence of localised pitting corrosion was observed in the regions where the paint protection was broken.

The ferrous pieces from the propeller hub and transmission system showed good homogeneity and uniform corrosion. In contrast, the ferrous bolts from the Spitfire wing showed a more degraded state with thicker corrosion products, as observed in Fig 4e. As shown in Fig. 2, some bolts disappeared, which is attributed to the corrosive process.

One thing interesting to recall is that the Fe bolts from the Spitfire wing suffered a more advanced degradation than their surrounded Al plate despite the possible cathodic protection provided by their Al galvanic pair.

Our first hypothesis was to consider that a paint protective layer on the Al plates acted as an electrical insulator between the pieces, thus avoiding the galvanic interaction. However, this was dismissed as there is still electrical conductivity between the iron bolts and the Al plate (with a resistance value of around 0.1 ohms (measured after removing the corrosion products on the parts)).

A second hypothesis still open is to consider the effect of the protective paint layer on this Al surface, which could have changed its galvanic potential towards more noble values, decreasing the galvanic protection effect over the Fe bolts, or even changing the role of which part is acting as anode or cathode. Furthermore, the good condition of the Al plates has been associated with the protective effect of its paint layer, even after a long exposure time in seawater [6].

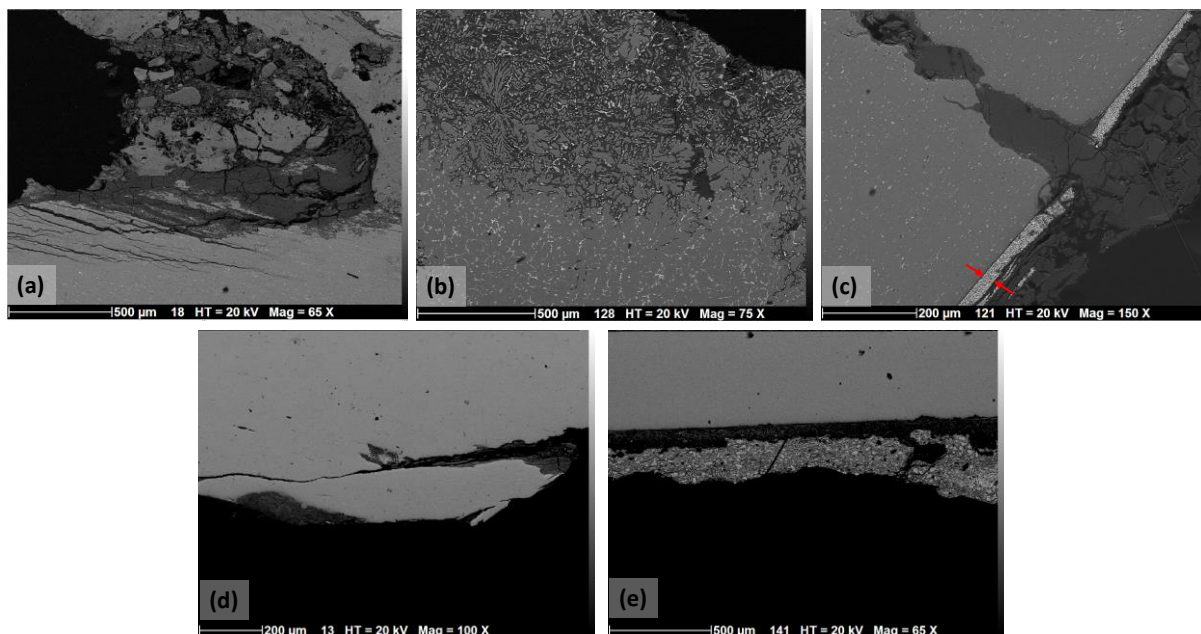
In Fig. 2. the aluminium part covering the transmission system of the propeller also exhibits an important degree of deterioration. Fig. 4b shows characteristics of intergranular corrosion on this piece favoured by the presence of nobler AlFeMnSi and Cu-rich phases, making this region more reactive than the bulk of the grains, causing this zone to corrode preferentially, and creating micro galvanic corrosion cells between the cathodic phases and the anodic aluminium matrix [13].

**Fig. 4** Cross-section images from the different parts of the artefacts: (a) Propeller blade of Al, (b) Al cover of the transmission system, (c) Al plate from the Spitfire wing, (d) Propeller hub of Fe and (e) Fe bolt from the Spitfire wing.

The exfoliation, intergranular and pitting corrosion forms observed on the different parts of Al alloys can be explained by the aggressive marine environment as the composition and microstructure of the alloy and the aggressive environmental conditions to which they were exposed during the time they were buried.
