Moenjodaro UNESCO Emergency Mission Following Disastrous Rainfall in 2022: 1st Mission Report

1st Mission Report

1st Mission Report 21 - 29 October 2022

Thierry Joffroy, CRAterre-ENSAG
joffroy.t@grenoble.archi.fr

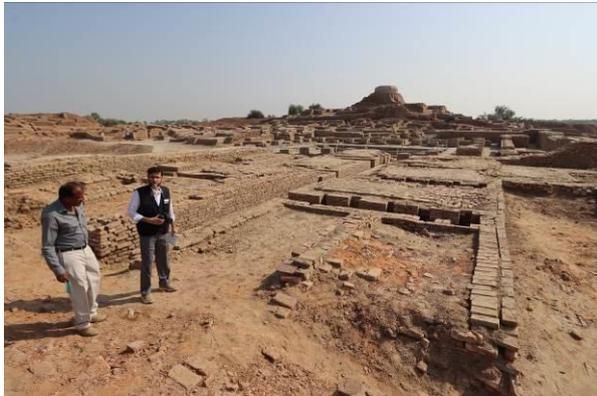
SD Area, the best preserved

It should be noted though that the state of conservation varies area by area. The SD area being the best preserved while the Moneer area, that probably received less attention in the past, is in a preoccupying state of conservation (see pictures above).

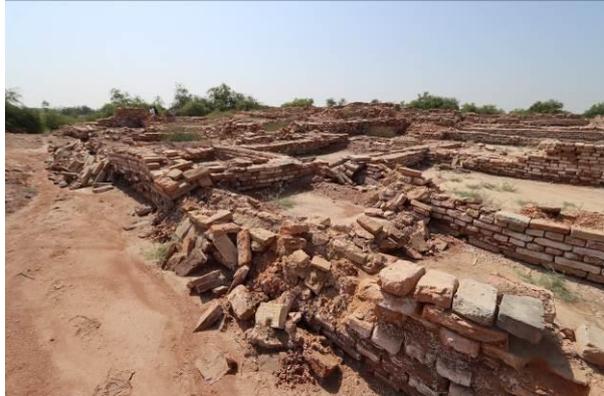
Moneer area, in a preoccupying state of conservation

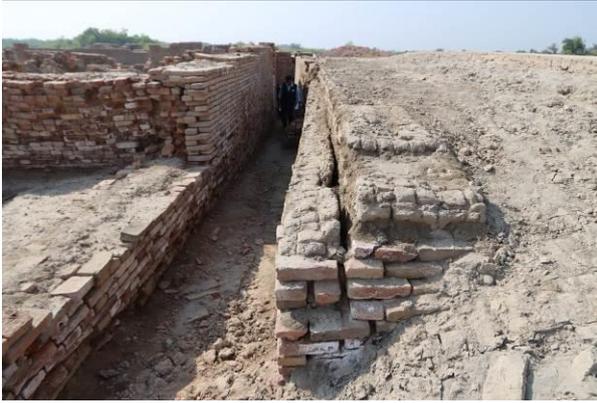
Typical wall deformation with crack at DK Area

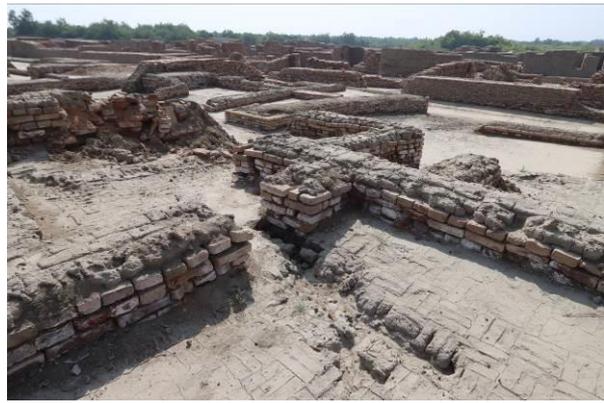
Gully type of erosion of drainage system at DK area

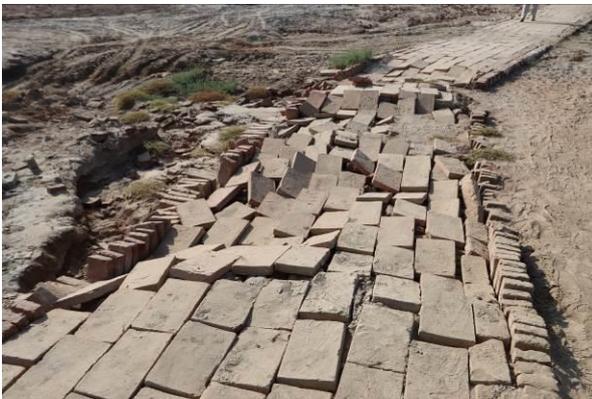
A specific additional point is the visitor's pathways which at some places were seriously affected by the flows of water. Many of the tubes installed at water flows levels have proven to be under-equipped for the heavy flows. Besides, some paths have slopes leaning towards archaeological remains or tend to block water flows, situations that have already led to weakening the walls basis that do need to be revised.

Damaged pathway between SD and L areas

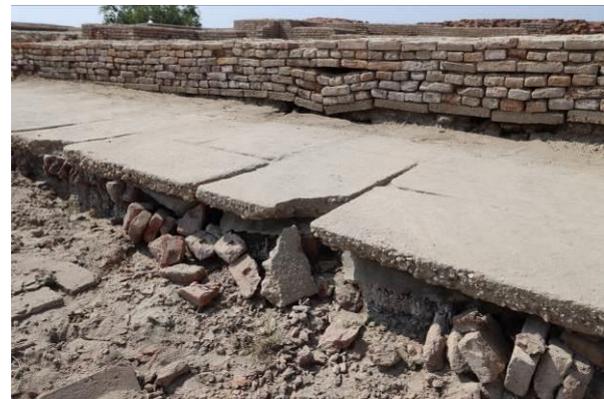
Slopes of pathway led to self and wall damages (L area)

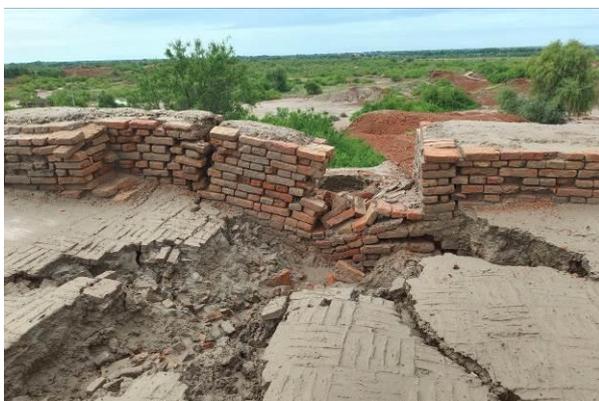
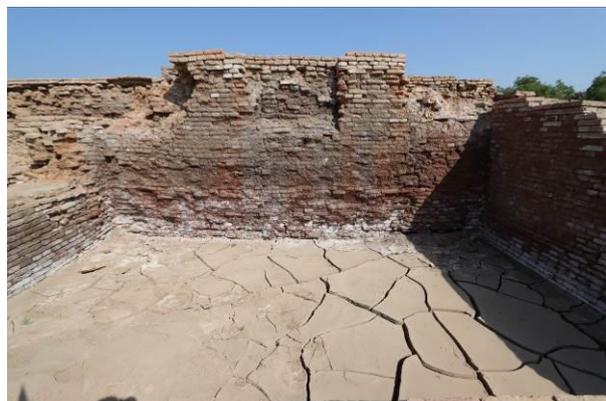
Failure of drainage system at SD area © N. A. Sangha: Temple at HR area, with traces of high water level

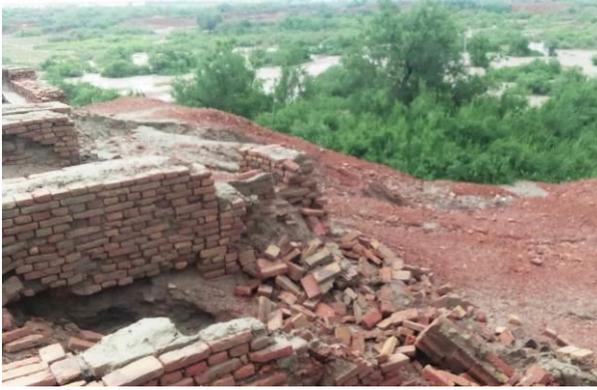
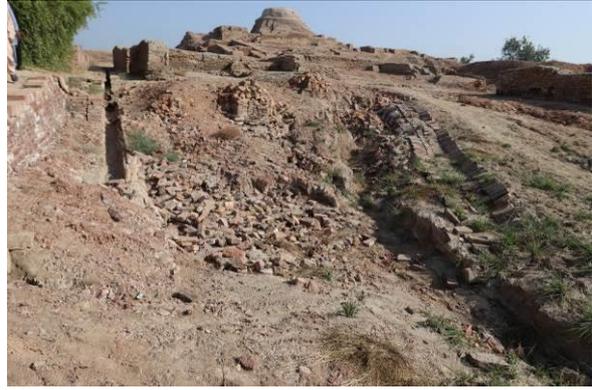
Undermining of wall by run-off, SD area © N. A. Sangha Ancient drainage systems damaged, south of SD area

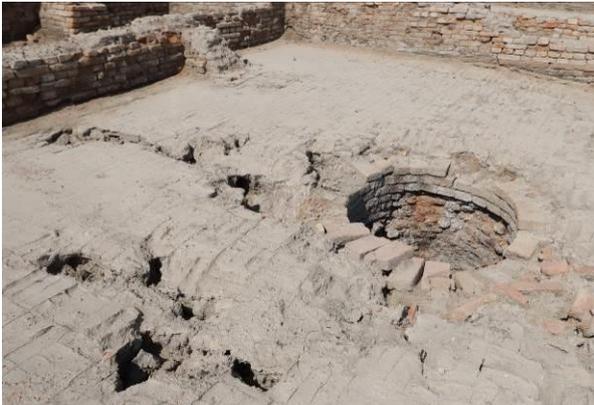
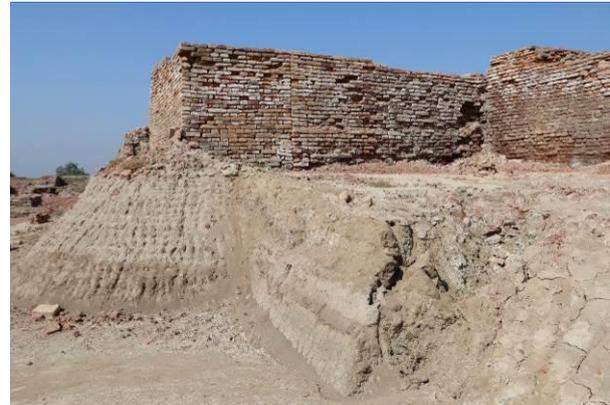
One should note that the system used at Moenjodaro for the treatment of the floors (sundried mud bricks laid on a layer of sand) though giving satisfaction for draining water flows placed a negative impact when run-off developed large gullies which manage to fully erode the surface bricks, with very little resistance of the sand layer and acceleration of the erosion process.

Gaps left by eroded sand under mud brick floor SV area Pushta protection affected by water infiltration HR area

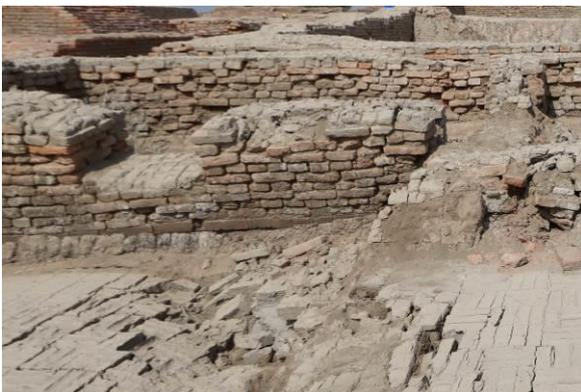
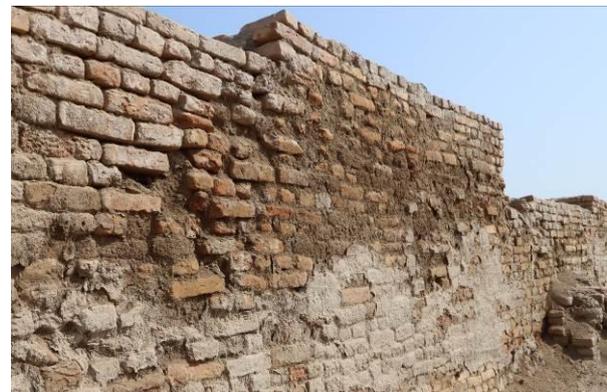
Besides that, this system is allowing water infiltration through the bricks and then through the layer of sand down to the original fabric. The resulting issue is that this humidity is like trapped under this layer of sand with the only potential of being evaporated through wall structures, at times above ground level, but also when structures are forming terraces (more specifically the case of the stupa zone, but not only), and as such, increasing the potential of crystallisation of salts on their surfaces (see next chapter).

Traces of high humidity content under floor SD area Traces of high humidity on retaining wall. SD area

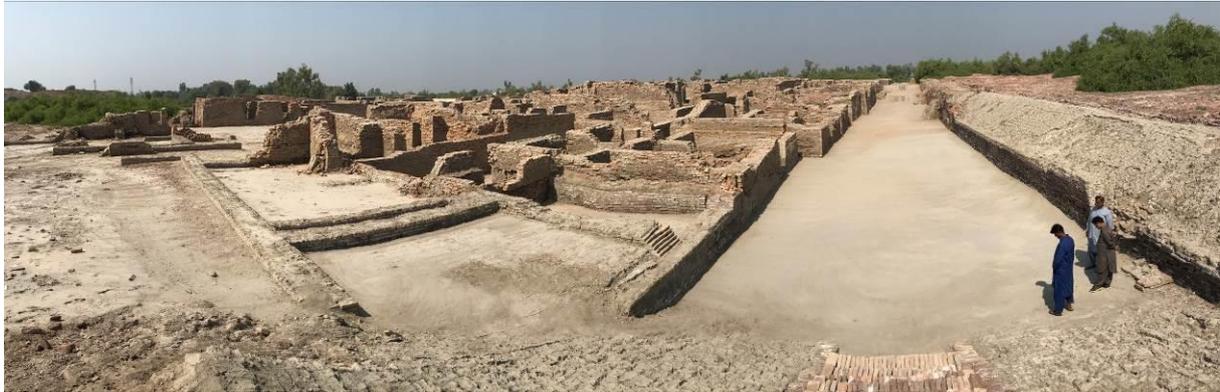
At a larger scale, it was noted that the overall drainage system sometimes involves collection of rainwater from large areas and instead of driving the run-off far from the archaeological remains, drives it inside narrow streets. This is the case more specifically at DK area where the large street at the eastern side drives water towards south but as it is blocked by archaeological debris mounds turns right inside the old city fabric, to finally be drained towards the western canal. But there are many other similar situations where high run-off is guided towards archaeological remains instead of “to safe discharge areas”.

Main street at DK area. Water collected is blocked at its south end thus entering the old city fabric

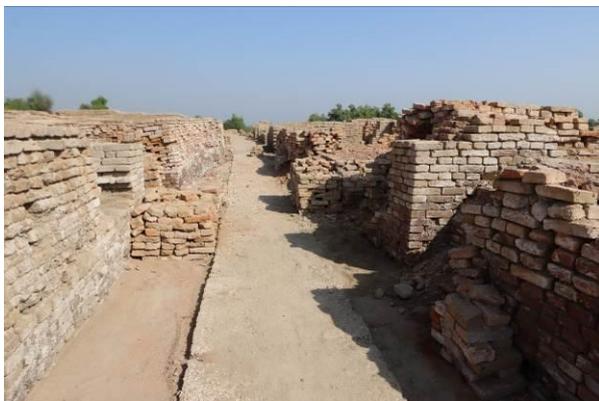
In addition to those, at times paths constructed for visitors also play a negative role within driving run-off towards the wall structures with a high potential for a negative impact (mortar erosion, weakening of brick strength).

Path blocking run-off, HR area

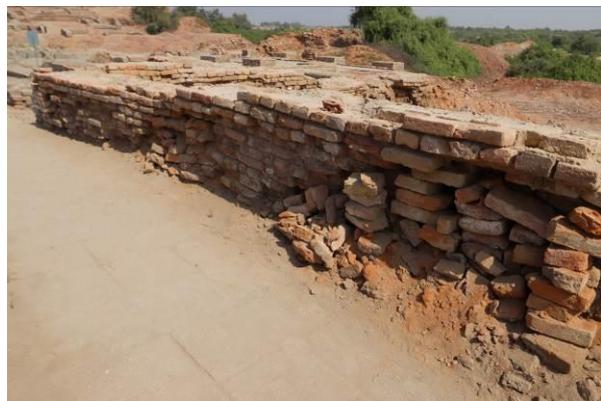
Concrete path with slope driving run-off to a wall. L area

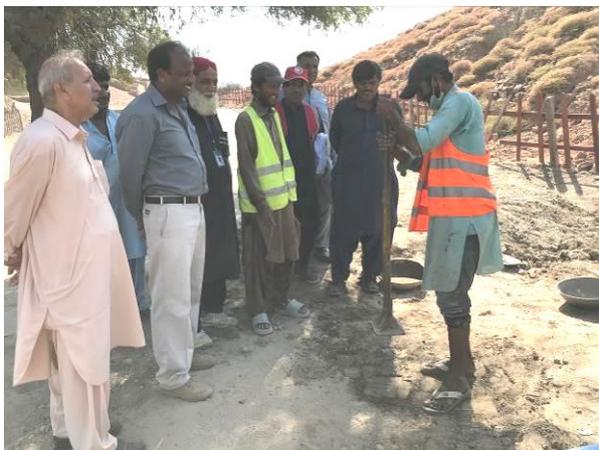
Successful repair of a gully at the entry of SD area

Looking at what had already been done by the conservation team to start repairing the gullies in some affected zones (slopes), a demonstration has been made during the mission on the rammed earth technique which would be very much adapted to that, if attention is paid to:

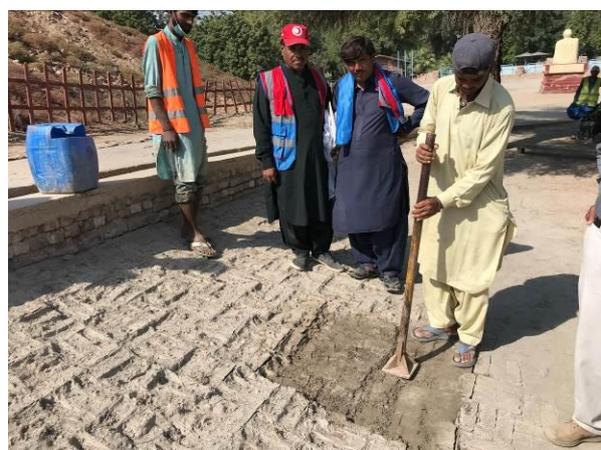
Unsuccessful test on “bricks on sand” floor.

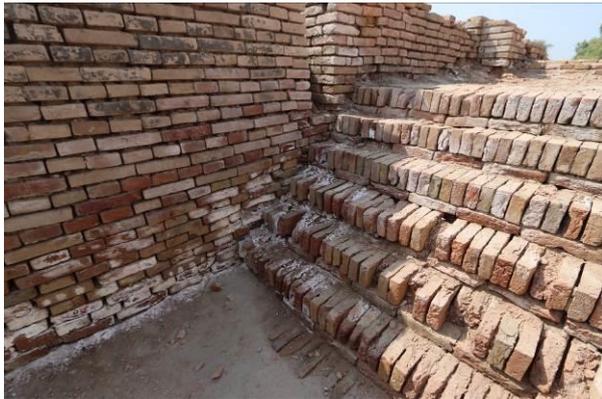
Presence of salts at DK Area

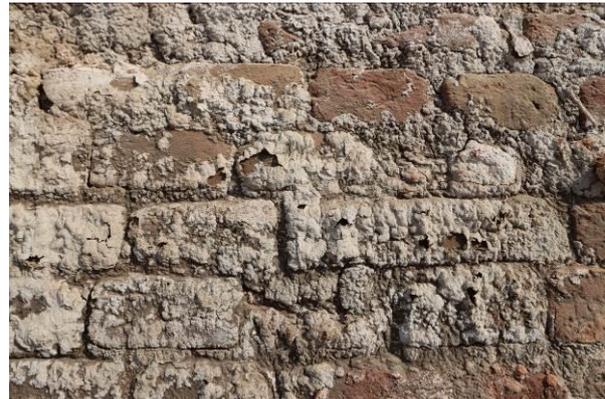
Use of mud slurry to form a salt crust against bricks

- . applying mud slurry on the surface of the walls, that behaves as a sacrificial layer in which salt crystallizes;
- . applying mud plaster, which plays a similar role, though having greater impact in places prone to condensation and as such salt expansion.
- . removal of salt-laden earth and replacement with “sweet-earth”, including the removal of waste from sacrificial coatings.

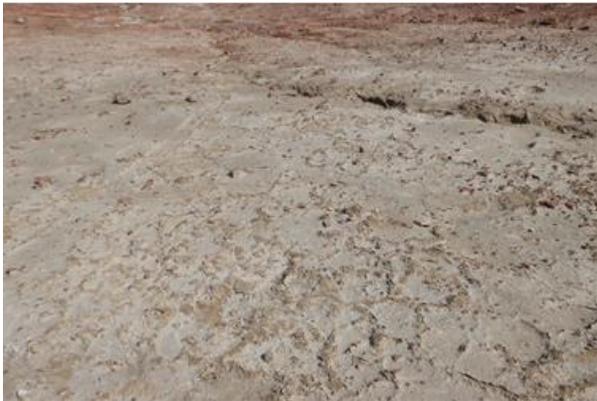
Flooring with high salt content, HR Area

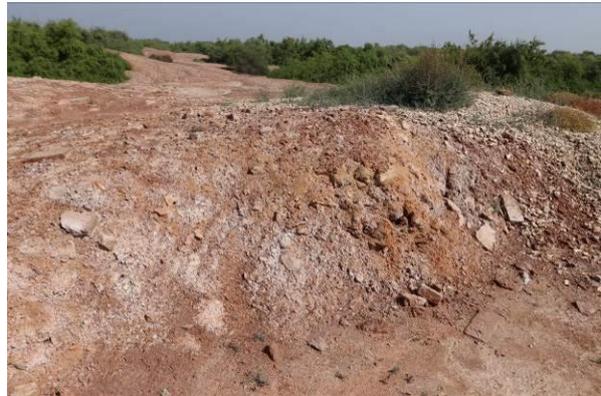
Archaeological debris pits are an other source of salts

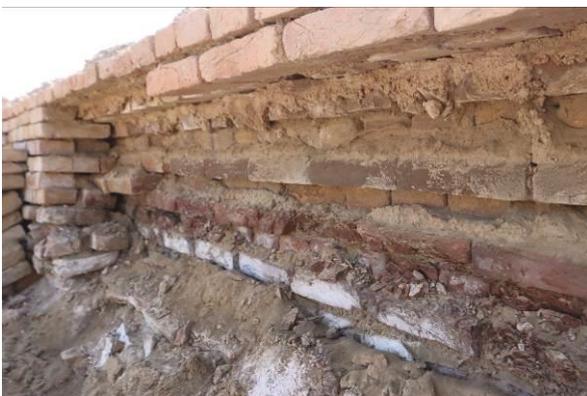
Another potential factor is that of the presence of gaps inside the walls, whether they be inside the original fabric or located at the interface of the old fabric and that of the restoration works. That would explain the presence of huge quantities of salts inside the walls, very visible when the restored fabric has collapsed. That calls for specific attention when restoring to make sure that gaps are fully filled and also that if the old and “new” fabric are not well connected, cracks can appear which then represent a double threat that of this high presence of salts in addition to the structural weakness. When structures are weakened at the wall base (elevation side exposed to water flows or stagnation, or simply damp) they often develop cracks that drive rainwater down. Processes of dissolution of salt and migration again inside the structural fabric are most probable, a kind of vicious circle which constantly increase the problem.

Salt inside the wall visible after collapse, HR Area

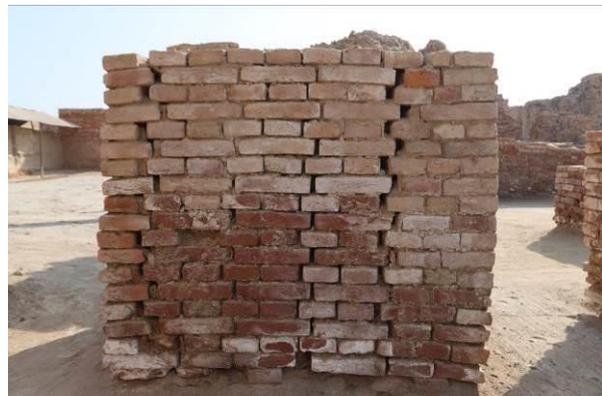
Structural cracks allowing infiltration and salt dissolution

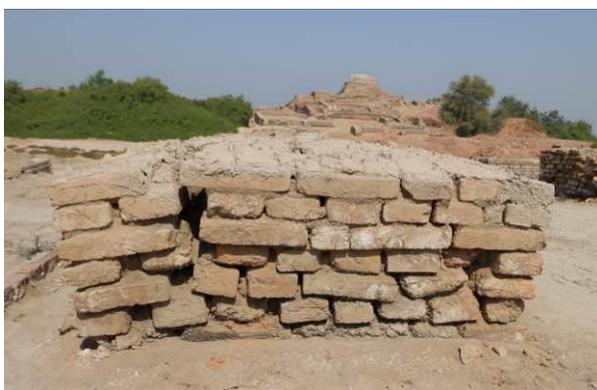
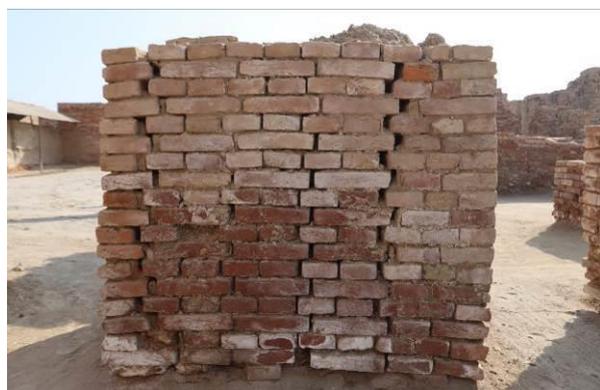
Though what appears clear is that many destructions observed have often a double origin. At first, the wall bases may have been weakened by the water run-off of water stagnation, entailing a tendency of the wall (or when the case, the restored part of the wall, usually that forming the façade) to lean out. This having occurred, cracks are up to the top making possible infiltration of water as described by Hughes, which fasten the weakening process up to collapse.

Two column types of wall (L and DKG areas) illustrating well the typical collapse process starting from the base

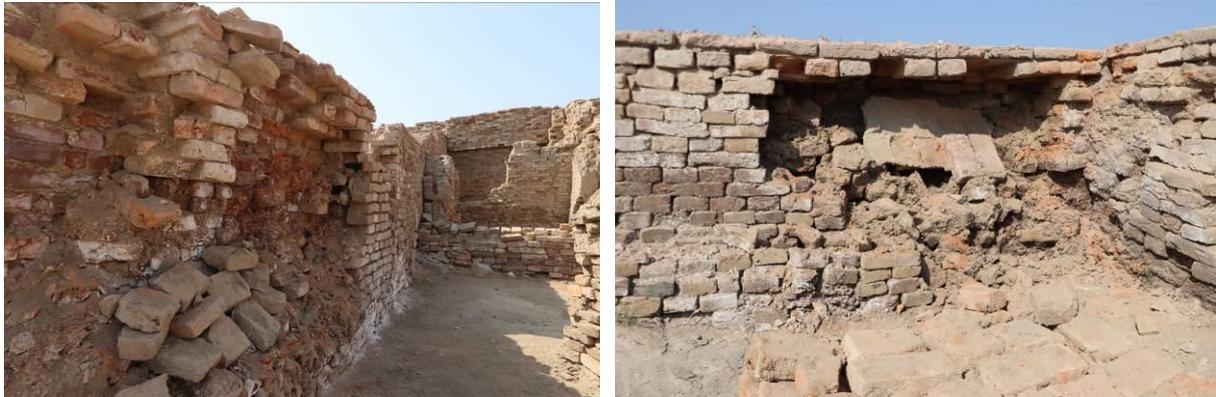
Though this typical phenomenon as described above is developing in many different ways and is also much favored when the burnt bricks at the wall bases are already prone to salt degradation that has a serious effect on their bearing capacity.

Wall collapses where salt attack has played a strong role at DKG (left) and HR (right) areas.

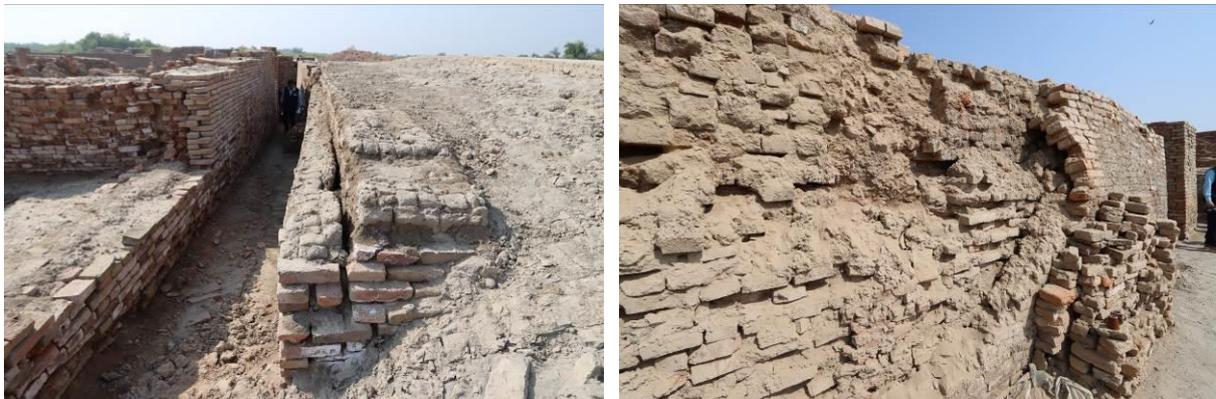
Another factor which appears to favor wall collapses is that most of the restored parts of the walls have little connection to the original parts. This is something very common at many archaeological sites around the world as there is a global reluctance to touch the original fabric either through removing parts of it to make sure that there is proper bonding between the old and the new, or to install connecting assets (e.g. tie rods). In such cases, the weakening of the external part of the wall base has a much quicker effect than it would be on a full homogeneous (well bonded) wall as the surface concerned is far less.

Two stages of the process of separation between the new and the old parts of walls, DKG area.

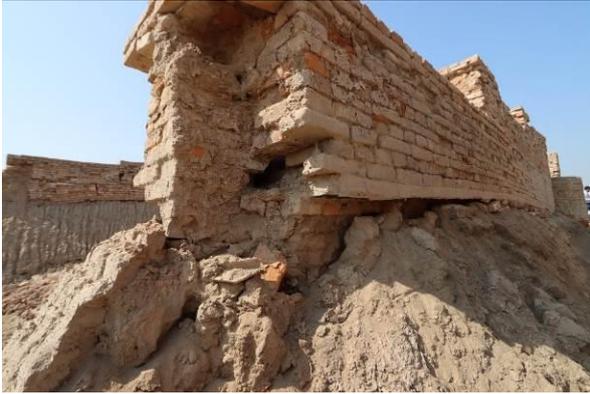
Concerning the damp proof courses, most of them are only on a small portion of the wall, thus not really functioning as damp proof course. And for the upper layer at the top of the wall, though it has allowed to maintain partly the structure, what was supposed to serve as a protection and a sort of the beam did not prevent some collapses, leaving some of the wall structures in a strange form with the upper part overhanging over huge gaps.

Damp proof course at DKG partly efficient

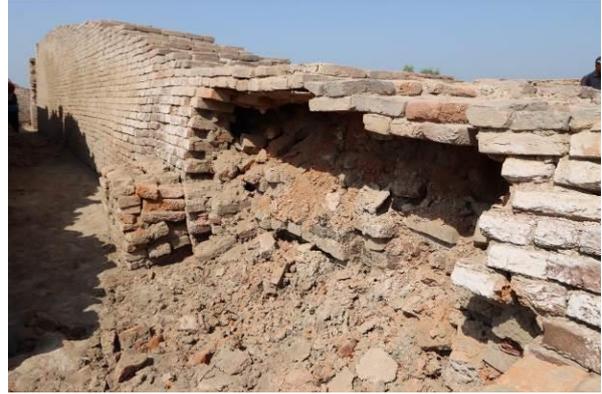
Concrete layer between the two last brick courses at HR

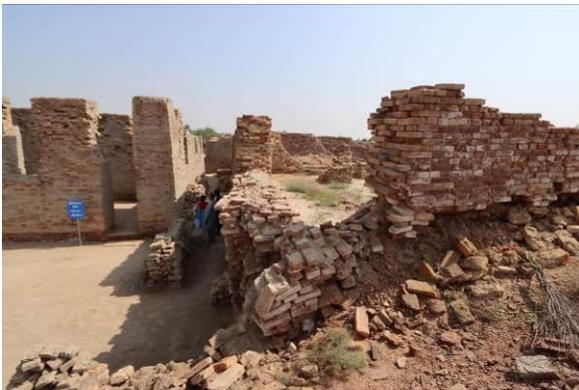
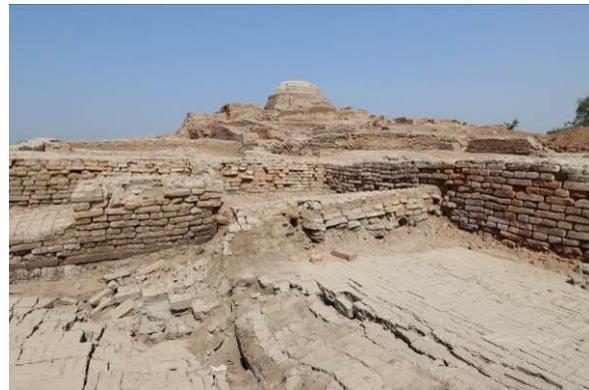
And the situation is even worse when there are no or too little water outlets from floors which are above streets levels, that entail water penetration in the infill, bringing about the extra weight and volume as described by Hughes. This has led to some of the major collapses, including a paramount one, the collapse and also dangerous leaning out of a major part of the exit canal from the baths at SD area.

Pressure against walls by backfilling of platforms / rooms floors, DKG area (left) and SD area (right)

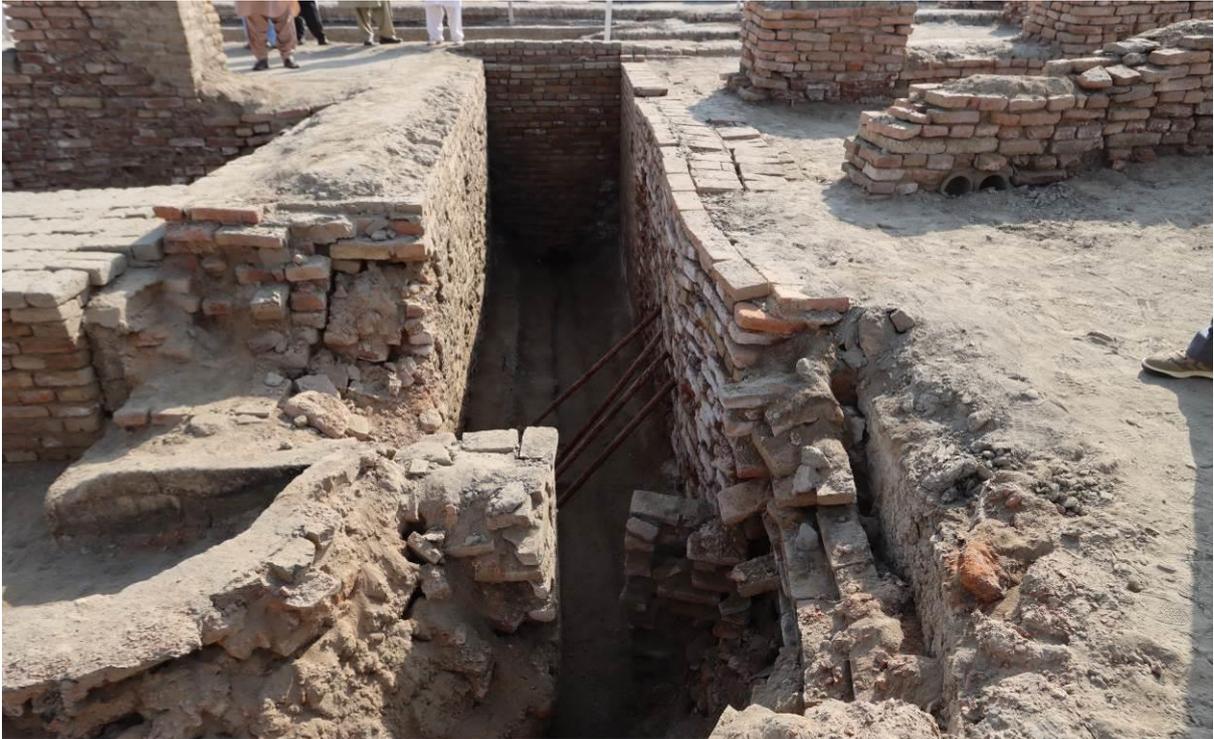
Instability of retaining wall at the southern side of canal from bath in SD area.

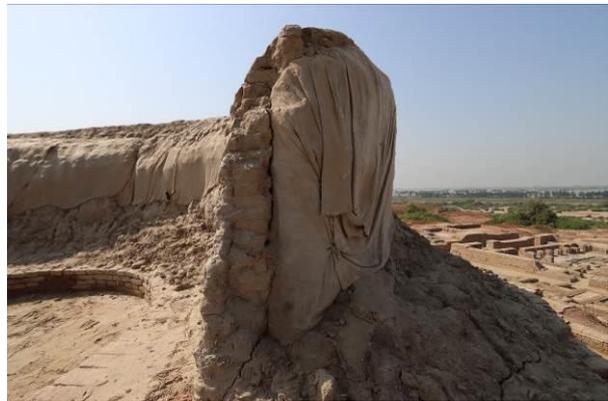
Though time was too short during the mission to make a serious condition survey of this important heritage asset, a specific condition survey of this structure will be undertaken during the second UNESCO expert mission that will require organizing easier access (ladders or scaffolding) so as to be able to check the condition of the part under the geotextile.

Picture showing fallen part and protective geotextile

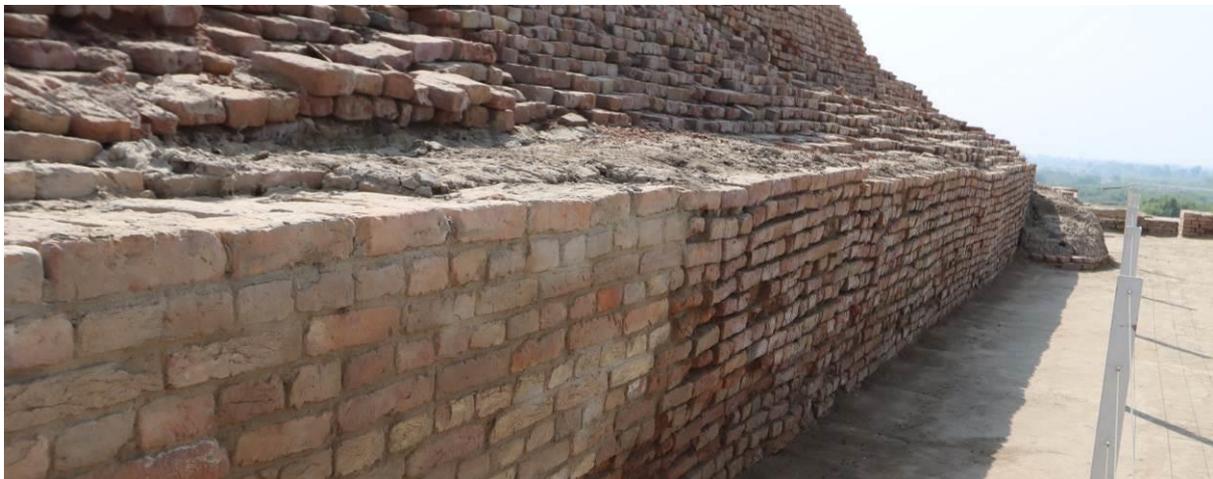
Another observation is that the walls at the base of the stupa appear to be leaning out. This is also a point of attention that needs to be tackled during next mission, taking as a base the restoration reports that could give some indications on what has been done there (or not) and when? Though, such a question will probably need a long period of observation / monitoring to have a precise idea of whether there is a movement or not. This will not prevent a reflection on what could be the reasons (potential infiltration of water above this wall) and to install preventative measures.

The retaining wall at the base of the stupa (west side) is clearly leaning out

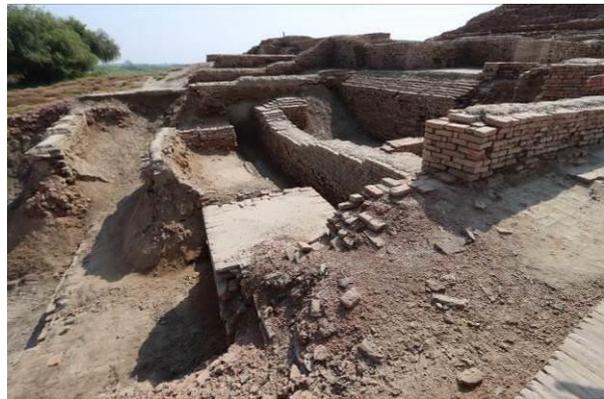
In fact, this could be the result of the presence of humidity inside the core of the citadel under the stupa, made more than possible by the flooring system (bricks on a sand layer) installed also at the upper platform which represents a huge water collection area while being very much exposed to rains. And two months after the heavy rains of August, many of the walls, including on the south side (better exposed to sun) were showing darker zones indicating the presence of damp.

North side of citadel showing bended walls

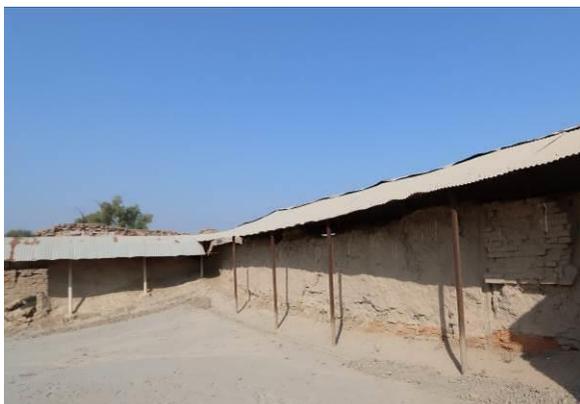
In DKG area, part of a mud brick wall (probably originating from the more recent period – Buddhist) has fallen down. This wall is protected by an iron sheet roof, making it clear that the collapse originates from insufficient drainage at its base, possibly linked with accumulation of sand (from wind) and debris in the narrow passage located at its western side.

Overall protected wall (fallen part at the left)

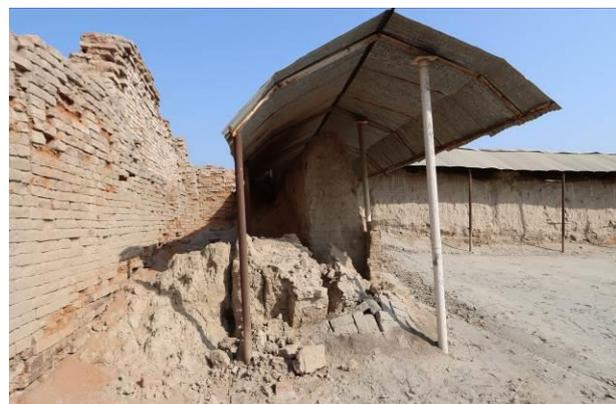
The fallen part (south west end)

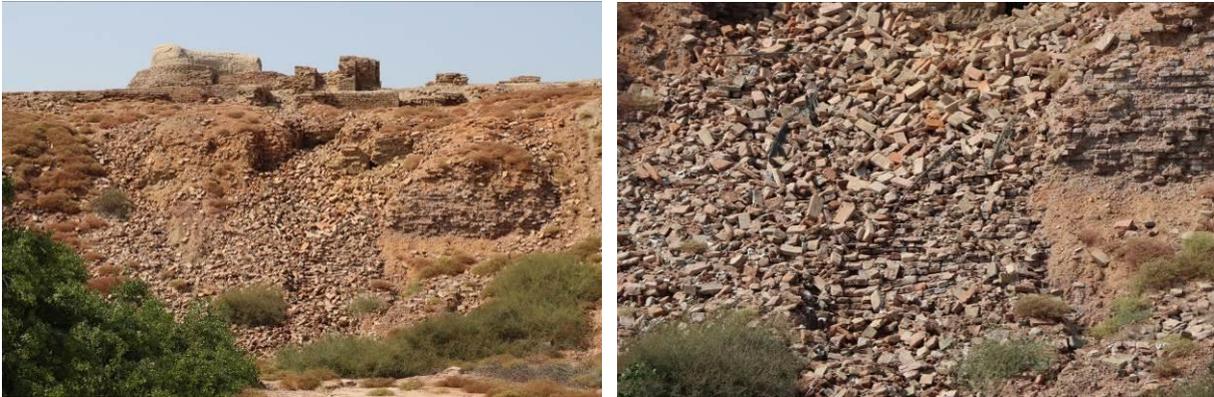
An exception given to the above proposal could be the structure observed at the eastern end of the citadel where what could have been the steps to the Buddhist stupa may have appeared. That might represent a major plus for the site and, as such, might be given consideration if a team could be mobilized to undertake a first cleaning exercise whose result might lead to programming a fully structured archaeological exploration / survey.

On the eastern side of the citadel area, the huge flows of water collected by the upper platform have revealed some structural elements which could be the original steps to the stupa.

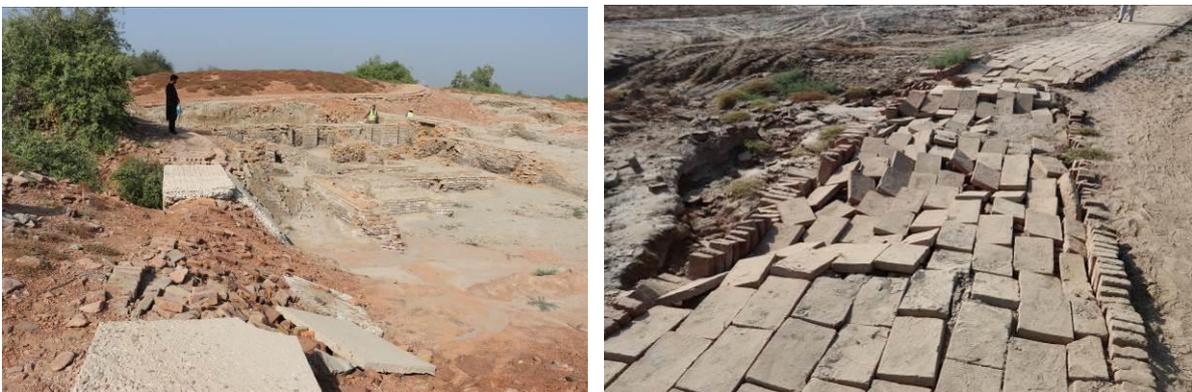
The visitor's paths that have been built in Moenjodaro either within the excavated areas or between them have also been subject to destruction. These have occurred mostly where gullies have evolved substantially, but also in most of the places where runoff is collected. Even where some specific assets (pipes) had been installed, many of them proved to be insufficient to support the intensity of the flows. Even some very heavy concrete slabs have been moved some of them substantially.

Concrete slabs of various sizes have been affected giving an idea of the violence of the runoffs

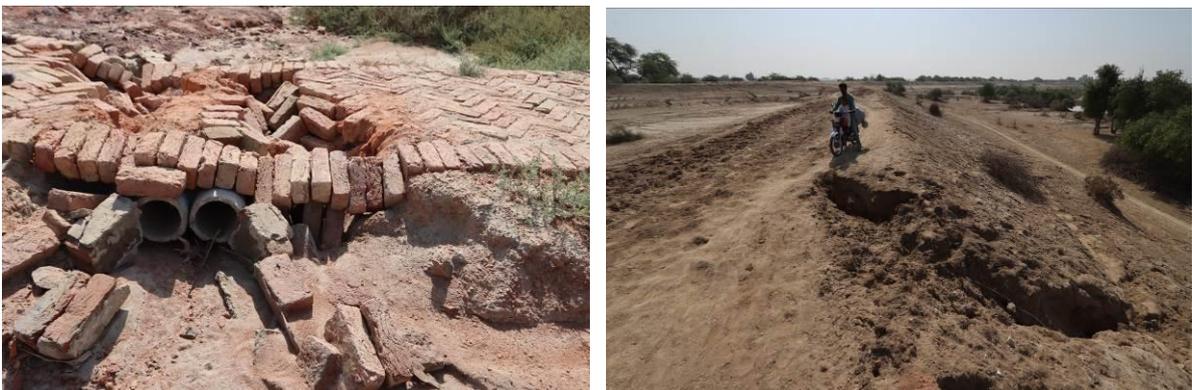
Burnt bricks paths have suffered but are easy to repair The roads at the top of the dikes have also suffered

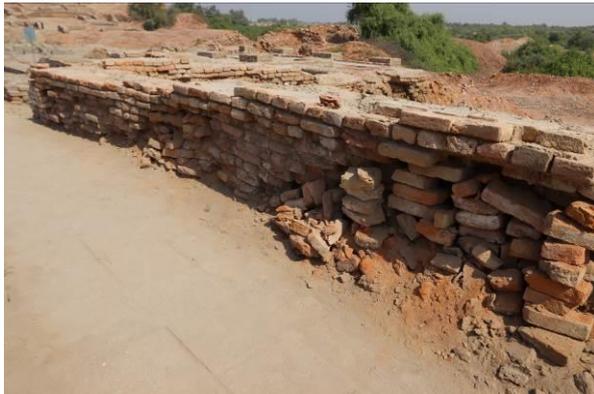
For these two phenomena, concrete slabs which hardly absorb any water have been the cause of the worst cases.

L Area, path leaning towards wall base

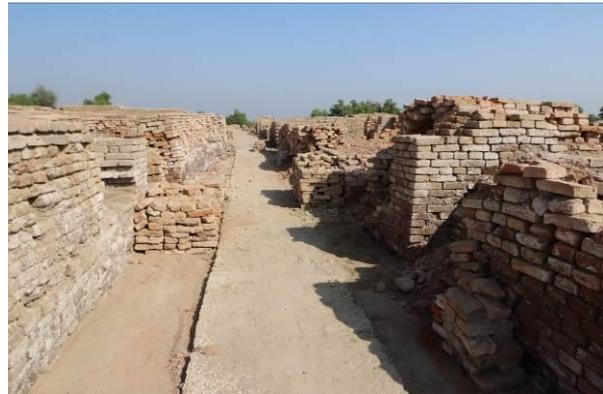
HR area, concrete slab path blocking runoff

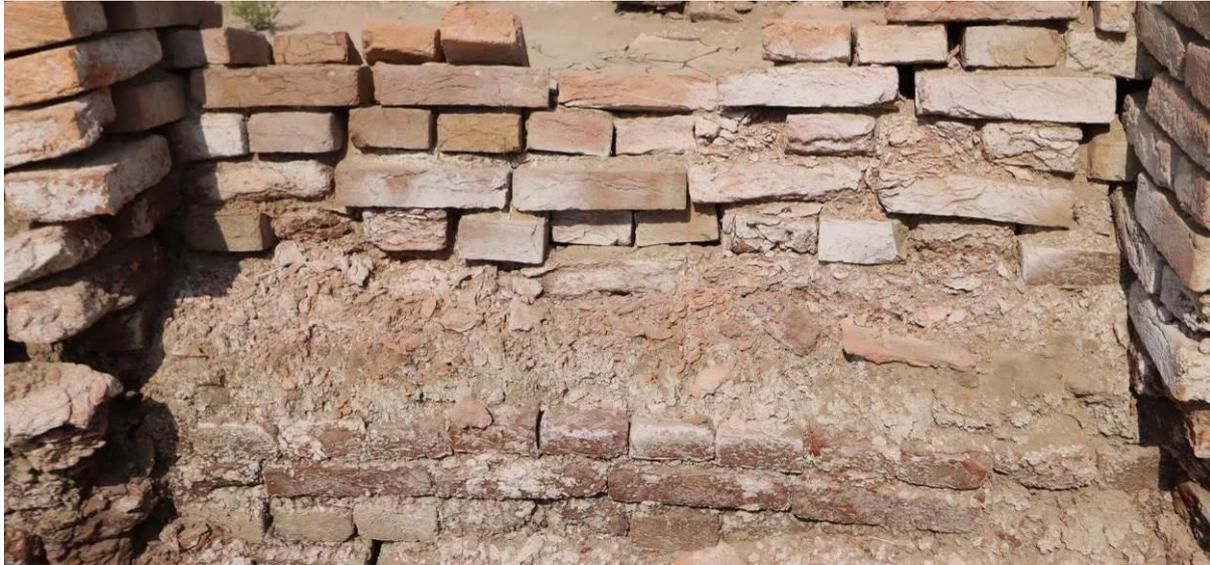
bricks is particularly illustrating that with in the presence of salts bricks in the same course can be in perfect state while another besides it is almost fully disintegrated. The issue of soil selection for mud bricks making and mortar, also seems to be somehow underestimated, as there is, probably for several years now (as there are signs in the eroded wall capping) the use of soils that contain quite a huge amount of vegetal matters (plant roots). The loads of soils at the entry of DKG Area appear to be in that line which is a bit surprising when knowing that there is a laboratory and a lab operator which could check the soils already at the quarry level.

The variety of quality of burnt bricks is very visible on this wall at DKG area, very good state at the base, almost fully disintegrated in the middle, acceptable at the top

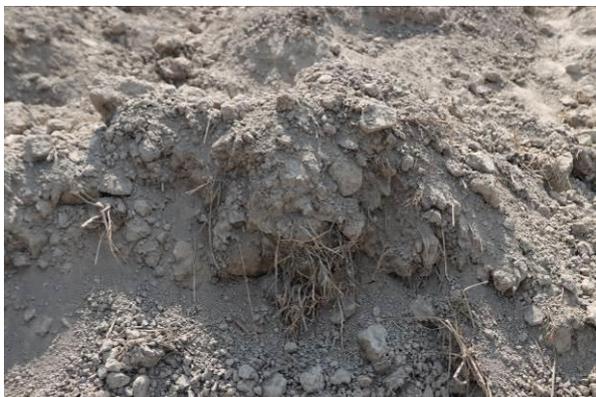
Soil just delivered at DKG Area with high humus content

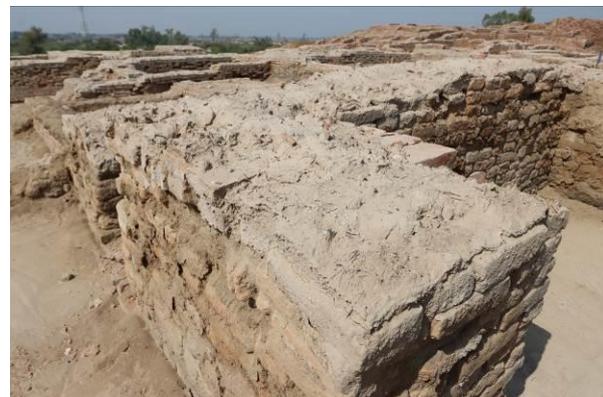
Same type of soil applied on wall capping at SD Area
