Over-Voltage and Cross-Conduction Hard Switching Stress on Schottky Gate-Type p-GaN HEMT in Half-Bridge Operation Experimental and Physical Approaches

L. Ghizzo^{a,b,c*}, D. Trémouilles^c, F. Richardeau^b, S. Vinnac^b,
F. Jamin^a, G. Guibaud^a

Abstract

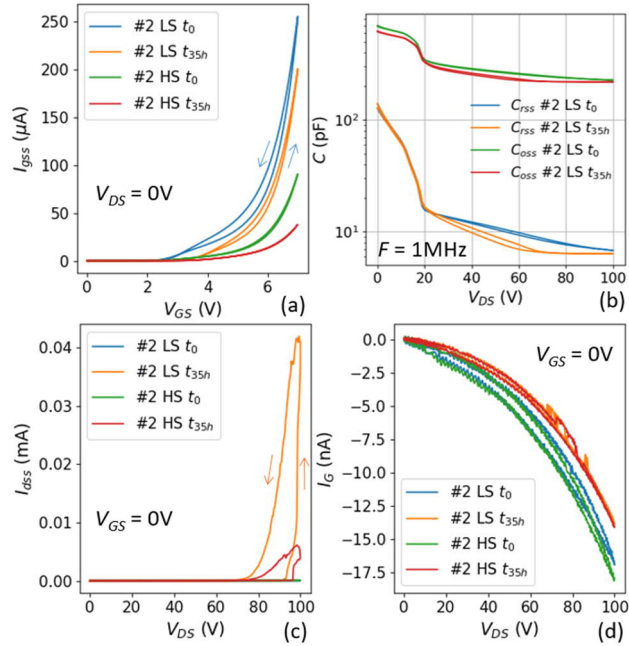
Figure 4: Characterization of board #2 before (t_0) and after (t_{35h}) stress at 120V with cross-conduction ($T_d = 30ns$). (a) Gate leakage current $I_{gss} = f(V_{GS})$ (b) C_{rss} and C_{oss} . (c) Drain leakage current $I_{dss} = f(V_{DS})$ at $V_{GS} = 0V$. (d) Gate current during the I_{dss} measurement depicted in (c). The main degradation to observe is the high drain-source leakage current that appears after a threshold voltage for around $V_{DS} = 95V$ for the LS and $V_{DS} = 97V$ for the HS.

The devices of boards #2 and #3 were also stressed under $V_{dc} = 120V$ (like boards #4 and #5) with an additional cross-conduction phenomenon. They also exhibit a change of the drain current leakage above 80V but stronger than in the previous cases. This leakage can reach the mA range. The capacitance $C_{GD} = C_{rss}$ has significantly changed in this case and becomes constant just before or near the abnormal current leakage.

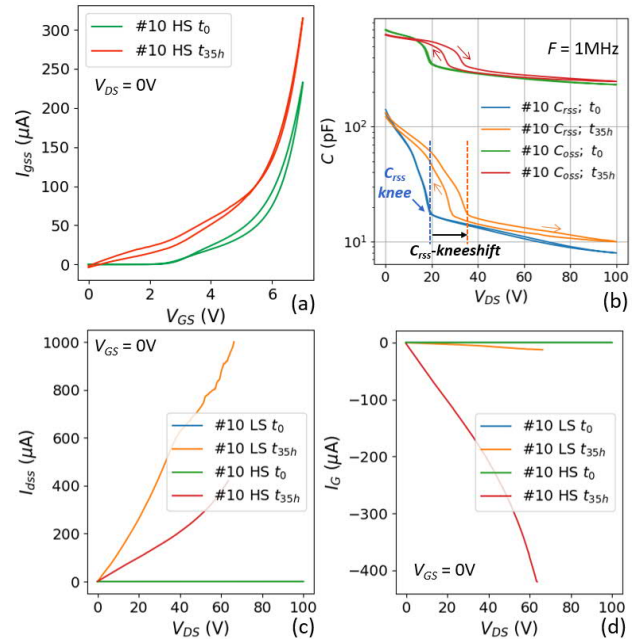
To evaluate the impact of cross-conduction alone, a stress under $V_{DS} = 67V$ (2/3 of the voltage rating) with a short deadtime of 20ns is conducted on boards #9 and #10. The degradation of the HS transistors identified by a high leakage current between gate and drain is depicted in Fig.5(c) and (d). The capacitance C_{rss} knee's drift to higher voltage (Fig.5(b)) and the gate leakage current $I_{gss} = f(V_{GS})$ tends to increase especially at low voltage (Fig.5(a)). The LS switches exhibit the same degradation patterns, yet in a less pronounced manner. The devices of board #1 that underwent cross-conduction at higher V_{DS} share the same degradation patterns on I_{gss} between t_0 and t_{35h} in addition to a constant C_{rss} starting at 60V. The I_{dss} curve has both

the electrical changes observed before: a gate drain leakage current and a steeper increase of the drain-source leakage current above $V_{DS} = 90V$.

Figure 5: Characterization of the stress board #10 before (t_0) and after 35hours of stress (t_{35h}) under 67V with cross-conduction ($T_d = 20ns$). (a) Gate leakage current $I_{gss} = f(V_{GS})$. (b) C_{rss} and C_{oss} . (c) Drain leakage current $I_{dss} = f(V_{DS})$. (d) Gate current during the I_{dss} measurement. The main degradation to observe is the drain-source high leakage current that appears for LS and the gate-drain leakage current for HS.

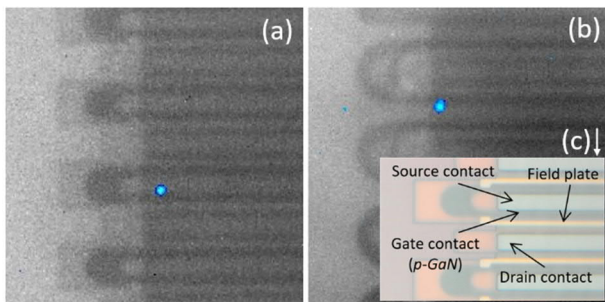
Figure 9: InGaAs camera PEM image of the emission spots. (a) Defect near the gate that might be a GD leakage current through the AlGaN barrier (b) defect near the drain metal that is expected to be a DS leakage current through the GaN layer. (c) optical zoom of the metal structure seen from the backside. The blur in these pictures cannot be avoided as it depends on the camera resolution and the remaining GaN thickness of $10\mu\text{m}$ we look through with the IR camera.

The spots located between gate and field plate could be related to the gate-drain leakage current observed on transistors of boards #1,#8,#9 (HS only), #10 and #11. It could be the failure of the D_{pin} diode in the gate stack see Fig.10a or may correspond to a leakage path on the sidewall of the p-GaN layer as illustrated in blue in Fig. 11. This zone is a weak spot in terms of insulation, the

The second spot location is a defect near the drain edge (or field plate drain side edge but less likely). This defect localization is correlated with a change of I_{dss} and C_{GD} at high voltage (above $V_{DS} = 80V$). The capacitance after the knee is reduced and for the strongest stresses (#2, #3 for instance) it even becomes constant at a given V_{DS} value. The depletion of the 2DEG is faster after the field plate ($V_{ds} > 20V$) for a degraded device and the surface of the 2DEG does not even vary (after 65V on Fig.4b for instance) for the devices that show a constant capacitance from a given V_{DS} value at t_{35h} . It means that the 2DEG is fully depleted or that the leakage current is entirely vertical through the defect. Indeed, the drain-source leakage current has no influence on the gate current during the I_{dss} measurement as seen on the characterization results (see Fig 4c and 4d).
