Over-Voltage and Cross-Conduction Hard Switching Stress on Schottky Gate-Type p-GaN HEMT in Half-Bridge Operation Experimental and Physical Approaches

L. Ghizzo^{a,b,c*}, D. Trémouilles^c, F. Richardeau^b, S. Vinnac^b,
F. Jamin^a, G. Guibaud^a

Abstract

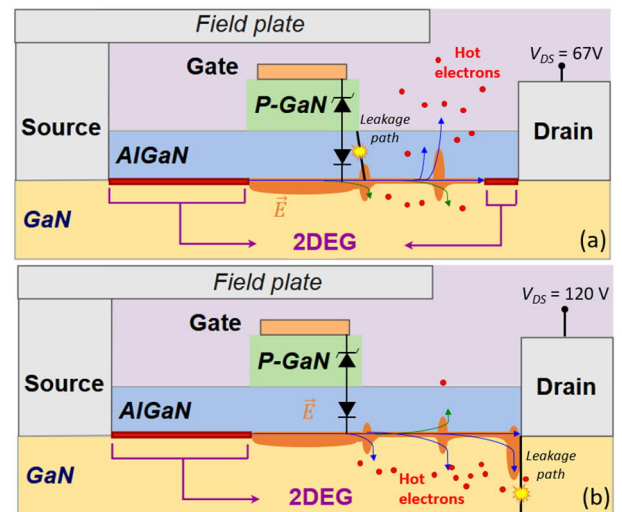
The spots located between gate and field plate could be related to the gate-drain leakage current observed on transistors of boards #1,#8,#9 (HS only), #10 and #11. It could be the failure of the D_{pin} diode in the gate stack see Fig.10a or may correspond to a leakage path on the sidewall of the p-GaN layer as illustrated in blue in Fig. 11. This zone is a weak spot in terms of insulation, the

This leakage path is expected to be at the edge of the drain metal and to be vertical across the GaN layer as illustrated on Fig. 10(b) and Fig. 11 in yellow. The leakage current then reaches the conductive epitaxial layers (AlGaIn or GaN, the epitaxy is a stack of AlGaIn and GaN layers) below the GaN buffer and connected to the source electrode. This leakage is not across the whole silicon substrate as the thinning of the silicon substrate (10 μm to 2 μm) and backside package removal did not make the spot disappear.

Figure 10: (a) Formation of the gate leakage path through degradation caused by the emission of hot electrons at (a) $V_{DS} = 67V$ and (b) $V_{DS} = 120V$. The yellow “explosions” symbols illustrate the defect heating/light emission captured with LIT and PEM on Fig. 9 through the GaN layer.

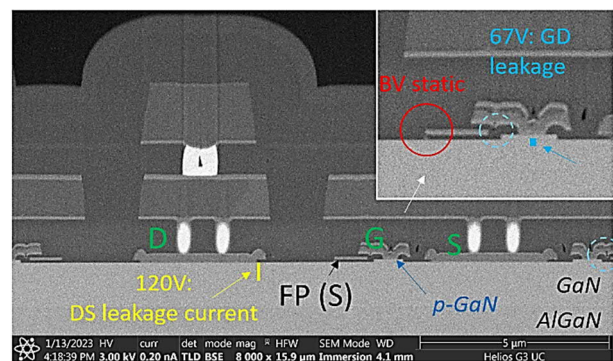
A drain-source leakage current between the field plate and the 2DEG across the AlGaIn and oxide layer under the field plate hypothesis can be ruled out thanks to another study we made on this part-number device (study of static V_{DS} breakdown voltage). This defect location leads to the melting of the FP and to a filament path (around 150V) see Fig 11, the current leakage path is a direct short and not an abnormal current leakage appearing only above 80V like in this case. A Focused Ion Beam (FIB) Slice and View verified this failure mechanism (Fig. 11 in red).

Figure 11: FIB cross-section of the active area showing the location where the defects are expected to be according to our hypothesis. In yellow the drain-source leakage which corresponds to Fig. 4c electrical signature. In blue the gate-drain leakage (Fig. 7ab) which is the failure of D_{pin} diode shown in Fig.10. Also, the form of the metal contact is not perfect due to fabrication maybe thermal relaxation. It makes a small spike and

a small cavity which reduces the dielectric insulation above (blue circles). This particular zone seems to be a weakness of this structure, in other pictures of the FIB Slice&View, it has been observed that the spike and the cavity could be bigger. In red the leakage path formed between drain and source in the previous study about static breakdown voltage. The AlGaN barrier is not visible in this picture due to its small thickness.
