# Over-voltage and cross-conduction hard switching stress on schottky gate-type p-GaN HEMT in half-bridge operation. Experimental and physical approaches

L. Ghizzo, David Trémouilles, Frédéric Richardeau, S. Vinnac, F. Jamin, G. Guibaud

L. Ghizzo, David Trémouilles, Frédéric Richardeau, S. Vinnac, F. Jamin, et al.. Over-voltage and cross-conduction hard switching stress on schottky gate-type p-GaN HEMT in half-bridge operation. Experimental and physical approaches. *Microelectronics Reliability*, 2023, 150, pp.115172. 10.1016/j.microrel.2023.115172 . hal-04242294

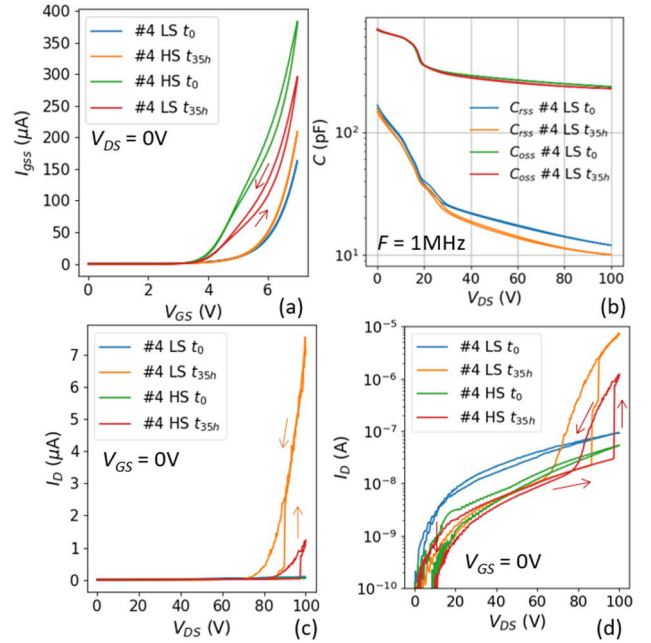
Figure 3: Characterization of the stress board #4 before ( $t_0$ ) and after 35 hours of stress ( $t_{35h}$ ) at  $120V$  with no cross-conduction ( $T_d = 120ns$ ). (a) Gate leakage current  $I_{gss} = f(V_{GS})$  at  $V_{DS} = 0V$ . (b)  $C_{rss}$  and  $C_{oss}$  under  $V_{DS}$  at  $F = 1\text{ MHz}$ . (c) Drain leakage current  $I_{dss} = f(V_{DS})$  at  $V_{GS} = 0V$ . (d) Display of (c) with log scale. The main degradation to observe is the high drain source leakage current that appears around  $V_{DS} = 90V$  for LS and  $V_{DS} = 98V$  for HS.

The transistors of boards #4 and #5 were stressed on the drain with a switched voltage of  $120\%$  of their rating (i.e.  $V_{dc} = 120V$ ). The irreversible degradation is visible on both transistors of board #4 as shown in Fig.3(c) on the drain leakage  $I_{dss} = f(V_{DS})$ . This degradation is visible starting at  $V_{DS} = 90V$  for the LS, and around  $V_{DS} = 98V$  for the HS. It is characterized by a steep increase of the drain leakage current. Below this voltage, the leakage current mainly overlaps with the curve at  $t_0$  and the drain leakage is around  $10nA$  at this voltage. When  $V_{DS}$  is reduced again (backward sweep), the leakage current gets back to a normal value as in the forward sweep as shown in Fig.3(d). This leakage current seems to be between drain and source, as the gate current during this measurement is not changed (similar curves to  $I_{dss}$  of board #2 in Fig.3(a)).

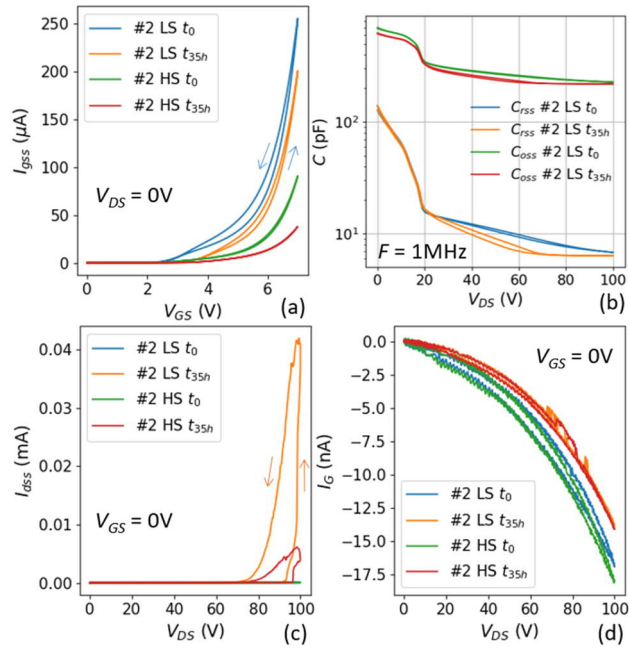
Figure 4: Characterization of board #2 before ( $t_0$ ) and after ( $t_{35h}$ ) stress at 120V with cross-conduction ( $T_d = 30ns$ ). (a) Gate leakage current  $I_{gss} = f(V_{GS})$  (b)  $C_{rss}$  and  $C_{oss}$ . (c) Drain leakage current  $I_{dss} = f(V_{DS})$  at  $V_{GS} = 0V$ . (d) Gate current during the  $I_{dss}$  measurement depicted in (c). The main degradation to observe is the high drain-source leakage current that appears after a threshold voltage for around  $V_{DS} = 95V$  for the LS and  $V_{DS} = 97V$  for the HS.

The devices of boards #2 and #3 were also stressed under  $V_{dc} = 120V$  (like boards #4 and #5) with an additional cross-conduction phenomenon. They also exhibit a change of the drain current leakage above 80V but stronger than in the previous cases. This leakage can reach the mA range. The capacitance  $C_{GD} = C_{rss}$  has significantly changed in this case and becomes constant just before or near the abnormal current leakage.

The second spot location is a defect near the drain edge (or field plate drain side edge but less likely). This defect localization is correlated with a change of  $I_{dss}$  and  $C_{GD}$  at high voltage (above  $V_{DS} = 80V$ ). The capacitance after the knee is reduced and for the strongest stresses (#2, #3 for instance) it even becomes constant at a given  $V_{DS}$  value. The depletion of the 2DEG is faster after the field plate ( $V_{ds} > 20V$ ) for a degraded device and the surface of the 2DEG does not even vary (after 65V on Fig.4b for instance) for the devices that show a constant capacitance from a given  $V_{DS}$  value at  $t_{35h}$ . It means that the 2DEG is fully depleted or that the leakage current is entirely vertical through the defect. Indeed, the drain-source leakage current has no influence on the gate current during the  $I_{dss}$  measurement as seen on the characterization results (see Fig 4c and 4d).

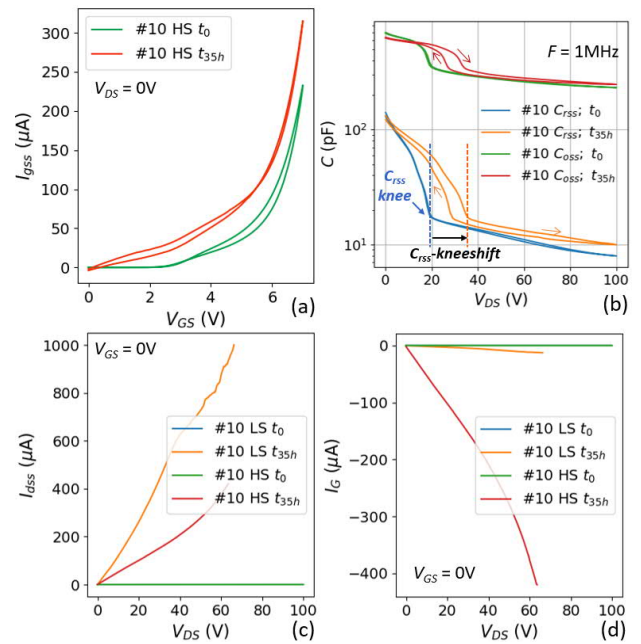
To evaluate the impact of cross-conduction alone, a stress under  $V_{DS} = 67V$  (2/3 of the voltage rating) with a short deadtime of 20ns is conducted on boards #9 and #10. The degradation of the HS transistors identified by a high leakage current between gate and drain is depicted in Fig.5(c) and (d). The capacitance  $C_{rss}$  knee's drift to higher voltage (Fig.5(b)) and the gate leakage current  $I_{gss} = f(V_{GS})$  tends to increase especially at low voltage (Fig.5(a)). The LS switches exhibit the same degradation patterns, yet in a less pronounced manner. The devices of board #1 that underwent cross-conduction at higher  $V_{DS}$  share the same degradation patterns on  $I_{gss}$  between  $t_0$  and  $t_{35h}$  in addition to a constant  $C_{rss}$  starting at 60V. The  $I_{dss}$  curve has both

the electrical changes observed before: a gate drain leakage current and a steeper increase of the drain-source leakage current above  $V_{DS} = 90V$ .

Figure 5: Characterization of the stress board #10 before ( $t_0$ ) and after 35hours of stress ( $t_{35h}$ ) under 67V with cross-conduction ( $T_d = 20ns$ ). (a) Gate leakage current  $I_{gss} = f(V_{GS})$ . (b)  $C_{rss}$  and  $C_{oss}$ . (c) Drain leakage current  $I_{dss} = f(V_{DS})$ . (d) Gate current during the  $I_{dss}$  measurement. The main degradation to observe is the drain-source high leakage current that appears for LS and the gate-drain leakage current for HS.

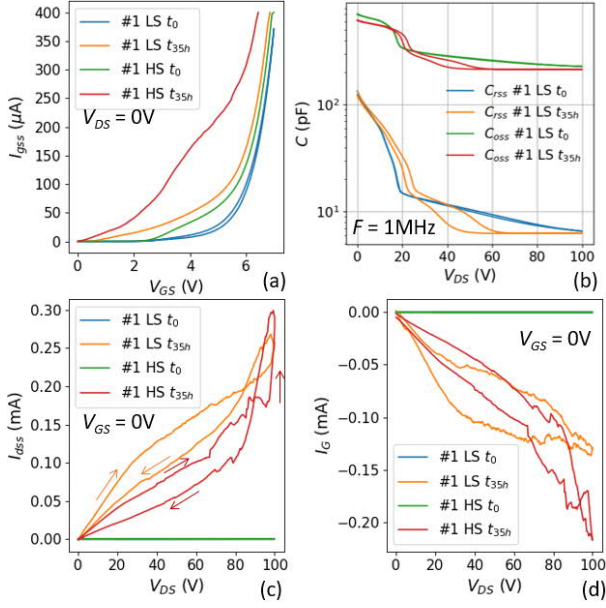
Figure 6: Characterization of the stress board 1 before ( $t_0$ ) and after 35hours of stress ( $t_{35h}$ ) under 120V with cross-conduction ( $T_d = 30ns$ ). (a) Gate leakage current  $I_{gss} = f(V_{GS})$ . (b)  $C_{rss}$  and  $C_{oss}$ . (c) Drain leakage current  $I_{dss} = f(V_{DS})$  at  $V_{GS} = 0V$ . (d) Gate current during the measurement depicted on (c). The main degradation to observe is the gate to drain short on (c) and (d).

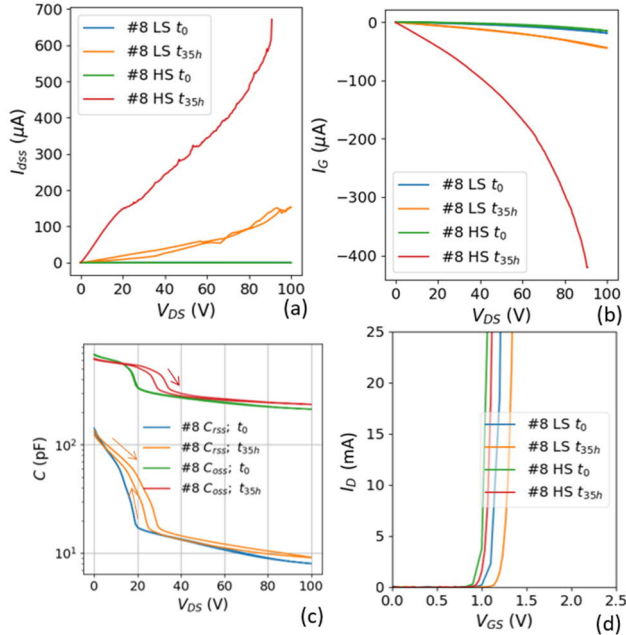
The transistors of the other boards #7,#11,#6,#8 tested under a  $V_{dc}$  voltage within the ratings and no cross-conduction show a similar change but less significant than the low voltage cross-conduction case (see Fig. 7 for #8). A high gate-drain leakage current also appears and the  $C_{rss}$  knee is shifted to higher  $V_{DS}$  values for all transistors. The stress was done with a smaller  $R_{G,OFF}$  value for #7 and #11 in order to reduce the switching energy but no change has been observed compared to transistors #6 and #8.

Figure 7: Characterization of the stress board #8 before ( $t_0$ ) and after 35hours of supposedly no stress ( $t_{35h}$ ) under 67V without cross-conduction ( $T_d = 130ns$ ). (a) Drain leakage current  $I_{dss} = f(V_{DS})$ . (b) Gate current leakage during  $I_{dss}$  measurement of (a) showing the gate drain leakage (c)  $C_{rss}$  and  $C_{oss}$ . (d) Preconditioned measurement of  $V_{th}$  (for obtaining a stable value independent from the history of the device), a shift up to 25% can be observed.

working post-stress. Despite being physically degraded after  $t_{35h}$ , the transistors are still functional, they still switch and no visible change ( $dv/dt$ ,  $\delta V_{GS}$ , oscillations...) has been observed, even for the degraded ones. The less degraded transistors have leakage levels within the ratings given in the datasheet despite being physically and electrically “changed”. With the hard switching stress or high  $V_{DS}$  voltage stress, 100% of the devices tested drifted or were degraded. Unexpectedly, for the “non-stressed” transistors ( $V_{DS}$  67V, long deadtime conditions) that were not supposed to drift as well as for the transistors that were under DC voltage at off-state for the same duration, around 30% of these devices were physically degraded (for example board #8 as it can be seen in Fig. 7).

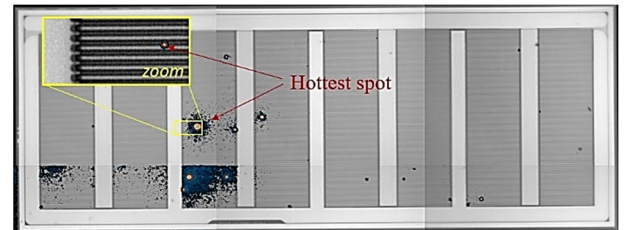
Figure 8: Infrared light LIT of transistor #2 LS (stitching of several images) with a 5x magnification under an electric polarization between 75V and 95V (lock-in frequency 25Hz), applied with probes landed on the electrical vias. The acquisition time is 3 to 5s. The LS transistor of board 2 was cut-off from the

board, all the board layers (PCB and copper layers), leadframe and transistor package were mechanically removed by parallel lapping. The silicon substrate was thinned to a thickness of  $100\mu\text{m}$ . The view of the chip on Fig.8 is an upside-down view of the chip's GaN layers through the silicon substrate. Around 20 hot spots appear on the chip with one hotter than the others (10x magnification zoom in small window).

A localization of physical degradation has been conducted with infrared Lock-In Thermography (LIT) (Fig.8) indicating the location of possible physical degradations in the transistor. Many hotspots were revealed on the whole active surface of the device. As shown in Fig. 9, that uses another type of localization of defect method called Photon Emission Microscopy (PEM), the emission spots (defects zones) are on two different locations on the metal pattern of the transistor represented on Fig.9c. One of them is near the gate, between the gate and the field plate (FP) (Fig.9a) while the other is closer to the drain contact, between the field plate and the drain metal (Fig.9b). The most stressed devices (#1,#2,#3: High voltage and cross-conduction), have numerous spots in both LIT and PEM (more than 20) and are on the two locations that have been described before, but mainly near the drain edge. In general, it has been observed that spots are near the drain for devices that have been stressed at  $V_{\text{DS}}=120\text{V}$  and near the gate for 67V stress. A non-stressed device was also tested and presented no such hot spots.

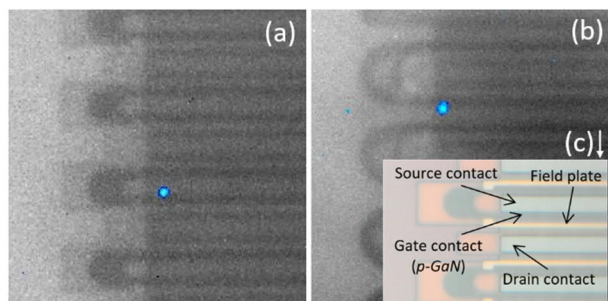
Figure 9: InGaAs camera PEM image of the emission spots. (a) Defect near the gate that might be a GD leakage current through the AlGaN barrier (b) defect near the drain metal that is expected to be a DS leakage current through the GaN layer. (c) optical zoom of the metal structure seen from the backside. The blur in these pictures cannot be avoided as it depends on the camera resolution and the remaining GaN thickness of  $10\mu\text{m}$  we look through with the IR camera.

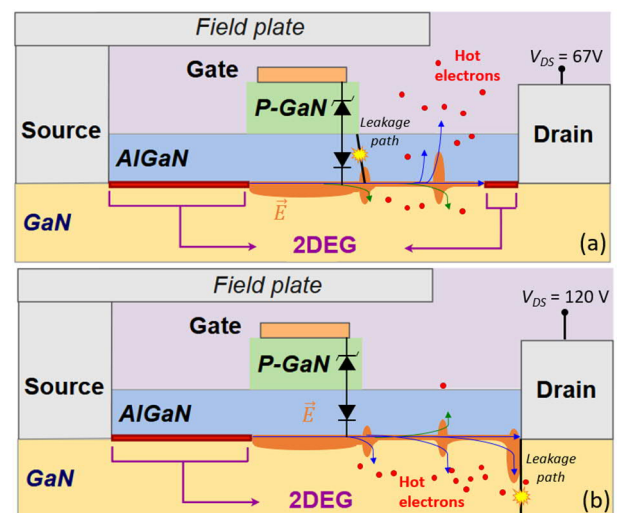
The spots located between gate and field plate could be related to the gate-drain leakage current observed on transistors of boards #1,#8,#9 (HS only), #10 and #11. It could be the failure of the  $D_{\text{pin}}$  diode in the gate stack see Fig.10a or may correspond to a leakage path on the sidewall of the p-GaN layer as illustrated in blue in Fig. 11. This zone is a weak spot in terms of insulation, the

This leakage path is expected to be at the edge of the drain metal and to be vertical across the GaN layer as illustrated on Fig. 10(b) and Fig. 11 in yellow. The leakage current then reaches the conductive epitaxial layers (AlGaN or GaN, the epitaxy is a stack of AlGaN and GaN layers) below the GaN buffer and connected to the source electrode. This leakage is not across the whole silicon substrate as the thinning of the silicon substrate (10  $\mu m$  to 2 $\mu m$ ) and backside package removal did not make the spot disappear.

Figure 10: (a) Formation of the gate leakage path through degradation caused by the emission of hot electrons at (a)  $V_{DS} = 67V$  and (b)  $V_{DS} = 120V$ . The yellow “explosions” symbols illustrate the defect heating/light emission captured with LIT and PEM on Fig. 9 through the GaN layer.

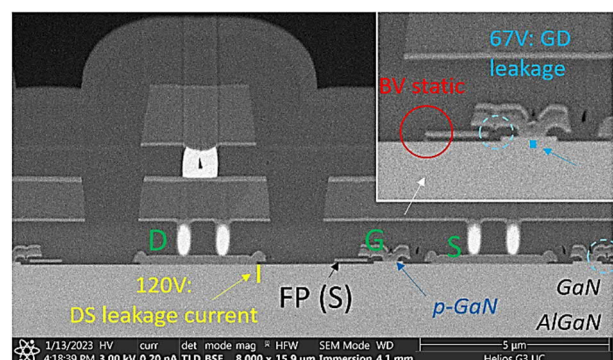
form of the gate metal makes a spike and a cavity below, reducing the insulation distance. During the FIB Slice&View it has been observed that this distance could be much smaller than the one represented in Fig.11. Electrically, it shorts the equivalent  $D_{\text{pin}}$  diode between the p-GaN/AlGaN and AlGaN/GaN interfaces. This leakage current is correlated with the  $C_{\text{rss}}$ -knee shift to higher  $V_{\text{DS}}$  (Fig.7c). The preconditioned threshold voltage (see the full protocol in [6]) is also affected with an increase up to 30% as shown in figure 7. The  $C_{\text{GD}}$ -knee shift to higher  $V_{\text{DS}}$  is an indicator of degradation in the field plate (FP) area.

A drain-source leakage current between the field plate and the 2DEG across the AlGaN and oxide layer under the field plate hypothesis can be ruled out thanks to another study we made on this part-number device (study of static  $V_{DS}$  breakdown voltage). This defect location leads to the melting of the FP and to a filament path (around 150V) see Fig 11, the current leakage path is a direct short and not an abnormal current leakage appearing only above 80V like in this case. A Focused Ion Beam (FIB) Slice and View verified this failure mechanism (Fig. 11 in red).

Figure 11: FIB cross-section of the active area showing the location where the defects are expected to be according to our hypothesis. In yellow the drain-source leakage which corresponds to Fig. 4c electrical signature. In blue the gate-drain leakage (Fig. 7ab) which is the failure of  $D_{pin}$  diode shown in Fig.10. Also, the form of the metal contact is not perfect due to fabrication maybe thermal relaxation. It makes a small spike and

a small cavity which reduces the dielectric insulation above (blue circles). This particular zone seems to be a weakness of this structure, in other pictures of the FIB Slice&View, it has been observed that the spike and the cavity could be bigger. In red the leakage path formed between drain and source in the previous study about static breakdown voltage. The AlGa<sub>N</sub> barrier is not visible in this picture due to its small thickness.
