# Over-Voltage and Cross-Conduction Hard Switching Stress on Schottky Gate-Type p-GaN HEMT in Half-Bridge Operation Experimental and Physical Approaches [ESREF'23]

# Over-Voltage and Cross-Conduction Hard Switching Stress on Schottky Gate-Type p-GaN HEMT in Half-Bridge Operation Experimental and Physical Approaches

<sup>a</sup> THALES SIX France SAS, Toulouse, France <sup>b</sup> LAPLACE University of Toulouse, CNRS, INPT, UPS, Toulouse, France <sup>c</sup> LAAS-CNRS, University of Toulouse, CNRS, Toulouse, France

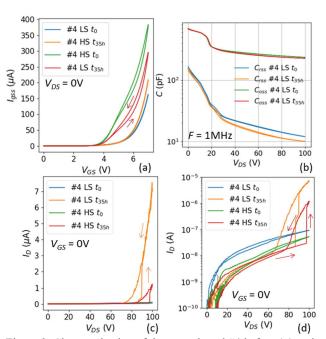
Figure 3: Characterization of the stress board #4 before (t<sub>0</sub>) and after 35 hours of stress (t<sub>35h</sub>) at 120V with no cross-conduction ( $T_d = 120$ ns). (a) Gate leakage current  $I_{gss} = f(V_{GS})$  at  $V_{DS} = 0$ V. (b)  $C_{rss}$  and  $C_{oss}$  under  $V_{DS}$  at F = 1 MHz. (c) Drain leakage current  $I_{dss} = f(V_{DS})$  at  $V_{GS} = 0$ V. (d) Display of (c) with log scale. The main degradation to observe is the high drain source leakage current that appears around  $V_{DS} = 90$ V for LS and  $V_{DS} = 98$ V for HS.

The transistors of boards #4 and #5 were stressed on the drain with a switched voltage of 120% of their rating (i.e.  $V_{dc}=120V$ ). The irreversible degradation is visible on both transistors of board #4 as shown in Fig.3(c) on the drain leakage  $I_{dss}=f(V_{DS})$ . This degradation is visible starting at  $V_{DS}=90V$  for the LS, and around  $V_{DS}=98V$  for the HS. It is characterized by a steep increase of the drain leakage current. Below this voltage, the leakage current mainly overlaps with the curve at  $t=t_0$  and the drain leakage is around 10nA at this voltage. When  $V_{DS}$  is reduced again (backward sweep), the leakage current gets back to a normal value as in the forward sweep as shown in Fig.3(d). This leakage current seems to be between drain and source, as the gate current during this measurement is not changed (similar curves to  $I_{dss}$  of board #2 in Fig.3(a)).

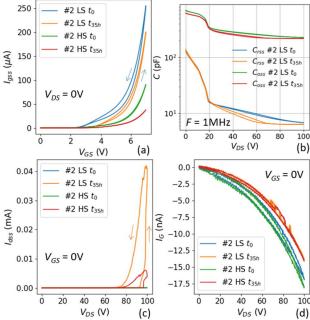
Figure 4: Characterization of board #2 before ( $t_0$ ) and after ( $t_{35h}$ ) stress at 120V with cross-conduction ( $T_d = 30ns$ ). (a) Gate leakage current  $I_{gss} = f(V_{GS})$  (b)  $C_{rss}$  and  $C_{oss}$ . (c) Drain leakage current  $I_{dss} = f(V_{DS})$  at  $V_{CS} = 0V$ . (d) Gate current during the  $I_{dss}$  measurement depicted in (c). The main degradation to observe is the high drain-source leakage current that appears after a threshold voltage for around  $V_{DS} = 95V$  for the LS and  $V_{DS} = 97V$  for the HS.

The devices of boards #2 and #3 were also stressed under  $V_{dc} = 120V$  (like boards #4 and #5) with an additional cross-conduction phenomenon. They also exhibit a change of the drain current leakage above 80V but stronger than in the previous cases. This leakage can reach the mA range. The capacitance  $C_{GD} = C_{rss}$  has significantly changed in this case and becomes constant just before or near the abnormal current leakage.

The second spot location is a defect near the drain edge (or field plate drain side edge but less likely). This defect localization is correlated with a change of I<sub>dss</sub> and C<sub>GD</sub> at high voltage (above  $V_{DS} = 80V$ ). The capacitance after the knee is reduced and for the strongest stresses (#2, #3 for instance) it even becomes constant at a given V<sub>DS</sub> value. The depletion of the 2DEG is faster after the field plate(Vds>20V) for a degraded device and the surface of the 2DEG does not even vary (after 65V on Fig.4b for instance) for the devices that show a constant capacitance from a given V<sub>DS</sub> value at t<sub>35h</sub>. It means that the 2DEG is fully depleted or that the leakage current is entirely vertical through the defect. Indeed, the drain-source leakage current has no influence on the gate current during the  $I_{dss}$  measurement as seen on the characterization results (see Fig 4c and 4d).

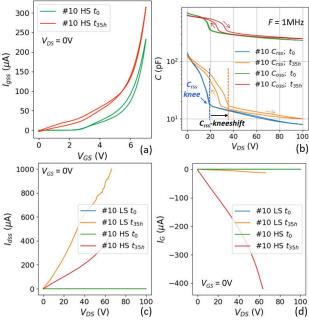
To evaluate the impact of cross-conduction alone, a stress under  $V_{DS} = 67V$  (2/3 of the voltage rating) with a short deadtime of 20ns is conducted on boards #9 and #10. The degradation of the HS transistors identified by a high leakage current between gate and drain is depicted in Fig.5(c) and (d). The capacitance  $C_{rss}$  knee's drift to higher voltage (Fig.5(b)) and the gate leakage current  $I_{gss} = f(V_{GS})$  tends to increase especially at low voltage (Fig.5(a)). The LS switches exhibit the same degradation patterns, yet in a less pronounced manner. The devices of board #1 that underwent cross-conduction at higher  $V_{DS}$  share the same degradation patterns on  $I_{gss}$  between  $t_0$  and  $t_{35h}$  in addition to a constant  $C_{rss}$  starting at 60V. The  $I_{dss}$  curve has both

Figure 5: Characterization of the stress board #10 before ( $t_0$ ) and after 35hours of stress ( $t_{35h}$ ) under 67V with cross-conduction ( $T_d$  =20 $n_s$ ). (a) Gate leakage current  $I_{gss} = f(V_{GS})$ . (b)  $C_{rss}$  and  $C_{oss}$ . (c) Drain leakage current  $I_{dss} = f(V_{DS})$ . (d) Gate current during the  $I_{dss}$  measurement. The main degradation to observe is the drain-source high leakage current that appears for LS and the gate-drain leakage current for HS.

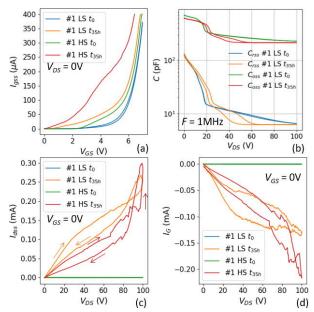
Figure 6: Characterization of the stress board 1 before  $(t_0)$  and after 35hours of stress  $(t_{35h})$  under 120V with cross-conduction  $(T_d = 30ns)$ . (a) Gate leakage current  $I_{gss} = f(V_{GS})$ . (b)  $C_{rss}$  and  $C_{osss}$ . (c) Drain leakage current  $I_{dss} = f(V_{DS})$  at  $V_{GS} = 0V$ . (d) Gate current during the measurement depicted on (c). The main degradation to observe is the gate to drain short on (c) and (d).

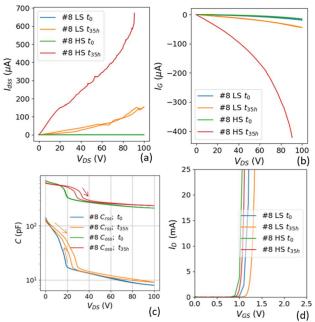
The transistors of the other boards #7,#11,#6,#8 tested under a  $V_{dc}$  voltage within the ratings and no cross-conduction show a similar change but less significant than the low voltage cross-conduction case (see Fig. 7 for #8). A high gate-drain leakage current also appears and the  $C_{rss}$  knee is shifted to higher  $V_{DS}$  values for all transistors. The stress was done with a smaller  $R_{G,OFF}$  value for #7 and #11 in order to reduce the switching energy but no change has been observed compared to transistors #6 and #8.

Figure 7: Characterization of the stress board #8 before ( $t_0$ ) and after 35hours of supposedly no stress ( $t_{35h}$ ) under 67V without cross-conduction ( $T_d = 130ns$ ). (a) Drain leakage current  $I_{dss} = f(V_{DS})$ . (b) Gate current leakage during Idss measurement of (a) showing the gate drain leakage (c)  $C_{rss}$  and  $C_{oss}$ . (d) Preconditioned measurement of  $V_{th}$  (for obtaining a stable value independent from the history of the device), a shift up to 25% can be observed.

working post-stress. Despite being physically degraded after  $t_{35h}$ , the transistors are still functional, they still switch and no visible change (dv/dt,  $\delta V_{GS}$ , oscillations...) has been observed, even for the degraded ones. The less degraded transistors have leakage levels within the ratings given in the datasheet despite being physically and electrically "changed". With the hard switching stress or high  $V_{DS}$  voltage stress, 100% of the devices tested drifted or were degraded. Unexpectedly, for the "non-stressed" transistors ( $V_{DS}$  67V, long deadtime conditions) that were not supposed to drift as well as for the transistors that were under DC voltage at off-state for the same duration, around 30% of these devices were physically degraded (for example board #8 as it can be seen in Fig. 7).
