Conservation of a WWII Supermarine Spitfire section wing

EVE PAILLAUX¹
 SOTIRIS BAMPITZARIS¹
 JANE ECHINARD¹
 GILLES BARON¹
 CESAR ESCOBAR-CLAROS¹  
 MAGALI BRUNET²  
 LUC ROBBIOIA³  
 ELODIE GUILMINOT^{1*}

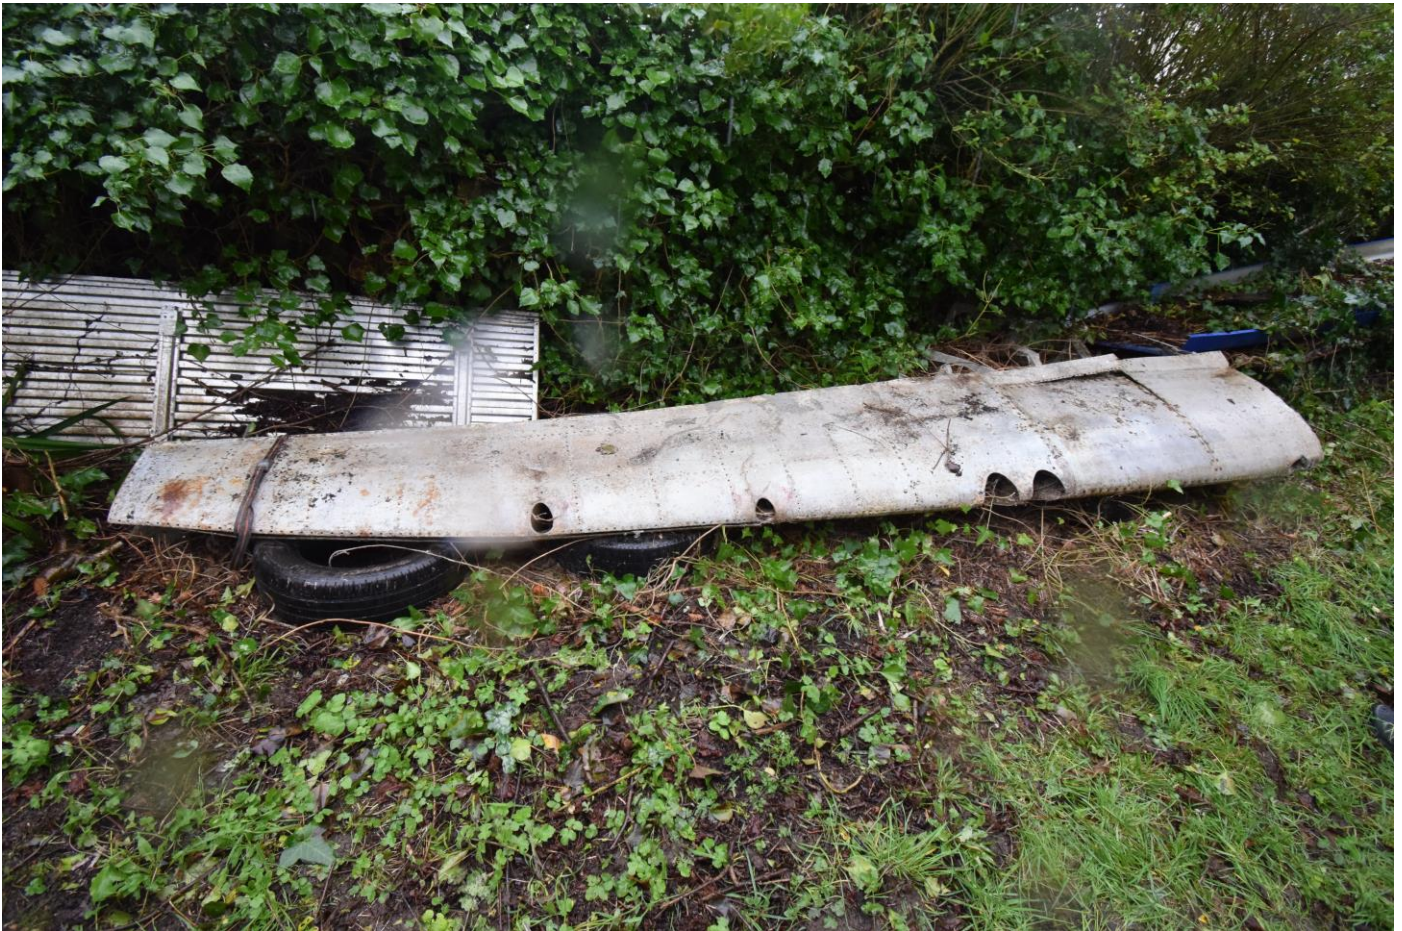
After 44 years on the seabed, the wing fragment was stored for a further 34 years in a private garden (Figure 3). The plane's history has resulted in a wide range of visible deterioration; mechanical degradation caused by the combat and crash (Figure 4a), deterioration due to seawater (Figure 4b-c), and the presence of undergrowth during the period of outdoor storage in the garden (Figure 4d). In our conservation process we undertook a full condition assessment including of the mechanical and electro-chemical deterioration. The main observations are summarized in Table 1.

Figure 3. The Spitfire Mk VII wing fragment stored in the garden.

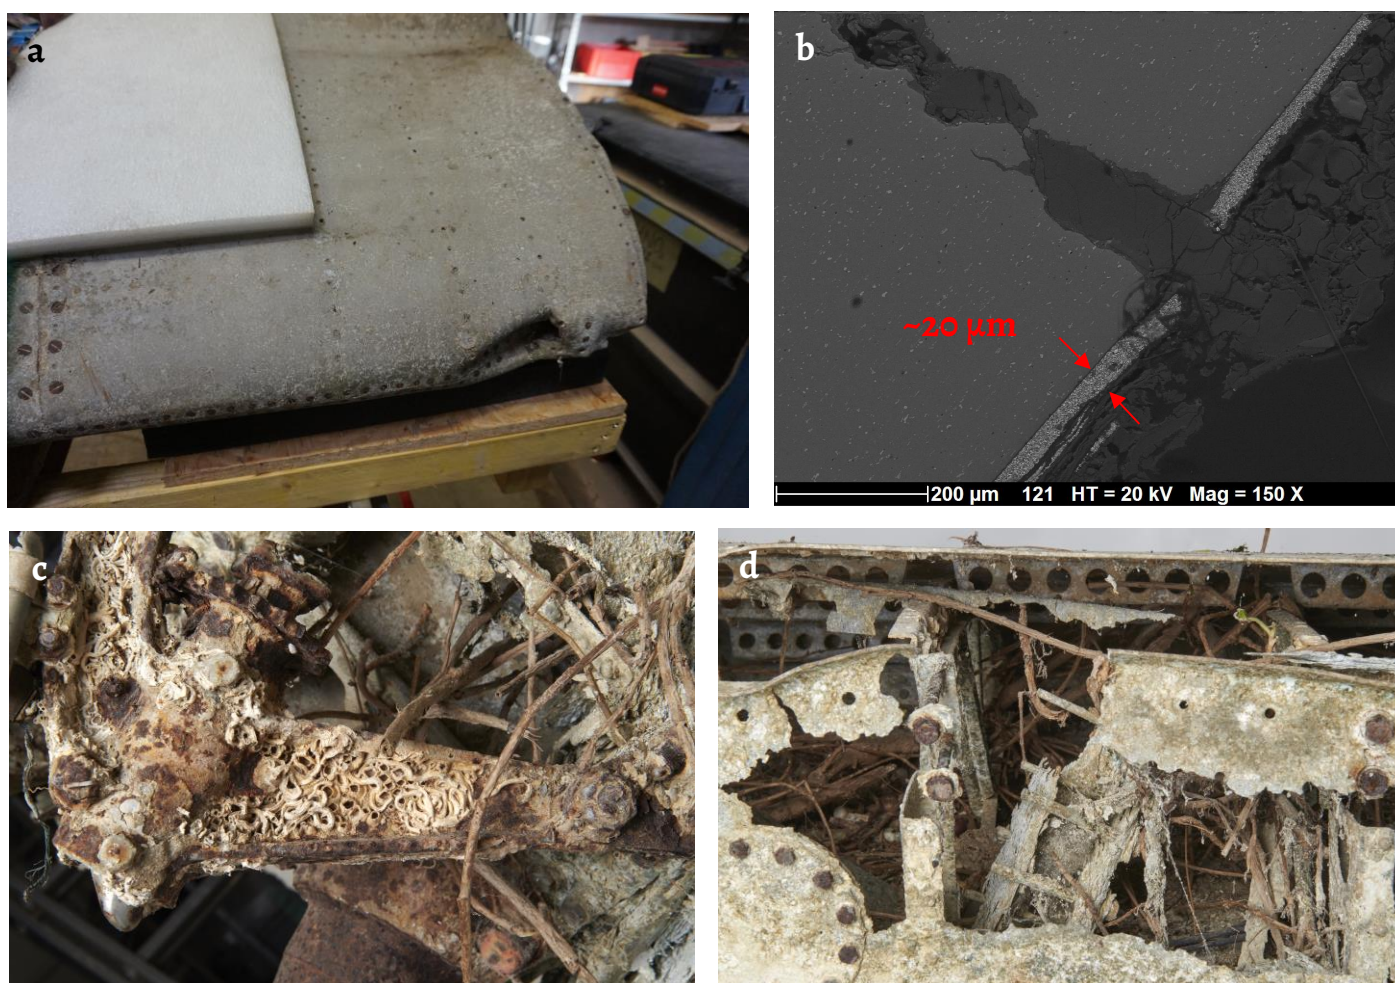
Figure 4. Examples of deterioration observed on the wing fragment of the Spitfire Mk VII: *a)* bullet impact; *b)* SEM photo of a sample (cross-section) from the wing showing generalized corrosion with inter- and intragranular corrosion in relation to micrometric intermetallic precipitates; *c)* development of marine microorganisms, called “concretions”; *d)* presence of undergrowth inside the wing.

Duralumin is highly sensitive [4] when in contact with chlorides, developing pitting and intergranular corrosion aggravated by the presence of intermetallic precipitates (Figure 4b).

Records [3] show that Duralumin parts of the Spitfire were usually protected by Al cladding (pure Al hot-rolled on both sides of the alloy, to provide more resistance to corrosion) and painting. However, SEM analysis of samples taken from different areas of the wing did not reveal any cladding. During the period of storage in the garden, the wing fragment was under a plastic tarp, surrounded by vegetation which generated humid conditions resulting in increased Al alloy corrosion. Localized corrosion had become generalized in some areas, especially at the level of the internal structure. Al alloys are highly sensitive to variations in relative humidity which produces mechanical stress and enhanced mechanical deterioration. The disappearance of the rivets due to corrosion had worsened the mechanical condition of various elements which were no longer physically held together.

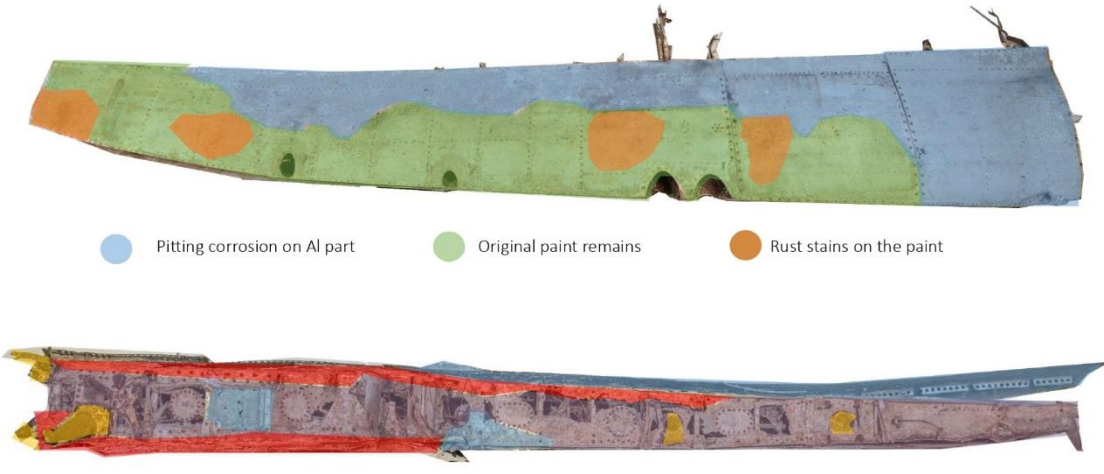
<p>Main alterations caused by corrosion</p>

<p> ● Pitting corrosion on Al part ● Original paint remains ● Rust stains on the paint </p> <p> ● Pitting corrosion on Al part ● Uniform corrosion, pitting and structural cavities ● Corrosion of Fe parts ● Exfoliation corrosion </p>
<p>Main mechanical alterations</p>	<ul style="list-style-type: none"> - Adherent and non adherent deposits (marine concretions/remains of vegetation) - Severe deformations, gaps, uncoupling, cracks, breaks, missing structural elements mostly (95 %) on the internal structure - Mild deformations, gaps, cracks, stains and missing structural elements on the skin structure (30 %)

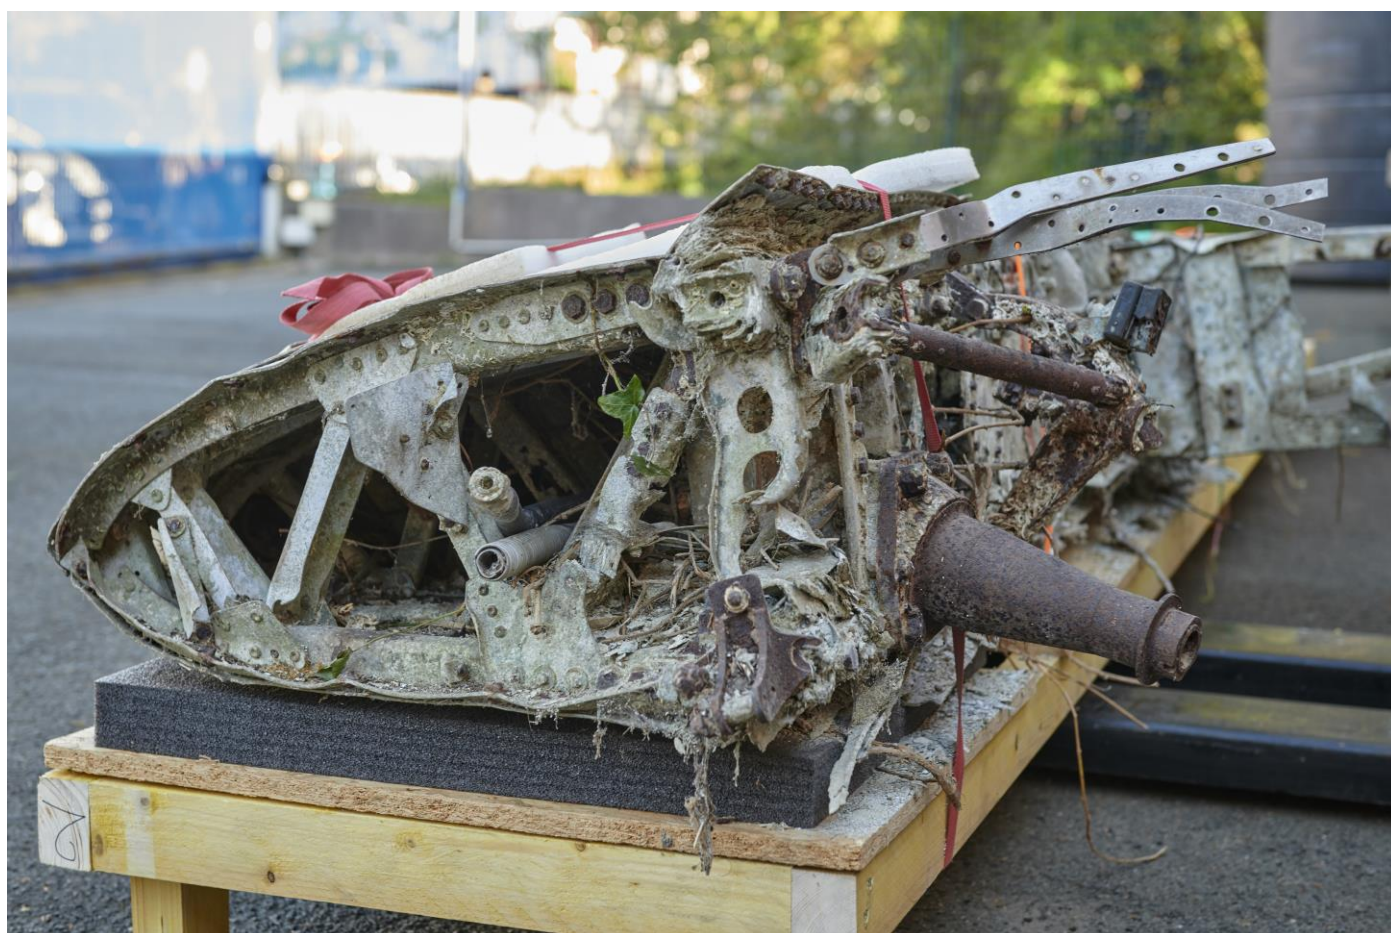
Figure 5. Exfoliation of the spar which caused the Al sheet to buckle.

The wing skin was in relatively good condition but required cleaning. Due to corrosion of the Duralumin, internal structure parts were in really poor condition, particularly the front spar and stringers (Figure 2). The front spar is the major structural element and this required urgent remedial conservation treatment (Figure 4d) as it had developed extensive exfoliation. Stringers needed consolidation, while some ribs that were too severely degraded had to be removed (about 10 %).

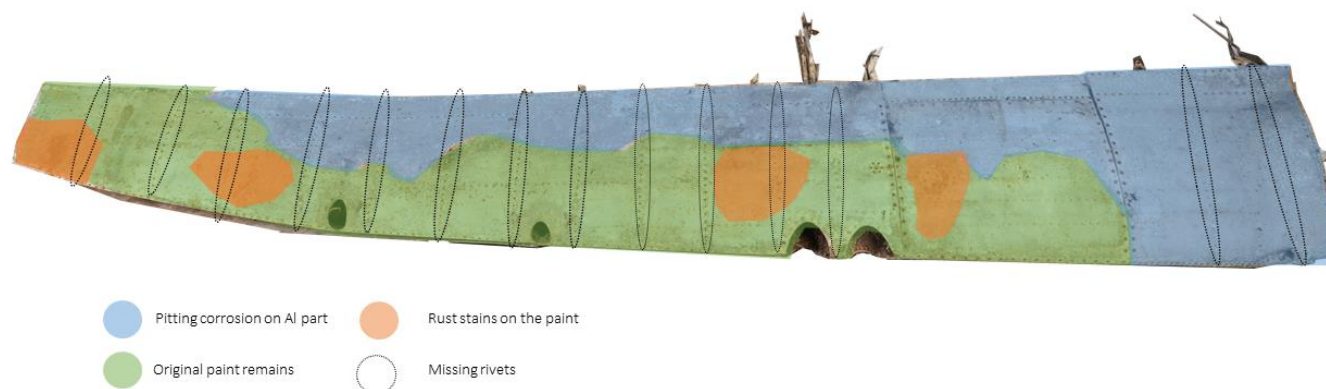
Figure 6. Location of various degradations on the wing fragment of the Spitfire Mk VII.

Mechanical damage due to bullet holes was visible on the side of the location of the machine guns. Most of the rivets that attached the ribs to the wing skin were missing. These Al-Cu alloy rivets are richer in Mg than Duralumin and are more susceptible to corrosion. The tank and elastomer parts do not seem to have deteriorated. The Fe bolts had resisted better and were still present. On the other hand, the presence of Fe elements had caused galvanic corrosion by accelerating the degradation of the Al alloys. The Fe elements were slightly corroded, and Fe corrosion products had caused rust stains on the surface of the wing.
