Conservation of a WWII Supermarine Spitfire section wing

Eve Paillaux, Sotiris Bampitzaris, Jane Echinard, Gilles Baron, Cesar Escobar-Claros, Magali Brunet, Luc Robbiola, Elodie Guilminot

1. GPLA-Arc'Antique, Département de Loire Atlantique, France

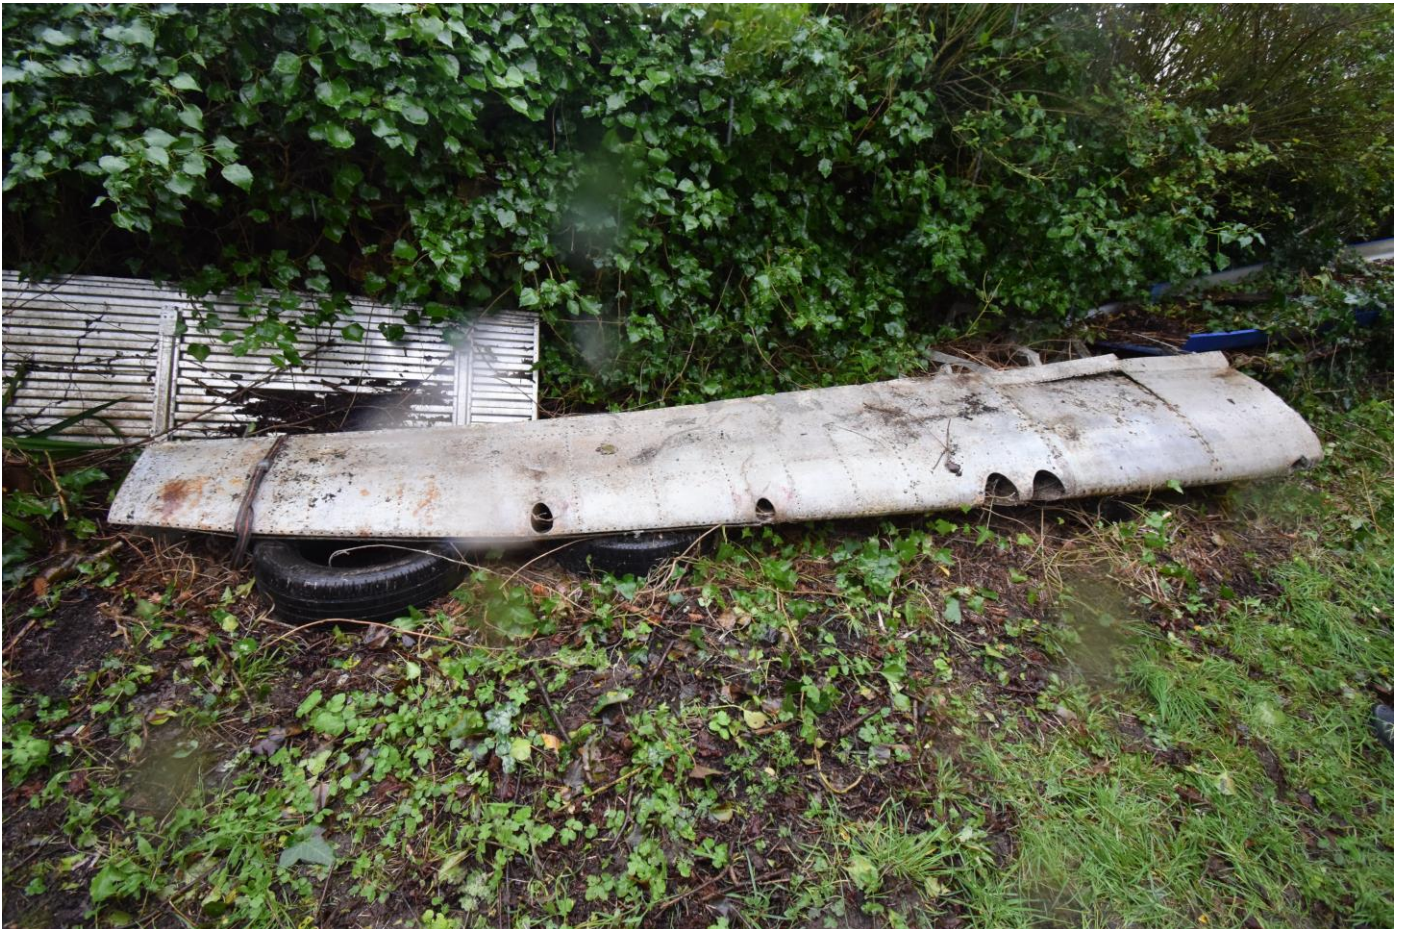
After 44 years on the seabed, the wing fragment was stored for a further 34 years in a private garden (Figure 3). The plane's history has resulted in a wide range of visible deterioration; mechanical degradation caused by the combat and crash (Figure 4a), deterioration due to seawater (Figure 4b-c), and the presence of undergrowth during the period of outdoor storage in the garden (Figure 4d). In our conservation process we undertook a full condition assessment including of the mechanical and electro-chemical deterioration. The main observations are summarized in Table 1.

Figure 3. The Spitfire Mk VII wing fragment stored in the garden.

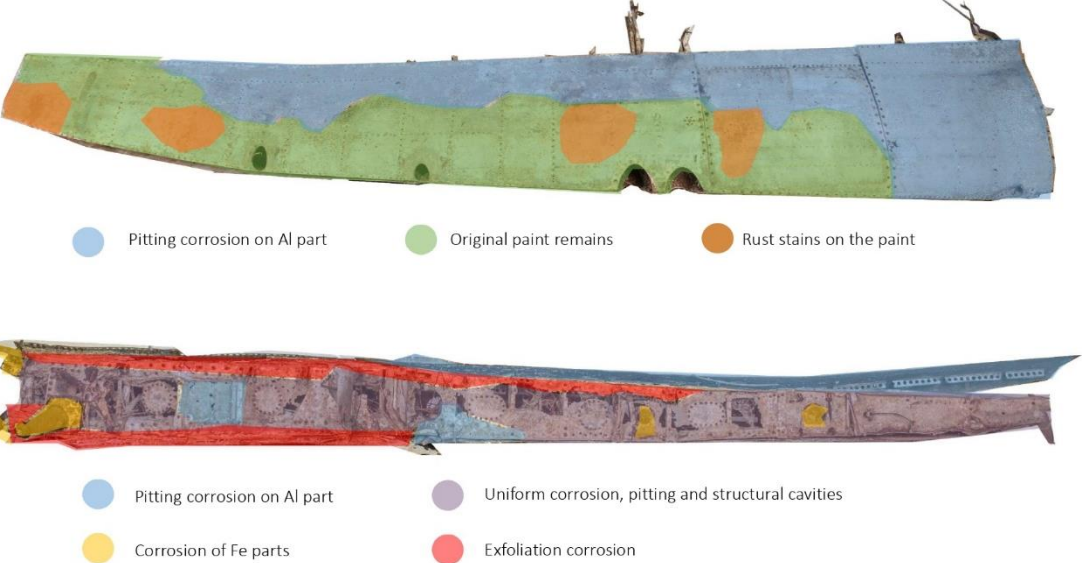
Main alterations caused by corrosion

<p data-bbox="432 1384 1284 1415"> ● Pitting corrosion on Al part ● Original paint remains ● Rust stains on the paint </p> <p data-bbox="432 1637 1209 1720"> ● Pitting corrosion on Al part ● Uniform corrosion, pitting and structural cavities ● Corrosion of Fe parts ● Exfoliation corrosion </p>
Main mechanical alterations	<ul style="list-style-type: none"> - Adherent and non adherent deposits (marine concretions/remains of vegetation) - Severe deformations, gaps, uncoupling, cracks, breaks, missing structural elements mostly (95 %) on the internal structure - Mild deformations, gaps, cracks, stains and missing structural elements on the skin structure (30 %)

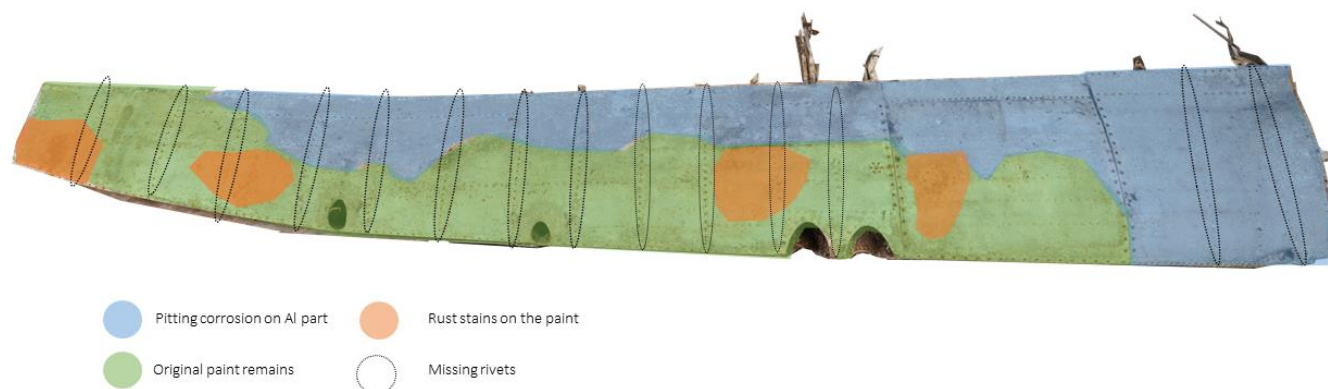
Figure 6. Location of various degradations on the wing fragment of the Spitfire Mk VII.

Mechanical damage due to bullet holes was visible on the side of the location of the machine guns. Most of the rivets that attached the ribs to the wing skin were missing. These Al-Cu alloy rivets are richer in Mg than Duralumin and are more susceptible to corrosion. The tank and elastomer parts do not seem to have deteriorated. The Fe bolts had resisted better and were still present. On the other hand, the presence of Fe elements had caused galvanic corrosion by accelerating the degradation of the Al alloys. The Fe elements were slightly corroded, and Fe corrosion products had caused rust stains on the surface of the wing.

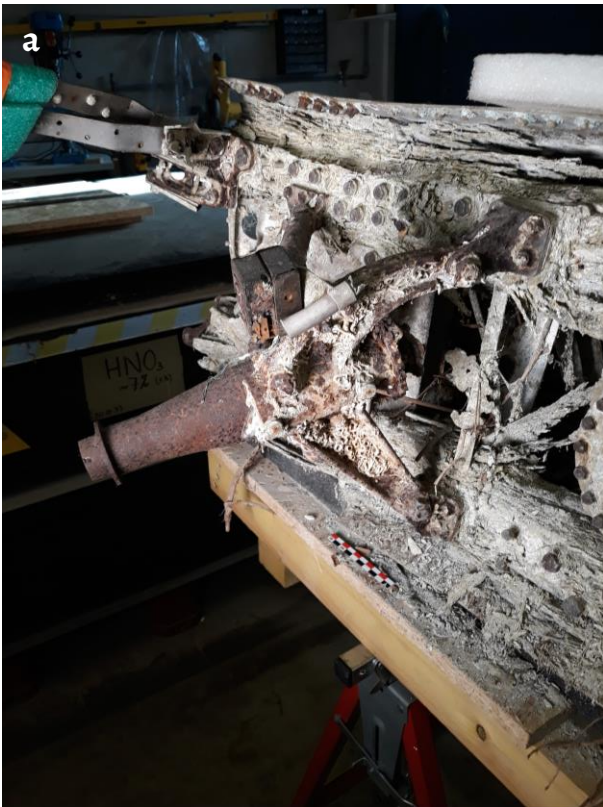
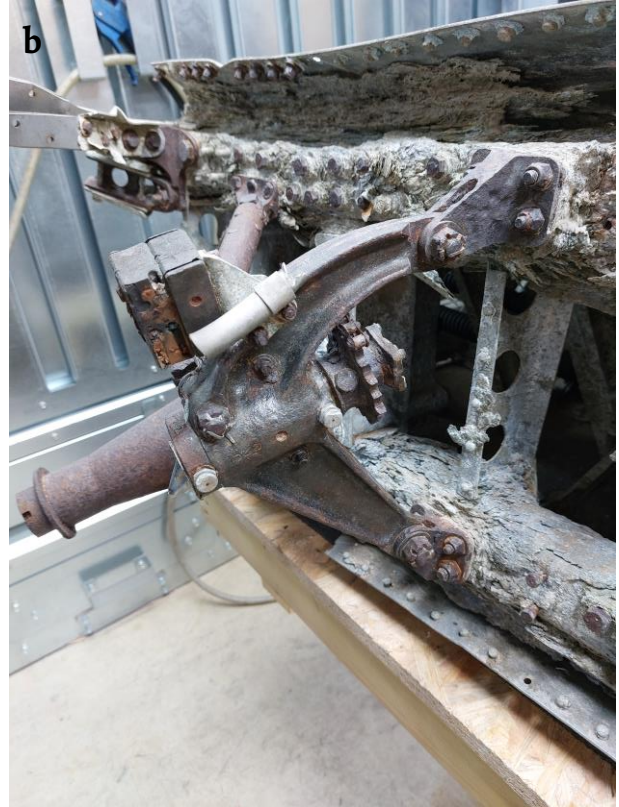
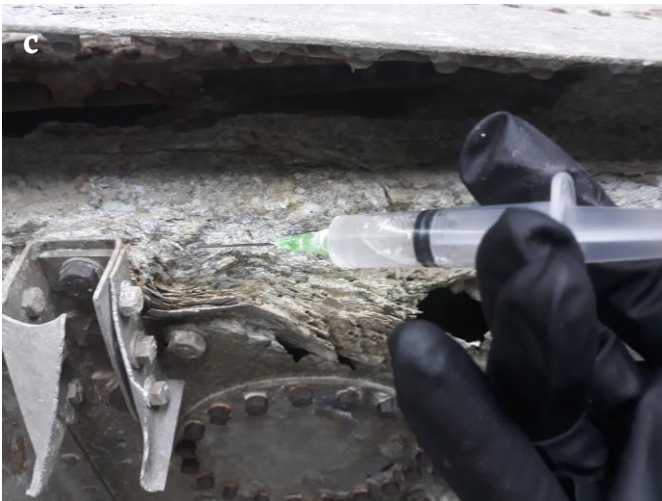
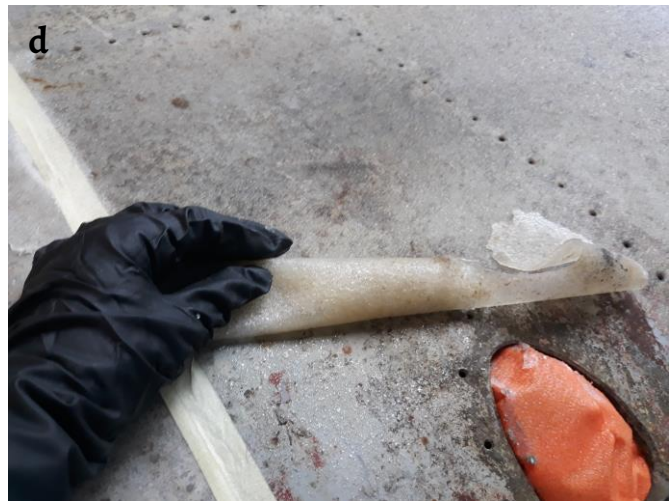
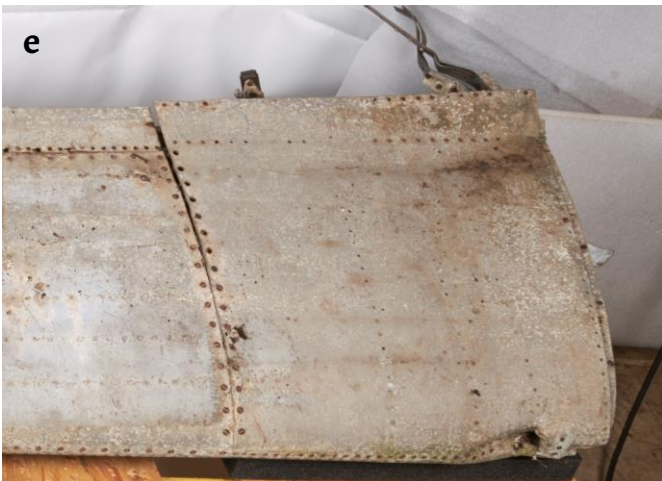
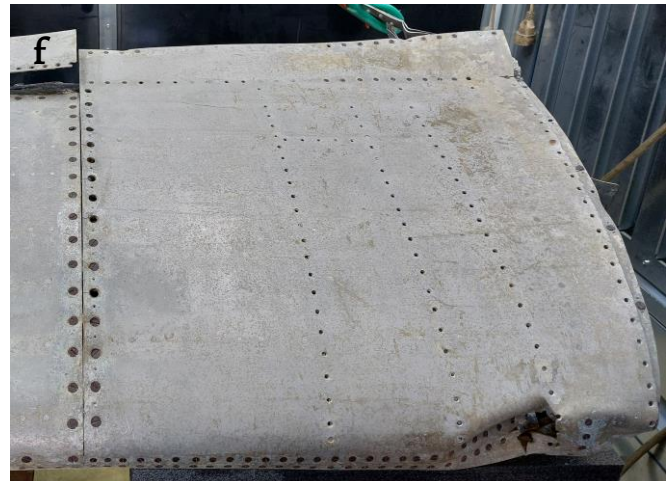
Figure 7. Mechanical cleaning: *a)* before; *b)* after treatment; *c)* consolidation; and chemical cleaning with TAC 5 % w/v applied with Agar gel to 3 % w/v by spray: *d)* removal of the gel; *e)* surface before cleaning; *f)* surface after cleaning.

The first step was to clean the internal area, removing any sediment, soil, sand, concretions and vegetation still present. Micro-suction enabled most of the various deposits to be extracted. After preliminary cleaning, the object gained considerably in terms of legibility. It was then necessary to consolidate the most severely damaged parts of the structure. For those parts that were exfoliating, an initial, in-depth consolidation was made with Paraloid B44 at 15 % w/v in acetone, then a second consolidation on the surface with Paraloid B44 at 30 % w/v in acetone. The front spar was lined with fiberglass using Paraloid B72 at 30 % or 60 % w/v in acetone. It was necessary to fill some of the internal parts to stabilize all the elements and restore the overall appearance of the object. Fills were made of Paraloid B72 (at 60 % or 70 % w/v in acetone) loaded with glass microspheres and pigments. Marine concretions were removed from ferrous parts by mechanical techniques, mainly with a rotation system, micro engraver or micro chisel. On structural Al alloy parts, mechanical techniques (sandblasting) were generally sufficient. The removal of concretions was finalized with a cotton compress impregnated with nitric acid at 10 % w (pH=1) for 30 seconds, then the surface was rinsed abundantly.

For the cleaning of the wing skin, which presented paint residue, aluminium corrosion products and rust stains, a first round of chemical cleaning was employed with a solution of TAC at 5 % w/v applied by Agar gel to 3 % w/v. Compared to other chemical agents, TAC was more efficient in removing dirt and was less aggressive. The gel was sprayed hot, in line with a protocol determined for application to large surfaces [19]. Three 20-minute applications were necessary to remove dirt and reduce rust stains (Figure 7). Cleaning of the wing skin was followed by blasting with vegetal abrasive to homogenize the surface.
