Conservation of a WWII Supermarine Spitfire section wing

Eve Paillaux, Sotiris Bampitzaris, Jane Echinard, Gilles Baron, Cesar Escobar-Claros, Magali Brunet, Luc Robbiola, Elodie Guilminot

Eve Paillaux, Sotiris Bampitzaris, Jane Echinard, Gilles Baron, Cesar Escobar-Claros, et al.. Conservation of a WWII Supermarine Spitfire section wing. *Conservar Património*, 2023, 10.14568/cp28355 . hal-04268504

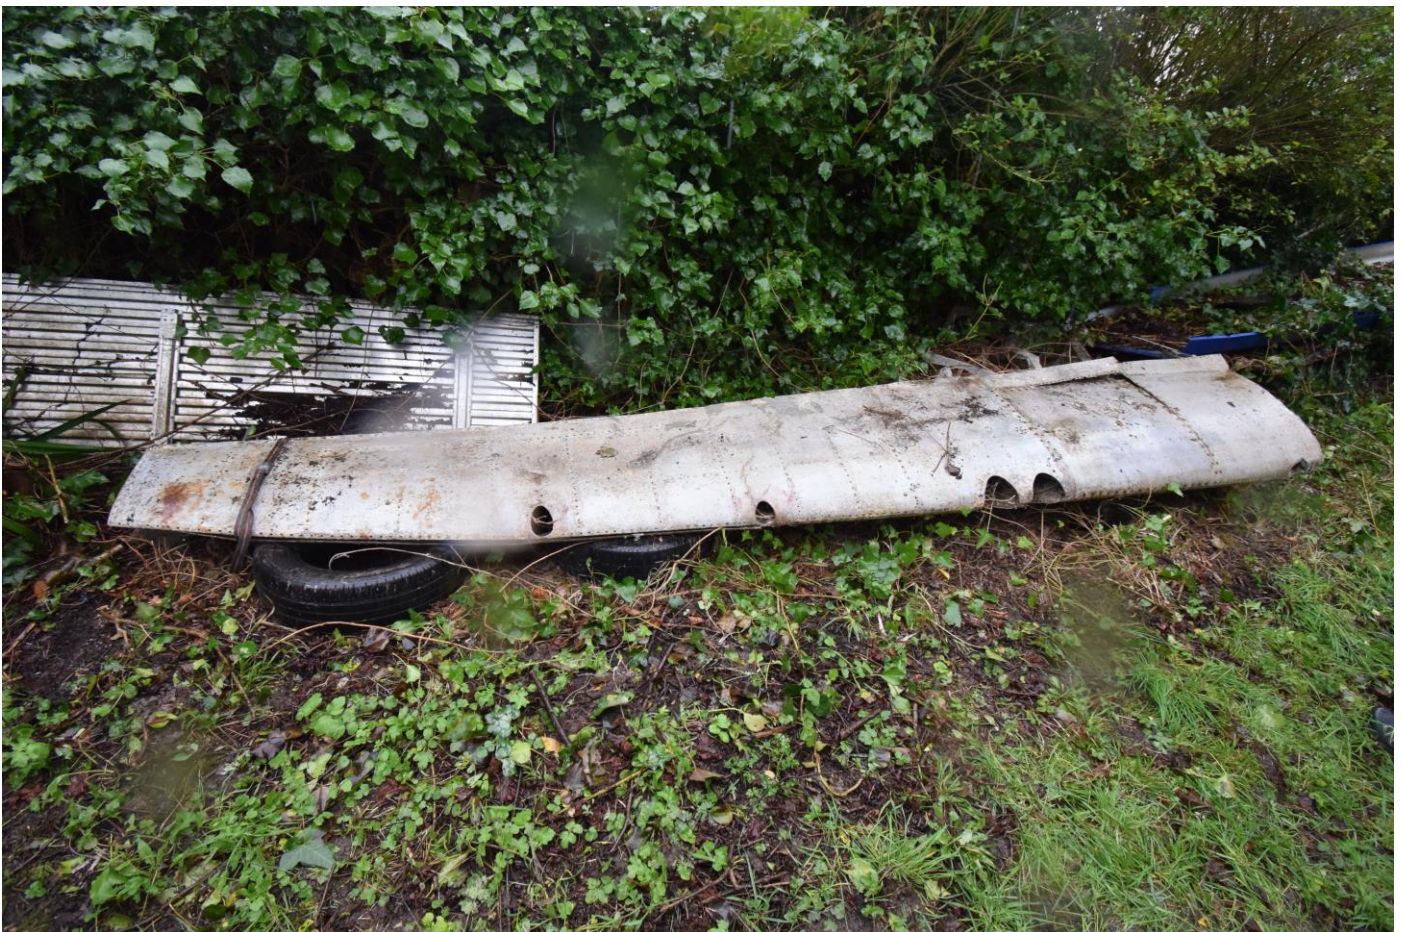
After 44 years on the seabed, the wing fragment was stored for a further 34 years in a private garden (Figure 3). The plane's history has resulted in a wide range of visible deterioration; mechanical degradation caused by the combat and crash (Figure 4a), deterioration due to seawater (Figure 4b-c), and the presence of undergrowth during the period of outdoor storage in the garden (Figure 4d). In our conservation process we undertook a full condition assessment including of the mechanical and electro-chemical deterioration. The main observations are summarized in Table 1.

Figure 3. The Spitfire Mk VII wing fragment stored in the garden.

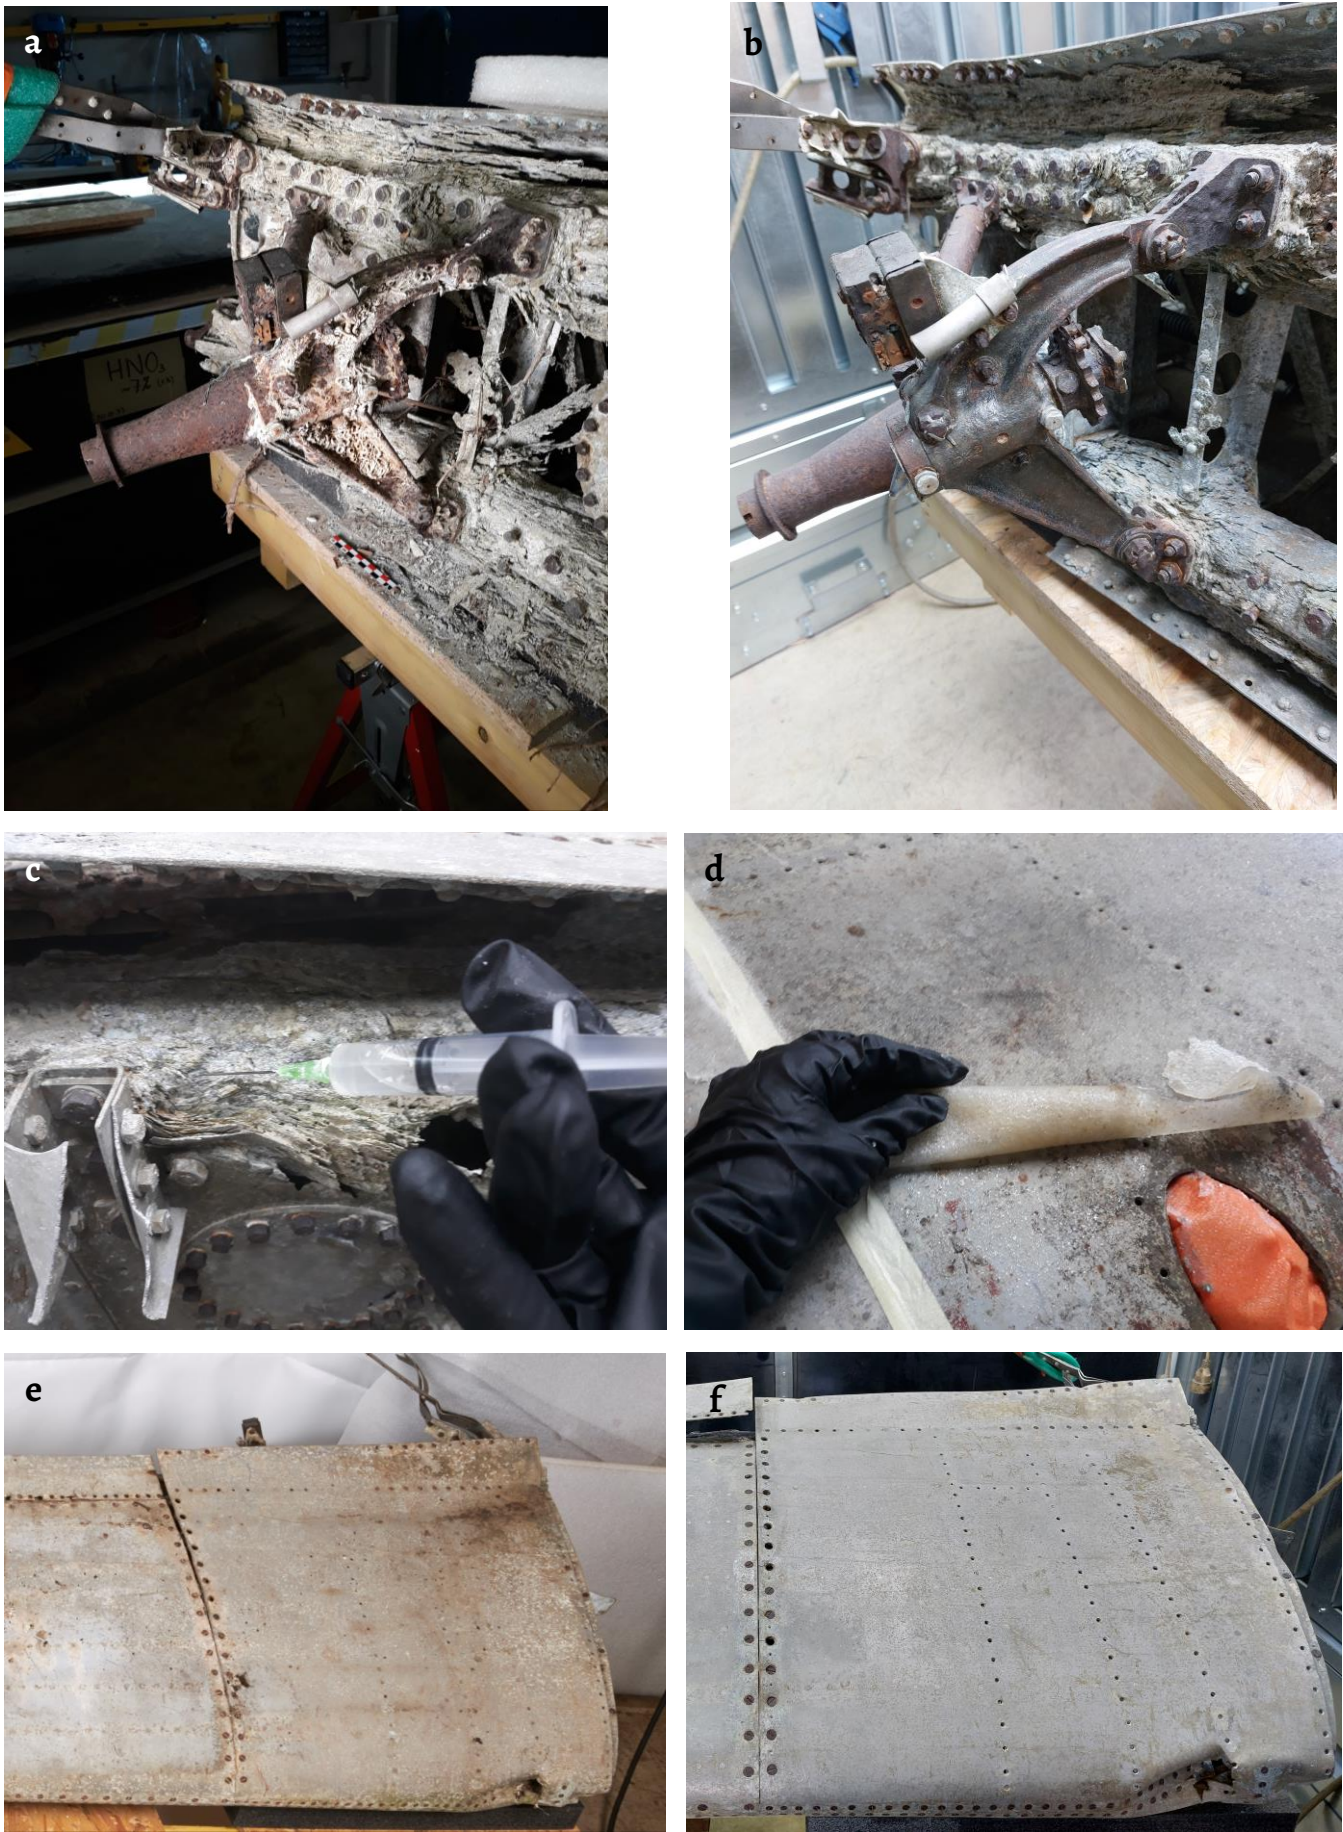
Figure 7. Mechanical cleaning: *a)* before; *b)* after treatment; *c)* consolidation; and chemical cleaning with TAC 5 % w/v applied with Agar gel to 3 % w/v by spray: *d)* removal of the gel; *e)* surface before cleaning; *f)* surface after cleaning.

The first step was to clean the internal area, removing any sediment, soil, sand, concretions and vegetation still present. Micro-suction enabled most of the various deposits to be extracted. After preliminary cleaning, the object gained considerably in terms of legibility. It was then necessary to consolidate the most severely damaged parts of the structure. For those parts that were exfoliating, an initial, in-depth consolidation was made with Paraloid B44 at 15 % w/v in acetone, then a second consolidation on the surface with Paraloid B44 at 30 % w/v in acetone. The front spar was lined with fiberglass using Paraloid B72 at 30 % or 60 % w/v in acetone. It was necessary to fill some of the internal parts to stabilize all the elements and restore the overall appearance of the object. Fills were made of Paraloid B72 (at 60 % or 70 % w/v in acetone) loaded with glass microspheres and pigments. Marine concretions were removed from ferrous parts by mechanical techniques, mainly with a rotation system, micro engraver or micro chisel. On structural Al alloy parts, mechanical techniques (sandblasting) were generally sufficient. The removal of concretions was finalized with a cotton compress impregnated with nitric acid at 10 % w (pH=1) for 30 seconds, then the surface was rinsed abundantly.

For the cleaning of the wing skin, which presented paint residue, aluminium corrosion products and rust stains, a first round of chemical cleaning was employed with a solution of TAC at 5 % w/v applied by Agar gel to 3 % w/v. Compared to other chemical agents, TAC was more efficient in removing dirt and was less aggressive. The gel was sprayed hot, in line with a protocol determined for application to large surfaces [19]. Three 20-minute applications were necessary to remove dirt and reduce rust stains (Figure 7). Cleaning of the wing skin was followed by blasting with vegetal abrasive to homogenize the surface.
