Conservation of a WWII Supermarine Spitfire section wing

EVE PAILLAUX¹
 SOTIRIS BAMPITZARIS¹
 JANE ECHINARD¹
 GILLES BARON¹
 CESAR ESCOBAR-CLAROS¹  
 MAGALI BRUNET²  
 LUC ROBBIOLO³  
 ELODIE GUILMINOT^{1*}

1. GPLA-Arc'Antique, Département de Loire Atlantique, France

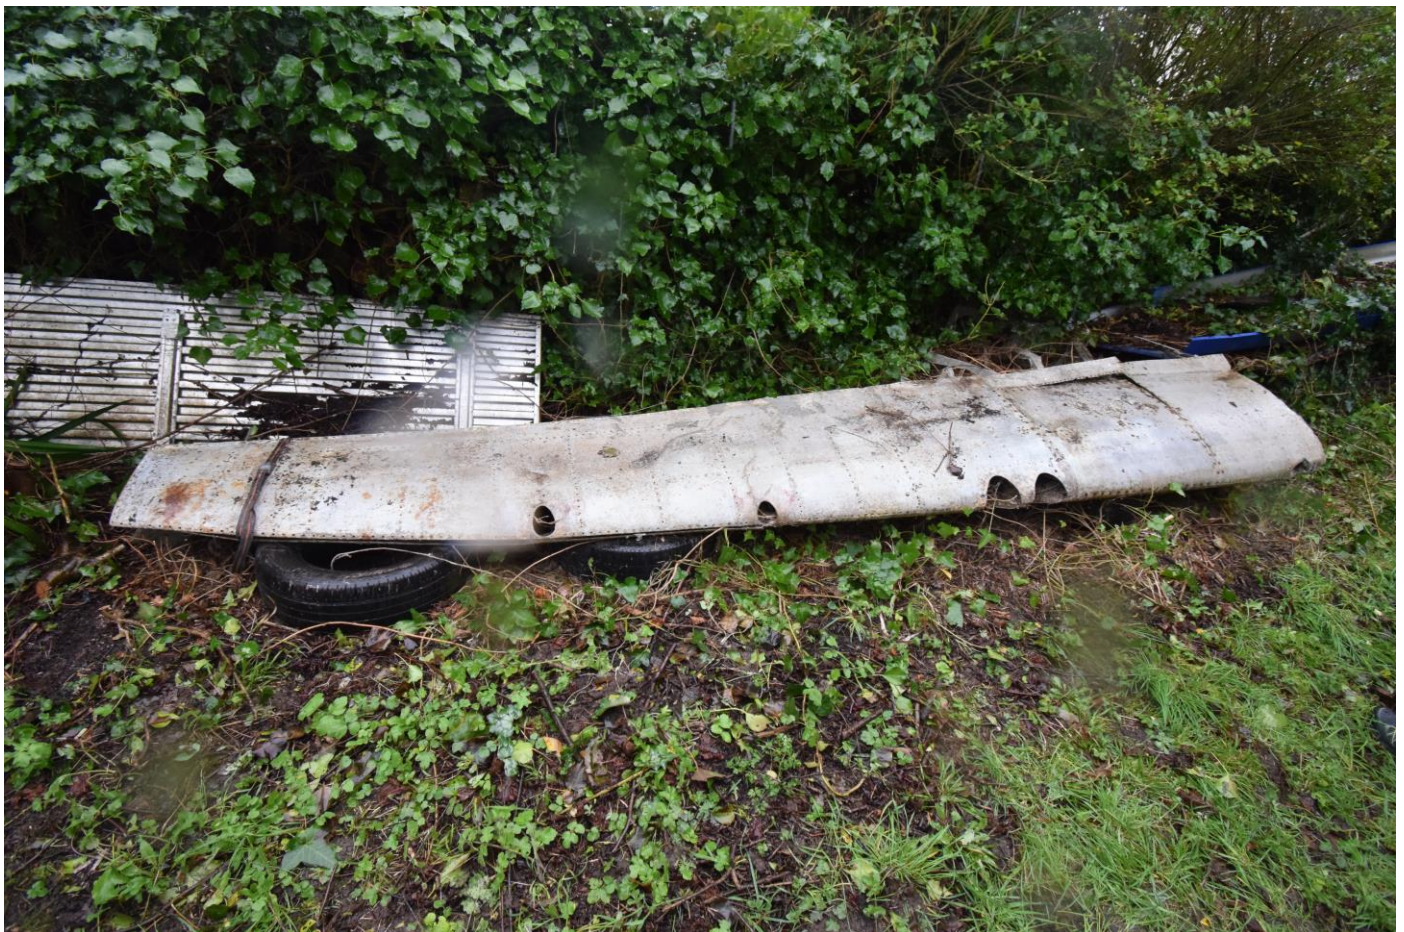
After 44 years on the seabed, the wing fragment was stored for a further 34 years in a private garden (Figure 3). The plane's history has resulted in a wide range of visible deterioration; mechanical degradation caused by the combat and crash (Figure 4a), deterioration due to seawater (Figure 4b-c), and the presence of undergrowth during the period of outdoor storage in the garden (Figure 4d). In our conservation process we undertook a full condition assessment including of the mechanical and electro-chemical deterioration. The main observations are summarized in Table 1.

Figure 3. The Spitfire Mk VII wing fragment stored in the garden.

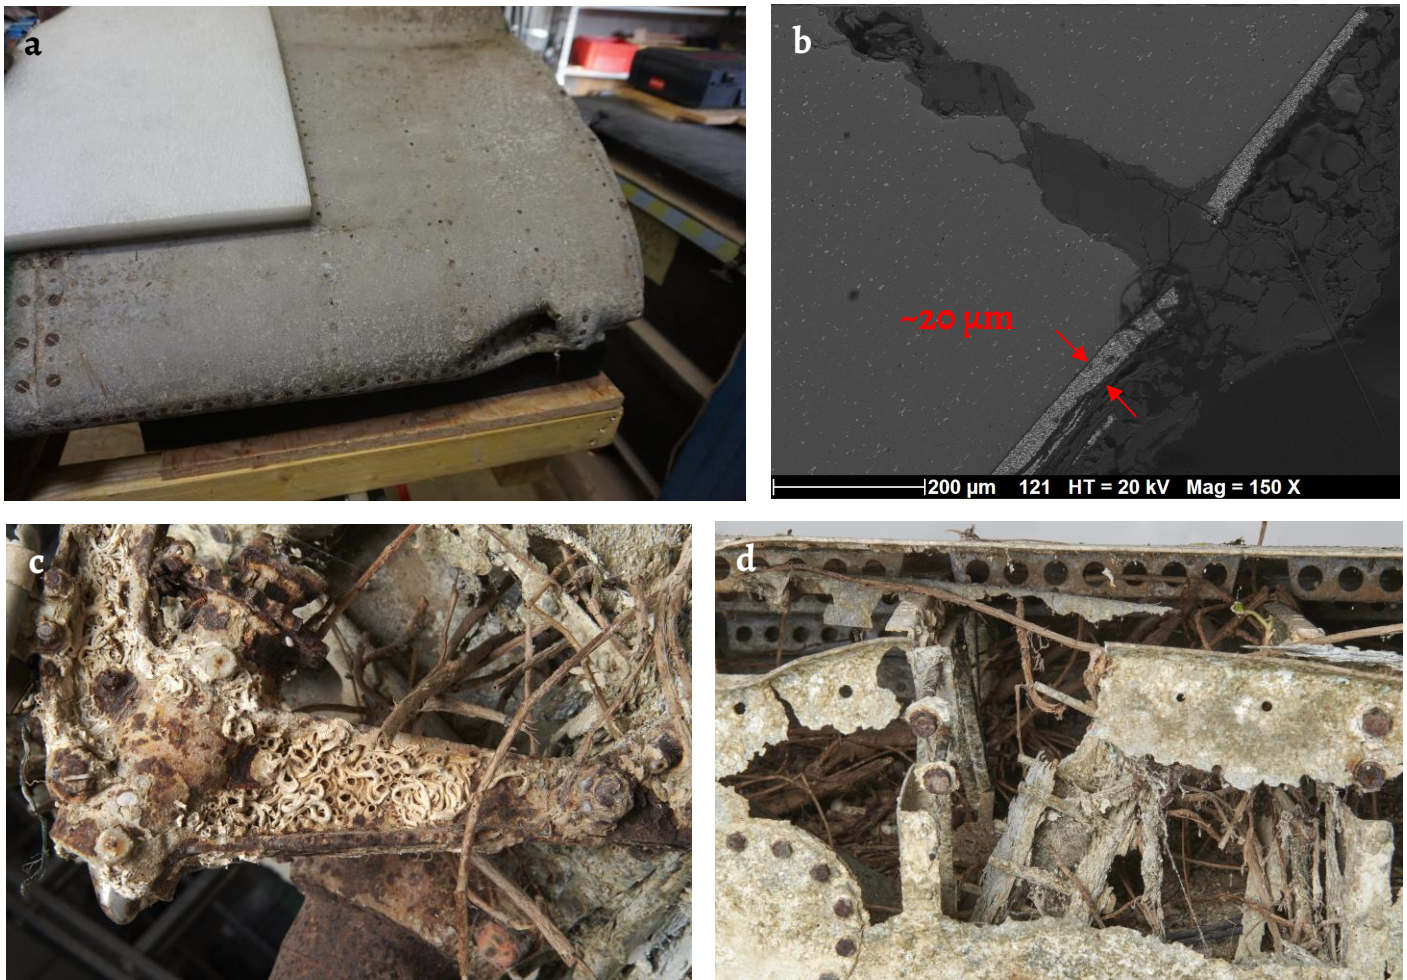
Figure 4. Examples of deterioration observed on the wing fragment of the Spitfire Mk VII: a) bullet impact; b) SEM photo of a sample (cross-section) from the wing showing generalized corrosion with inter- and intragranular corrosion in relation to micrometric intermetallic precipitates; c) development of marine microorganisms, called “concretions”; d) presence of undergrowth inside the wing.

The most severe mechanical degradation of the aircraft probably dates from the time of the crash. The fisherman recovered only the front part of the starboard wing which accounts for no more than 30 % of the total area of a Spitfire wing. Significant degradation also took place during the period it was in the sea and stored outdoors. The internal structure had undergone extensive damage. There are major differences of state between the interior and exterior parts. The internal wing structure was in poor condition; the front spar, stringers and ribs no longer provided adequate mechanical strength due to major exfoliation and pitting corrosion. The corrosion had buckled and lifted the Al sheet (Figure 5). The ribs near the tank were in good condition, while others were in very heterogeneous condition (poor to very poor). All of the ribs displayed localized corrosion, some of which had deteriorated into exfoliation. The location of the different degradations, which were classified into four categories: localized corrosion with pitting, original paint residues, rust stains and missing rivets (Figure 6). The skin (top and bottom) was in good condition overall with traces of paint still visible (Figure 3). Paint remains were abraded and poorly preserved. Localized mechanical surface alterations were visible but did not impact overall legibility.

Duralumin is highly sensitive [4] when in contact with chlorides, developing pitting and intergranular corrosion aggravated by the presence of intermetallic precipitates (Figure 4b).
