**HAL**  
open science

## Terahertz pulsed imaging of low velocity impact damage in woven fiber composite laminates

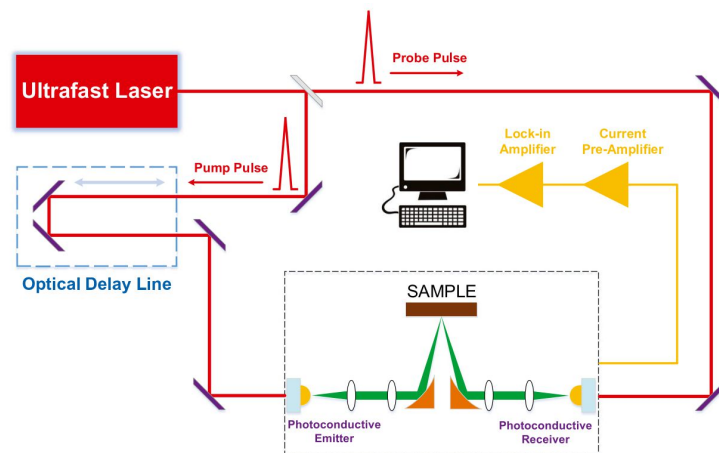
Figure 2: Schematic diagram of THz time-domain spectroscopy (THz-TDS) system in reflection mode [35].

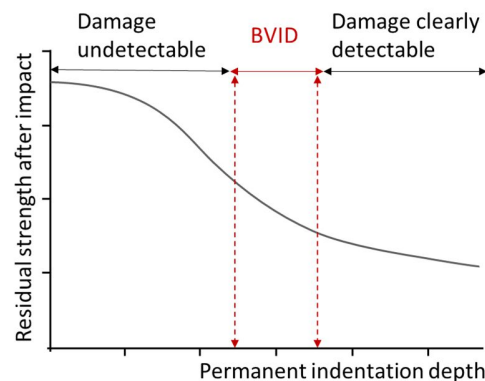
Figure 3: Schematic representation of the evolution of the residual strength after impact as a function of the measured PI on composites materials. The visual detectability range is also indicated from undetectable to detectable.

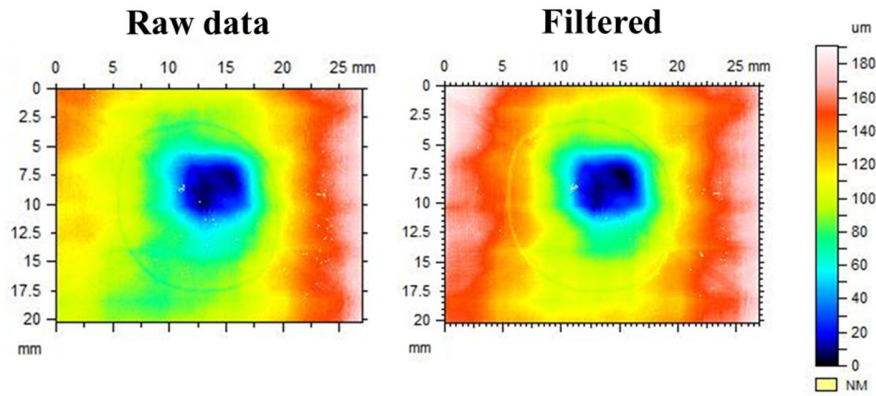
Figure 4: Surface texture of a sample, after an impact of 25 J, obtained using the optical profilometry, before (left) and after (right) applying a filter.

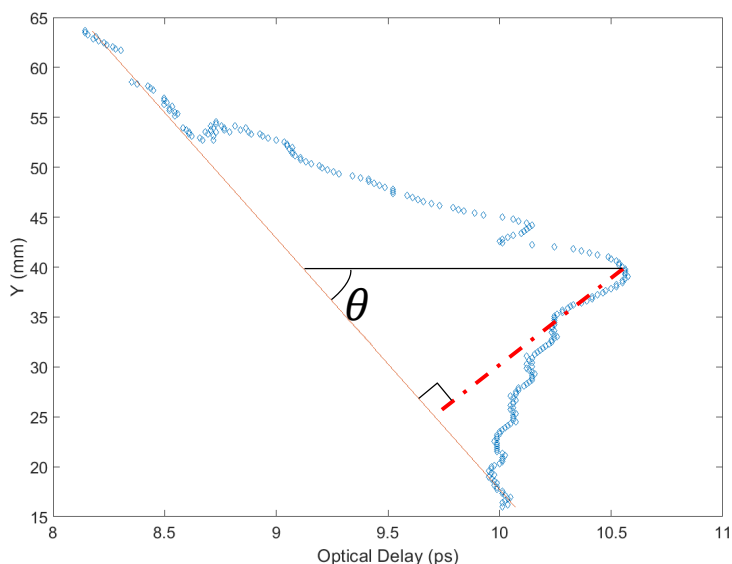
Figure 7 : Linear PI-depth regression plot on a B-scan at  $x = -15.5$  mm of a sample impacted at 25 J with example of PI depth. The solid red line is the nonimpacted sample surface obtained by regression. The red dotted line is the arrival time corresponding to the PI depth for a given point we wish to measure. The black line links this point to the continuous black line, with the  $y$ -coordinate constant. The sine of the angle  $\theta$  times the length of the black line gives the expected time of arrival. This calculation needs to be carried out at all points and all  $x$ -slices to find the largest PI depth.

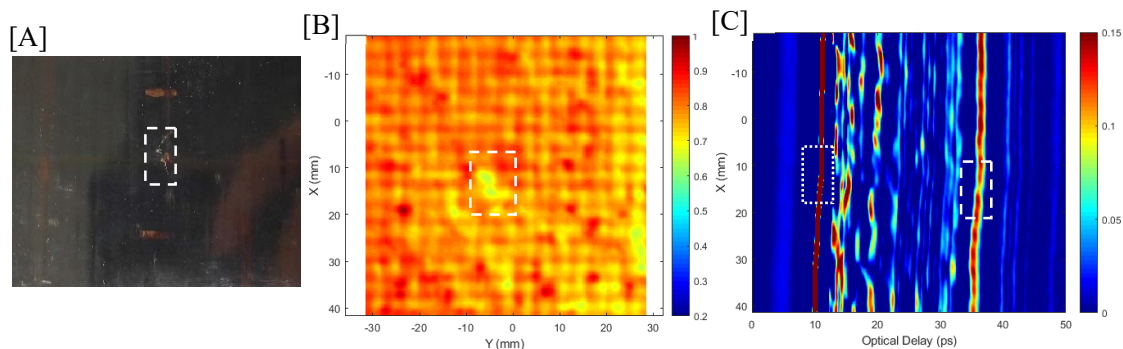
Figure 8: Analysis of the sample impacted at 14.2 J. [A] Photograph of the nonimpacted surface showing matrix cracking within dashed box. [B] THz C-scan of the non-impacted surface of the sample. Matrix cracking is visible as a decrease of the amplitude. [C] THz B-scans of the sample. The damage mechanisms are indicated as follows: *dotted box*: PI, *dashed box*: cracking of bottom surface.

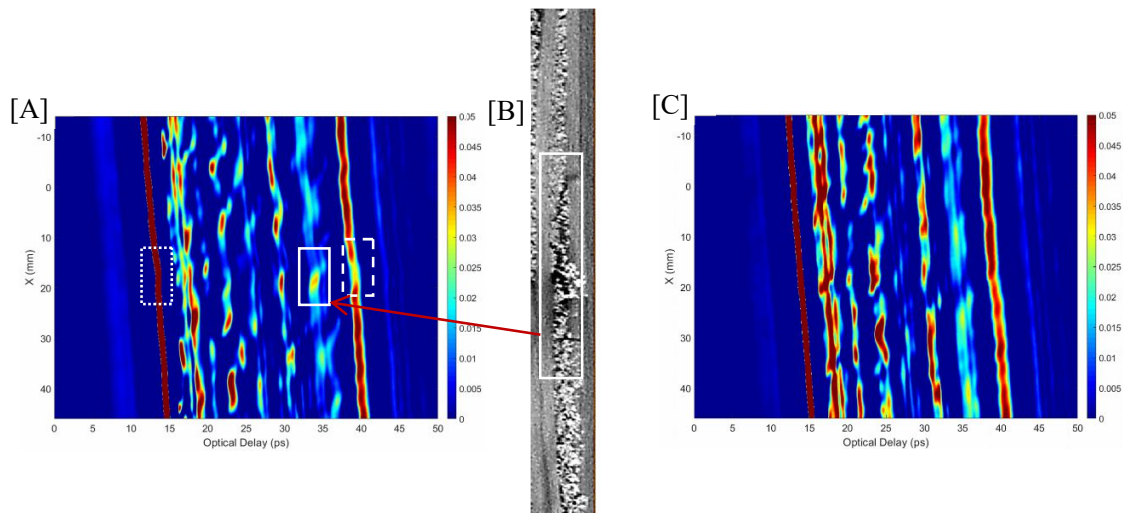
Figure 9: Analysis of the sample impacted at 18.1 J. [A] THz B-scan at impact location. [B] X-ray tomography image of the third layer near the impact location with a visible delamination. [C] Typical THz B-scan representation of an undamaged sample for comparison. Various damage types are visible: dotted box: permanent indentation (PI), dashed box: cracks on the bottom surface and continuous line box: delamination in the third layer.

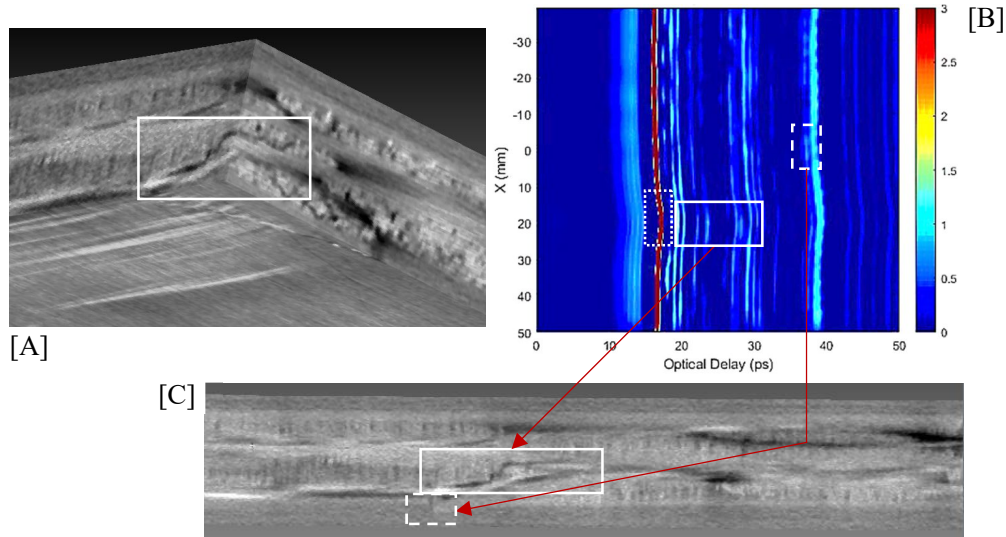
Figure 10: Analysis of the sample impacted at 23 J. [A] X-ray tomography image of the interior of the sample with the propagation of a crack to the second ply. [B] THz B-scan near the impacted region. [C] X-ray tomography image near the impacted region. Multiple damage types are visible: dotted box: Permanent Indentation (PI), dashed box: cracks on the bottom surface, and continuous line box: delamination in the third layer.

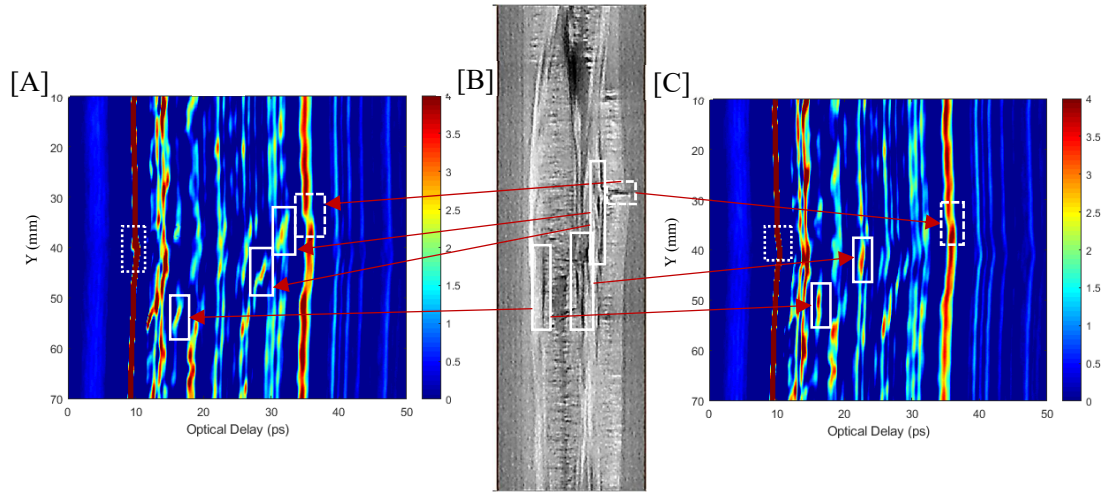
Figure 11: Analysis of sample impacted at 25 J. THz B-scan near PI at [A]  $x = -15.5$  mm and [C]  $x = -17.28$  mm. Some delaminations are more visible in one or the other B-scans. [B] X-ray tomography image of the damage mechanisms near the PI. Delamination and matrix cracking propagate in all layers. Various damage types are visible: *dotted box*: permanent indentation (PI) + matrix cracks, *dashed box*: cracks on the bottom surface, and *continuous line box*: delamination.

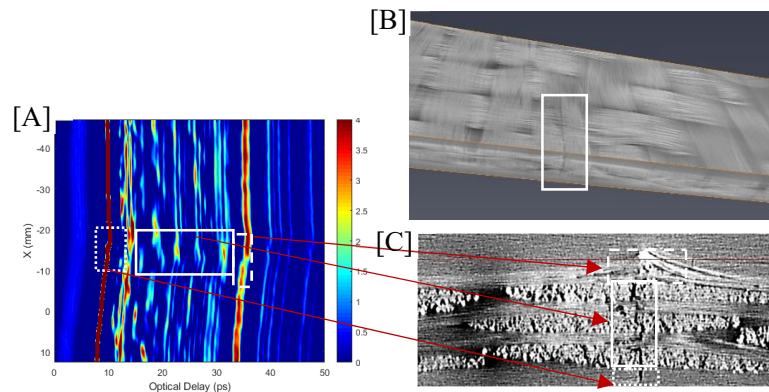
Figure 12: Analysis of the sample impacted at 25 J. [A] THz B-scan at near the impacted region. X-ray tomography image of the matrix cracks running from the non-impacted surface to the other in 3D [B] and in a longitudinal slice [C]. Various damage types are visible: *dotted box*: permanent indentation (PI) + matrix cracks, *dashed box*: cracks on the bottom surface, and *continuous line box*: delamination.

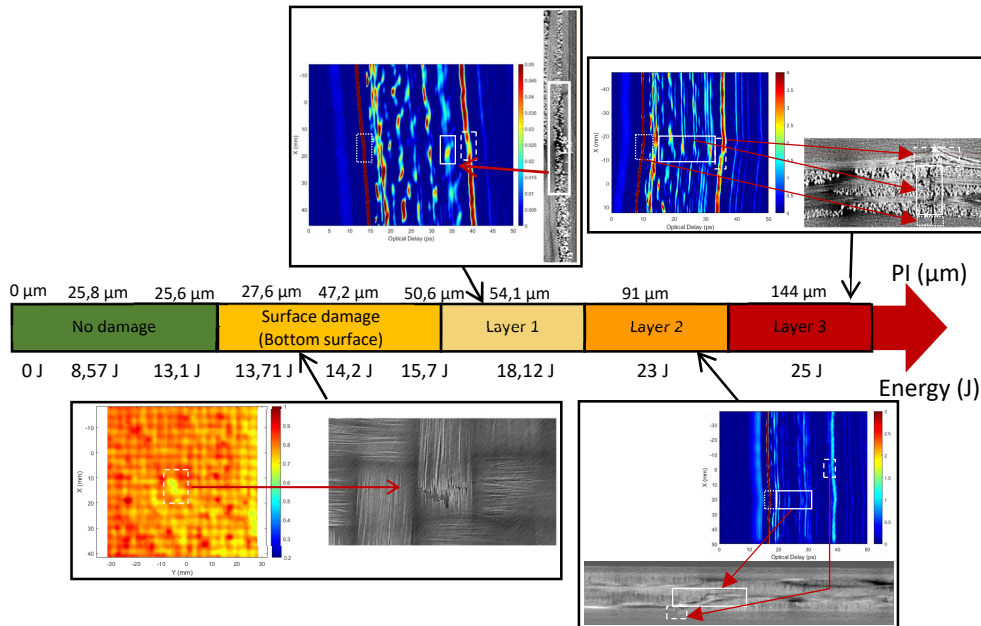
Figure 13: Summary of the proposed damage scenario for the studied material when undergo impact event. The propagation of damage through the sample are indicated. The impact energy as well as the PI depth are also given
