SiC MOSFET micro-explosion due to a single event burnout: analysis at the device and die levels

SiC MOSFET micro-explosion due to a Single Event Burnout: analysis at the device and die levels

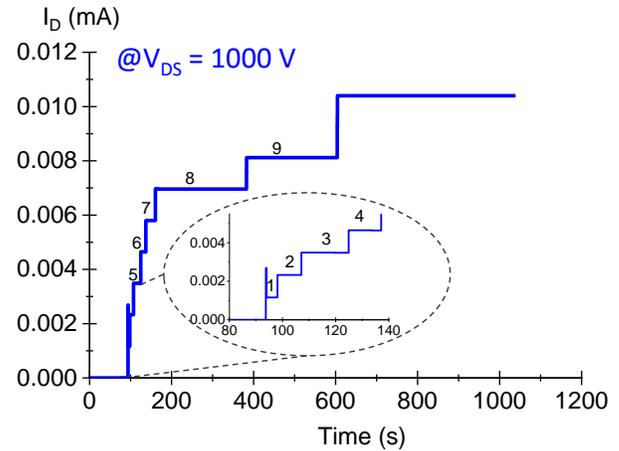
Figure 2: Evolution of the online current I_D during proton irradiation at 53 MeV of all ten SiC MOSFET DUTs in parallel.

A SEB event is detected by the sudden increase of the current. Notes that for isolation, a current-limiting resistance is used for each MOSFET. Fig. 2. shows the current change as a function of the irradiation time, related to the fluence of protons. The monitoring of the drain current I_D during the irradiation showed that nine devices have suffered from probable catastrophic SEB-type degradation. Four of these SiC MOSFETs were randomly selected for the further failure analysis. An analysis of the statistical properties of the SEB mechanism by applying Weibull statistics is presented in [19] indicating random failure over time, for this device irradiated with 53 MeV protons.

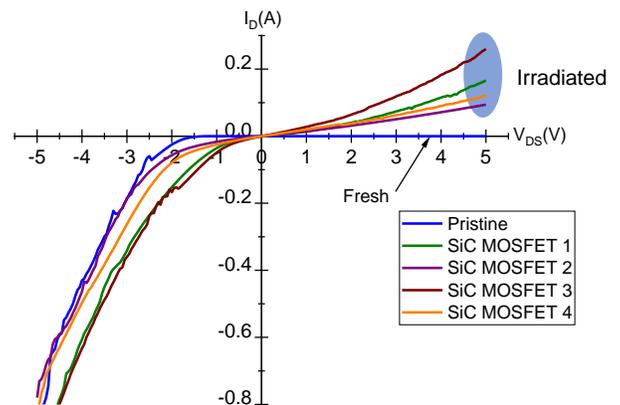
Figure 3: I_D - V_{DS} characteristics of the irradiated and failed devices. Characteristic are compared with a fresh device.

As expected, a conductive trend (I_D - V_{DS}) is measured after SEB. The electrical signature of the catastrophic SEB is then, the presence of a non-negligible current in direct polarization, even under small polarization from 500 mV. A variability between the four devices is measured. By comparing with the pristine device, the MOSFET channel control of the failed devices is lost. This result indicates catastrophic damage at the device gate. At $V_{DS} = 4$ V (Fig. 3), the current exceeds 0.1 A for all damaged DUTs after the irradiation. This strongly suggests that at the SiC die level, the degradation of the material produces a conductive pathway through the MOSFET structure and leads to a high leakage current in forward mode. Since the SiC MOSFET has internal diode formed by the P-I-N layers, this device presents the capacity to have reverse conduction. Interestingly, in reverse voltage I_D - V_{DS} characteristics, a survival of the diode characteristics of the SiC MOSFET is observed. The semi-log plot (Fig.4) shows that for $V_{DS} = -0.6$ V, the average measured leakage current is 14 mA for the degraded devices instead of 1.1 nA for the pristine one.

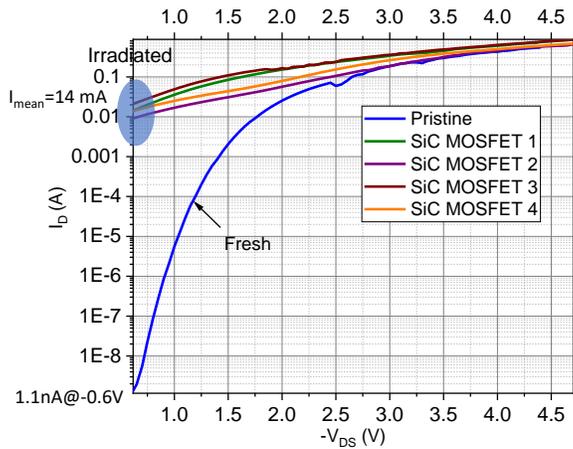
Figure 4: Reverse characterization at $V_{GS}=0V$ of four failed MOSFETs compared to the pristine device, for reverse bias.

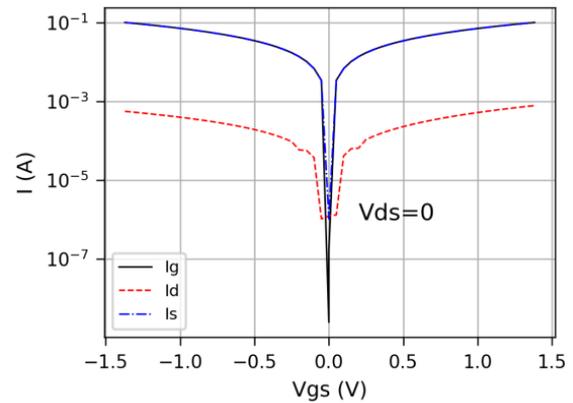
Furthermore, measurements of the drain, source and gate currents as a function of gate bias (V_{GS} with relative low values) for $V_{DS}=0V$, after irradiation (Fig.5), confirm the gate rupture: the gate current is high for forward and reverse V_{GS} bias. Comparing to the drain current, this characteristic shows that the I_D current flows mainly horizontally through the source and not through the epitaxial layer and the substrate (drain contact). After SEB a conductive patch is created locally between the gate and source contacts.

Figure 5: I_G , I_D and I_S as a function of gate bias for the irradiated device. A leakage has been triggered between Gate and Source.

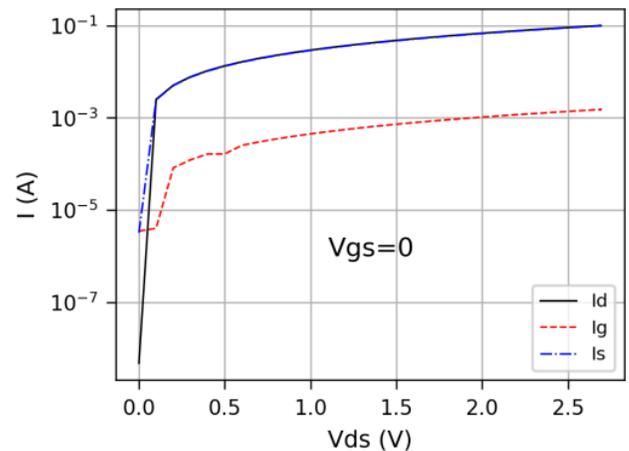
In addition, the same currents were measured as a function of drain bias after irradiation (Fig.6). The current flowing from drain to source shows that the p-type area below the gate has also been destroyed.

Figure 6: I_G , I_D and I_S as a function of drain bias for the irradiated device. A leakage has been triggered between drain and source.

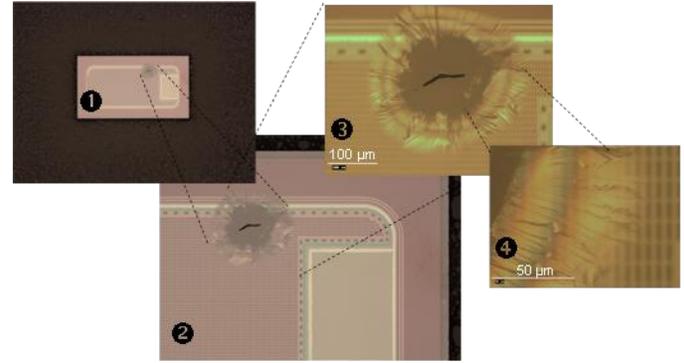
From the back-side, the thinning of the SiC chip face allows to locate the area of the defect through the transparency of the thin SiC die. This step represents a high risk, since SiC material is a rigid but brittle material. Its mechanical behavior is close to that of glass. Three of the four devices were broken at this stage of the sample preparation. SiC thinning from a thickness of $170\ \mu\text{m}$ to about $30\ \mu\text{m}$ was necessary to allow a good optical inspection through the SiC die. Fig.9 represents the optical inspection of a failed die. The die is isolated from the copper base plate (1). The damage consists of a longitudinal crack in the middle surrounding an area with multiple radial cracks (2). The defect occupies a circular area with a diameter of more than $280\ \mu\text{m}$ (3). Through the thinned SiC, a first black crown at the center and radial propagation traces can be observed (4).

Figure 9: Optical inspection of the failed die after thinning

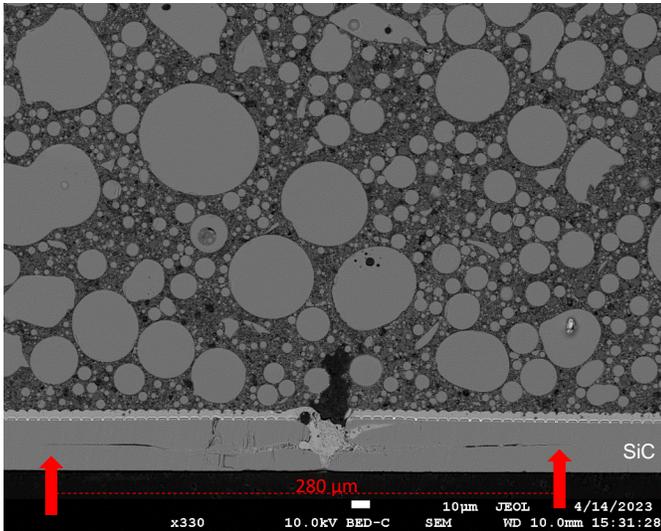
A mechanical cross section was prepared at the end of the sample preparation. Backscattered electron (BSE) imaging and energy dispersive X-ray spectroscopy (EDX) mapping were performed using a scanning electron microscope (SEM, JSM-7200F JEOL). A large view (with a relative magnification of 330, for a size of $360\ \mu\text{m} \times 280\ \mu\text{m}$) of the cross-section surface is reported in Fig. 10. At the interface between the EMC and the SiC die a cavity (area dark on Fig.10) is identified. Just below, the row of SiC MOSFETs is completely destroyed. In addition, a round-shaped area (which seems to have been melted) is observed in the SiC material. The observation of the large crack ($280\ \mu\text{m}$, indicated by the red arrows) inside the SiC semiconductor confirms that during the cross-sectional preparation, the cross-sectional stage has not caused any additional damage. This is the area shown on the backside on the Fig.9. A close up of the defect at the SiC die level is reported in Fig.11 a). At the top of the image, the mold EMC, the SiC MOSFET structure and the large crack in the SiC material can be observed. The outline image (Fig. 11b)), generated from the SEM view, allows to highlight the areas with strong deformation and therefore the collapse of the contact metal.

Figure 10: SEM view of the obtained cross section with backscattered electron detector.

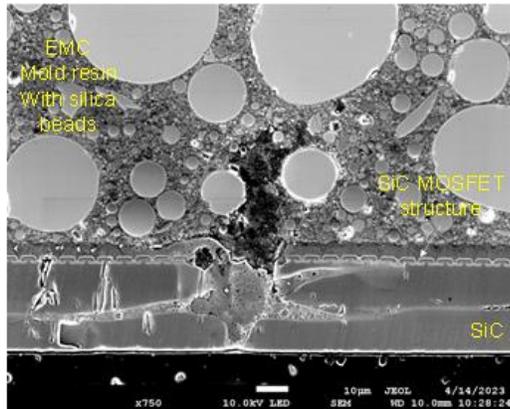
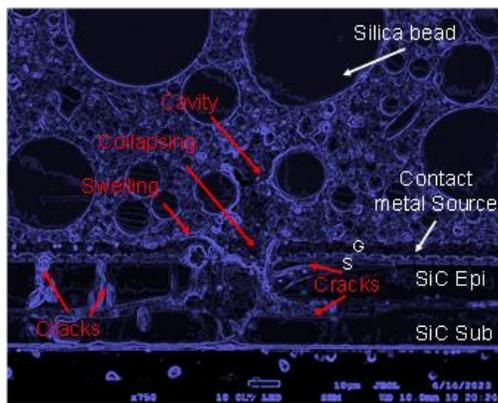
Under of the observed cavity, the different functional parts of the MOSFET structure are indicated in Fig. 11 b). The crack is located in the SiC substrate. The metallic source contact, just on top of the epilayer, is collapsed under the cavity, while at the left side, a swelling is observed.

Figure 11: (a) SEM view of the catastrophic degradation induced by the proton at the SiC die level, the SEM observation is zoomed on the damage in the gates region, at the center of the Fig.10 and (b) the generated contours image used for the analysis.

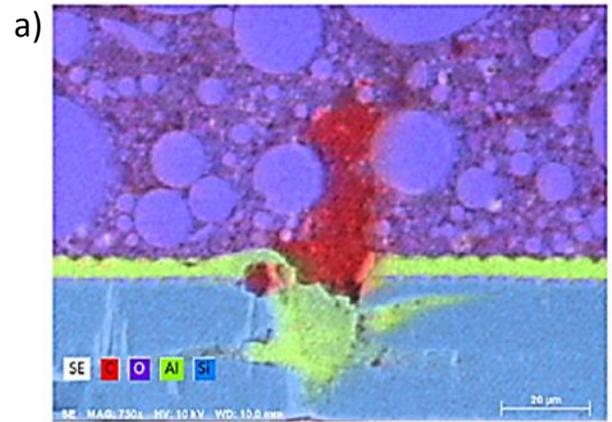
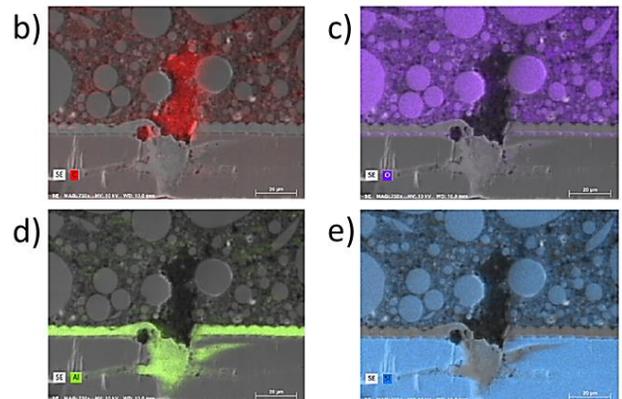
Figure 12: EDX measurements superimposed to the SEM view of the SiC cross section after the proton SEB. (a) the combined image for C (red), O (violet), Al (green), and Si (blue) (b) EDX mapping of C. (c) EDX mapping of Si. (d) EDX mapping of O. (e) EDX mapping of Al.

The location, isolation and analysis of the damage reveals the destruction of the SiC MOSFET and the defect inside the SiC semiconductor structure. EDX analysis reveals traces of carbon like a fire-place, indicating the occurrence of a micro-explosion. To better understand this micro-explosion, the local failure mechanism is correlated with the fire triangle. Indeed, in order to have combustion, it is necessary to have fuel, one oxidant (such as oxygen) and enough energy to initiate the reaction of combustion. In our present case, the proton SEB event generates in the SiC structure a high increase of local

temperature conducting to thermal decomposition of the SiC element. As oxygen is trapped in the MOSFET structure and EMC micro-pores, the energy transferred by the irradiation is sufficient, so combustion and thus explosion can take place. This is clearly visible in Fig. 12. High temperatures are reached, during the blast, when the local temperature exceeds the sublimation temperature of the SiC (> 2100 °C). The SiC epitaxial layer explodes, a cavity is created and is filled with the fusion of the aluminum layer (Fig. 12-f). The evidence of the combustion gas emissions is found in Fig.12-a) where a large concentration of Carbon is measured in the EMC packaging above the location of the SEB event. Failure analysis at the die level of a failed device after proton irradiation indicates micro-explosion like a thermal blast occurring during the SEB. The molten aluminum fills the cavity and creates new conductive path within the device, which is validated by the observed leakage current in the I-V characteristics.
